# Preliminary Site Investigation

## **Rosehill Recycled Water Scheme Extension**

Smithfield, Wetherill Park and Horsley Park, NSW

**Project No. 25284**

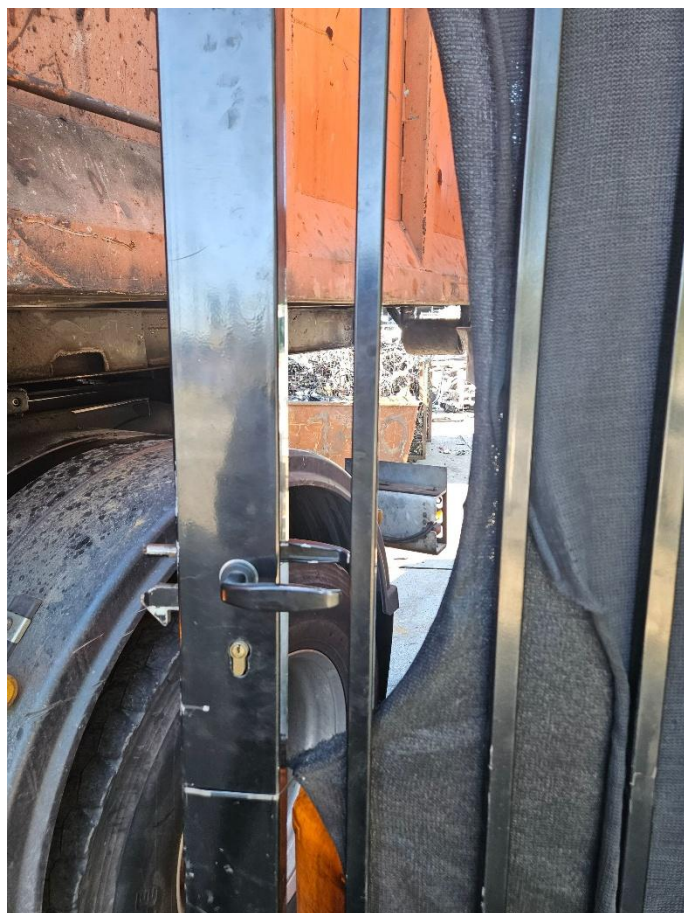
**Photo Description: Waste Disposal at a card yard**

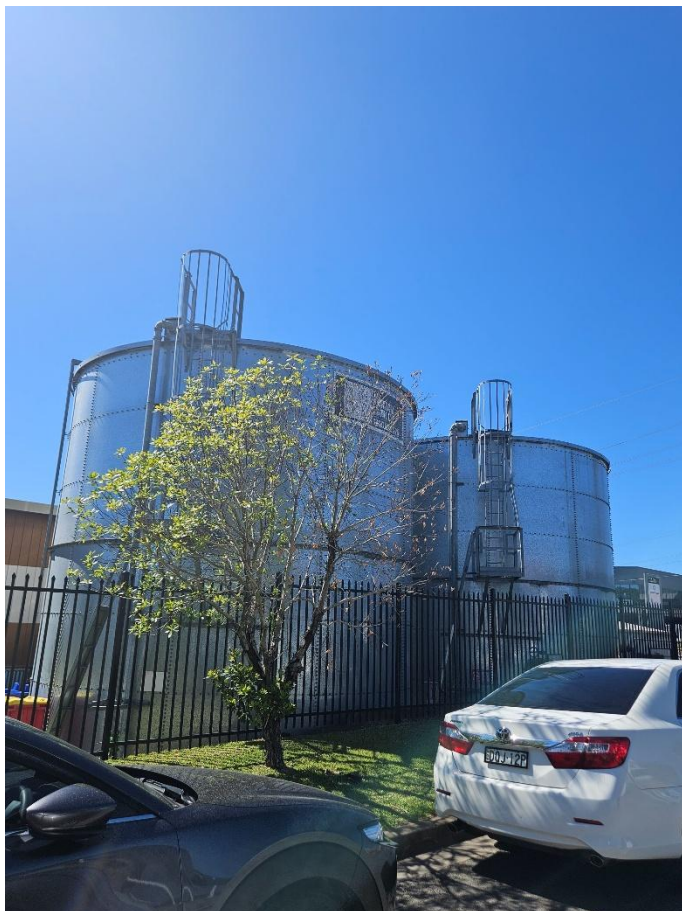
**Photo Description: 2x USTs on Allkotes premises.**

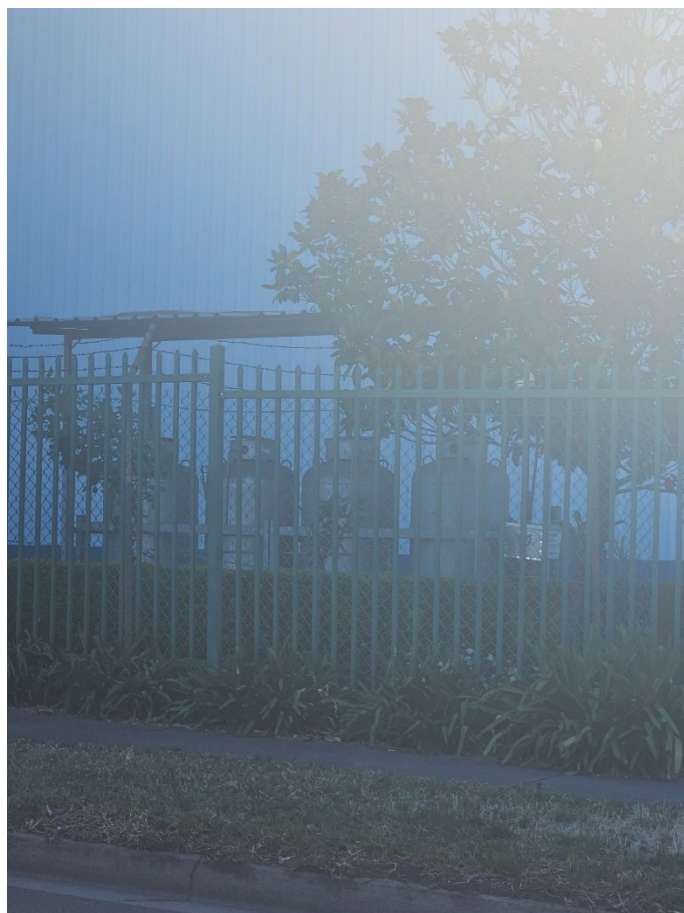
**Photo Description: Chemical / gas storage at ABC Tissue Products**

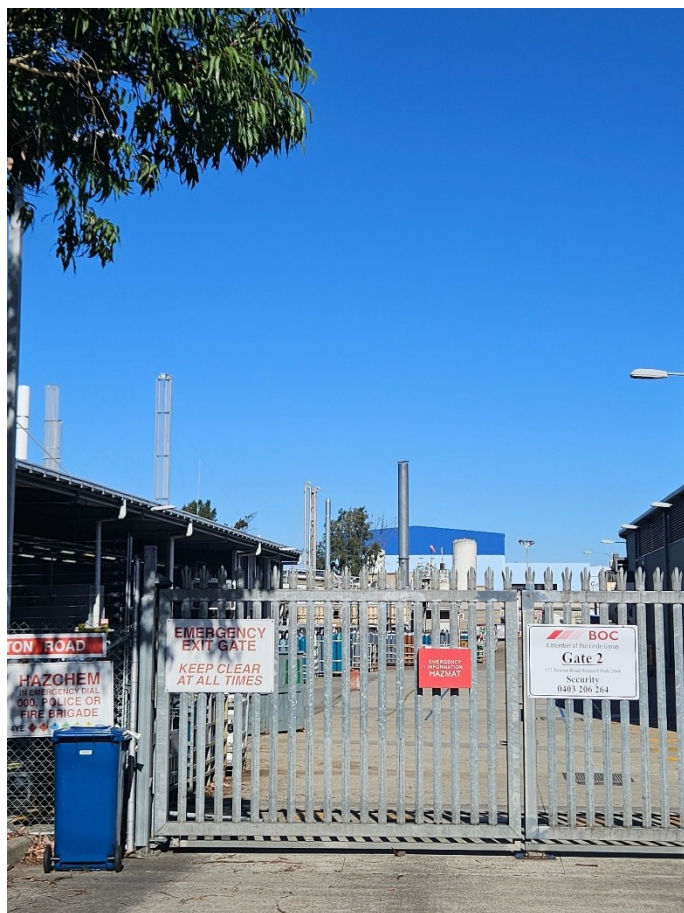
**Photo Description: BOC facility, storage of HAZCHEM**

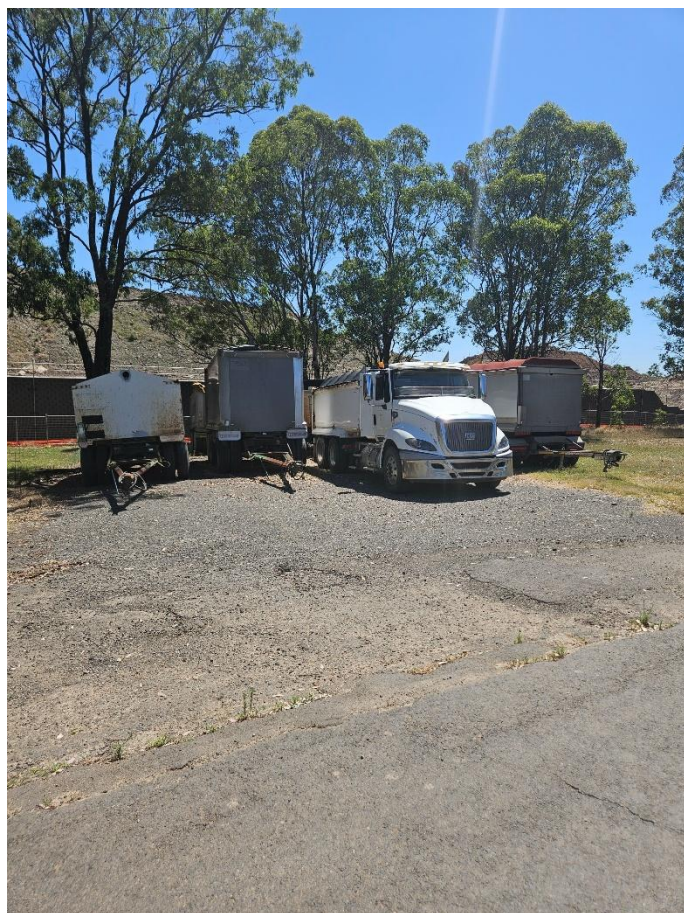
**Photo Description: Truck / trailer storage and offsite stockpiling and construction works**

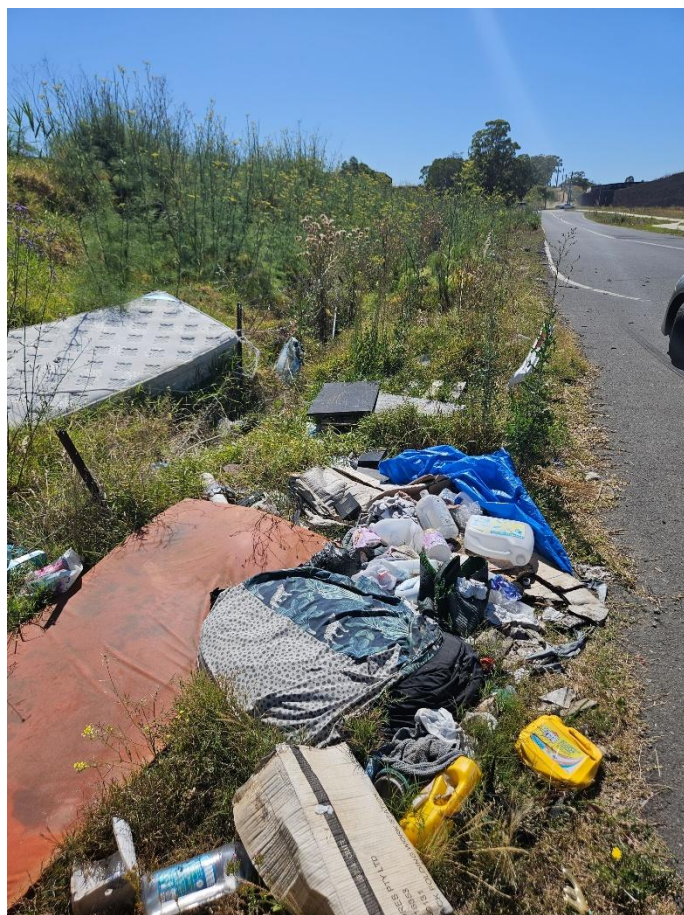
**Photo Description: Illegal dumping at the Western corner of Burnley Rd**

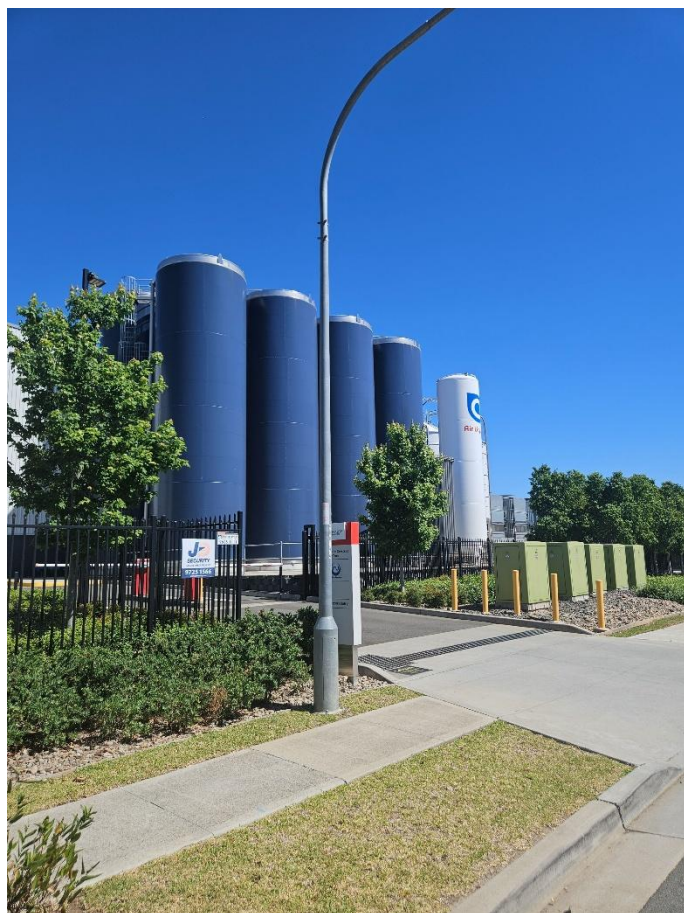
**Photo Description: Nu-Pure Beverages, transformers and ASTs**

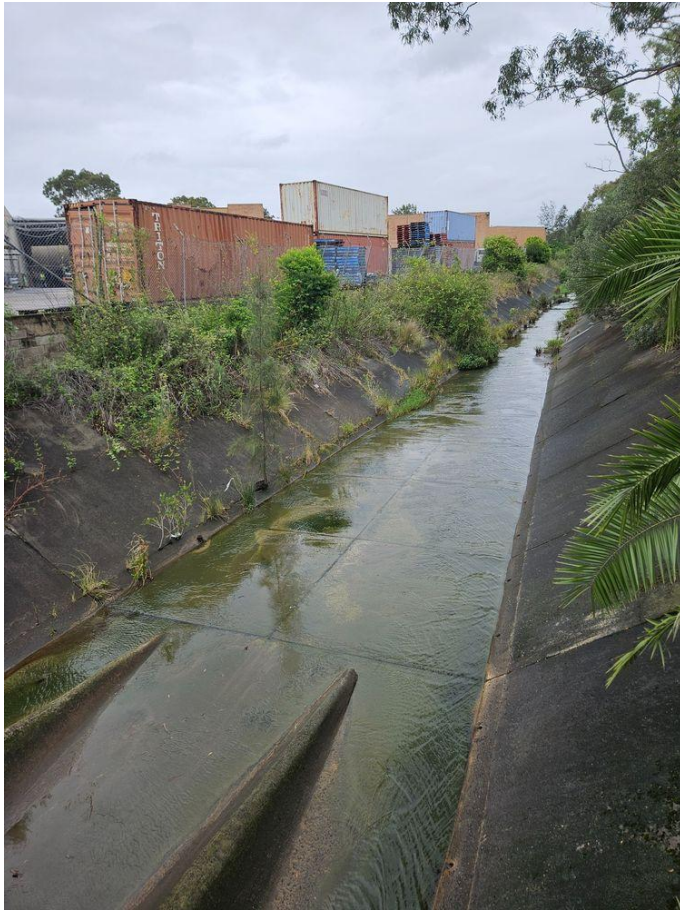
**Photo Description: Low flow stormwater channel flowing northward, very low ecological value. Cracks in concrete had no flow, and weepholes had low flow, so groundwater expected to be deep.**
