Report on  
Geotechnical Investigation

Proposed Residential Subdivision  
32 Lovelle Street and 141 Yarrowa Road,  
Moss Vale

Prepared for  
Prime Moss Vale Pty Ltd

Project 40494.03  
April 2020

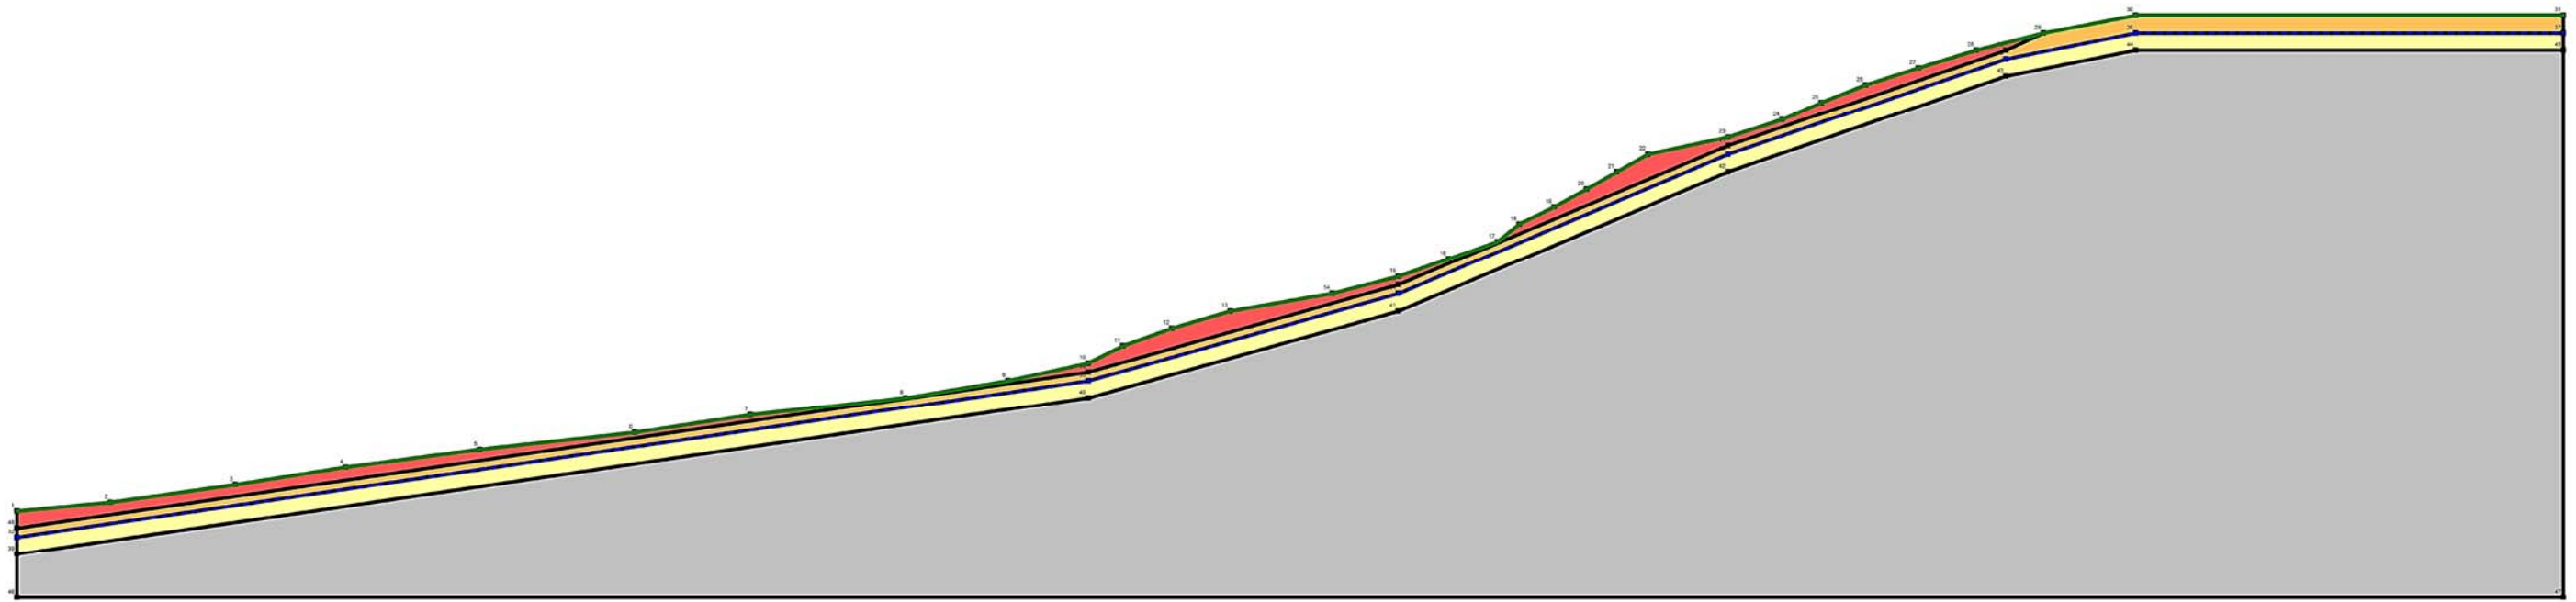
| Scenario | Calculated Factor of Safety |
|---|---|
| Calibration: Existing geometry and observed groundwater – shallow and intermediate depth failures | 1.04* – 1.36 |

In summary, the results indicate that the existing slope is sensitive to variations in groundwater water levels, particularly the movement-affected material. Based on these results it should be feasible to increase the long term factor of safety by implementing the hazard reduction measures detailed in Section 9.3.5.

FoS = 1.045

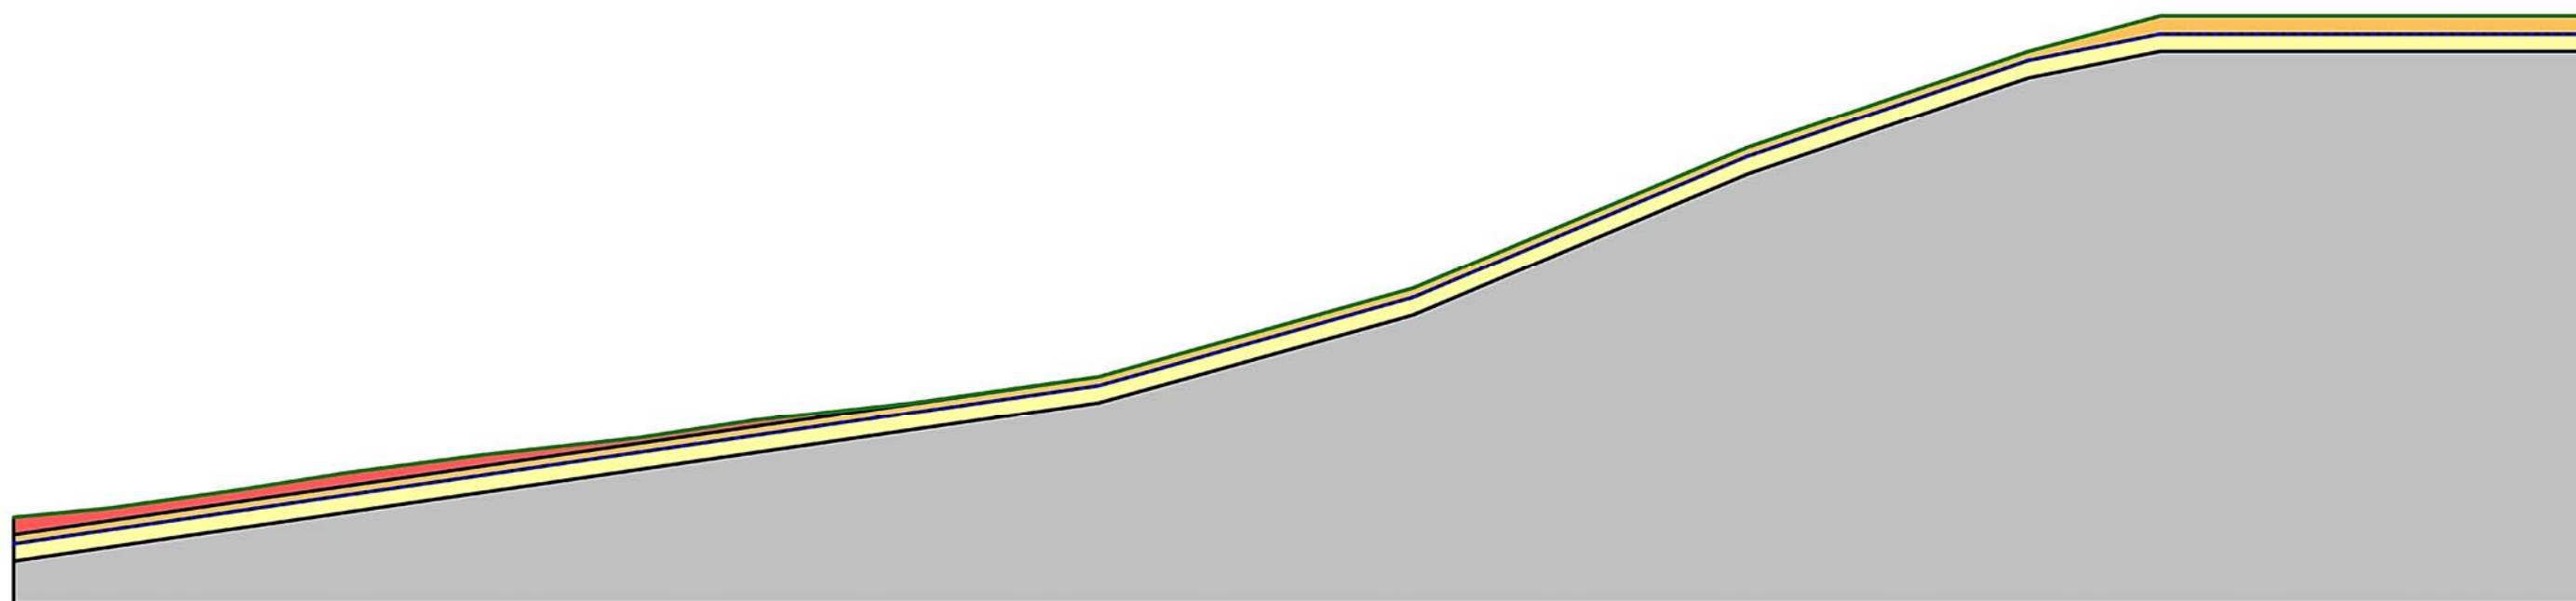
FoS = 1.589

| Scenario | Calculated Factor of Safety |
|---|---|
| Following remedial workings including subsurface drainage and removal and replacement of movement-affected material | > 1.5 |

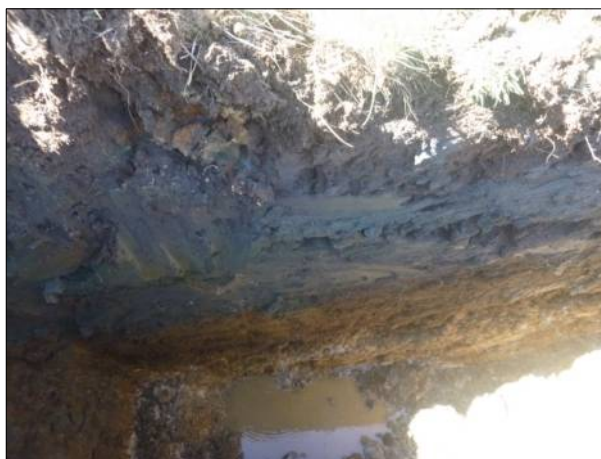
Pit 1 excavation.

Seepage was previously observed during DP's preliminary investigation in September 2018 in Pit 1 in an active area of slumping in the steep hillside. Seepage was also inferred during mapping and from a review of aerial photography:

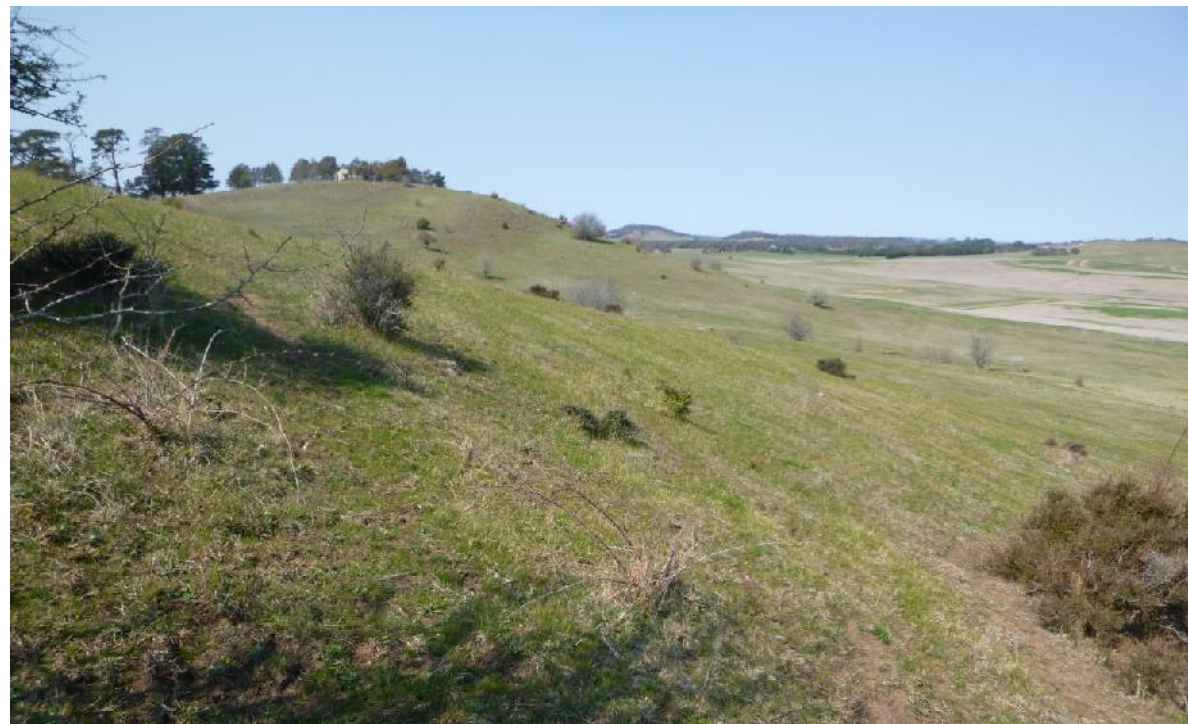
Photo 3: View looking southeast across the steep to very steep hillside in the northern part of the site.

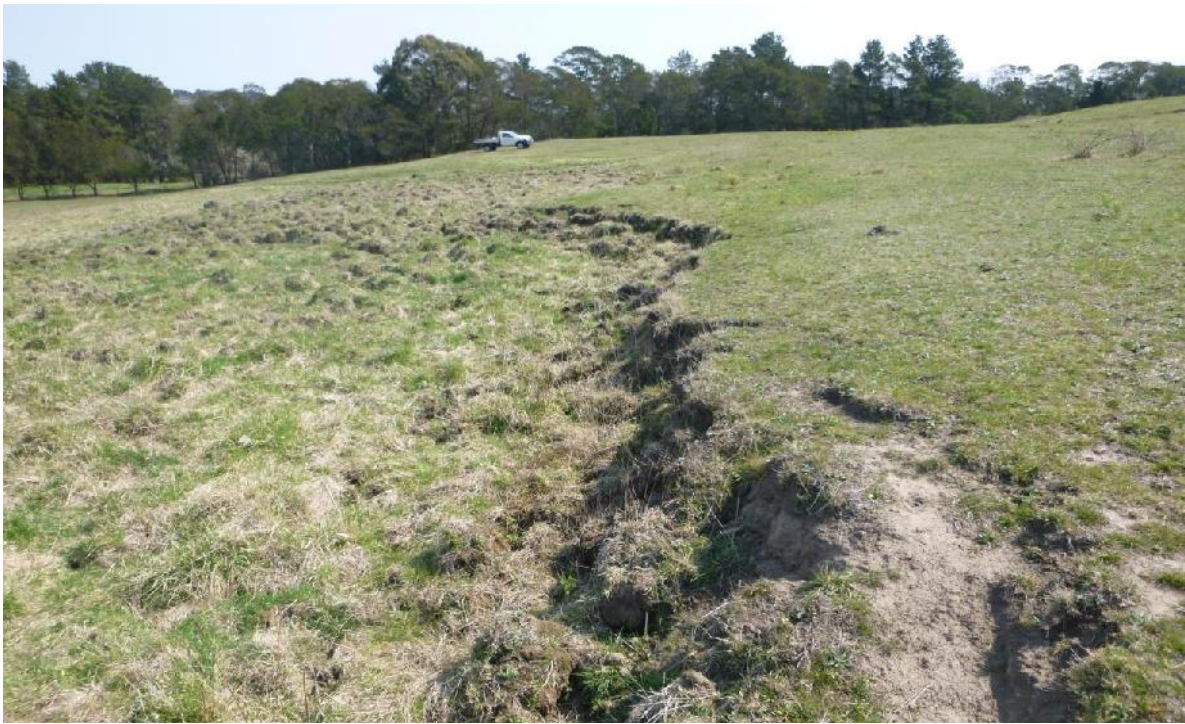
Photo 4: View looking northwest across the active scarp in the lower-middle part of the hillside in the northern part of the site.

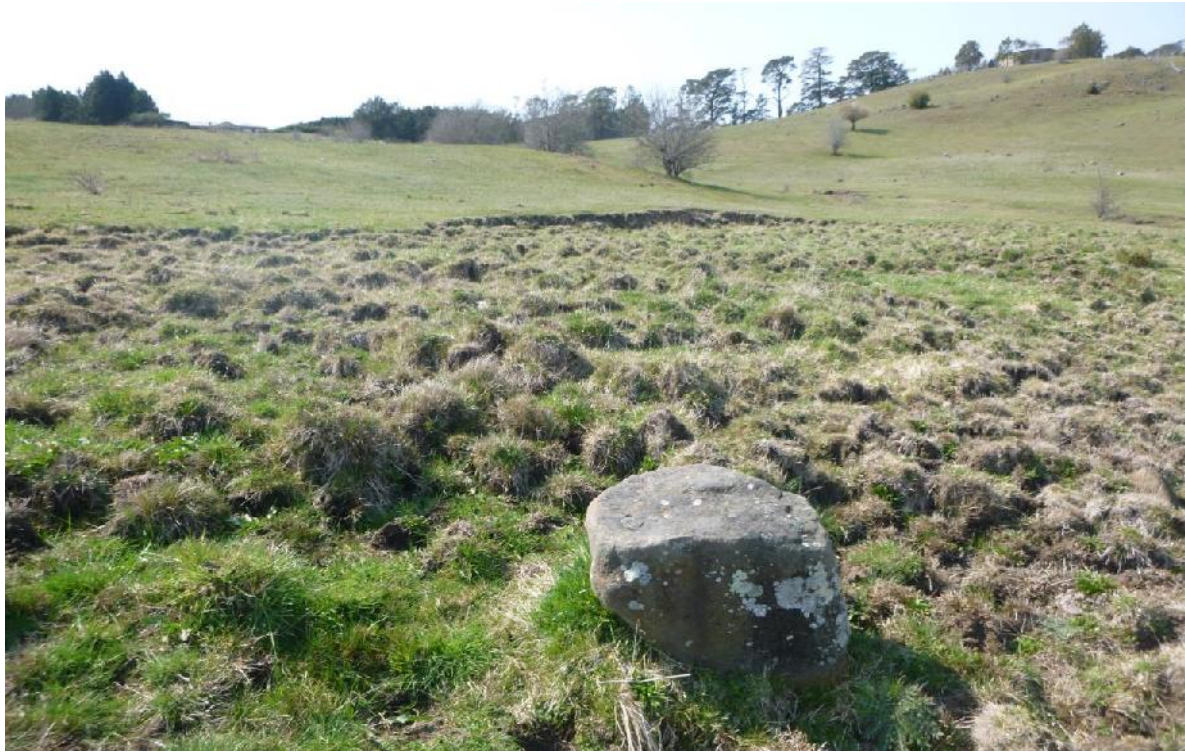
Photo 5: View looking northeast across the active scarp in the lower-middle part of the hillside in the northern part of the site. Note: the igneous boulders lying on the surface.

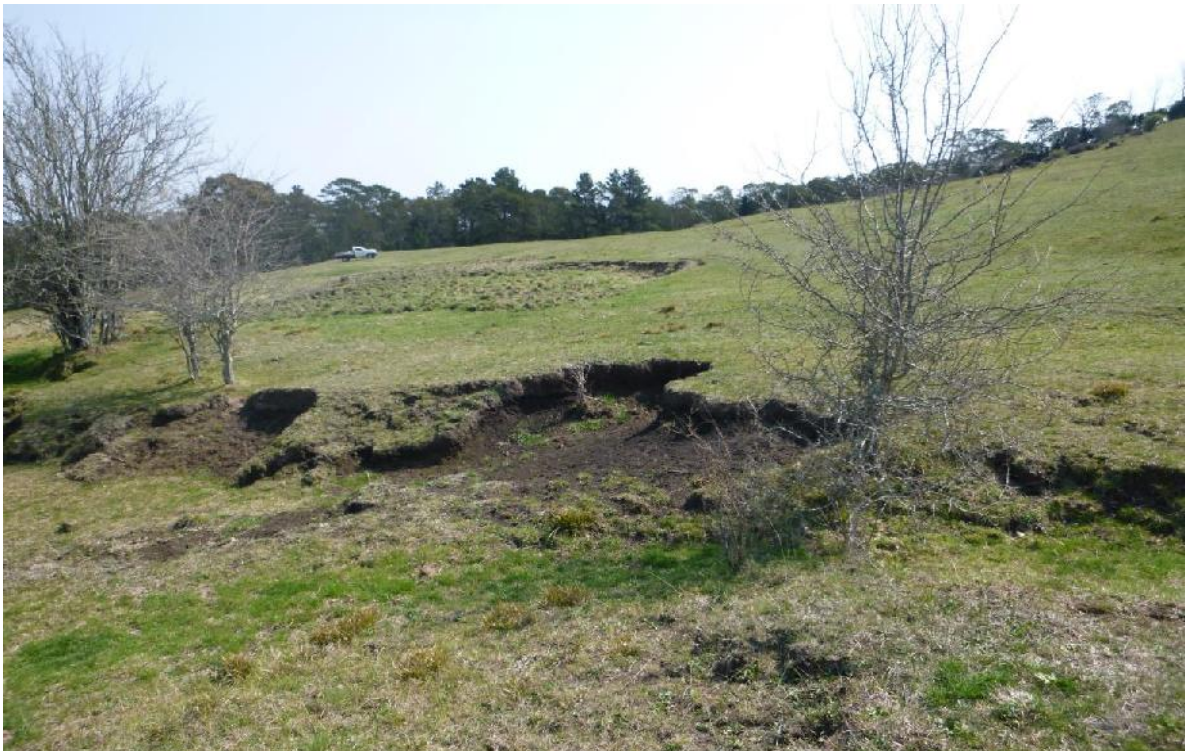
Photo 6: View looking at slumping in a drainage depression in the steep to very steep hillside in the northern part of the site.

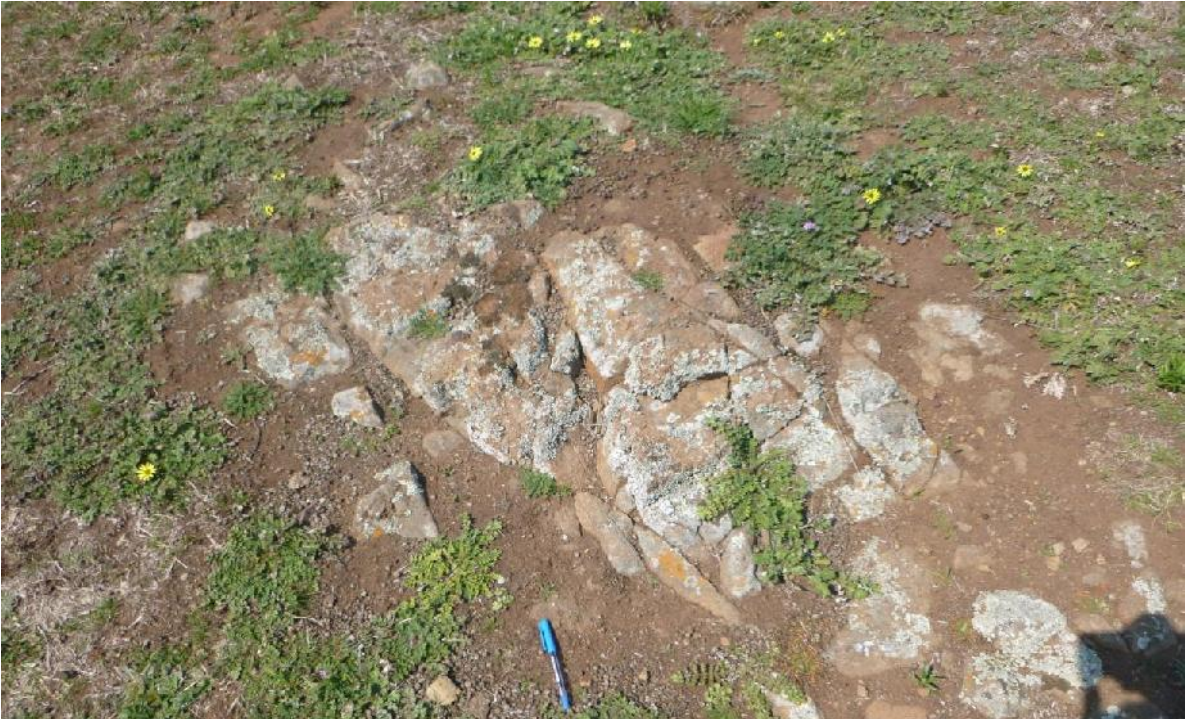
Photo 7: View looking at bedrock exposed near the crest of the steep to very steep hillside near the small water reservoir in the northern part of the site.
