# Safety Alert 191209-1

13 December 2019

## Serious burns sustained whilst operating high voltage switchgear

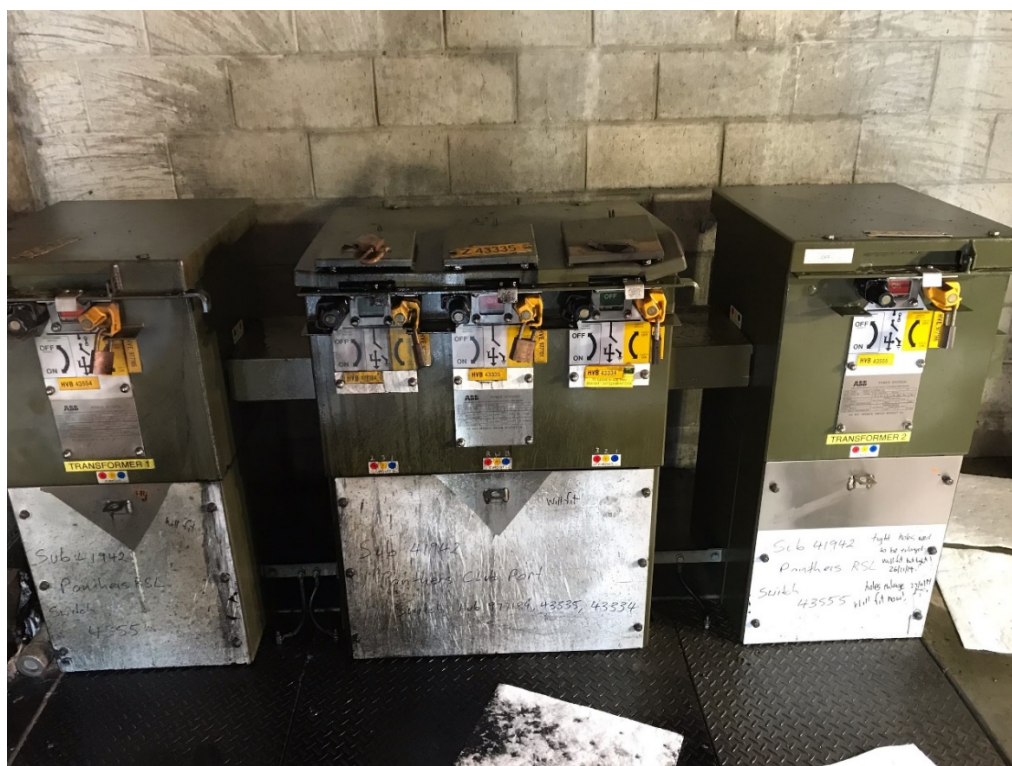
Two workers have sustained serious burn injuries while working on network assets.<sup>1</sup> Information provided by the network operator indicates that a **catastrophic failure occurred within an oil filled ABB SDAF metal clad switch while operating work was being performed**. IPART understands that Andelect and ABB branded SD-series metal clad switches are similar equipment.

Image taken at site by a SafeWork NSW inspector after the accident

- All distribution High Voltage (HV) oil filled switchgear is to be de-energised prior to local operation, with the HV conductors feeding the switchgear remotely isolated.
- Re-energisation shall only be completed via a remote switch, with the substation that the switch is housed in vacated and secured to prevent access during these operating activities.
- The operating restriction applies to all planned and unplanned work tasks.
- There are no additional restrictions regarding general access to substations containing HV oil filled switchgear and remote operating work may continue as per normal practice.
