SYDNEY DESALINATION PLANT PIPELINE

ASSET MANAGEMENT PLAN REVIEW

29 July 2016

SEG604-TD-WE-REP-1001 Rev 0

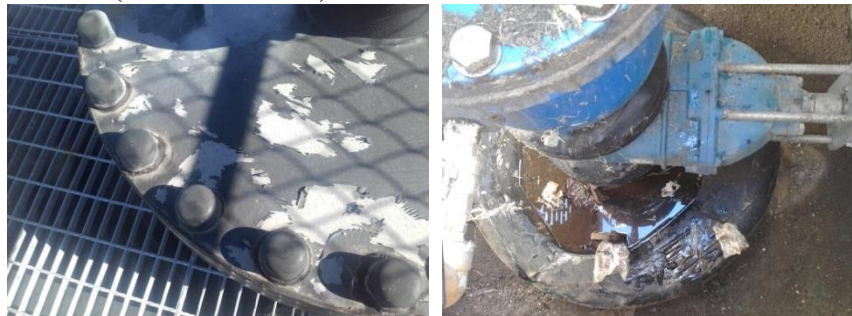
1. Water is pooling on top of the large flanges under some of the air valves. Approximately 50% of the coating has failed on the large flange under ROAV5 (above SWSOOS).

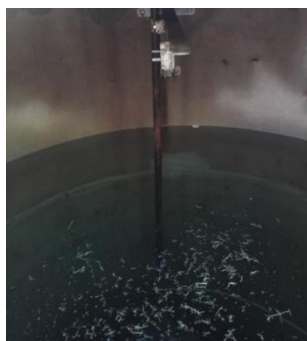
2. The scour valve MASC1 at Tempe Reserve was fully submerged in water.

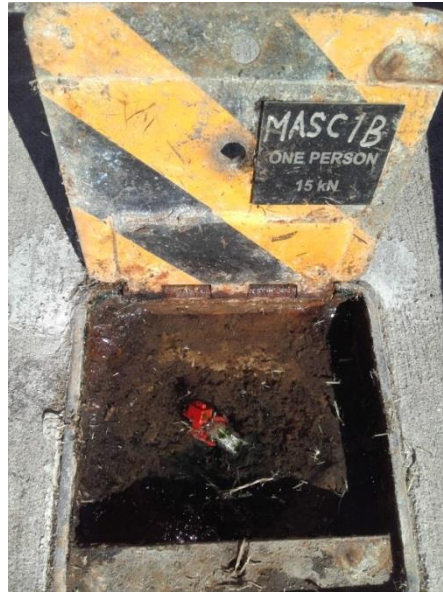
3. Anchor points around the valve pits at Tempe Reserve are badly corroded, especially the hinges and underside of the lids. Anchor point pits are full of mud, dirt and water. Load testing last completed November 2015 and are therefore compliant but with the level of attack by corrosion there is the possibility of noncompliance in the foreseeable future.

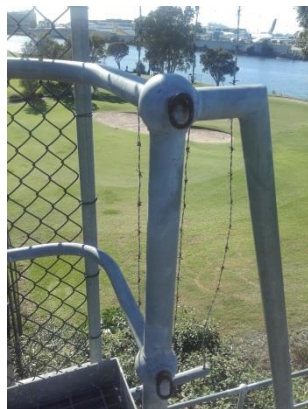
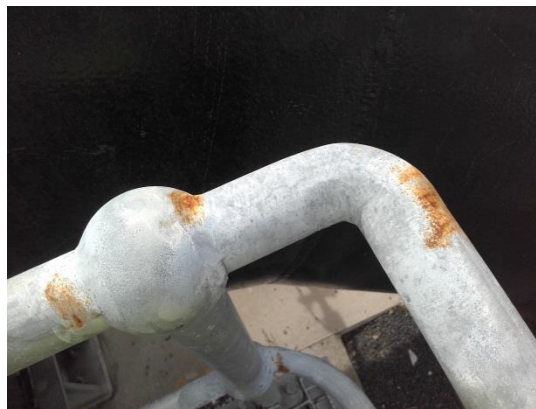
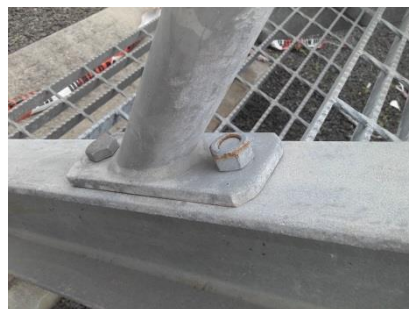
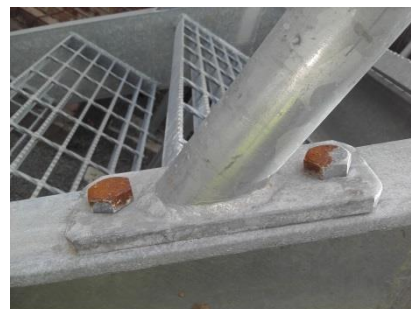
4. Most bolts on pipe flanges have caps fitted. One cap was removed to reveal a bolt covered with grease.
5. A few loose fasteners and short bolts on some stairways. Not considered high risk but it is a potential WHS hazard which may increase in risk over time. Surface corrosion was observed at some points on hand rails and chain hooks.

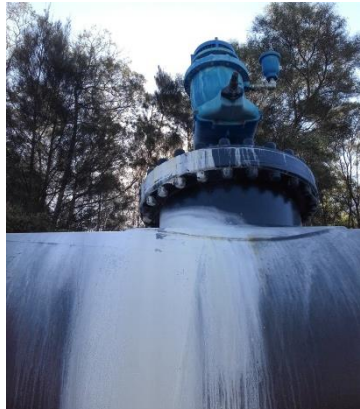
7. No leaks were observed during the inspection, although there was some evidence of previous leaks, especially at Air Valve MAAV3 (Alexandra Canal - CH585) which Veolia advised was the result of a ball valve being left partially open after a pressure gauge was stolen from this site.

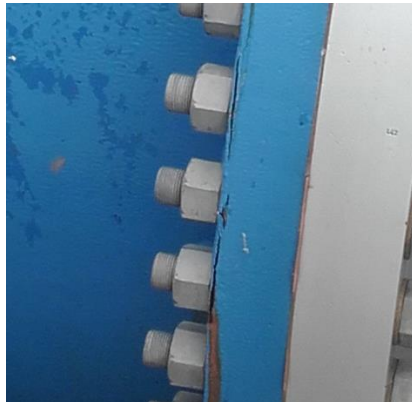
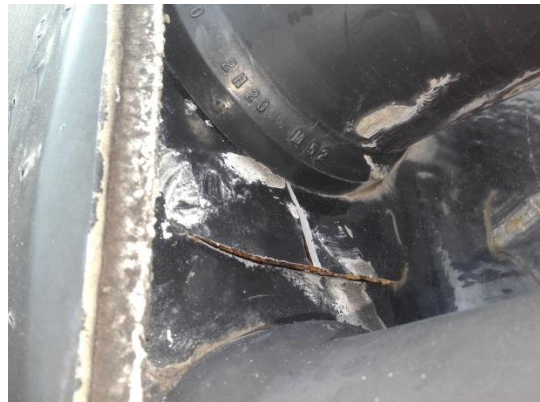
8. There are several areas where the protective coating is cracking, bulging or drummy around flanges and fasteners on the pipe at Kurnell Pump Station and Shaft 11C. The pipes with coating issues at these locations have epoxy coating, not Sintakote.

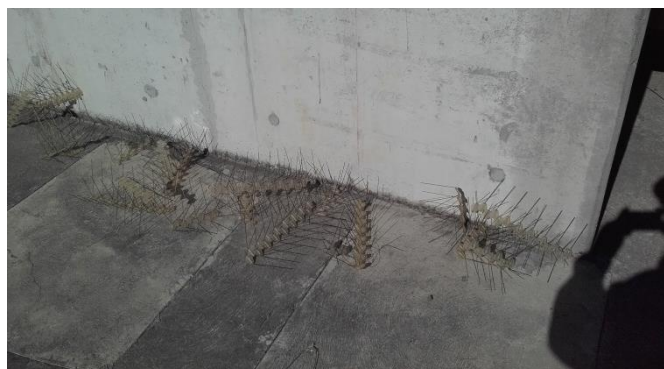
9. Several bird spikes are missing from the top of the pipe at the M5/SWSOOS crossover and Alexandra Canal. While this is not a significant risk for the pipe the bird spikes would be part of the requirement of SACL to manage and control the presence of birds in the vicinity of the airport in accordance with CASA regulations. It is assumed the bird spikes are a requirement of SACL's "Bird Hazard Management Guidelines" which is referred to in the SACL Maintenance Plan.

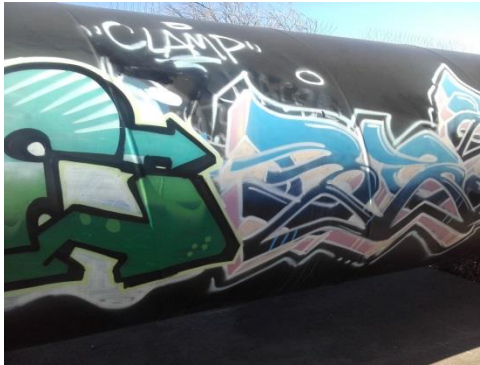
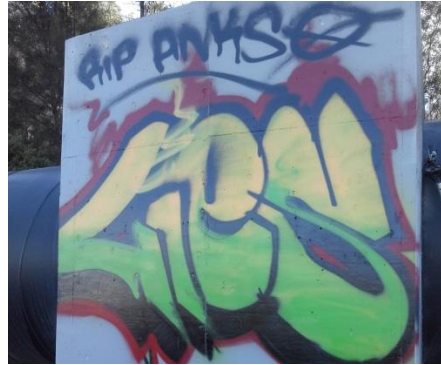
10. Graffiti was observed the M5/SWSOOS crossover on the pipe and anchor blocks and pipe supports and, to a lesser extent, along Alexandra Canal.

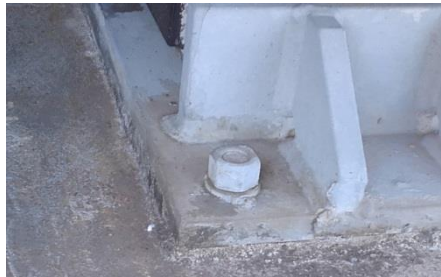
11. Some short and bent bolts were found on pipe footings along Alexandra Canal. While the risk to the pipeline is low, a short bolt means that the full design strength of the bolt is not able to be realised and thread stripping is more likely to occur if the pipe footing is subjected to stresses closer to the upper end of its design.

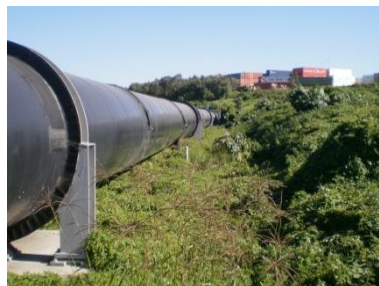
12. There was some overgrown vegetation in some areas, especially on the northern side of the pipe along Alexandra Canal (the side furthest from the Canal).

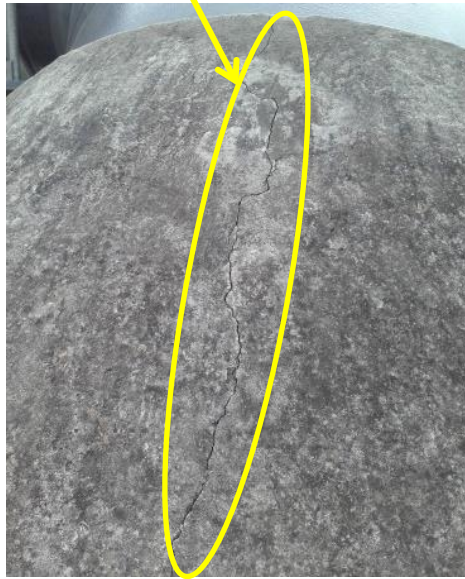
13. There is a longitudinal crack in the concrete encasement of the pipe where it rises from underground at Shaft 11C.

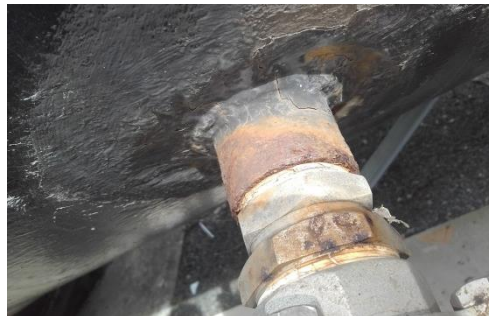
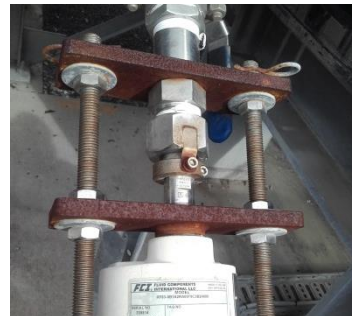
14. At Shaft 11C, there is corrosion and cracking where the flow switch is connected to the main pipe. There is also surface corrosion on the metal brackets used to secure the flow switch.

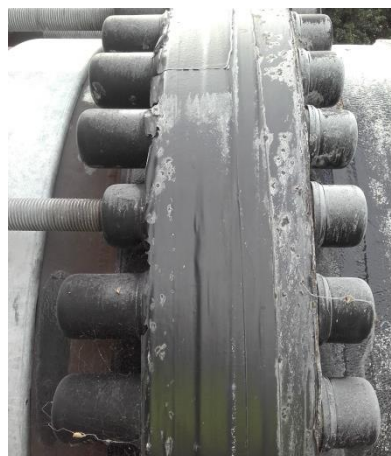
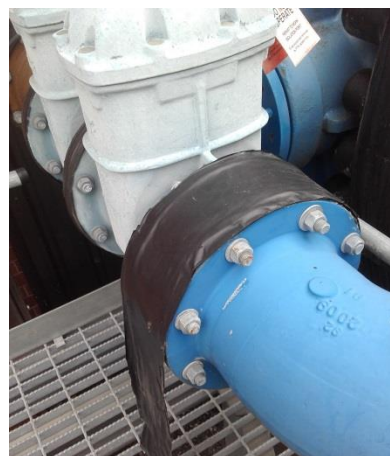
15. The protective tape wrapping on pipe flanges at Shaft 11C is in poor condition (several holes, coming loose from flange)

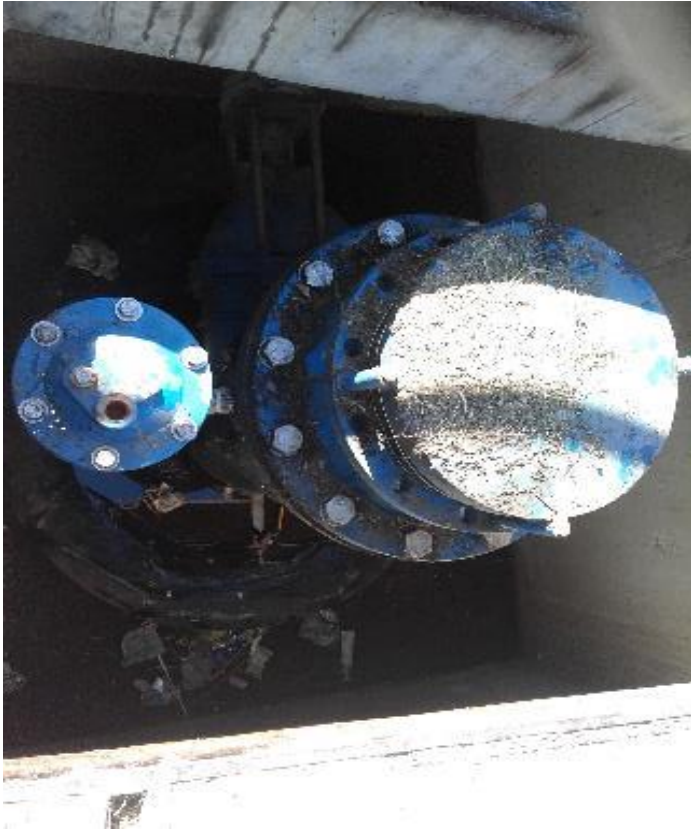
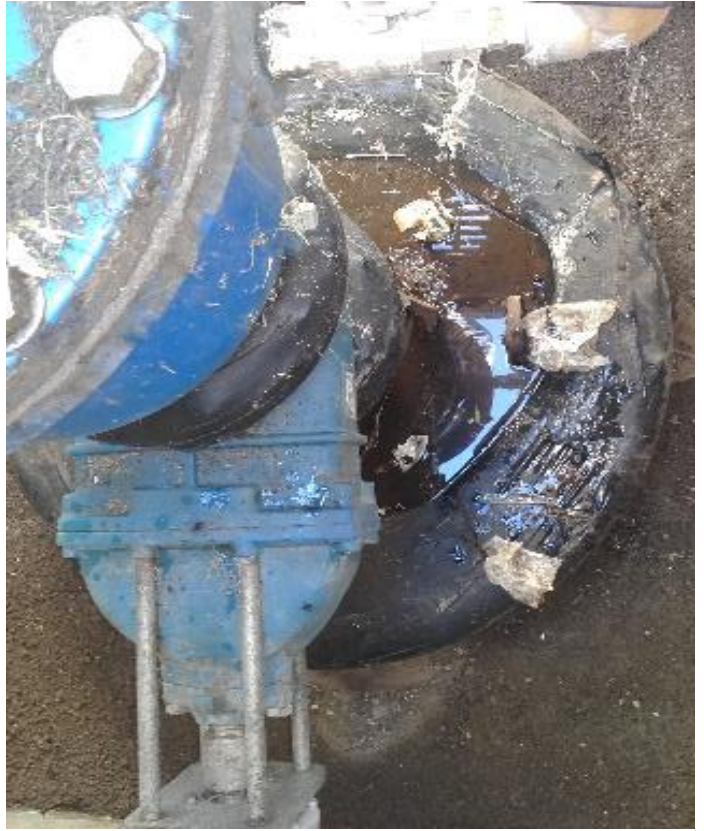
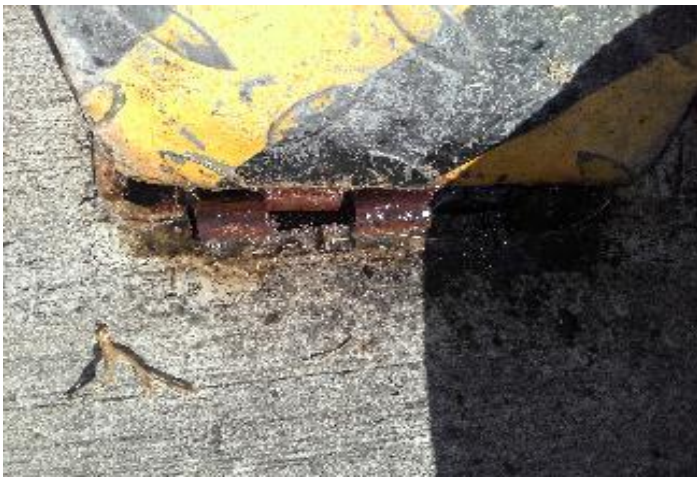
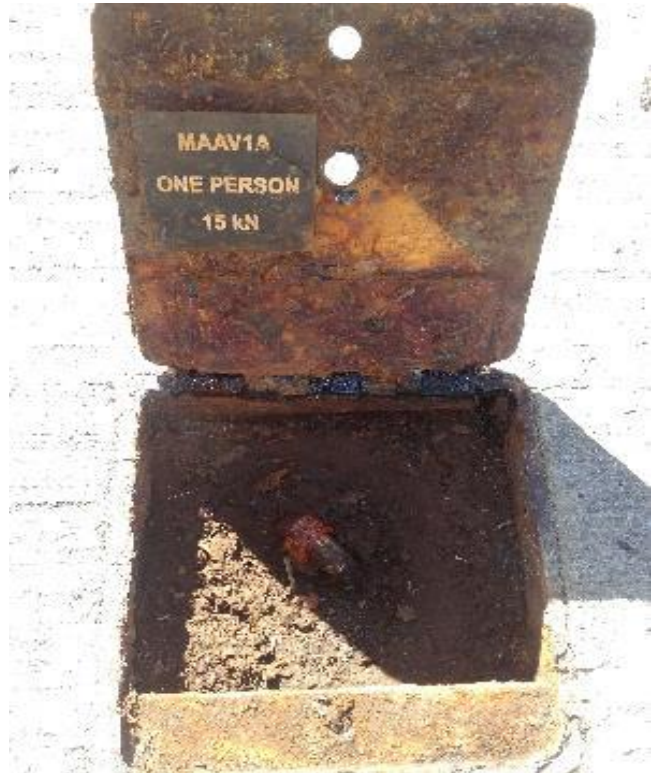
PIPELINE:	SDP Delivery Pipeline - Marrickville Section
LOCATION:	MAAV1 - Tempe Reserve, Next to Cooks River
DIAMETER:	250mm
INSPECTED BY:	Mark Mordini
INSPECTION DATE:	17/05/2016
EXTERNAL PROTECTIVE COATING TYPE:	Fusion Bonded Epoxy

Item	Rating (1 - 5)	Comments	Photo #
External Protective Coating	2	Minor wear and tear, some debris and dirt on surface	
Pipe Joints including Isolation Gasket (where applicable)	3	Water pooling on bottom flange	
Isolation Valve	2		
Fasteners (loose, missing, corroded)	2	Most fasteners are wrapped	
Ease of Operation	N/A	Valve not operated	
Spindle (including surface box)			
Gland and seals (where applicable)			
Pit Cover and Seat (where applicable)	3	Frame surface corrosion approx 90% of surface area. Moderate wear and tear	
Internal Pit Structure (where applicable)	2	Minor cracks and chips	
Stairs, Ladders and Access Platforms (where applicable)	N/A		
Other (specify) - Anchor Points	4	Badly corroded lids esp. hinge and underside of lid. Pits are full of mud, dirt and water. Testing due Nov 2016 (Compliant)

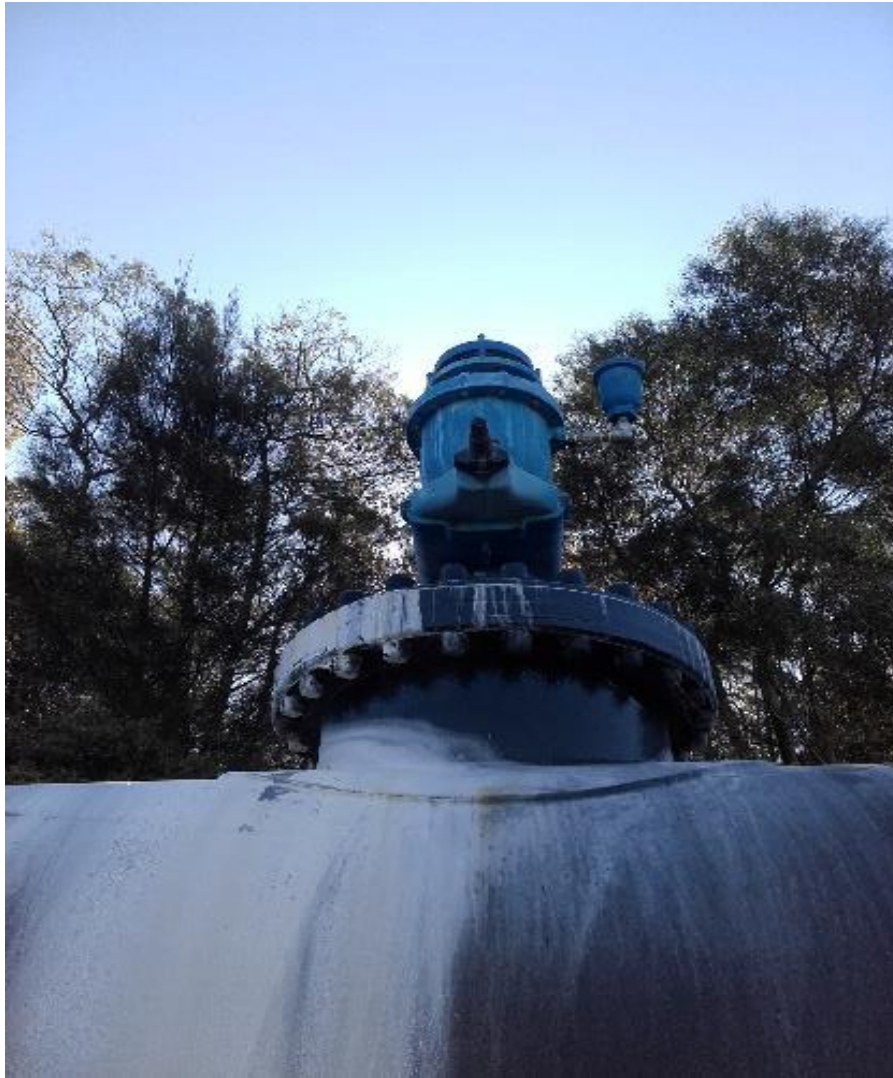
PIPELINE:	SDP Delivery Pipeline - Marrickville Section
LOCATION:	MAAV3 - Alexandria Canal - CH585
DIAMETER:	250mm
INSPECTED BY:	Mark Mordini
INSPECTION DATE:	17/05/2016
EXTERNAL PROTECTIVE COATING TYPE:	Fusion Bonded Epoxy

Item	Rating (1 - 5)	Comments	Photo #
External Protective Coating	2		
Pipe Joints including Isolation Gasket (where applicable)	2		
Isolation Valve	2		
Fasteners (loose, missing, corroded)	2		
Ease of Operation	N/A		
Spindle (including surface box)	2		
Gland and seals (where applicable)	2		
Pit Cover and Seat (where applicable)	N/A		
Internal Pit Structure (where applicable)	N/A		
Stairs, Ladders and Access Platforms (where applicable)	N/A		
Other (specify) - Pressure Gauge	5	Pressure gauge has been stolen. Ball valve was left partially open, which resulted in leak onto pipe (white stain from residue)

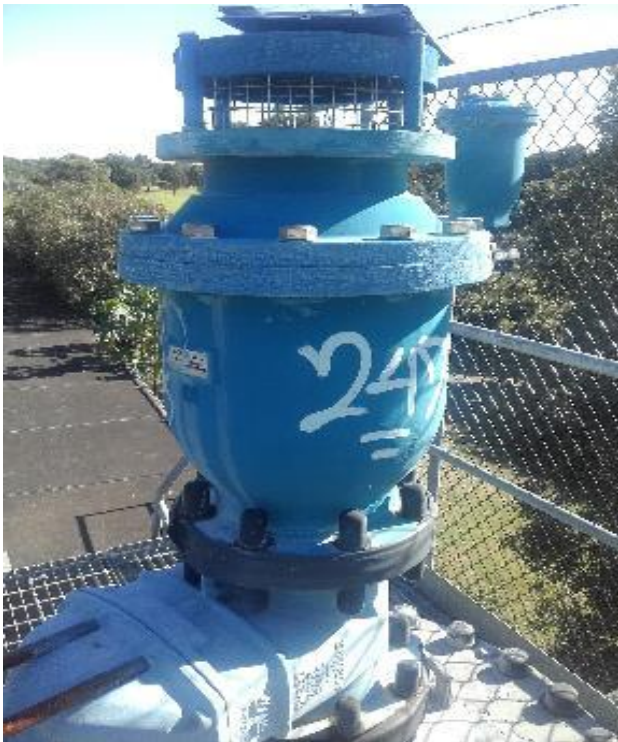
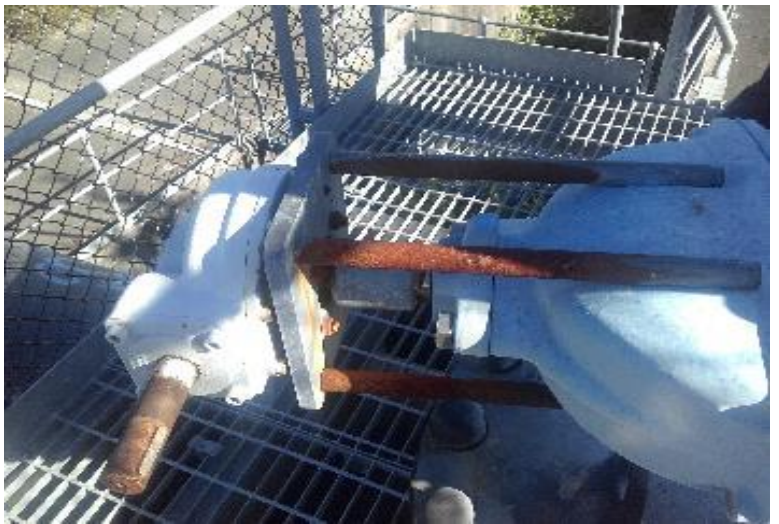
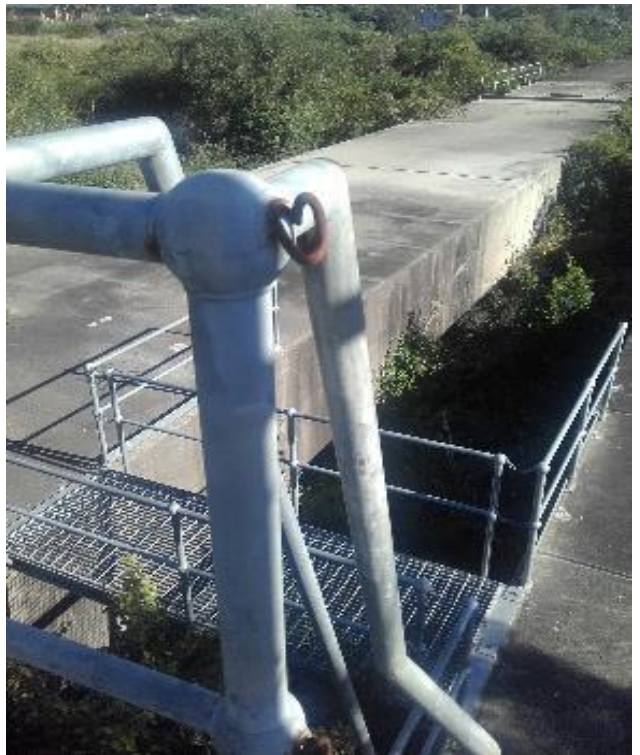
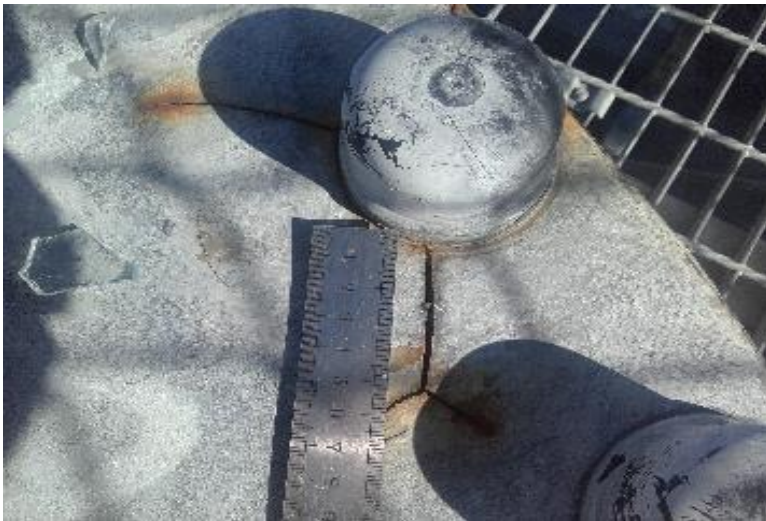
PIPELINE:	SDP Delivery Pipeline - Rockdale Section
LOCATION:	ROAV5 - Above SWOOS
DIAMETER:	250mm
INSPECTED BY:	Mark Mordini
INSPECTION DATE:	17/05/2016
EXTERNAL PROTECTIVE COATING TYPE:	Fusion Bonded Epoxy

Item	Rating (1 - 5)	Comments	Photo #
External Protective Coating	4	Moderate cracking around flange. ~50% coating failed on large flange on bottom	6-8, 15
Pipe Joints including Isolation Gasket (where applicable)	3		
Isolation Valve	2		14
Fasteners (loose, missing, corroded)	2	Caps on most bolts	13
Ease of Operation	N/A		
Spindle (including surface box)	2		
Gland and seals (where applicable)	3		
Pit Cover and Seat (where applicable)	N/A		
Internal Pit Structure (where applicable)	N/A		
Stairs, Ladders and Access Platforms (where applicable)	2	1 x loose fastener near bottom of stairs. Minor corrosion on some hand rails. Chain hooks badly corroded	1-5
Other (specify) - Gearbox	3	Corroded fasteners, and surface corrosion on handwheel shaft	9-10
Other (specify) - Pressure Gauge	4	Broken glass	12
