Correct Planning & Consultation for Mayfield Group

Draft Decision released for NSW Rail Access Undertaking

Complaint from CPCFM

Additional Information and evidence to support our formal complaint.

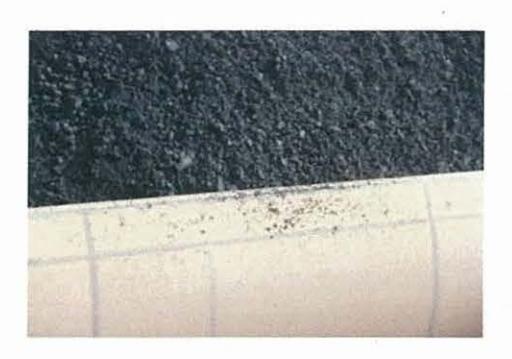
3/11/2013 Selwyn Street Close ups of unsecured load and spillage

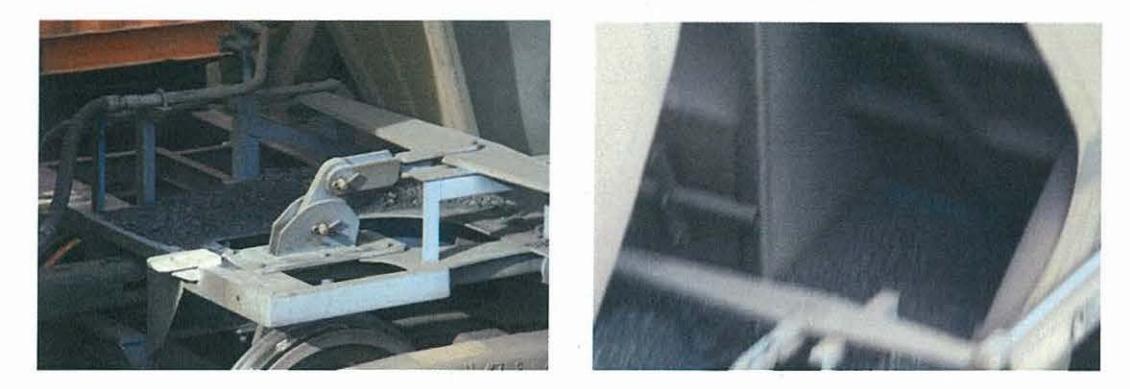
5/6/2013 Selwyn St Wagon platform coal unsecured waiting to fall

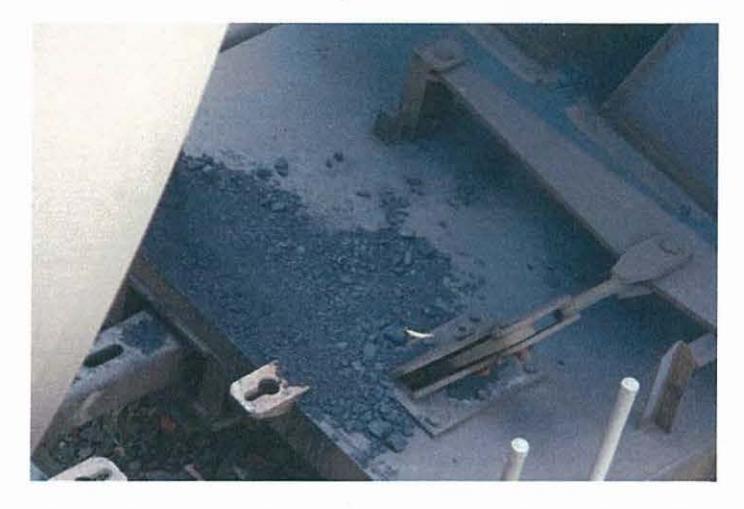
5/6/2013 Mayfield West, Wagon platform coal unsecured waiting to fall

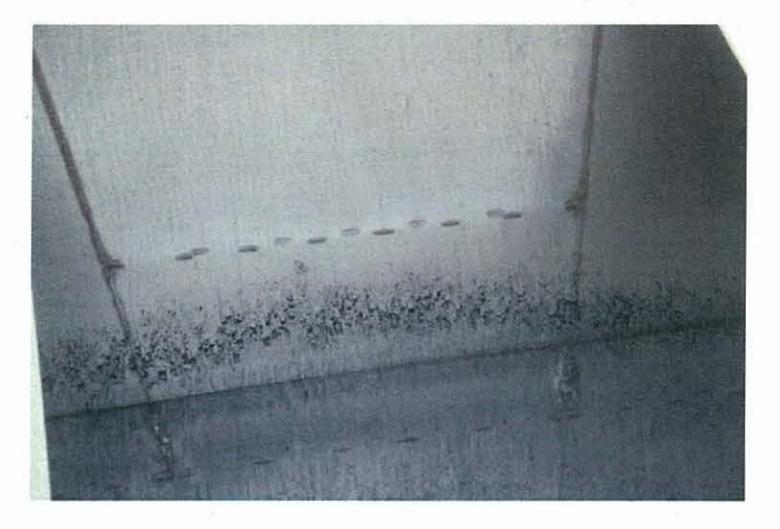
5/6/2013 Mayfield West Interior surface waiting to blow out

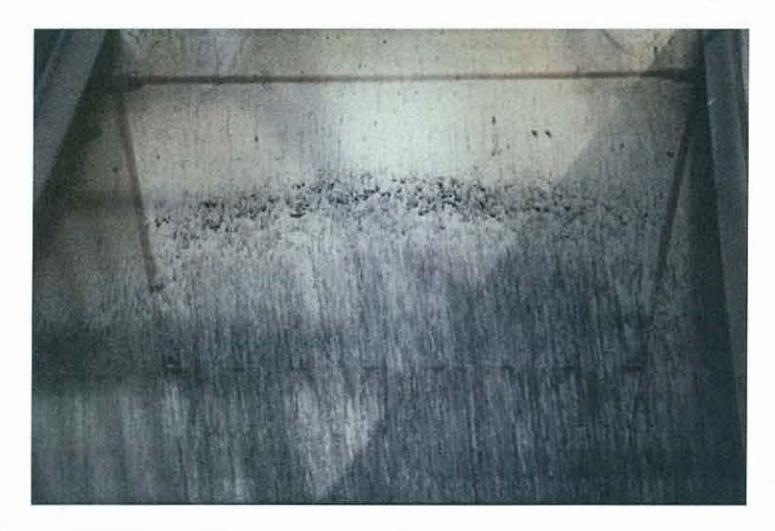
5/6/2013 Stick coal residue drying out ready to blow out

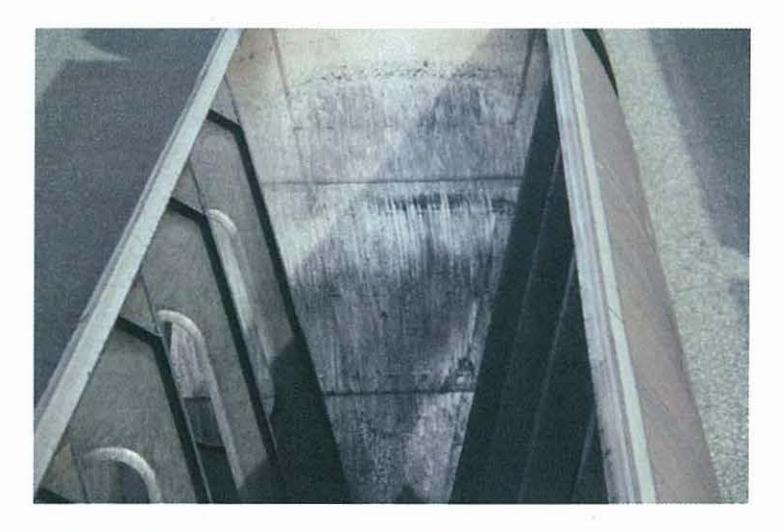
5/6/2013 Mayfield West, Stick coal residue drying out ready to blow out

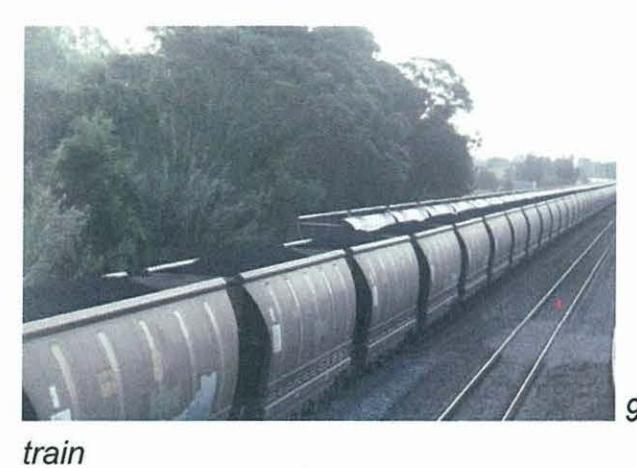
9/6/2013 Maitland Photo of over height

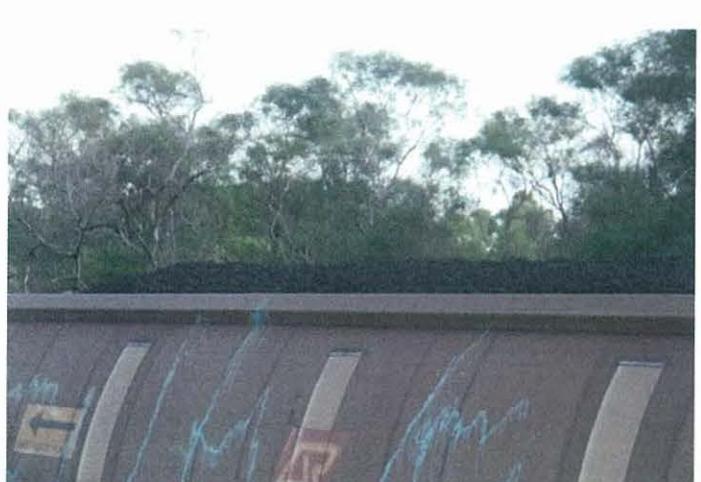
9/6/13 Maitland Excessive height

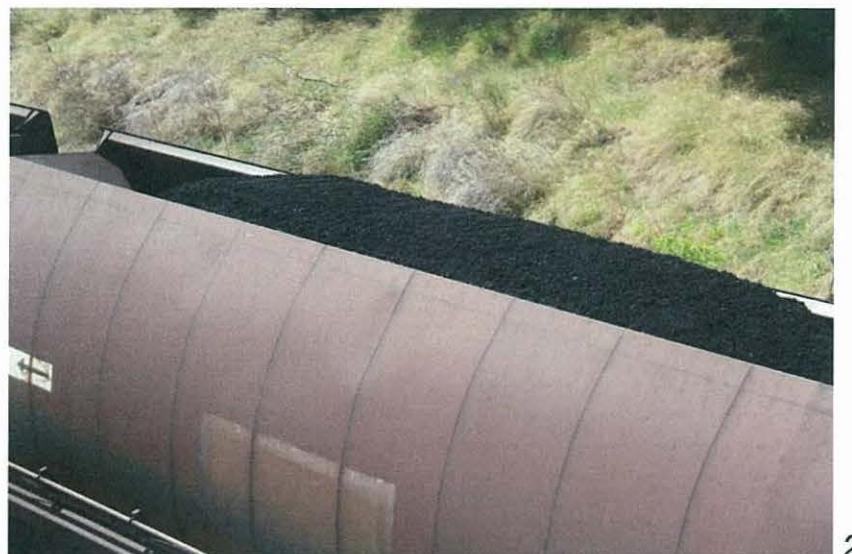
23/10/2013

Wagons are also loaded to the point that there is no freeboard and coal simply pours over the side

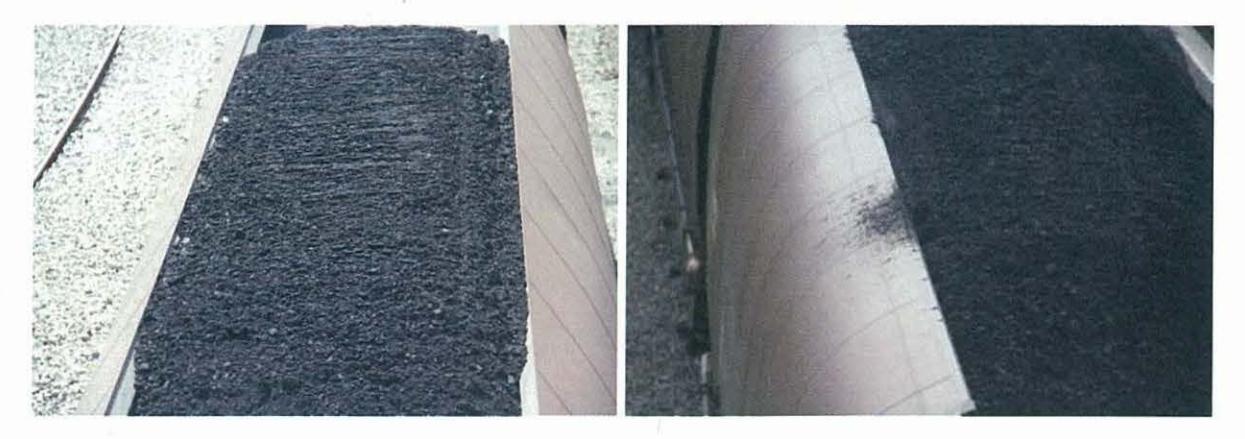
23/10/2013 Selwyn St3/11/2013 Selwyn StPhoto showing no freeboard and coal pouring down the wagon side.

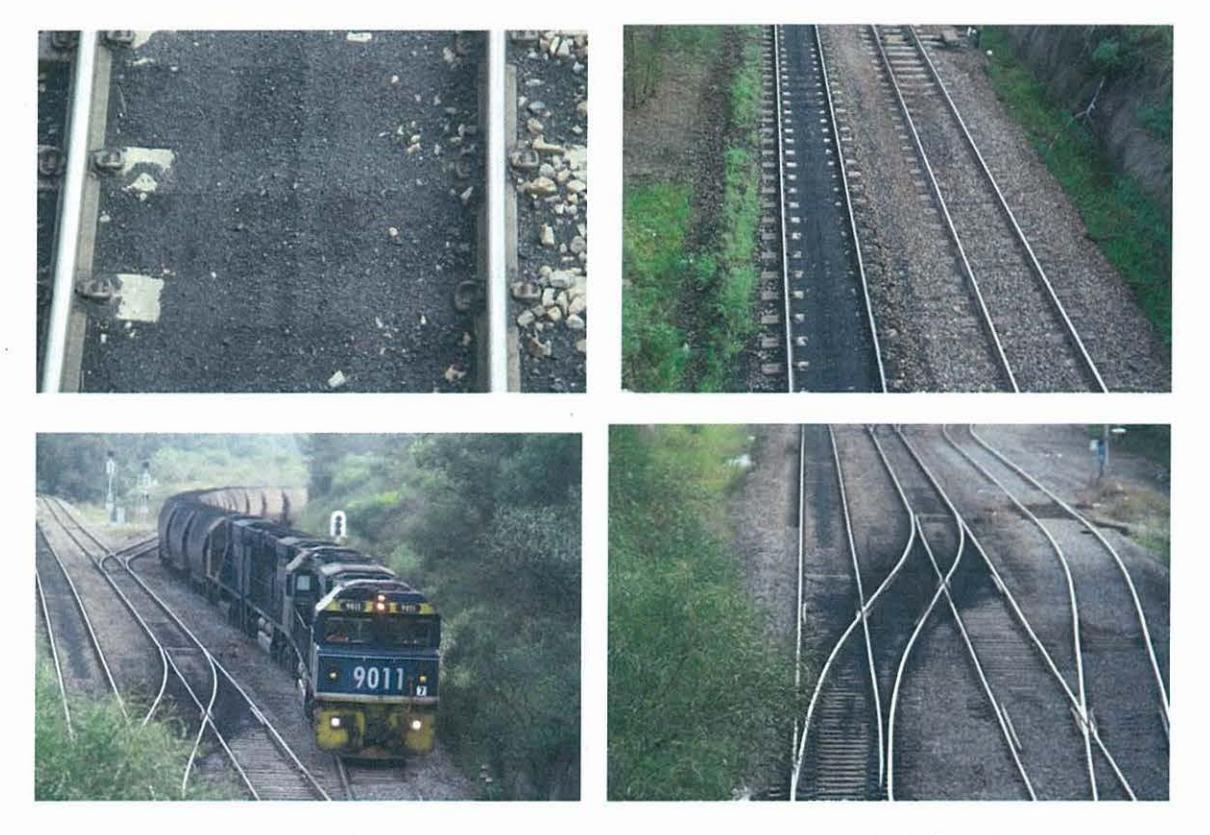
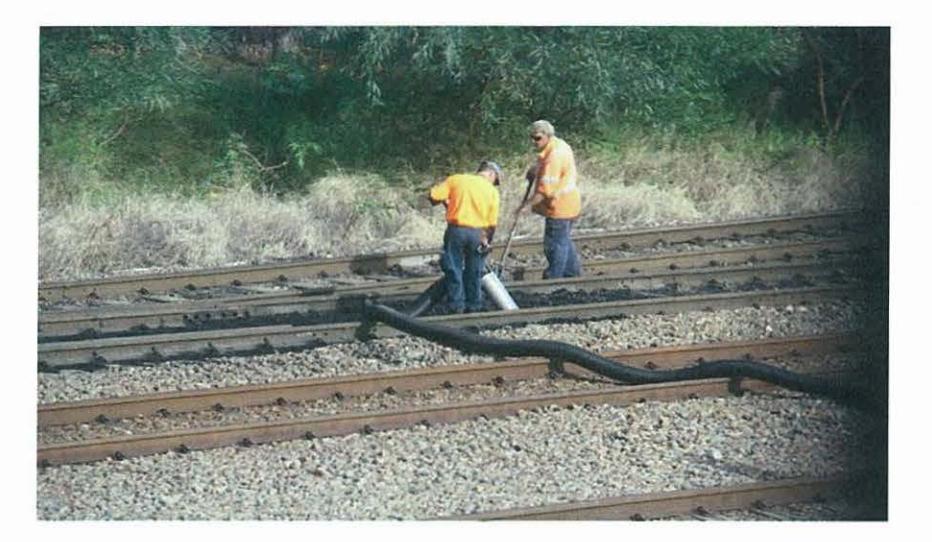
3. <u>Coal that becomes separated from the wagons is not constrained within</u> <u>the corridor.</u> There can be little dispute that coal falls from trains and enters the corridor. Once in the corridor the material may be airborne, or become airborne due to train turbulence. That material can settle on residences, schools and other places causing harm to the environment and community members.

Photos showing aspects of the rail corridor

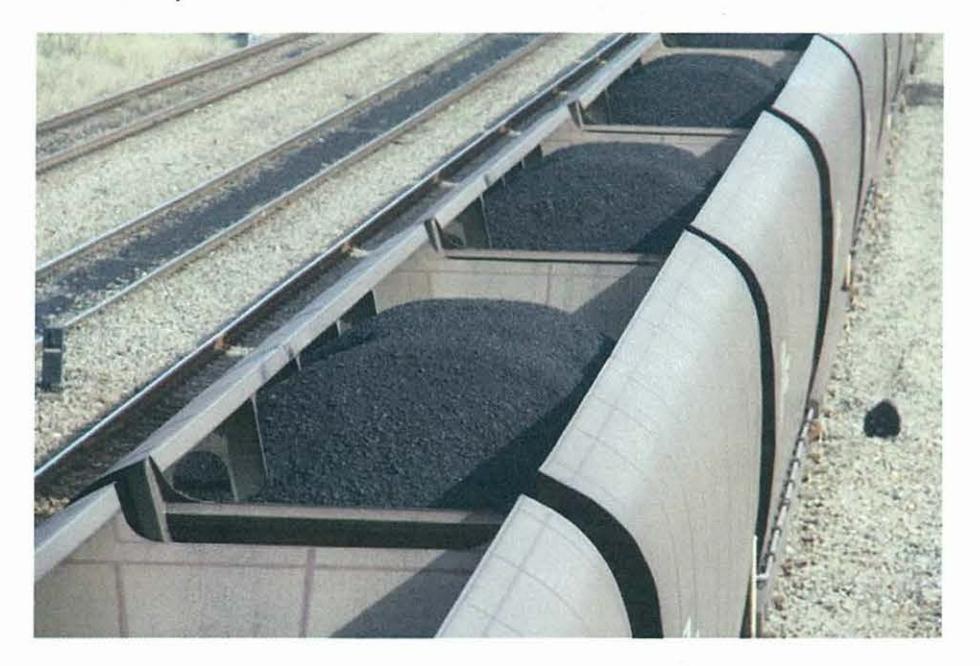
16 / 6 / 2013 Selwyn St

Some loads are not profiled or wet.

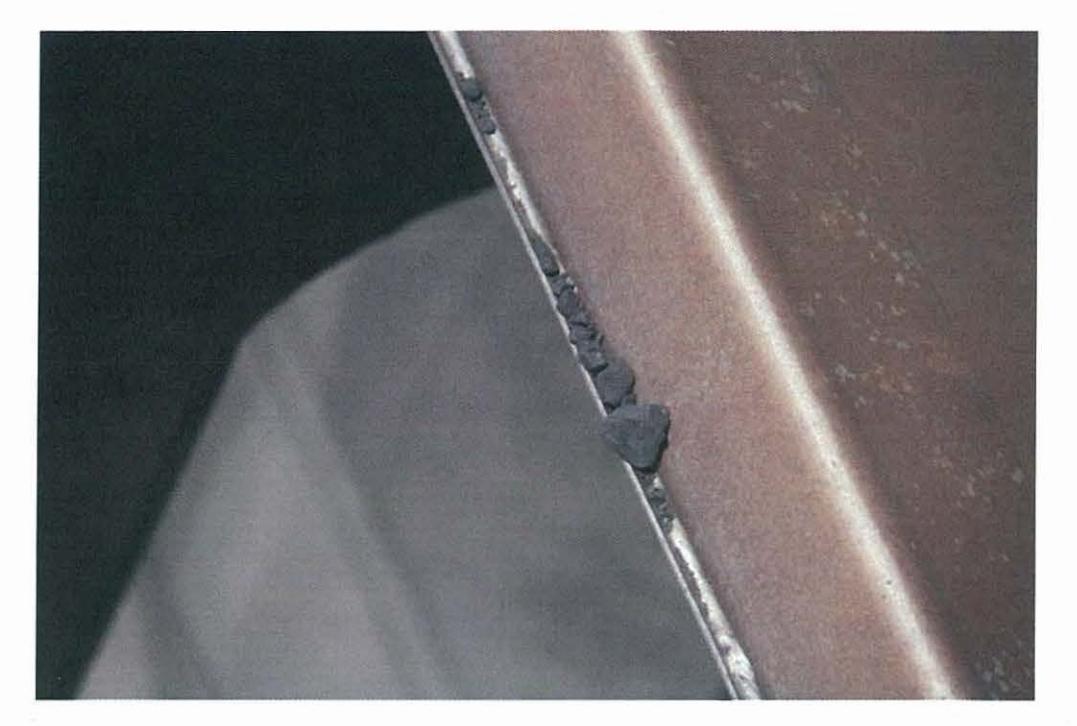
31 / 12 / 2013 Carrington, Coal ready to drop sitting on gunnel

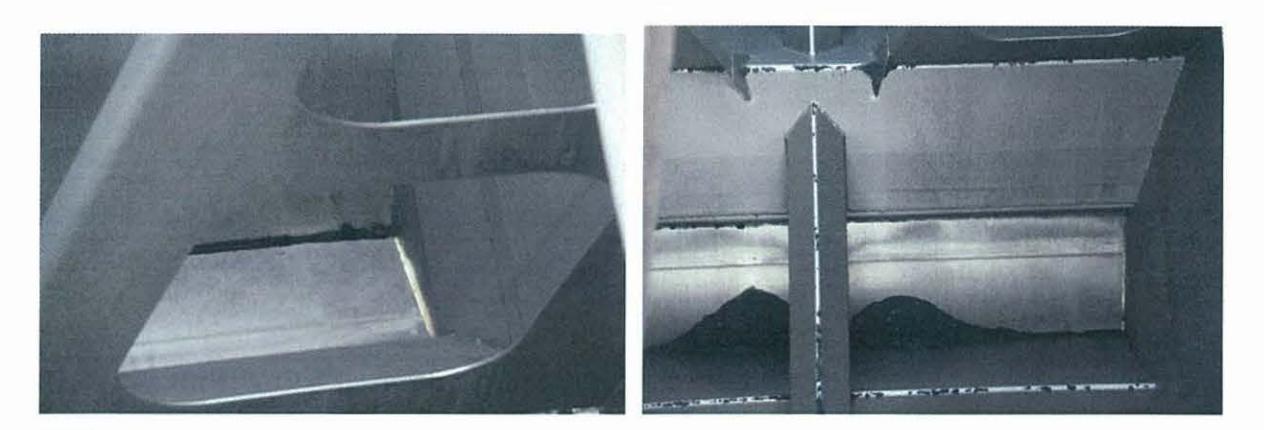
The bottom unloading doors on coal wagons frequently do not close correctly and or fail to seal. Thus residual coal in the wagon is free to fall out on the return journey.

5 / 6 / 2013 Carrington Photos of ill shutting doors.

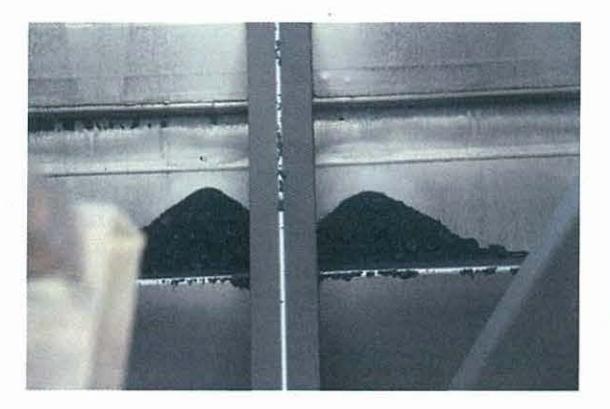
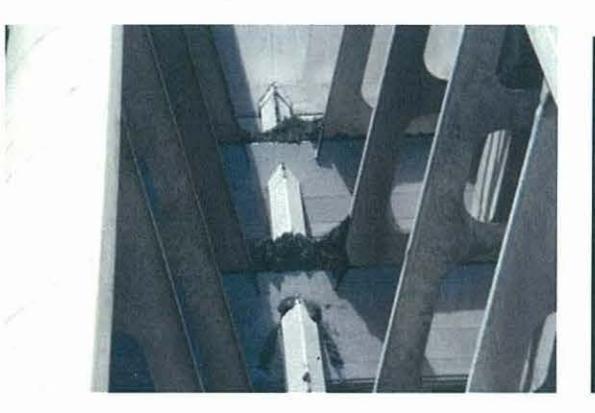
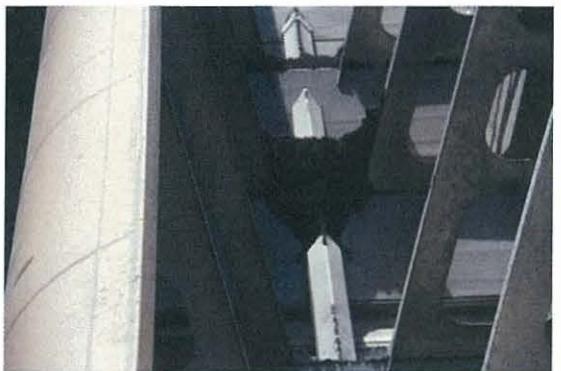
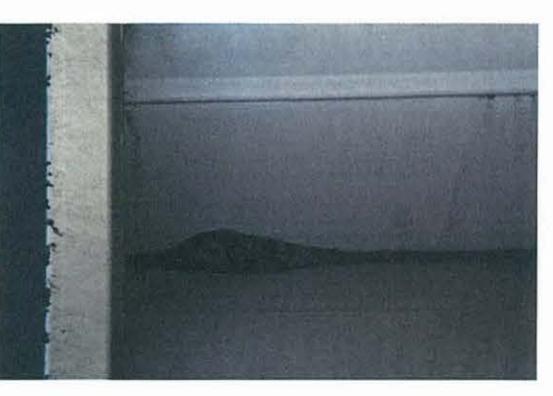
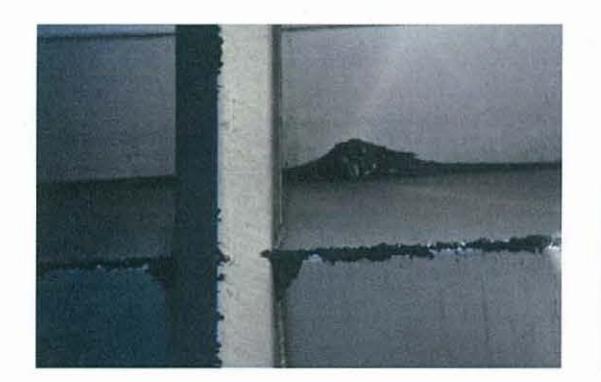
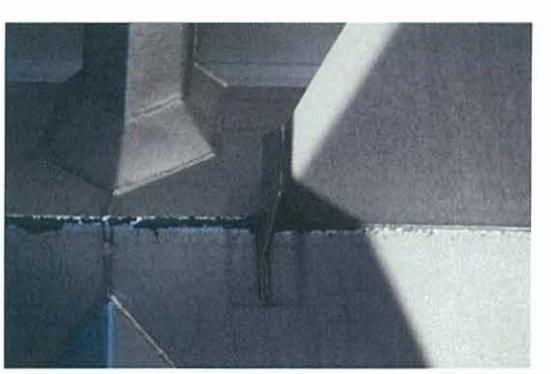
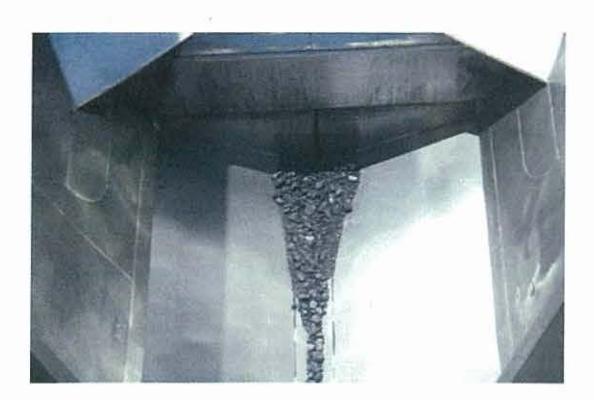
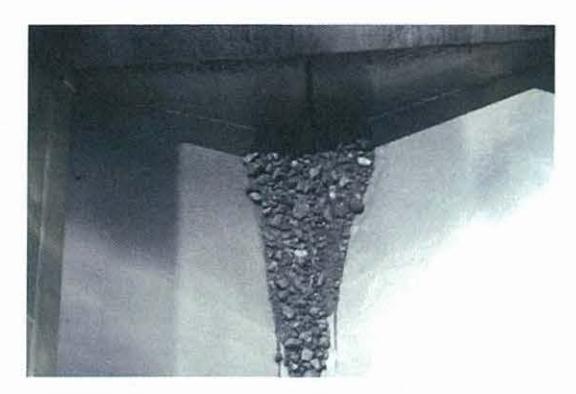
Coal of a high moisture content and or is sticky adheres to the internal sides of wagons or builds up into heaps. As the coal dries out it becomes dislodged and is drawn out of the wagon top or falls out the bottom. In wet conditions this material is rinsed out of the wagon only to fall into the corridor.

31 / 12 / 2013 Carrington Photos of coal in the wagons. 31 / 12 /2013 Carrington

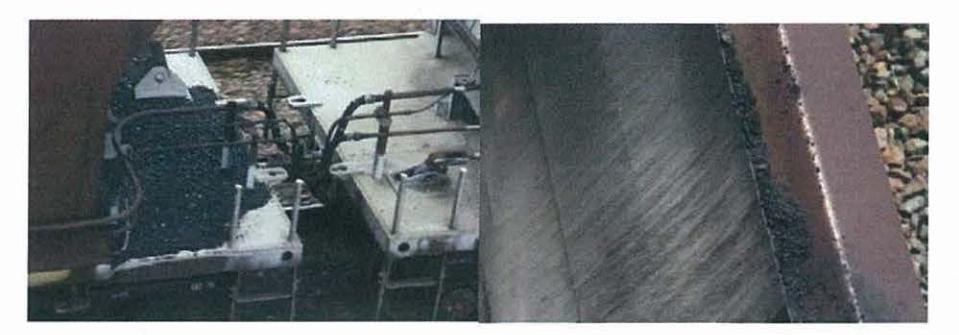
Considerable coal is carried on the exterior of the wagon. The gunnels, platform between the wagons and on the wings between the wagons are common locations. The wheels and underside of the wagon are also well known to carry coal especially following unloading.

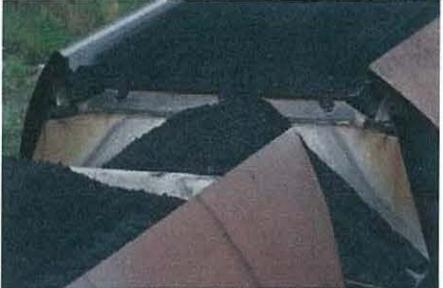
This wing is full!

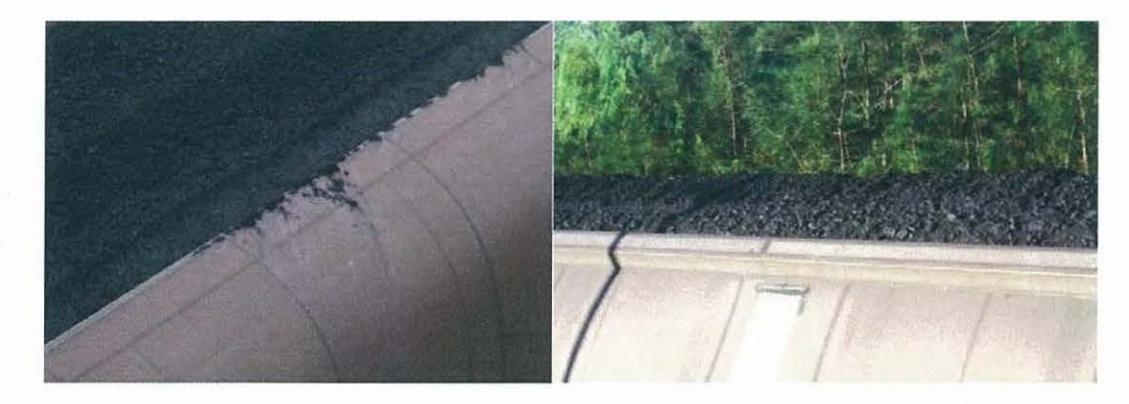
The excessive loading of a coal wagon to the point where the load pours down the side of the wagon could only be described as irresponsible. This material once in the corridor is free to flow into our streams and rivers or for the smaller particles to be recirculated into the atmosphere.

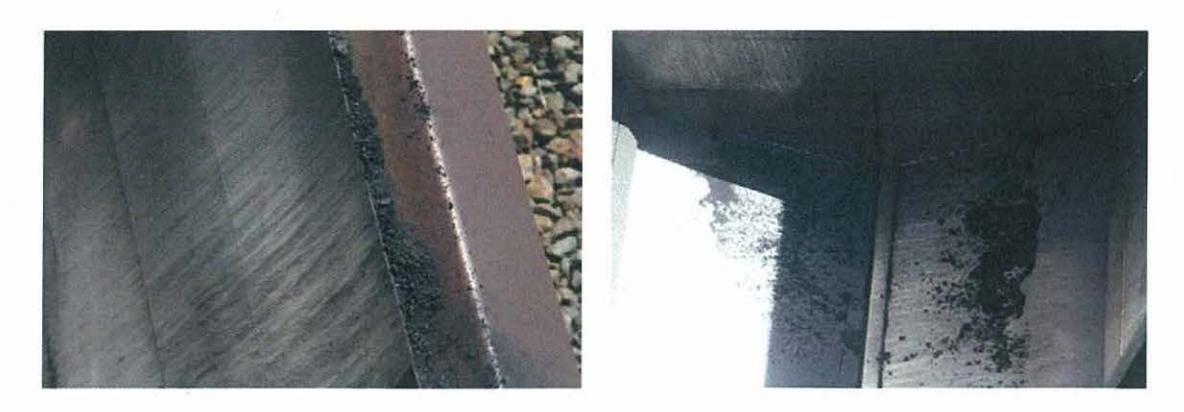
Particulate matter located within the coal wagon moves freely as it dries out. This material falls from the open unloading door or is sucked out of the wagon top.

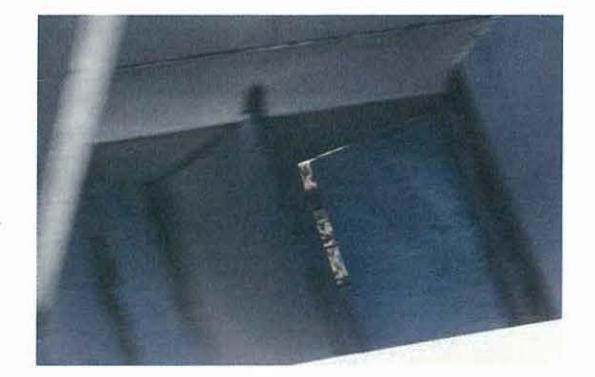
If the unloading doors are open then the coal simply runs out the bottom. The major cause is inappropriate adjustment.
