## Arboricultural Impact Assessment & Tree Protection Specification

| <b>Site Address:</b> | Kaluna Reserve<br>Smithfield<br>NSW<br>2164 |
| <b>Date:</b> | 20 April 2026 |

| <b>Project</b> | Western Sydney S4 facility recycled water supply |

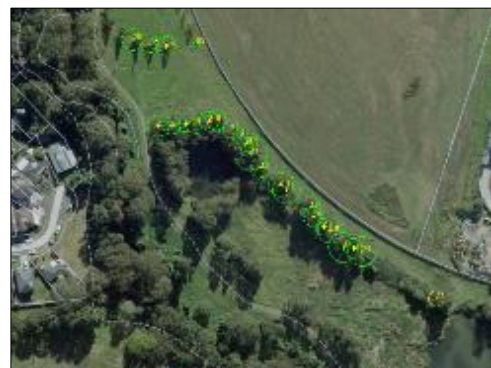
**Image 2:** Showing the subject trees as they are today.

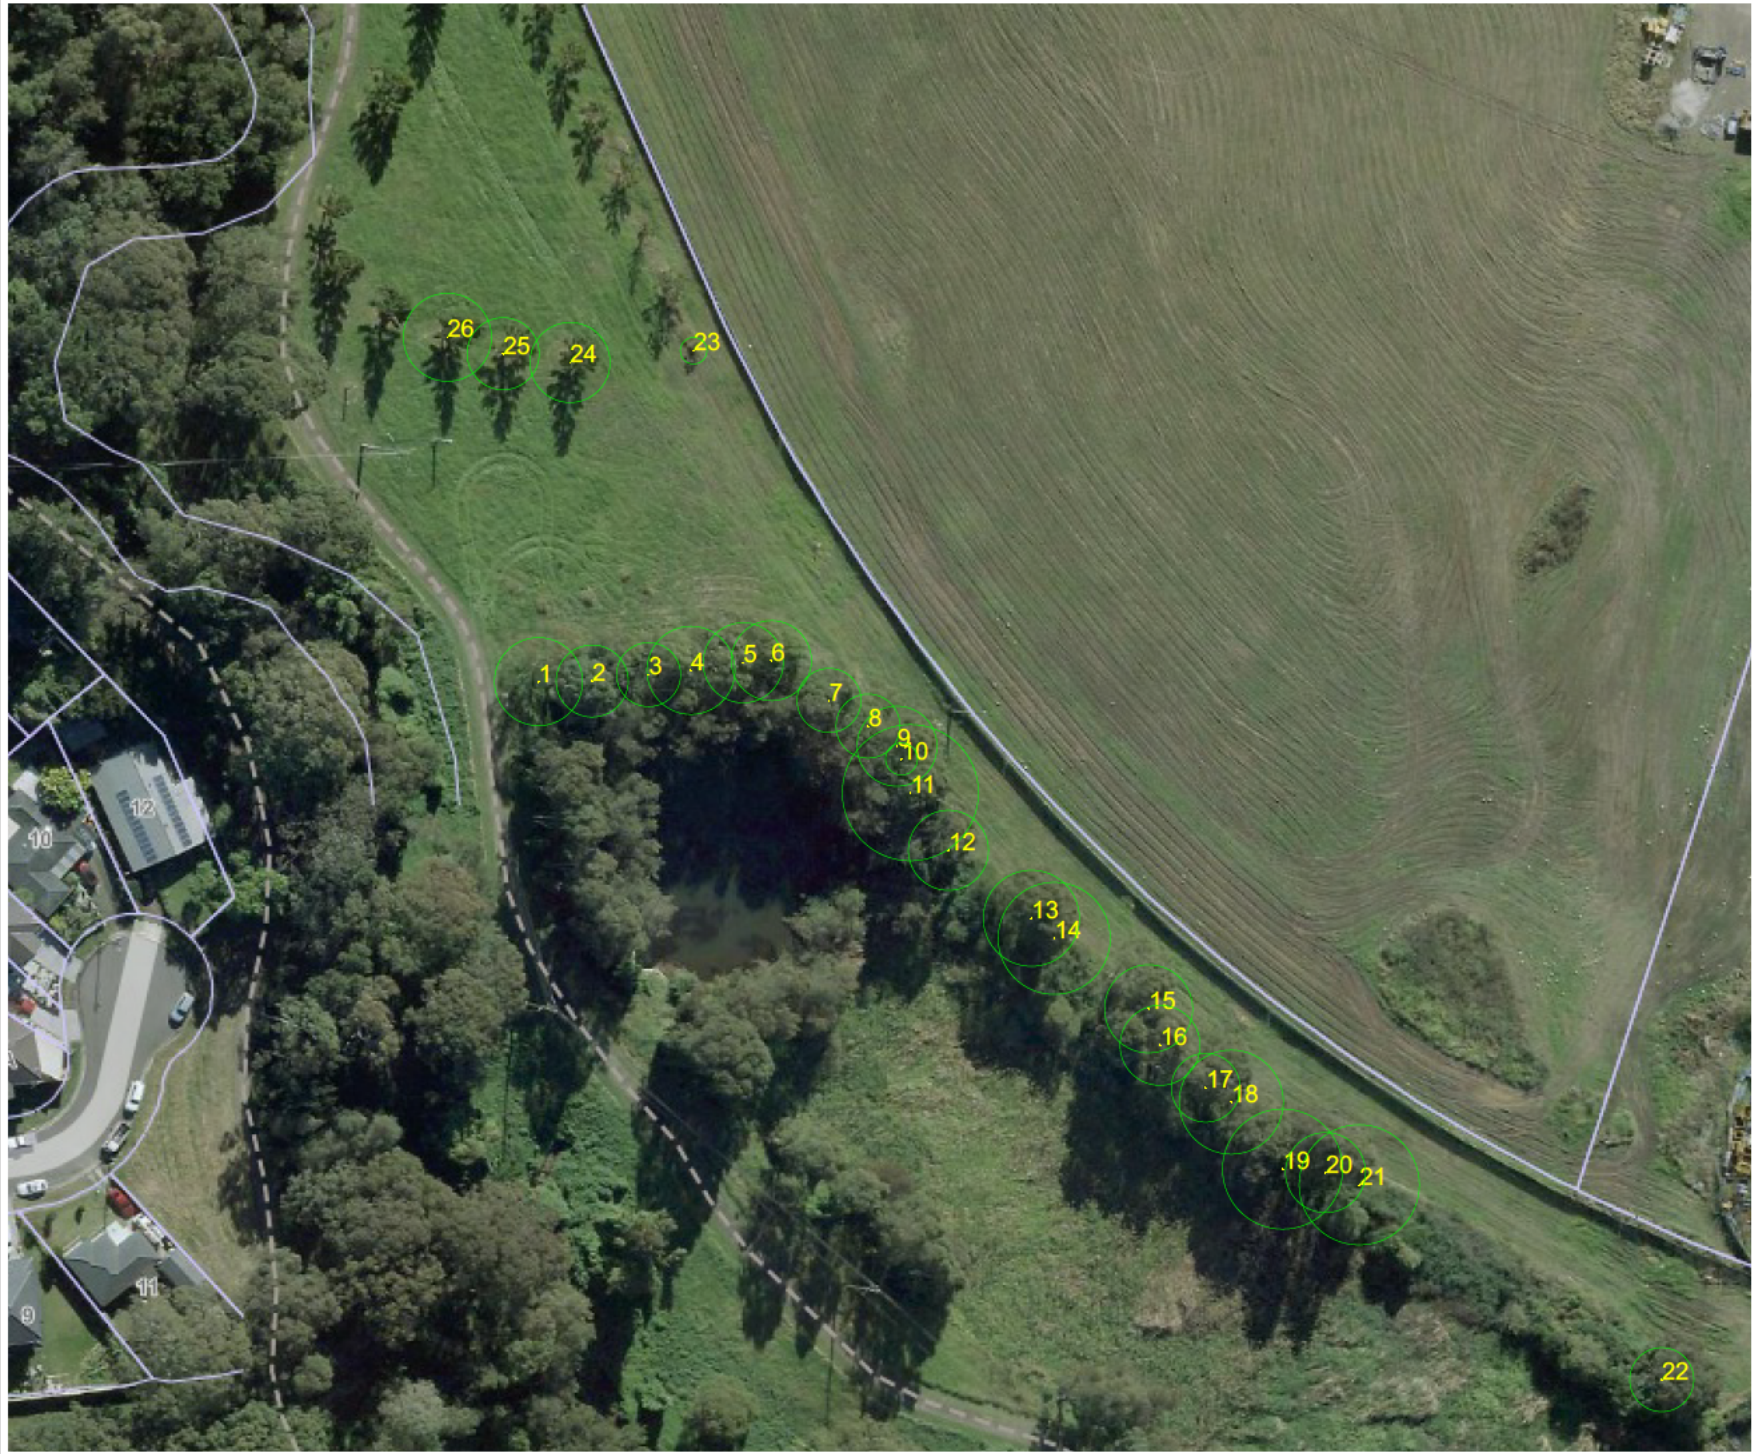
TITLE/DWG NO.  
**Appendix 3: Tree Location Plan**

Not one root zones have been calculated in accordance with AS4970(2025) - Protection of Trees on Development Sites.

Tree locations obtained from site survey data refer to Topographic Survey and Utility Mapping, prepared by Astrea.

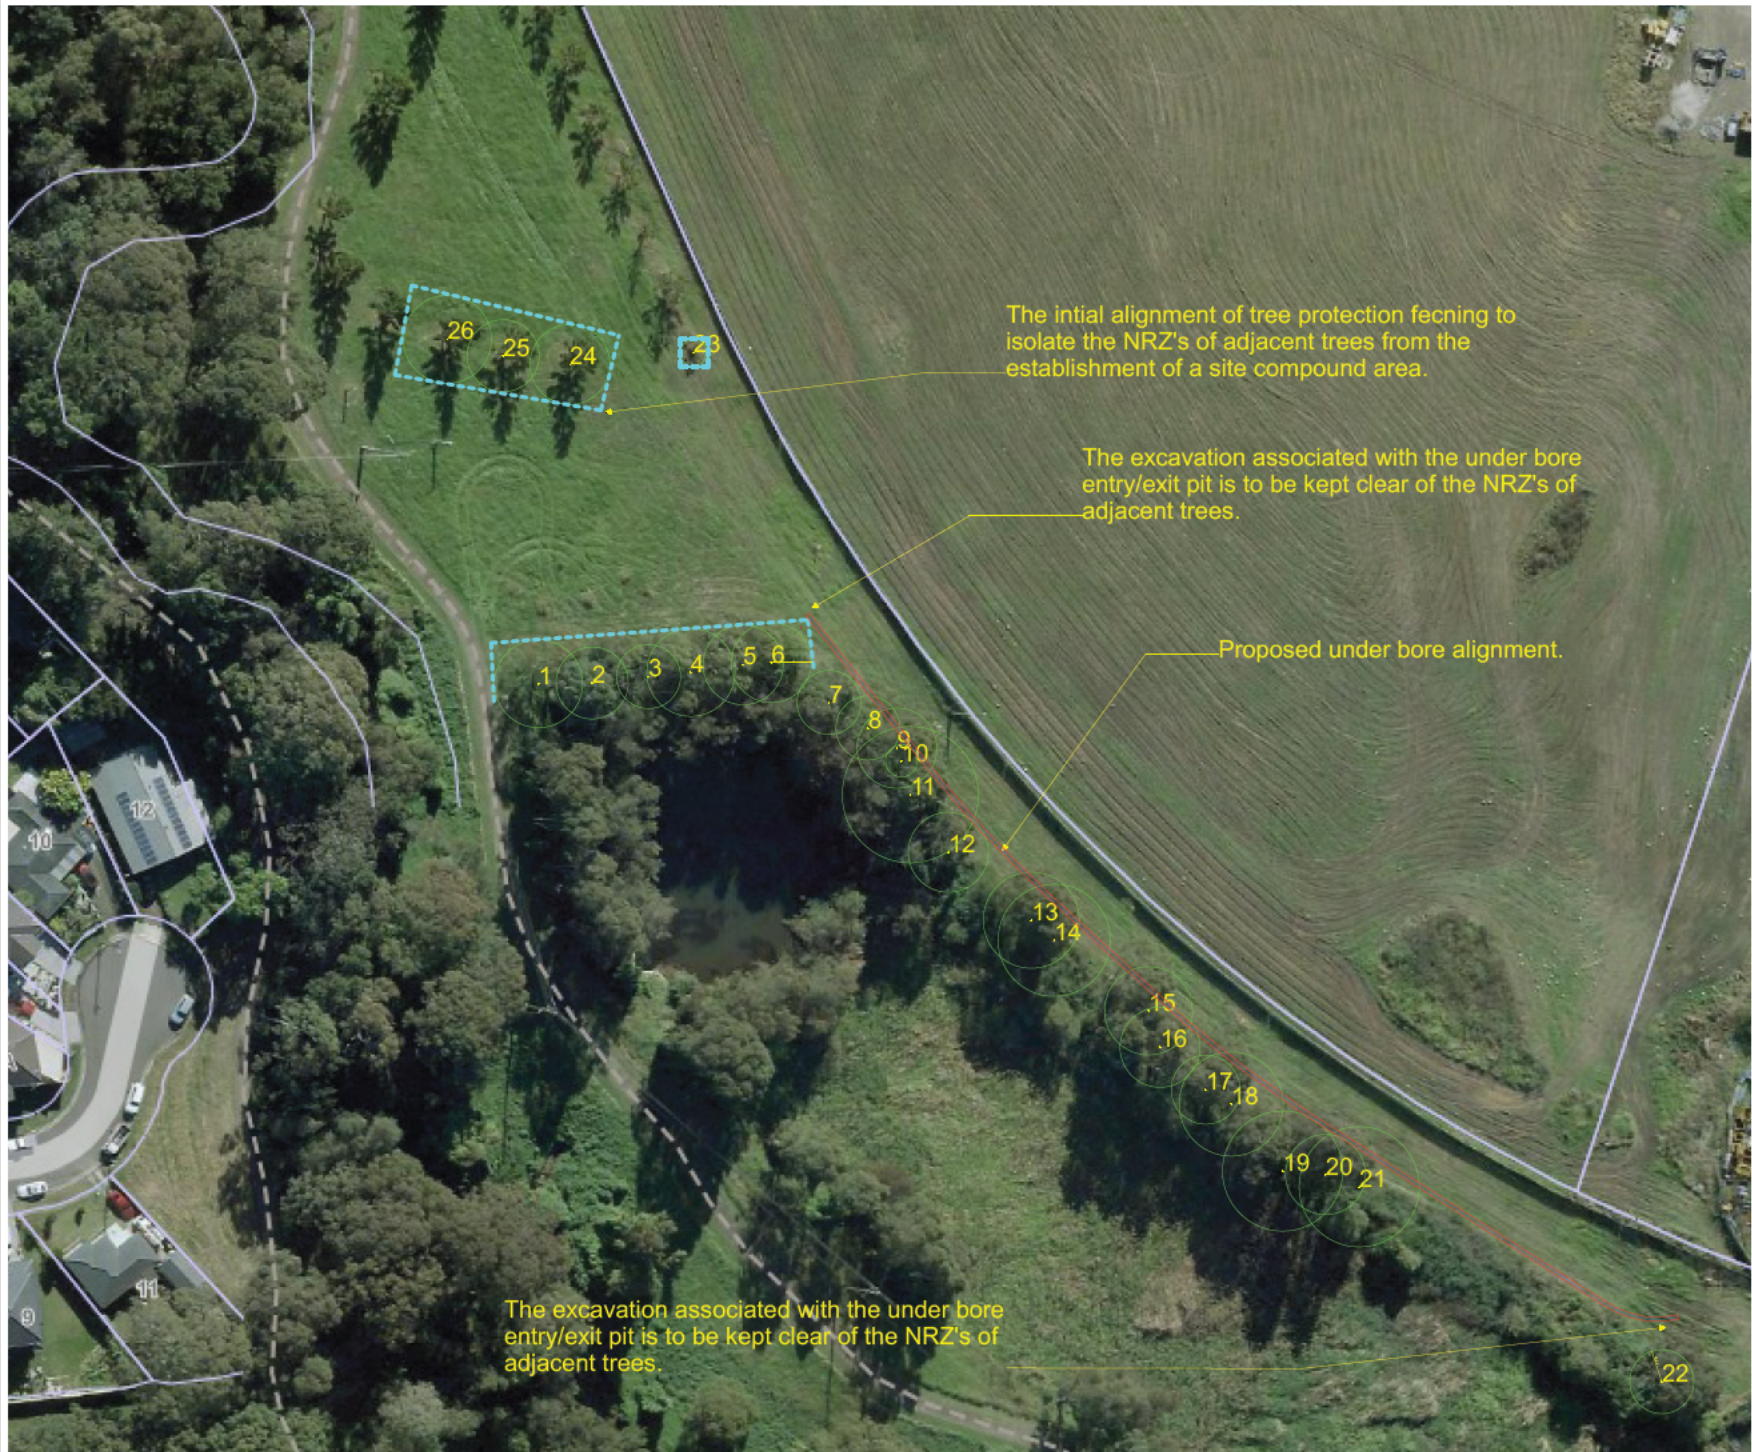
TITLE/DWG NO.  
**Appendix 4: Tree Protection Plan**

Notional root zones have been calculated in accordance with AS4970(2025) - Protection of Trees on Development Sites.

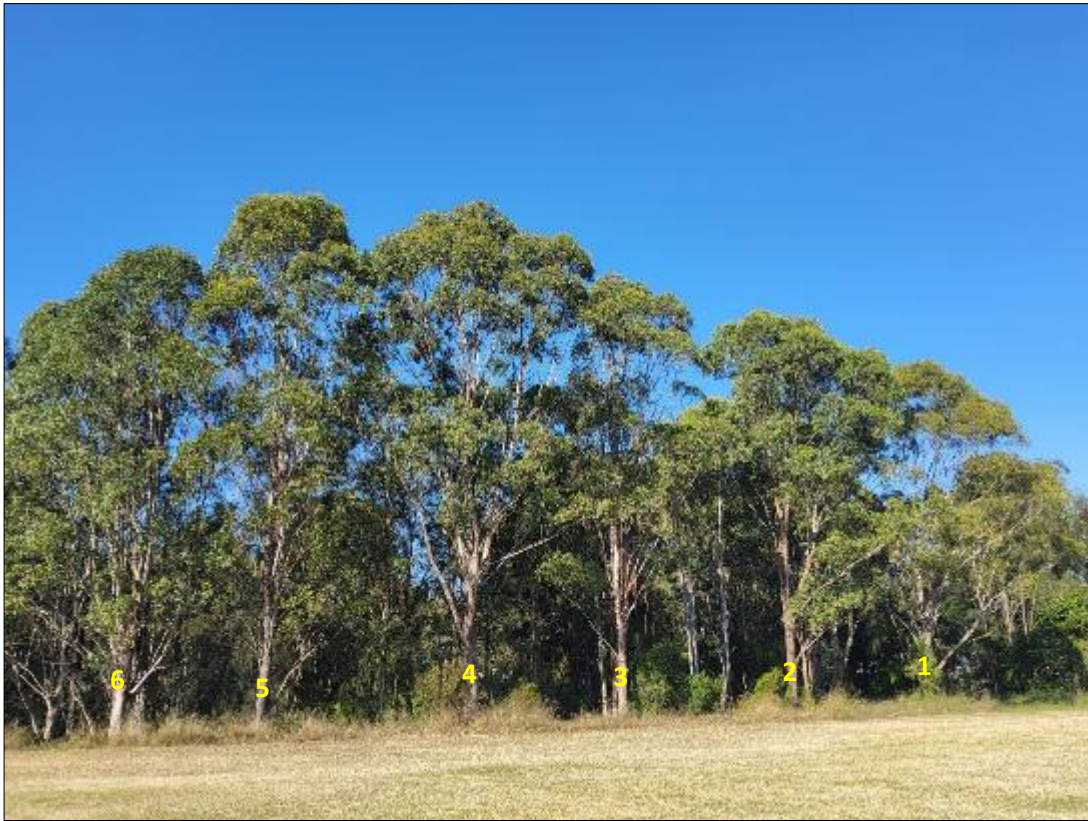
**Photograph 1:** Showing trees 1, 2, 3, 4, 5 and 6.

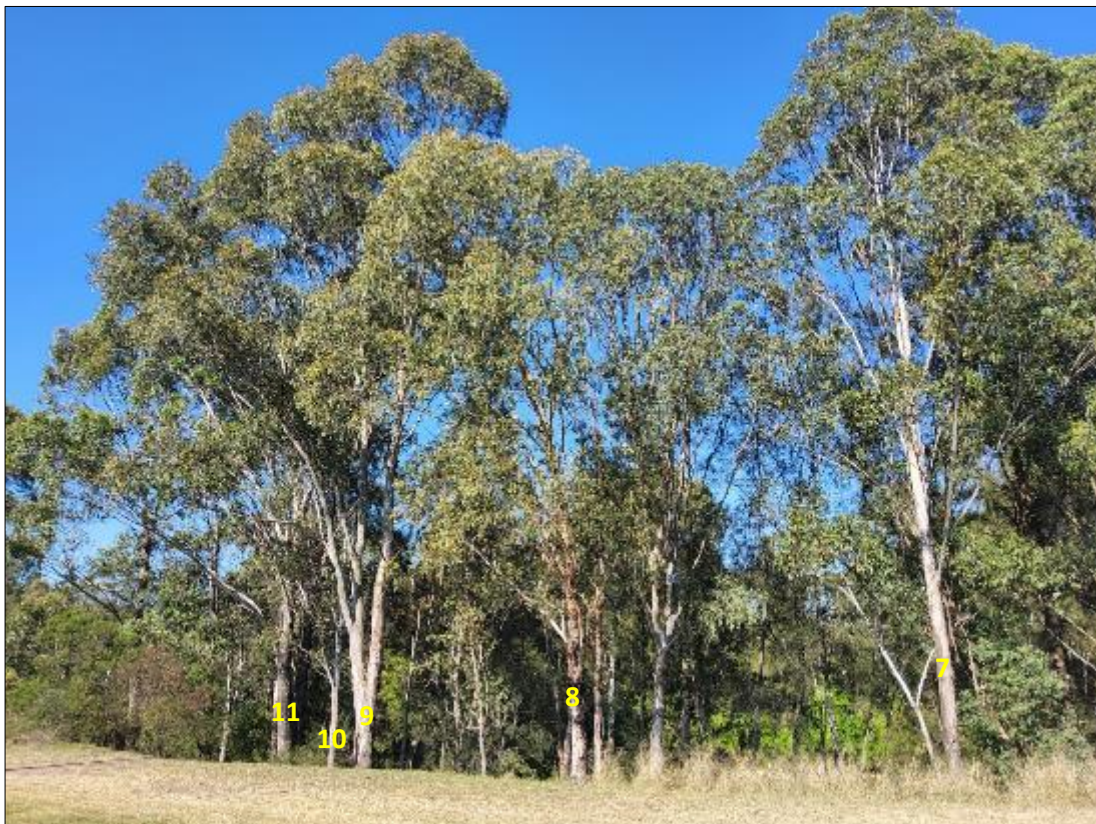
**Photograph 2:** Showing trees 7, 8, 9, 10 and 11.

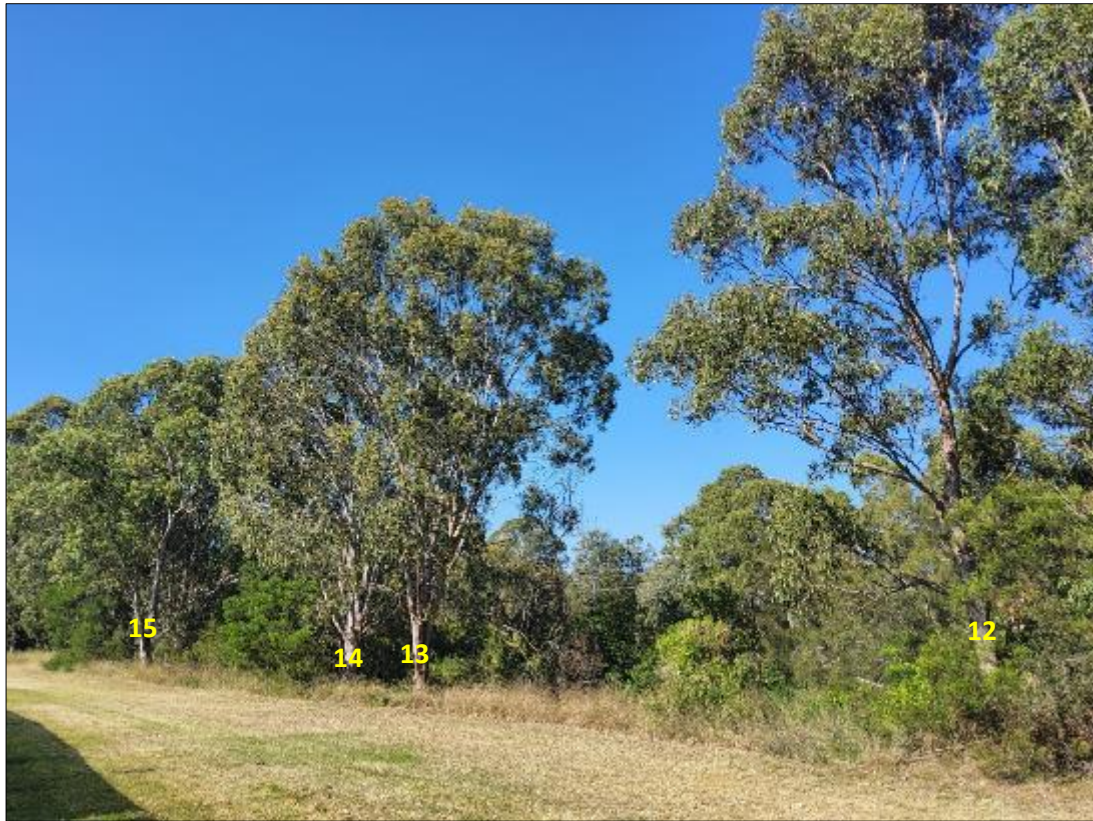
**Photograph 3:** Showing trees 12, 13, 14, and 15.

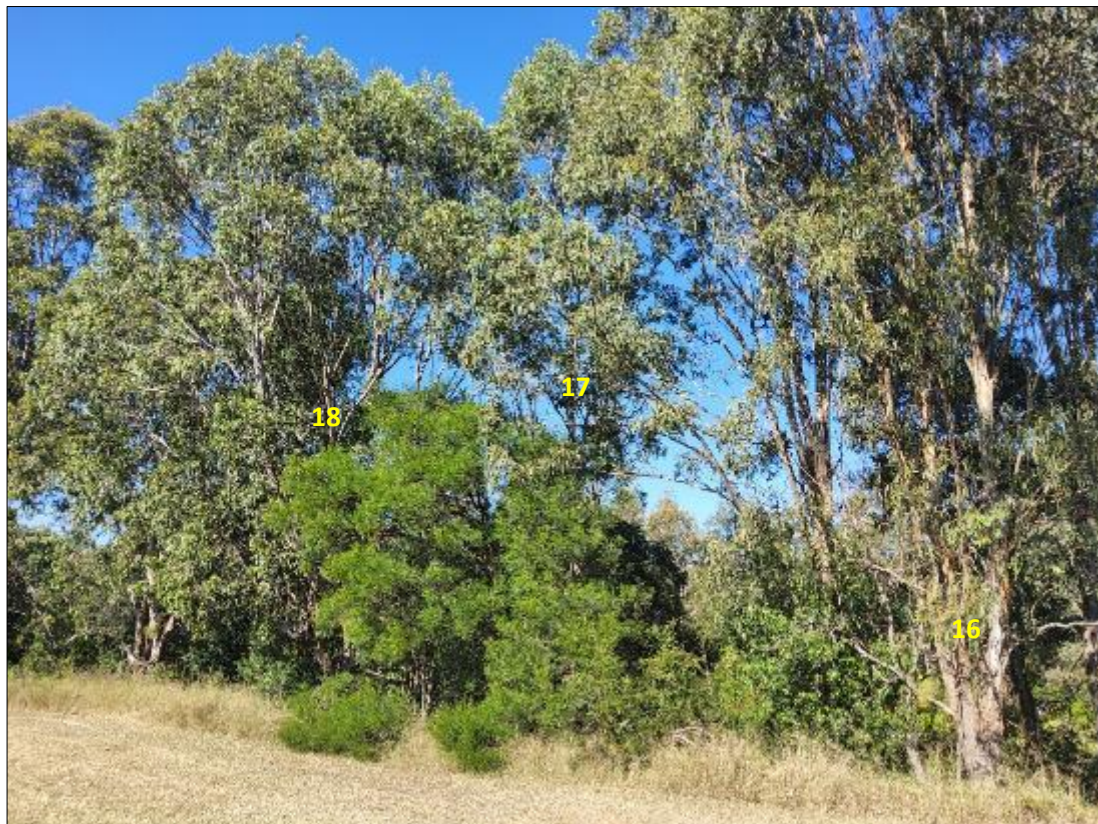
**Photograph 4:** Showing trees 16, 17 and 18.

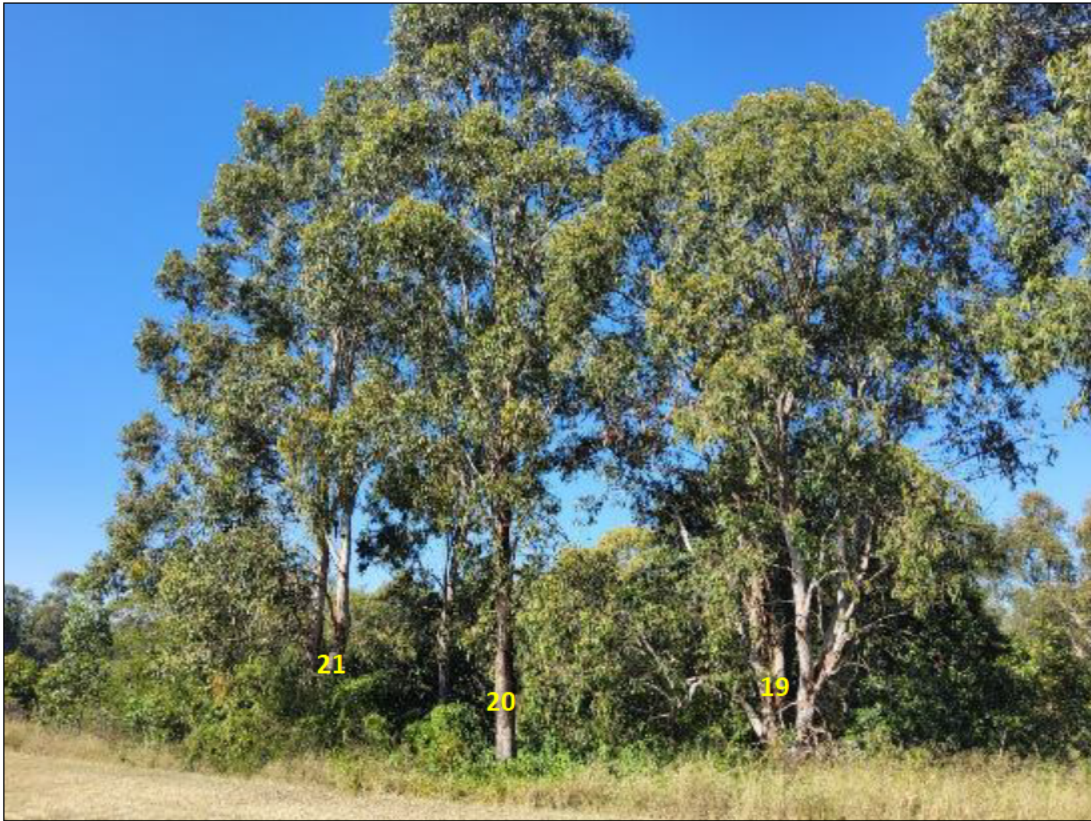
**Photograph 5:** Showing trees 19, 20 and 21.

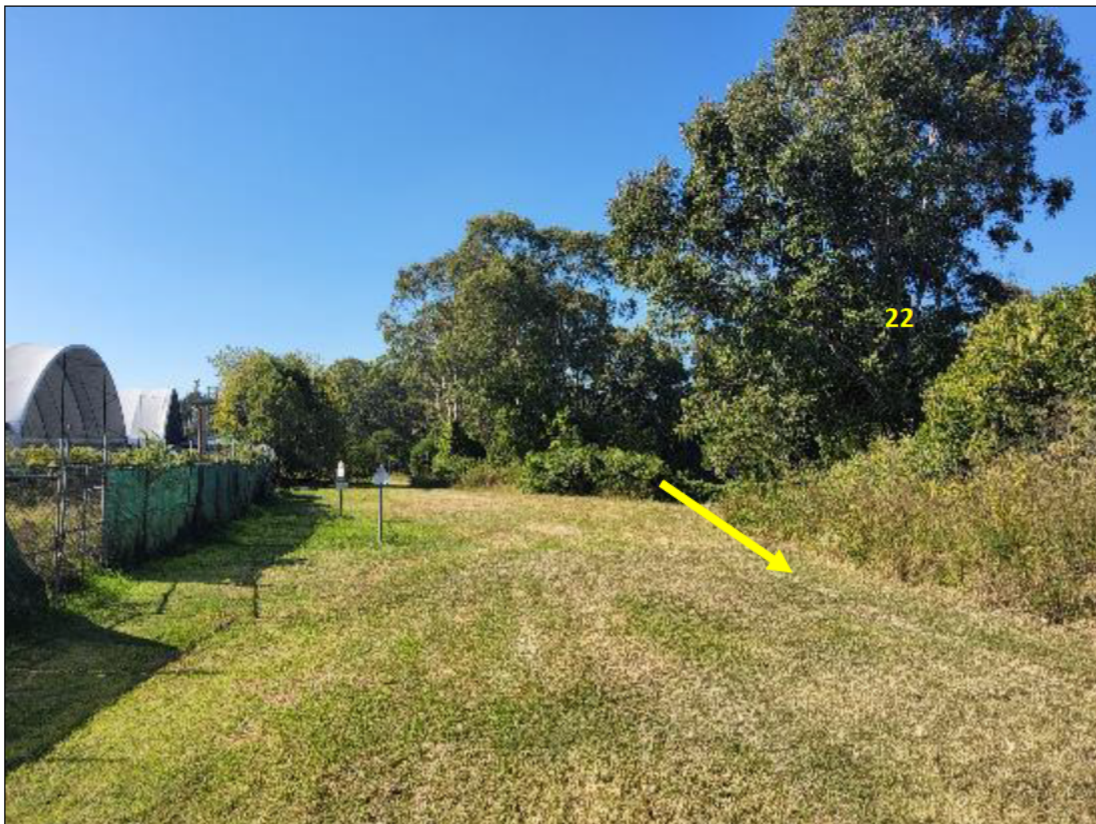
**Photograph 6:** Showing tree 22. The arrow indicates the existing recycled water access point (refer to survey data for alignment).

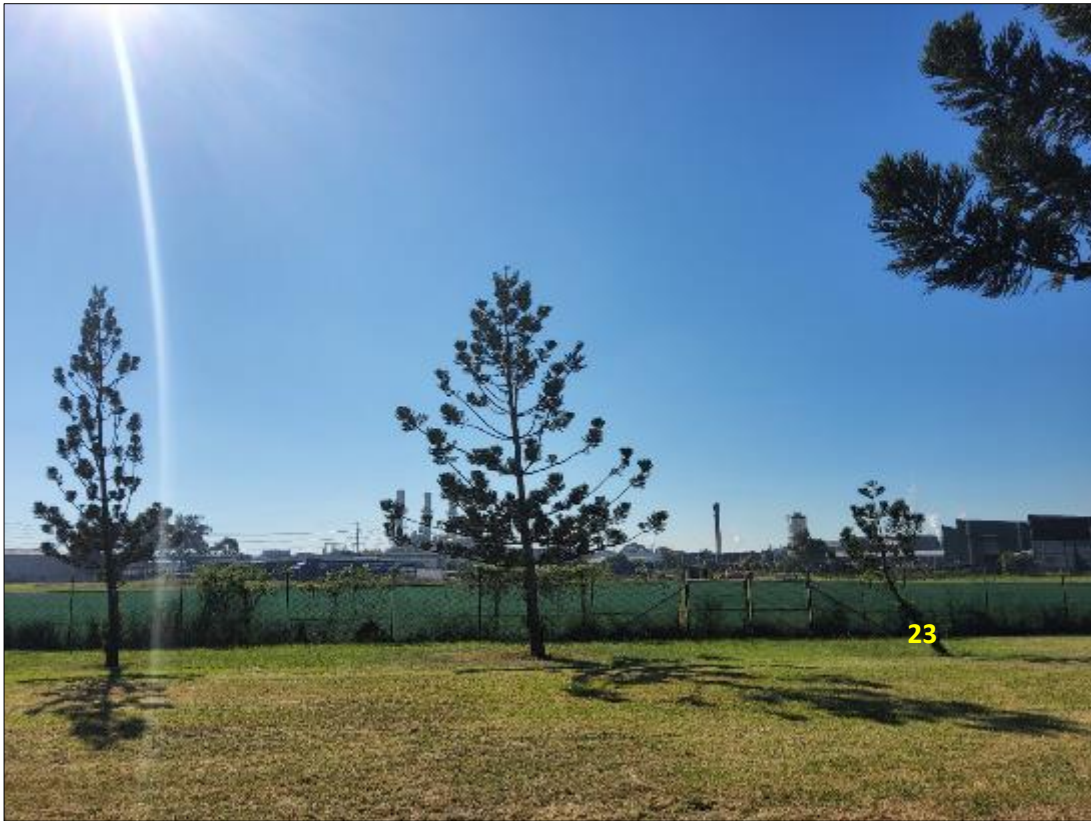
**Photograph 7:** Showing tree 23.

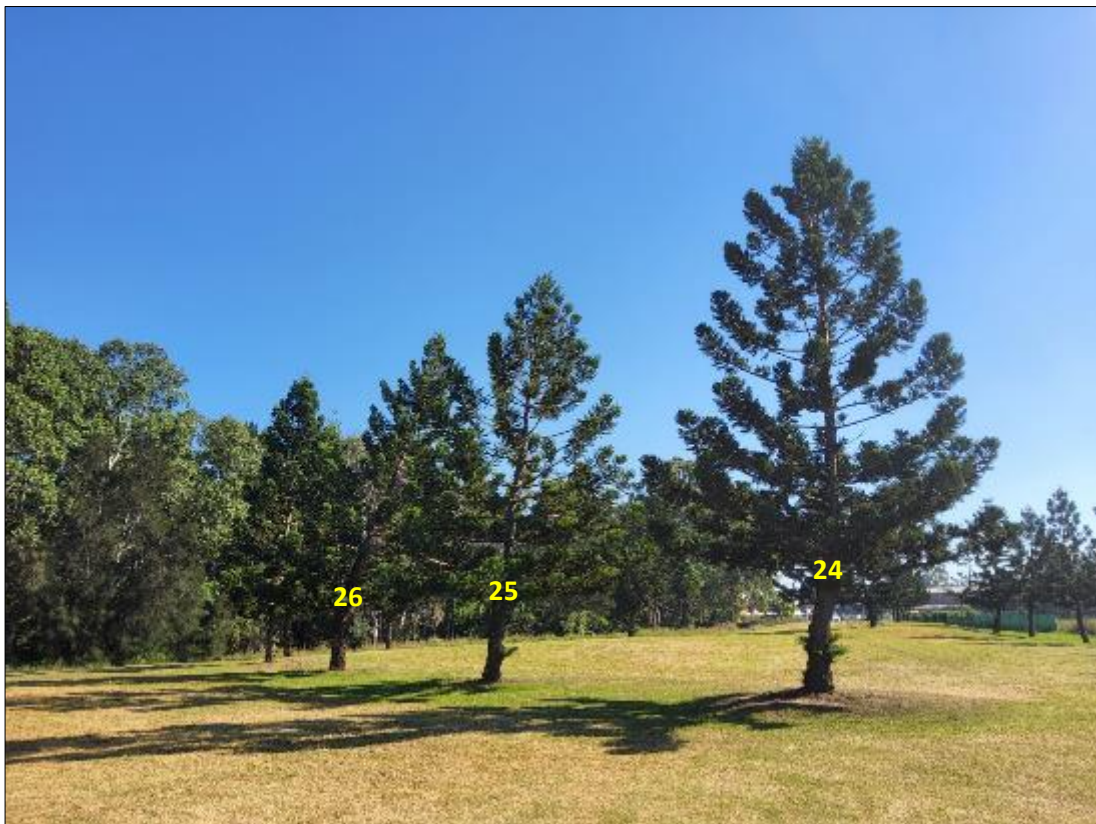
**Photograph 8:** Showing trees 24, 25 and 26.

| Tree No | Botanical Name | Development Impacts | Design Modifications | Justification for tree removal | Methods to minimise or avoid impacts on retained trees | Retain or Remove Tree |
|---|---|---|---|---|---|---|
| 25 | <i>Araucaria cunninghamii</i> | No direct impact expected from under boring works. Potential NRZ encroachment arising from the establishment of a works compound area and site access requirements. | The establishment of the works compound is to take into consideration the extent of the trees NRZ. No works are to be undertaken within 5.4m of the tree. | Nil | Establish a tree protection zone on the limits (2m radius) of the NRZ. Tree protection fencing is to be established in accordance with points 5.2.4, 5.2.5 and 5.2.6 of this report. The health and condition of the tree is to be monitored throughout the duration of the project works. | Retain |
| 26 | <i>Araucaria cunninghamii</i> | No direct impact expected from under boring works. Potential NRZ encroachment arising from the establishment of a works compound area and site access requirements. | The establishment of the works compound is to take into consideration the extent of the trees NRZ. No works are to be undertaken within 6.6m of the tree. | Nil | Establish a tree protection zone on the limits (2m radius) of the NRZ. Tree protection fencing is to be established in accordance with points 5.2.4, 5.2.5 and 5.2.6 of this report. The health and condition of the tree is to be monitored throughout the duration of the project works. | Retain |
