# ABORIGINAL HERITAGE DUE DILIGENCE REPORT – ROSEHILL RECYCLED WATER SCHEME EXTENSION

FINAL 20 / 05 / 2026

REPORT TO: ELEMENT ENVIRONMENT PTY LTD

REPORT BY: HERITAGE NOW PTY LTD

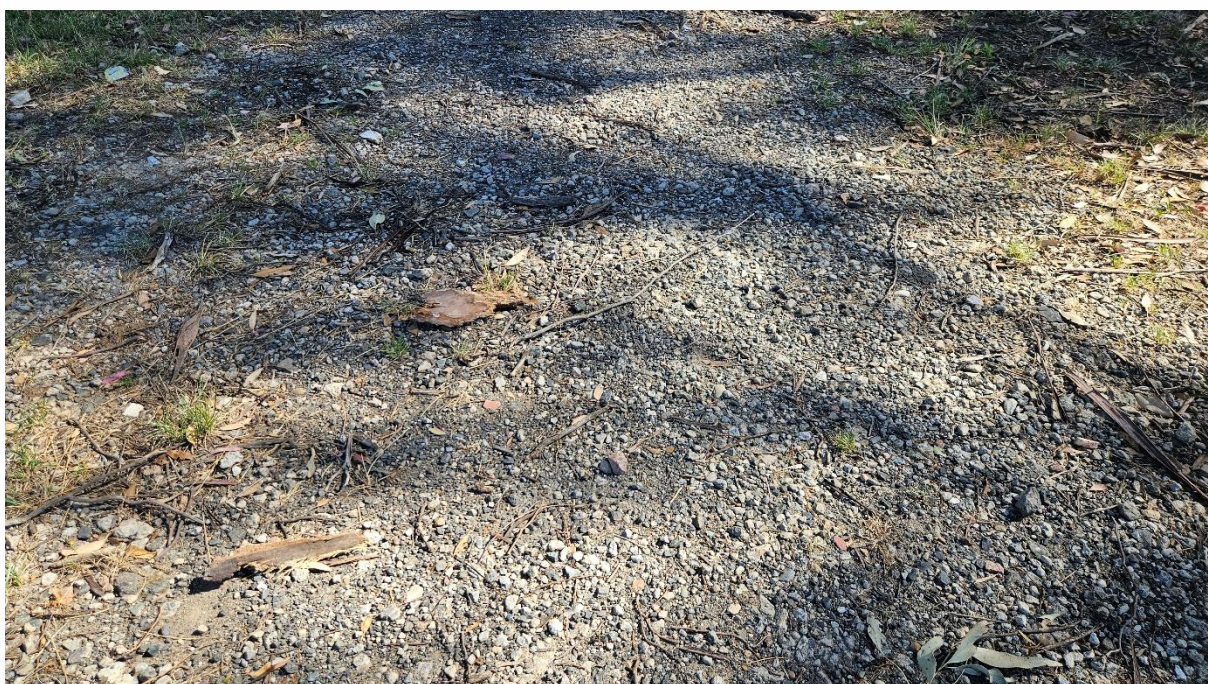
*Plate 4. Imported gravel covering the ground surface within the Project Area. (Source: Heritage Now 2025)*

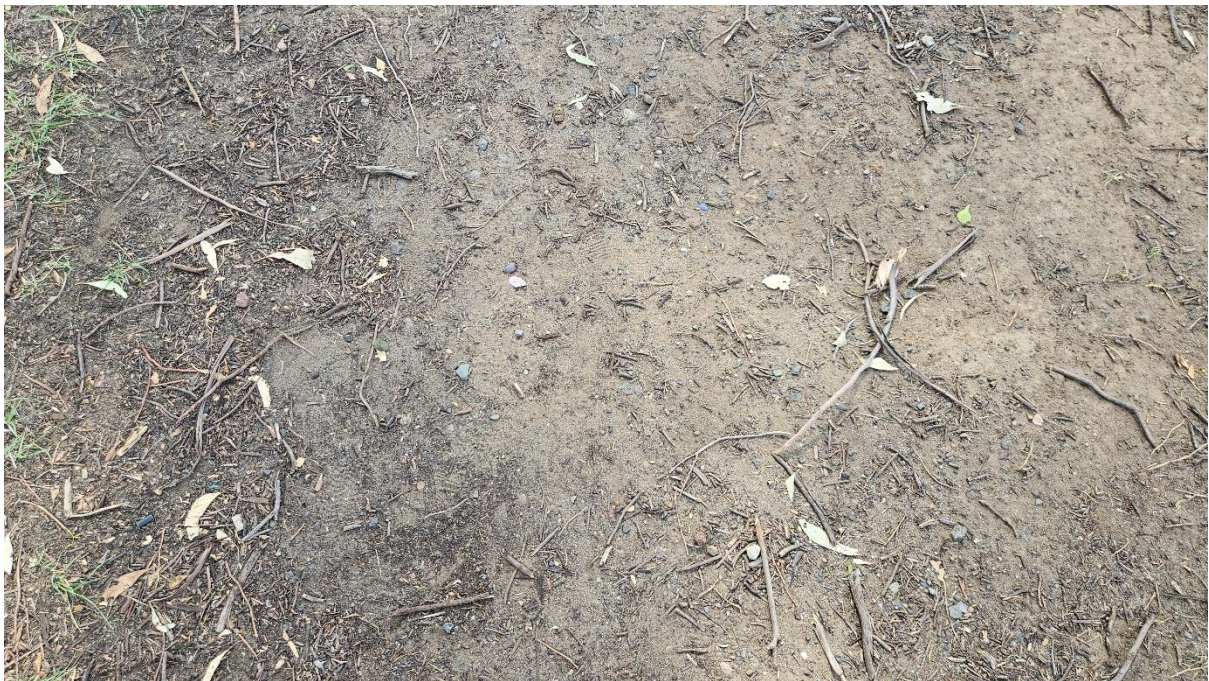
*Plate 8. Ground exposure showing very shallow A Horizon soil overlying B horizon clay. (Source: Heritage Now 2025)*

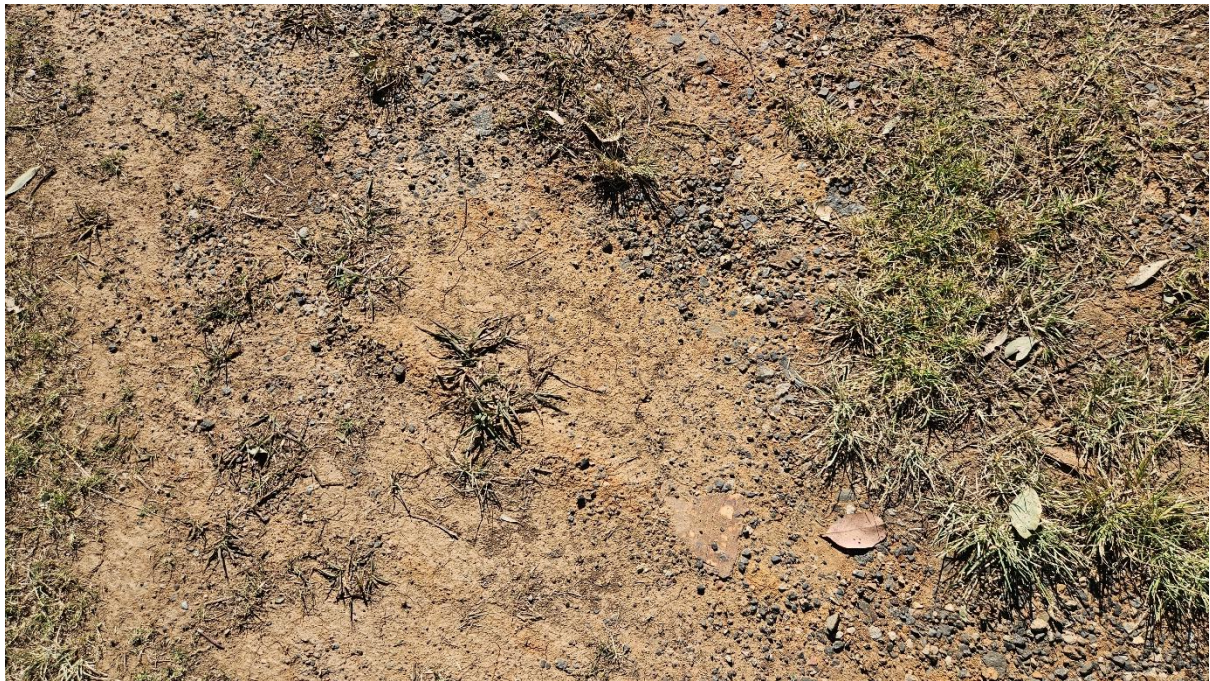
*Plate 9. Ground exposure showing B Horizon clay with mixed stone inclusions, including imported gravel. (Source: Heritage Now 2025)*

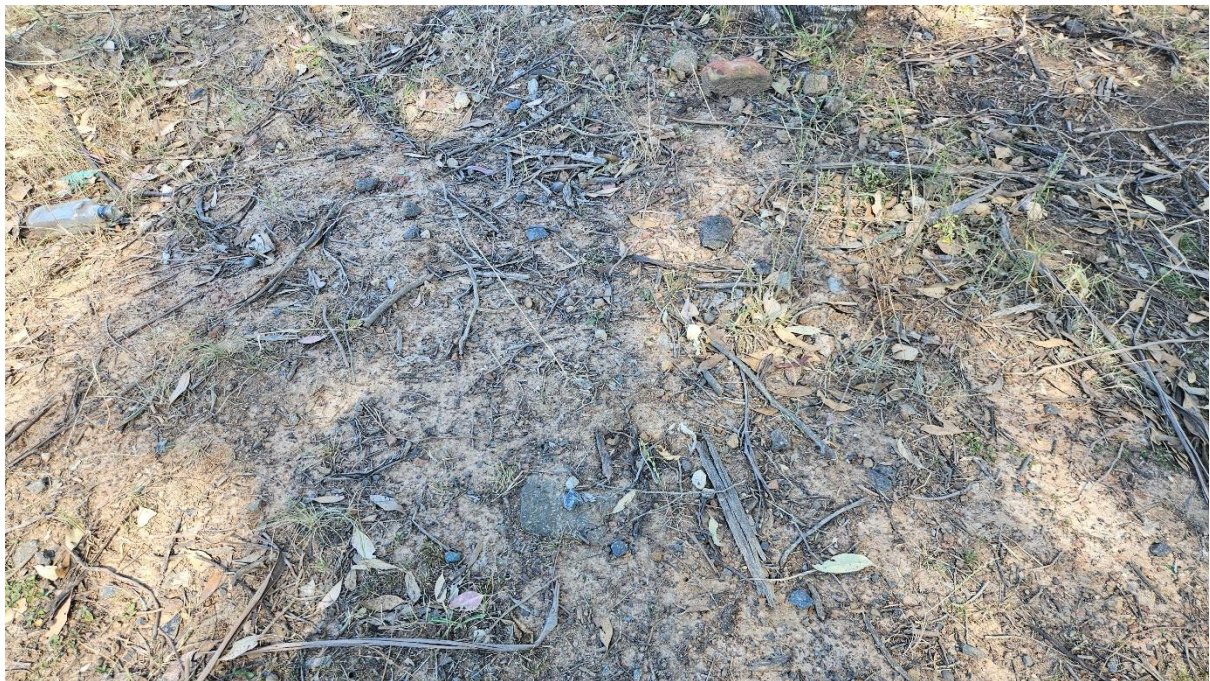
*Plate 10. Ground exposure showing B Horizon clay, with imported gravel and modern material. (Source: Heritage Now 2025)*

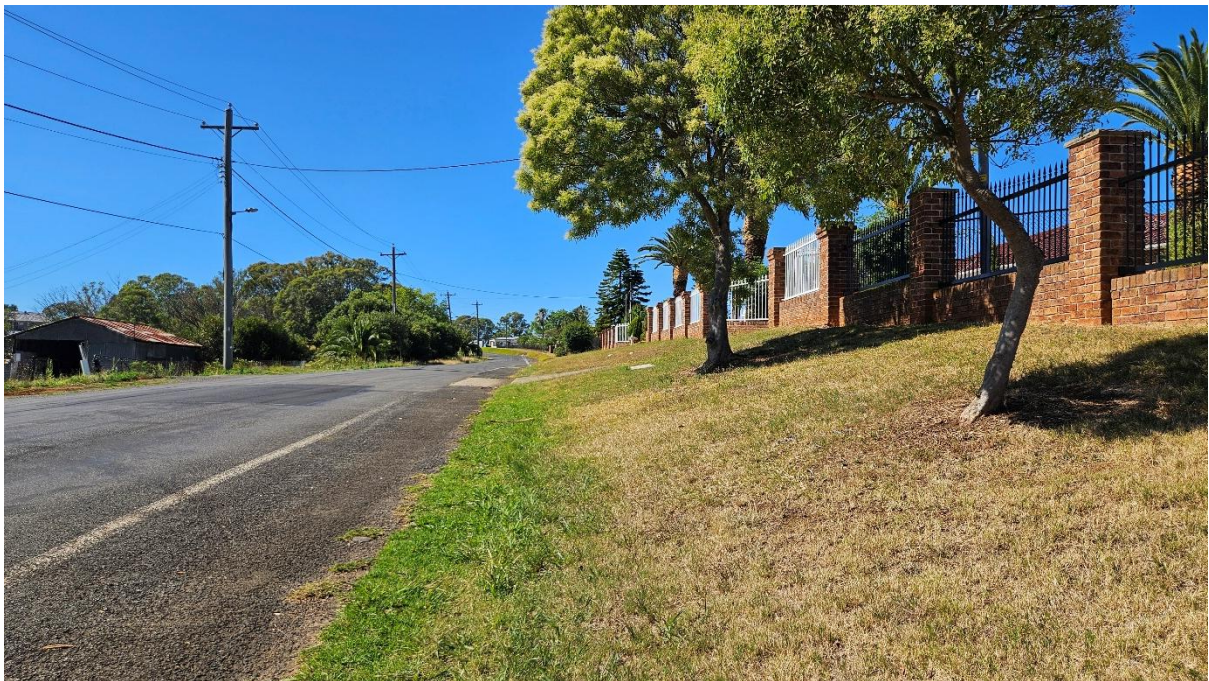
*Plate 12. The natural landform has been cut through and modified for the construction of the road. (Source: Heritage Now 2025)*

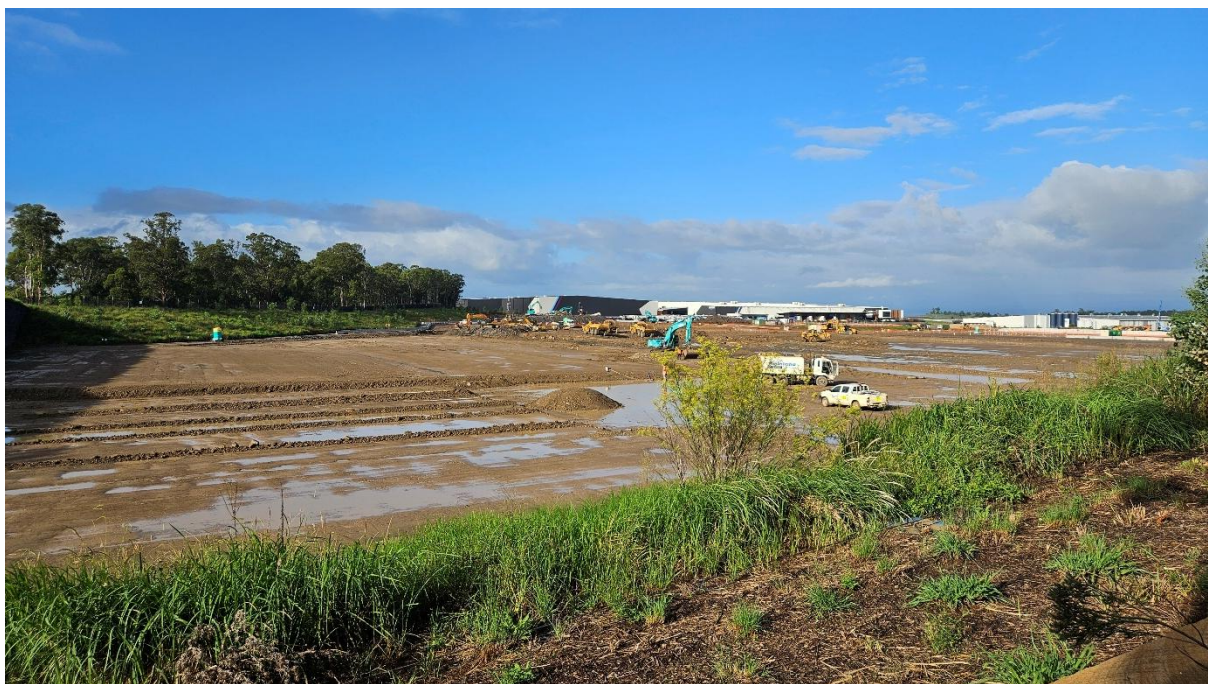
*Plate 18. Substantial ground cutting and soil stripping at the western end of the Project Area. (Source: Heritage Now 2025)*

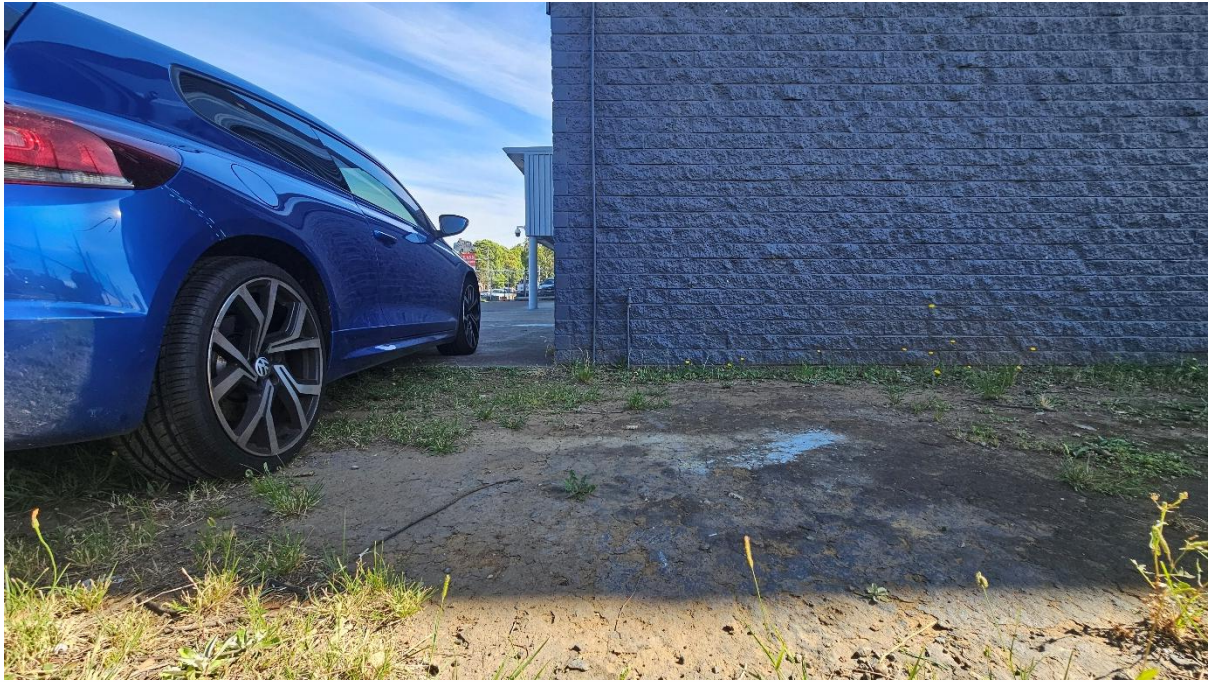
*Plate 27. An exposure within the pump station location, where B Horizon clay was visible. (Source: Heritage Now 2025)*

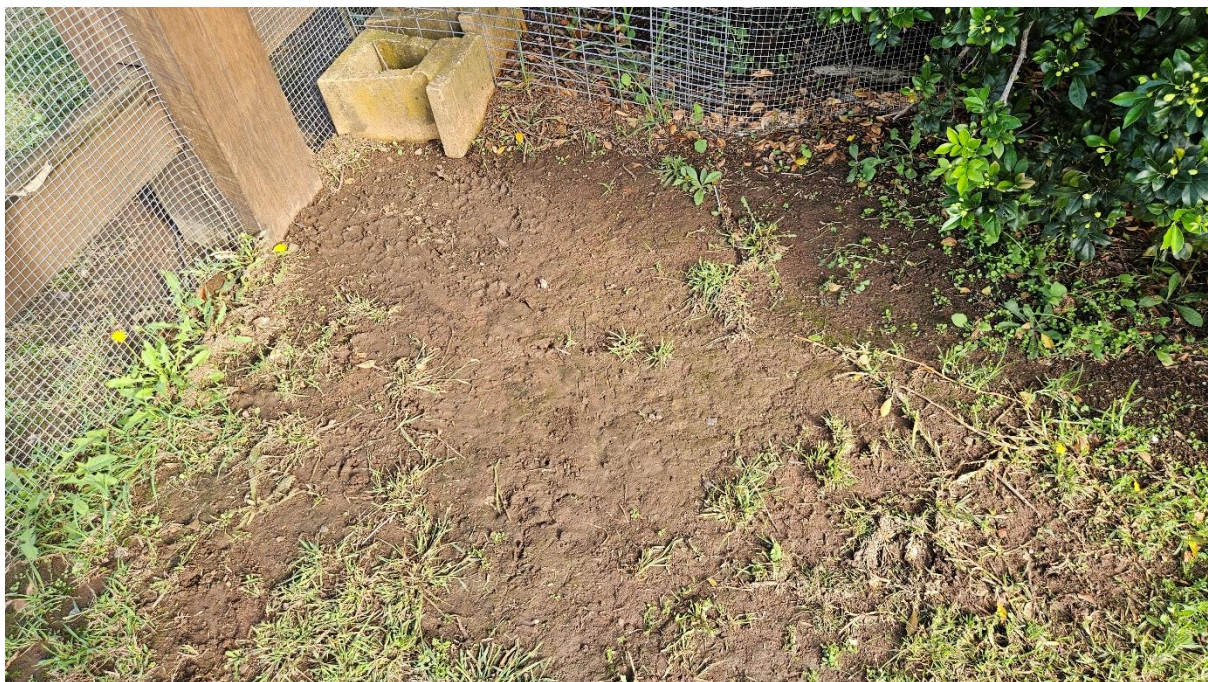
*Plate 31. A ground exposure at the proposed reservoir site showing A<sub>2</sub> Horizon soil. (Source: Heritage Now 2026)*

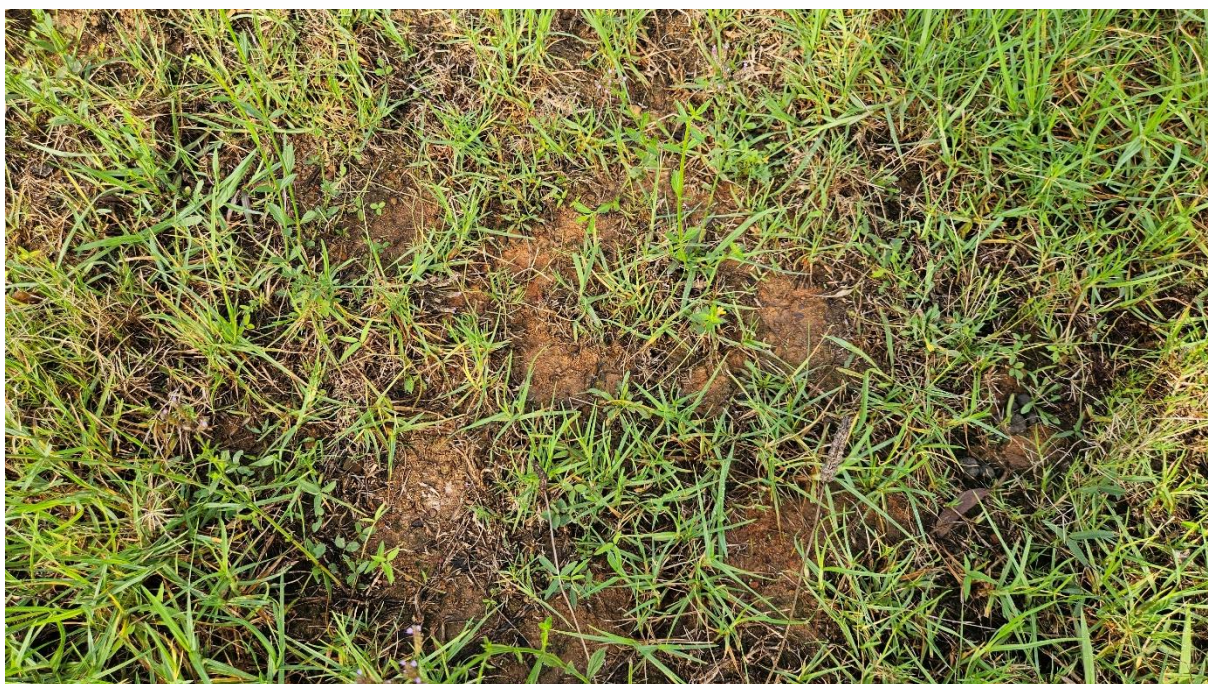
*Plate 32. Ground exposure showing B Horizon clay. (Source: Heritage Now 2026)*

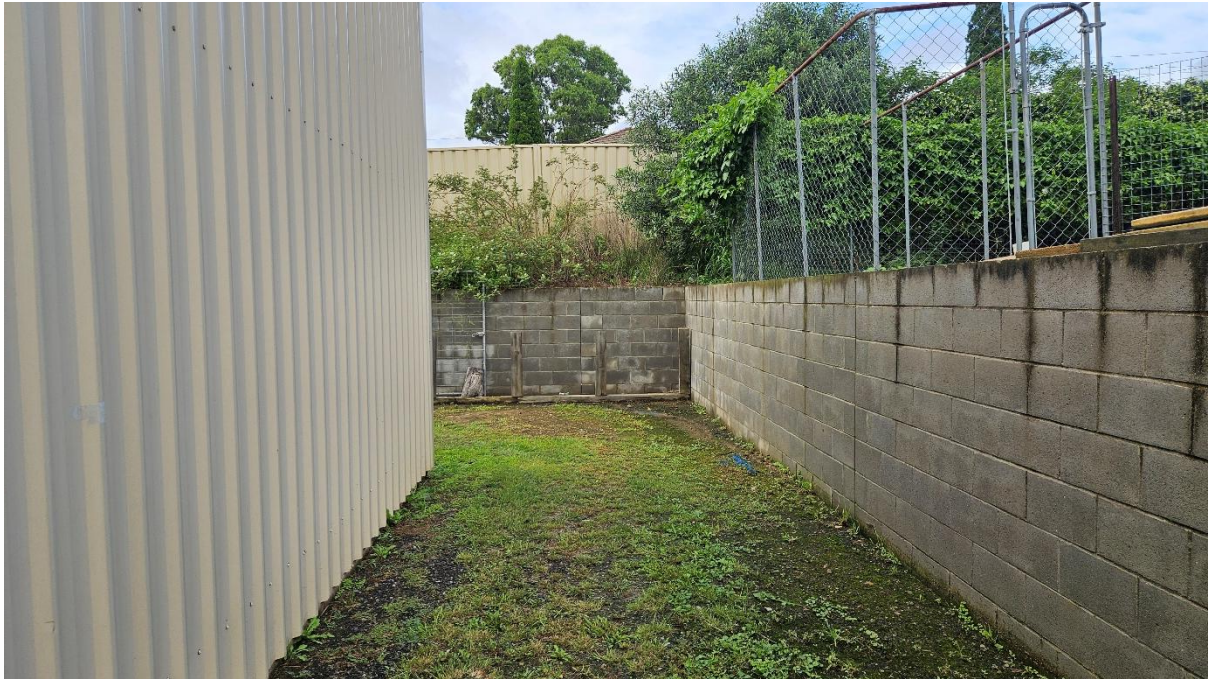
*Plate 33. Evidence of extensive cutting within the middle portion of the proposed reservoir site for the construction of an outbuilding, facing south. (Source: Heritage Now 2026)*

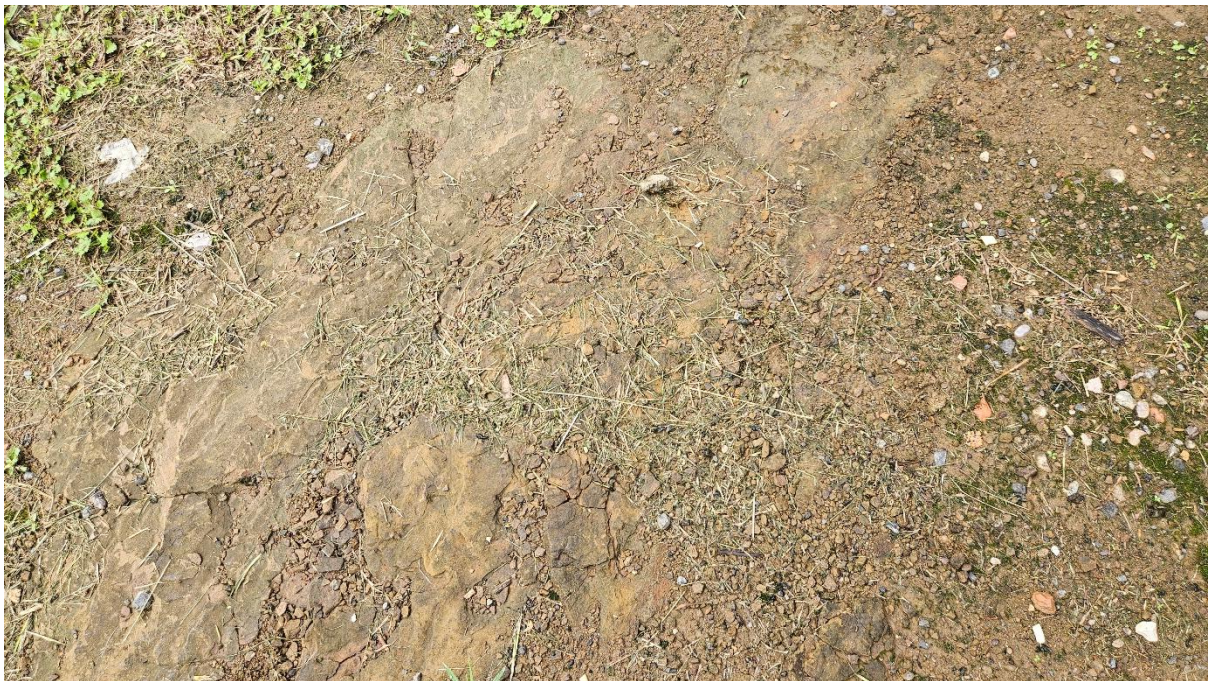
*Plate 34. Ground exposure showing shale bedrock behind an outbuilding, in the area where extensive cutting to the natural landform has taken place. (Source: Heritage Now 2026)*

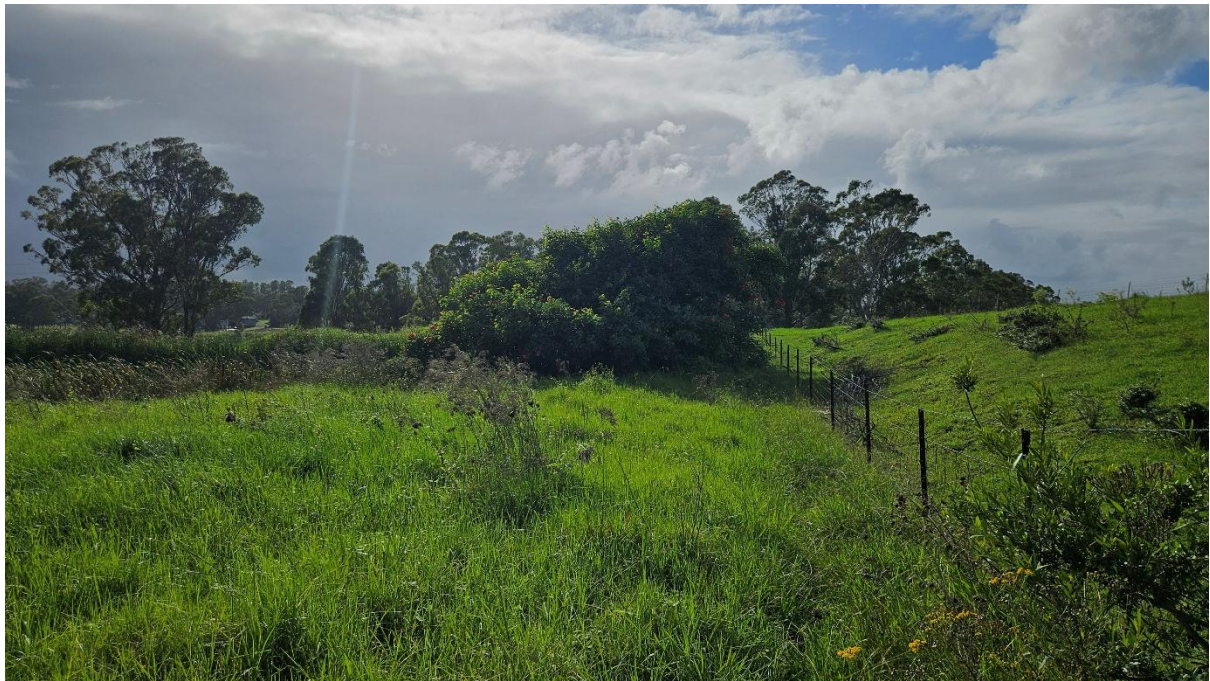
*Plate 35. Evidence of ground disturbance from the construction of the dam, facing east. (Source: Heritage Now 2026)*

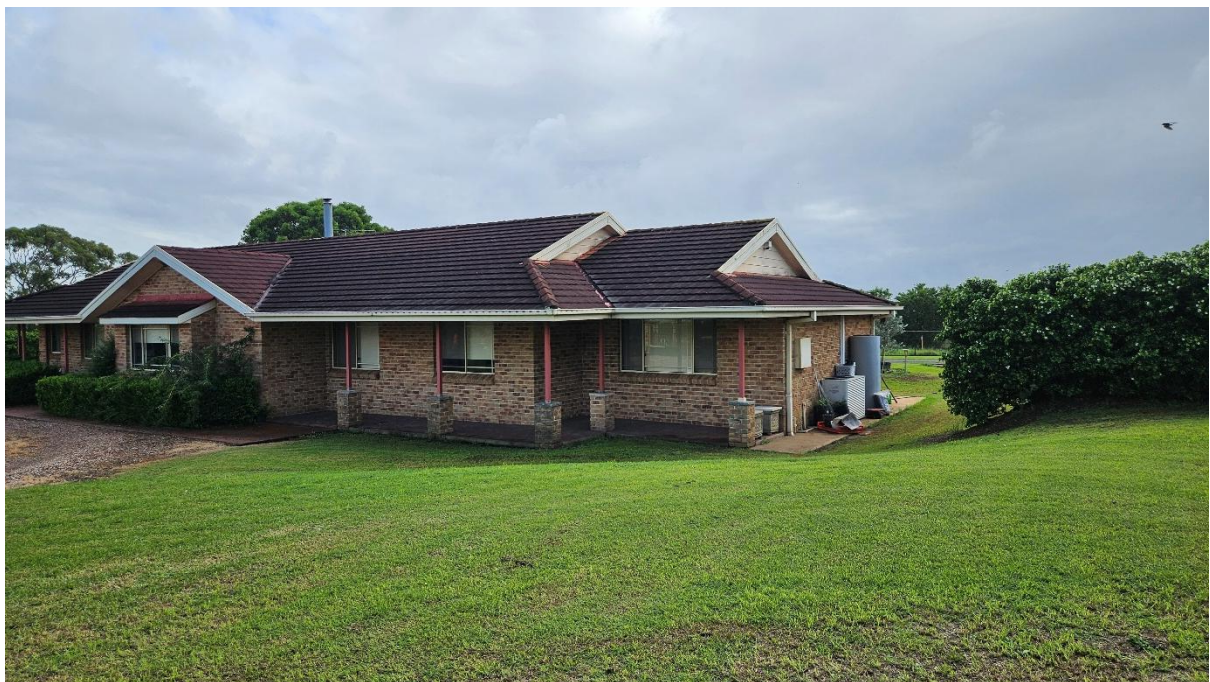
*Plate 36. Landform modification creating a flat surface for the main residence, facing north-east. (Source: Heritage Now 2026)*

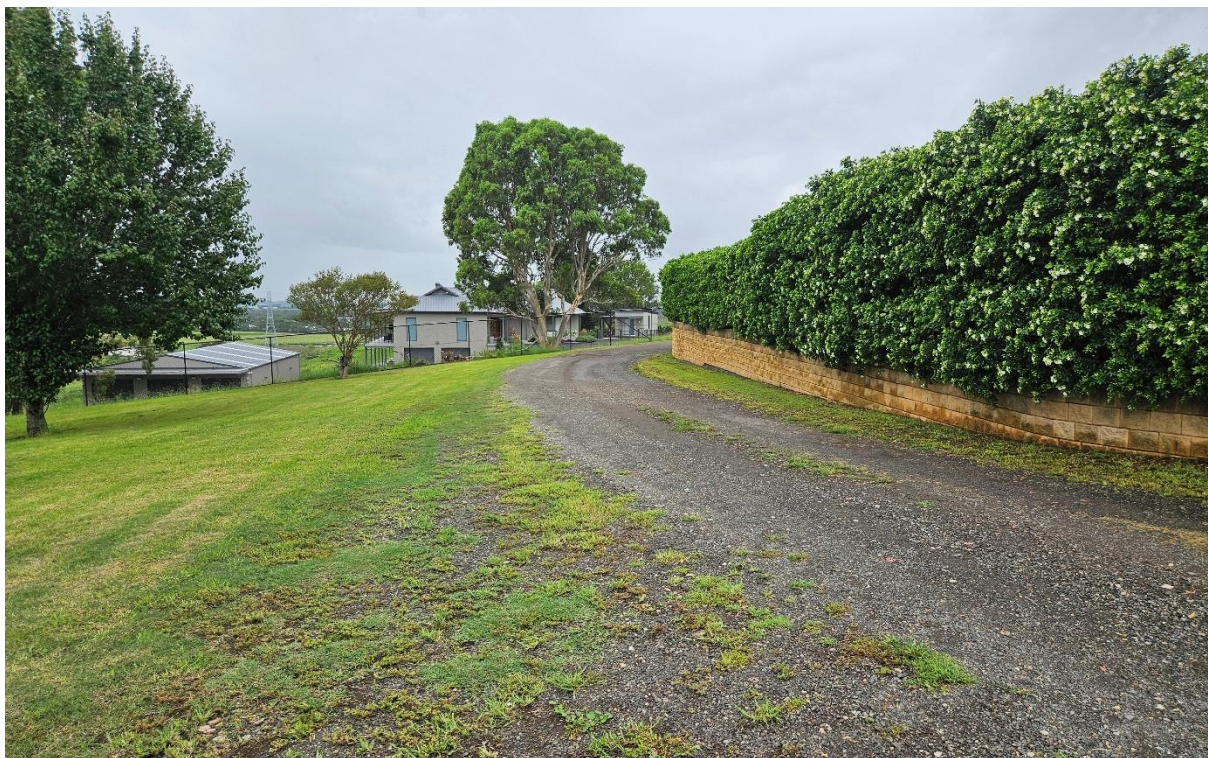
*Plate 37. Evidence of landform medication for a driveway, facing north-east. (Source: Heritage Now 2026)*

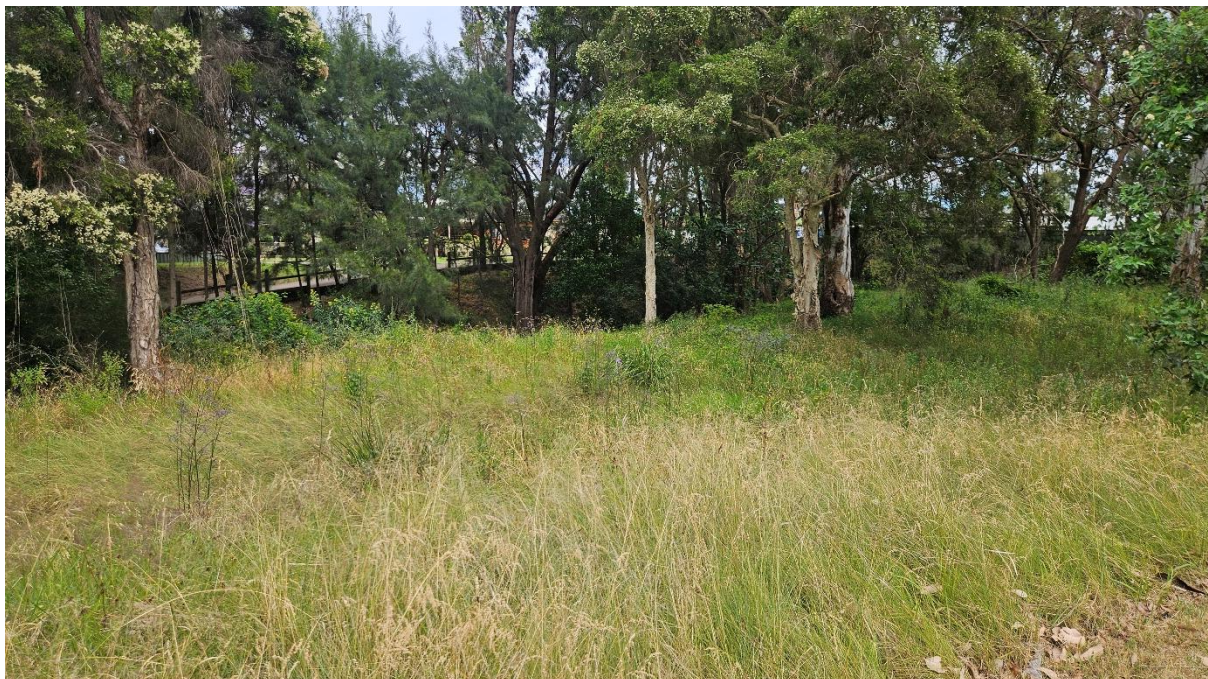
*Plate 38. Area of archaeological sensitivity located on the eastern bank of Prospect Creek, facing west. (Source: Heritage Now 2025)*

All on-site personnel are to be made aware of their obligations under the *National Parks and Wildlife Act 1974*, which includes protection of Aboriginal sites and the reporting of any new, or suspected, Aboriginal heritage sites. This may be done through an on-site induction or other suitable format. The identified area of sensitivity should be marked on all maps and plans and should also be shown during the induction to all on-site personnel. Measures are to be put in place to ensure that the underbore entry and exit pits are not located in, or within 10m of, the area of archaeological sensitivity. If there is a chance of inadvertent ground impacts to the area of sensitivity, this area should be fenced off.

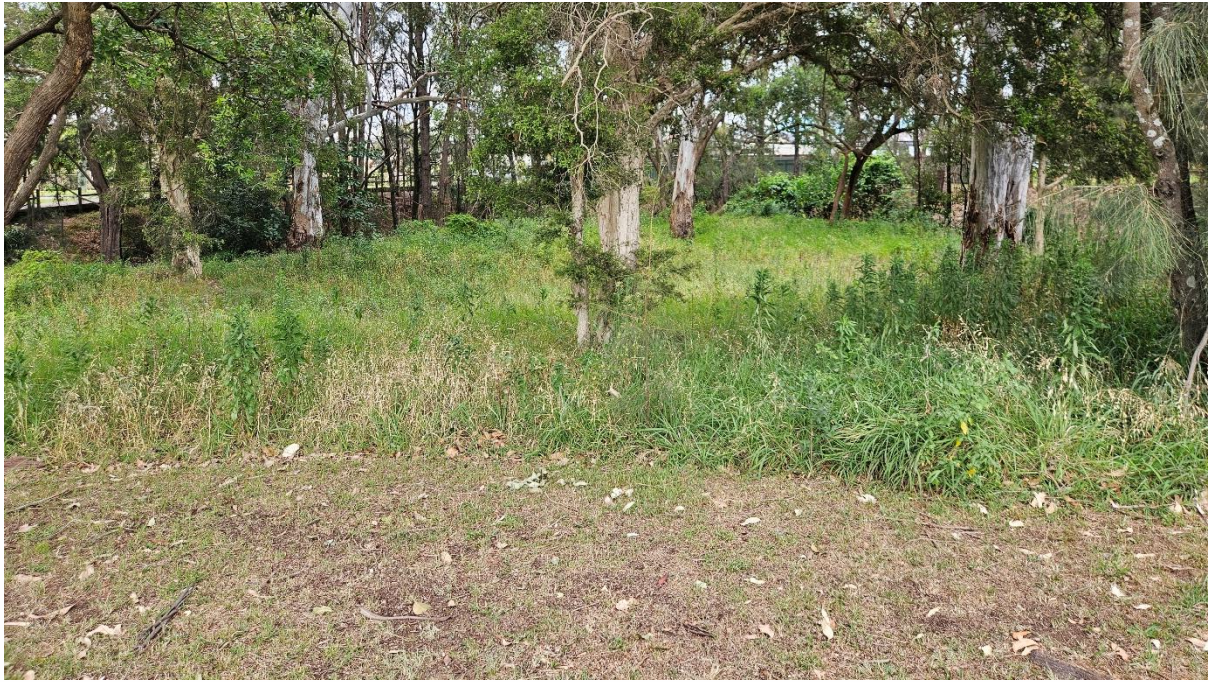
*Plate 39. A Horizon soils visible within the area of archaeological sensitivity, facing north-west. (Source: Heritage Now 2025)*

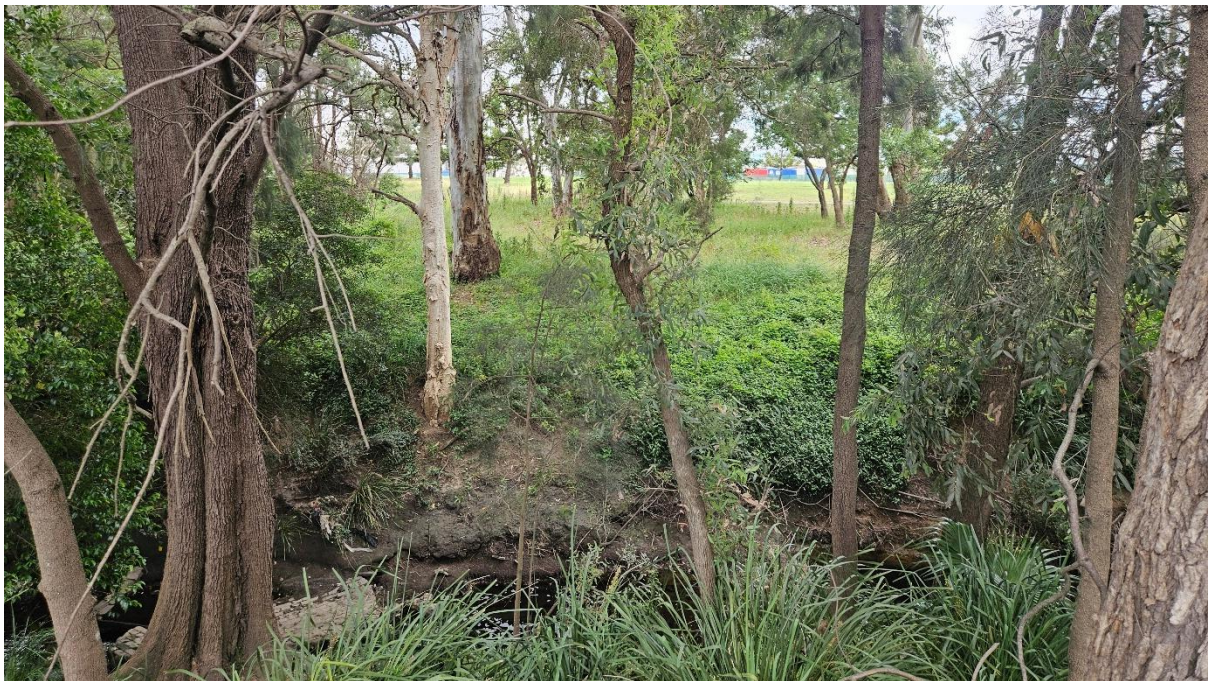
*Plate 40. The bank of Prospect Creek, showing A Horizons are still present within the area of archaeological sensitivity, facing east. (Source: Heritage Now 2025)*
