Report on  
Geotechnical Investigation

Proposed Residential Subdivision  
32 Lovelle Street and 141 Yarrowa Road,  
Moss Vale

Prepared for  
Prime Moss Vale Pty Ltd

Project 40494.03  
April 2020

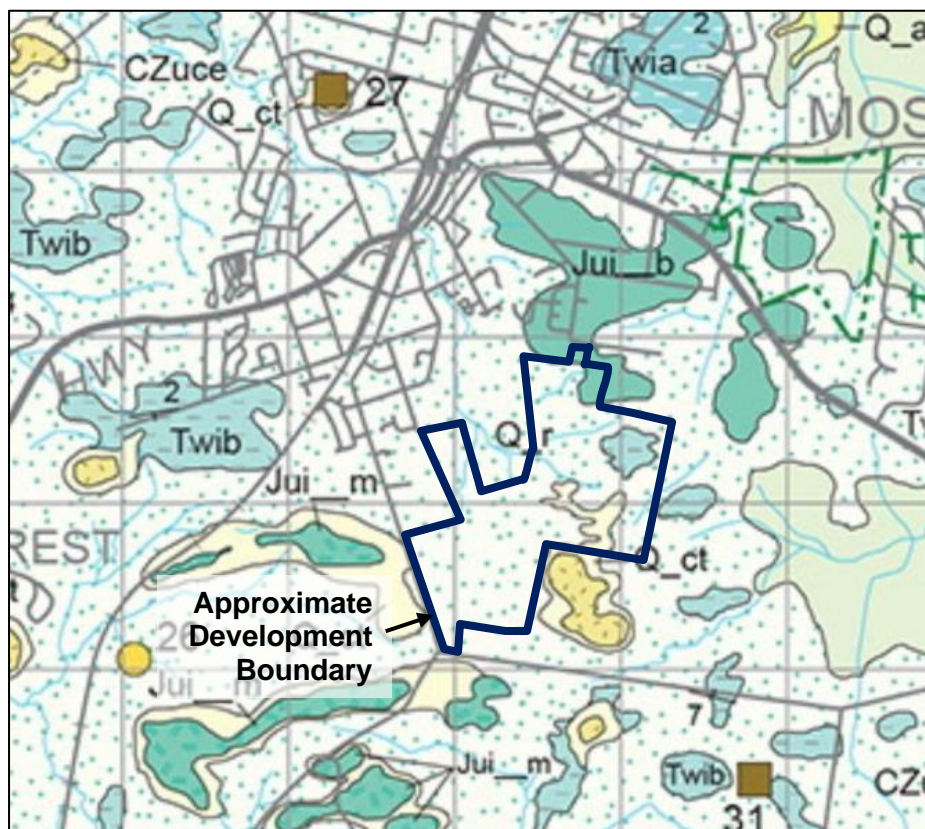
Figure 1: Distribution of Geological Units after Ref 1

**Quaternary residuum (*Q\_r*):** residual deposits of unconsolidated clayey coarse to fine grained sands to weakly consolidated sandy clay layers; poor to extensive soil development.

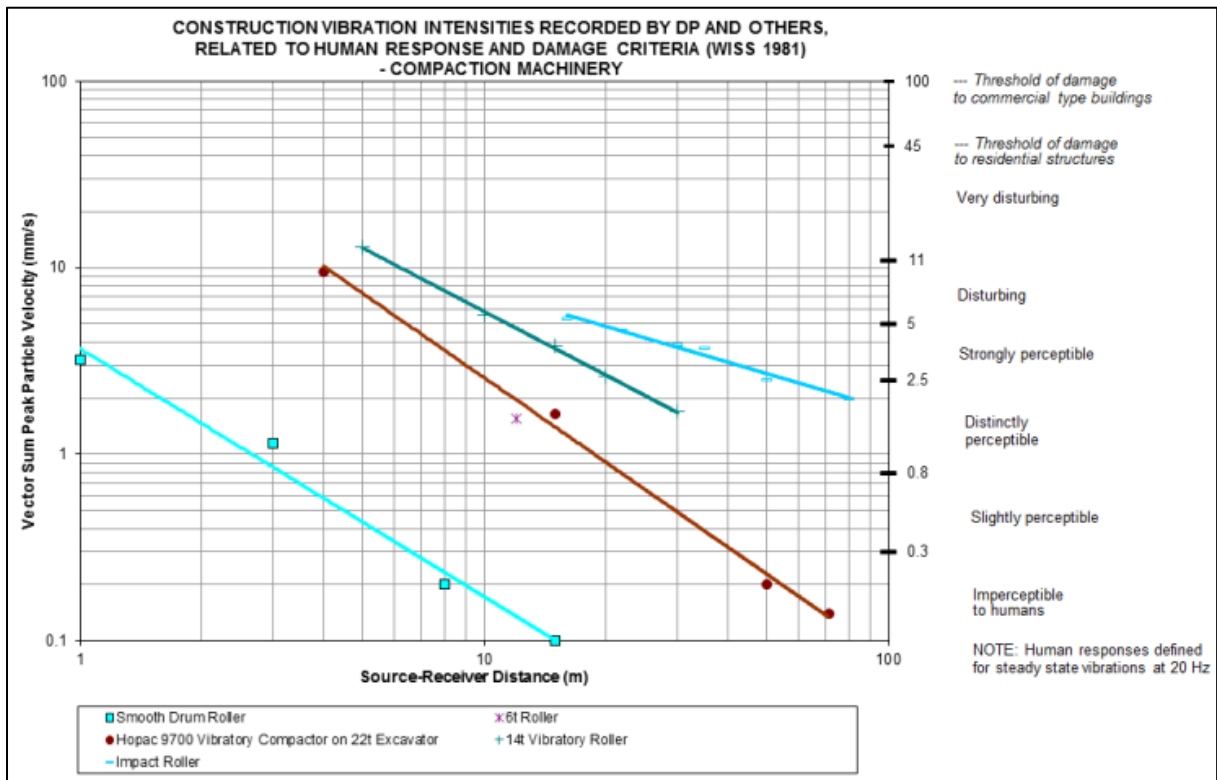
**Figure 3: Compaction Plant Vibration Levels**

Residential structures adjacent to active sections of the site can most likely withstand vibration levels higher than those required to maintain the comfort of their occupants. A human comfort criterion is therefore indicated and the peak particle velocity in any orthogonal direction  $i$  (PPVi), is proposed as the control parameter. It is recommended that a Provisional Allowed Vibration Limit of 8.0 mm/sec PPVi be set during normal working hours, measured at foundation level of the potentially affected residence/s. This limit is based on AS2670.2:1990 *Evaluation of Human Exposure to Whole-Body Vibrations – Continuous and Shock Induced Vibrations in Buildings (1 – 80 Hz)* but extended from only the vertical component to any directional component for conservative vibration management.

Reference to Figure 3 indicates that ground vibration levels in excess of the guidelines for human comfort (8.0 mm/sec PPVi) are likely to be exceeded by heavy (14 tonne) vibratory compaction plant at separation distances less than about 10 m. It is however noted that while vibration levels for human comfort are significantly less than those required for structural damage, complaints are likely at lower vibration levels. To minimise the potential for disruptions due to complaints, it is suggested that heavy rollers not be used in vibratory mode within 15 m of a residence. This may need to be confirmed on site by field trials with the equipment to be used during construction.

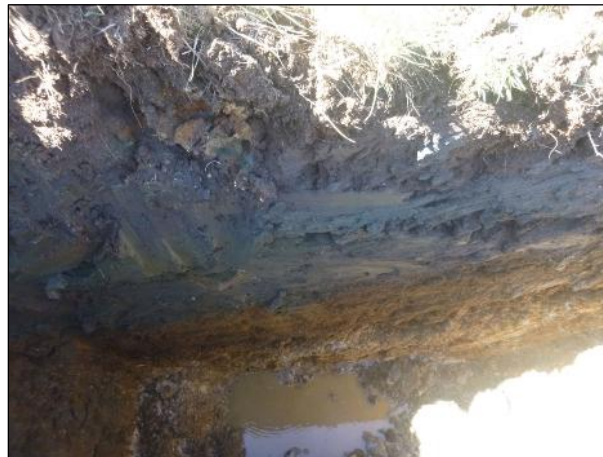
Seepage was previously observed during DP's preliminary investigation in September 2018 in Pit 1 in an active area of slumping in the steep hillside. Seepage was also inferred during mapping and from a review of aerial photography:

Pit 1 excavation.

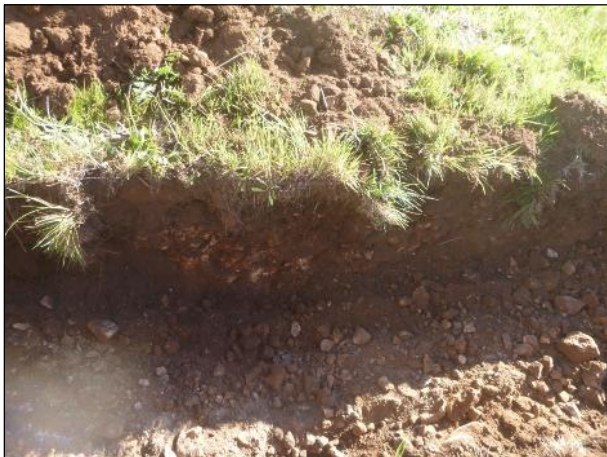
**Pit 2 excavation.**

RL	Depth (m)	Description of Strata	Graphic Log	Sampling & In Situ Testing				Water	Dynamic Penetrometer Test (blows per 150mm)			
				Type	Depth	Sample	Results & Comments		5	10	15	20
739	0.1	TOPSOIL - dark brown, silty clay with some sandstone cobbles, moist, FMC<PL	X X X X	D	0.1							
	0.5	DOLERITE - medium strength, moderately weathered, grey brown dolerite										
	0.5	Pit discontinued at 0.5m (Refusal on medium strength dolerite)		D	0.5

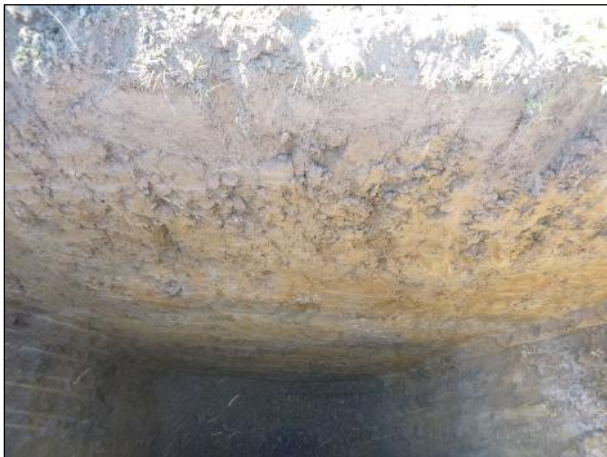
**Pit 3 excavation.**

RL	Depth (m)	Description of Strata	Graphic Log	Sampling & In Situ Testing				Water	Dynamic Penetrometer Test (blows per 150mm)
				Type	Depth	Sample	Results & Comments		
708	0.1	TOPSOIL - brown grey, silty clay, moist, FMC<PL		D	0.01				
		SILTY CLAY - stiff to hard, grey mottled orange brown, silty clay, moist, FMC<PL (COLLUVIUM)		B	0.4		pp = 400-500		
				D	0.5				
				D	0.6				
1	1.0	SILTY CLAY - very stiff, grey mottled orange brown, silty clay with some gravel-sized ironstone fragments, moist, FMC<PL (RESIDUAL)		D	1.0				
707	1.1	SILTSTONE - very low strength, moderately weathered, dark grey siltstone with extremely low strength, extremely weathered bands		D	1.5				
				D	2.0				
2				D	2.5				
706	2.5	- becoming extremely low strength, extremely weathered, grey with orange brown bands siltstone with very low strength bands below 2.4m Pit discontinued at 2.5m (Limit of Investigation)		D	2.5

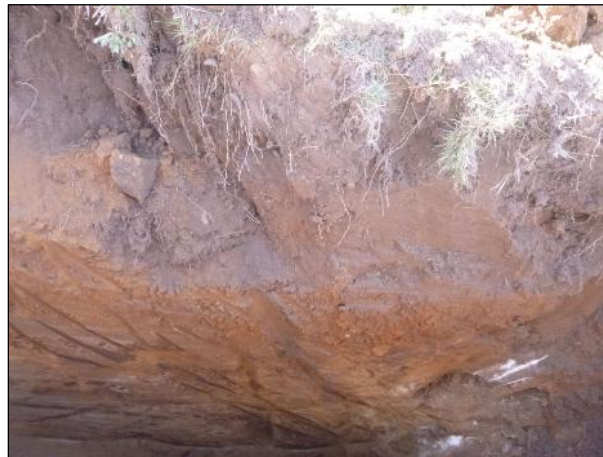
Pit 4 excavation.

RL	Depth (m)	Description of Strata	Graphic Log	Sampling & In Situ Testing				Water	Dynamic Penetrometer Test (blows per 150mm)
				Type	Depth	Sample	Results & Comments		
729	0.05	TOPSOIL - brown, sandy clay with some boulders (dolerite), moist, FMC<PL (COLLUVIUM)		D	0.1				
		SANDY CLAY - stiff, brown orange, friable, sandy clay, moist, FMC<PL (COLLUVIUM)		D	0.5				
	0.8	SANDY CLAY - stiff, orange brown, sandy clay with iron indurations, moist, FMC<PL (RESIDUAL)		D	1.0				
	1.1	DOLERITE - very low strength, highly weathered, orange brown dolerite with extremely low strength, extremely weathered bands		D	1.5				
728		- becoming low strength, moderately weathered brown orange with very low strength, highly weathered bands below 1.2m		D	2.0				
	2.0	Pit discontinued at 2.0m (Refusal on medium strength dolerite)		D	2.0

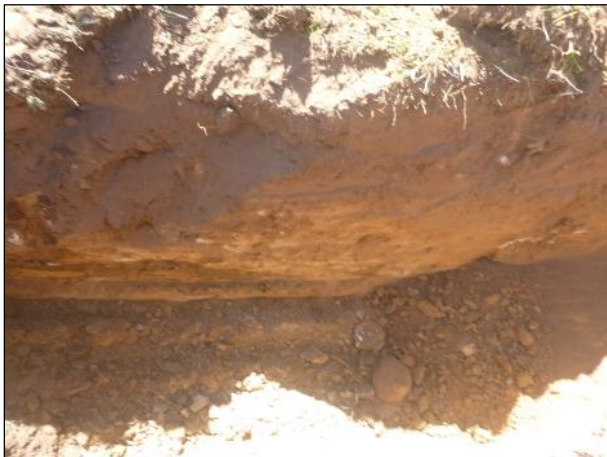
**Pit 5 excavation.**

RL	Depth (m)	Description of Strata	Graphic Log	Sampling & In Situ Testing				Water	Dynamic Penetrometer Test (blows per 150mm)
				Type	Depth	Sample	Results & Comments		
738	0.05	TOPSOIL - brown, silty clay, moist, FMC<PL		D	0.1				5 10 15 20
	0.4	SANDY CLAY - stiff to hard, brown mottled orange brown, sandy clay with some cobbles (dolerite) and iron indurations, moist, FMC<PL (COLLUVIUM)		D	0.5				
		DOLERITE - very low strength, highly weathered, brown orange dolerite with some ironstone and extremely low strength, extremely weathered bands							
	1.0	Pit discontinued at 1.0m (Refusal on medium strength dolerite)		D	1.0

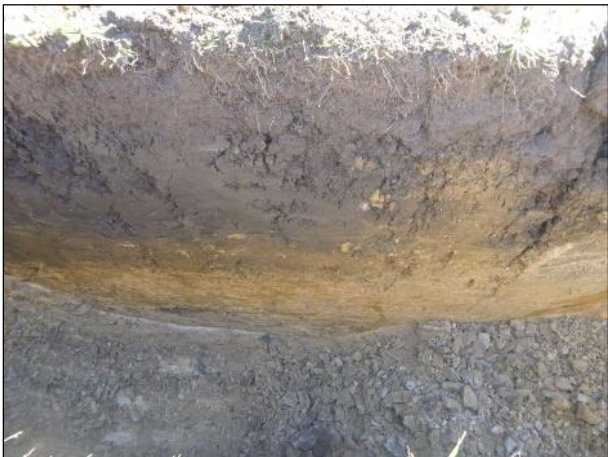
Pit 7 excavation.

D	0.1				
		SILTY CLAY - stiff, dark brown, silty clay, moist, FMC<PL (POSSIBLE COLLUVIUM/SLOPEWASH)		D	0.4		PEL*		
				D	0.5		pp >600		
				D	0.5				
1		- becoming very stiff to hard, grey mottled orange brown below 0.8m		D	1.0		pp >600		
	1.2	SILTSTONE - low to medium strength, moderately weathered, brown grey siltstone with very low strength, highly weathered bands							
	1.5	Pit discontinued at 1.5m (Refusal on medium strength siltstone)		D	1.5				
695

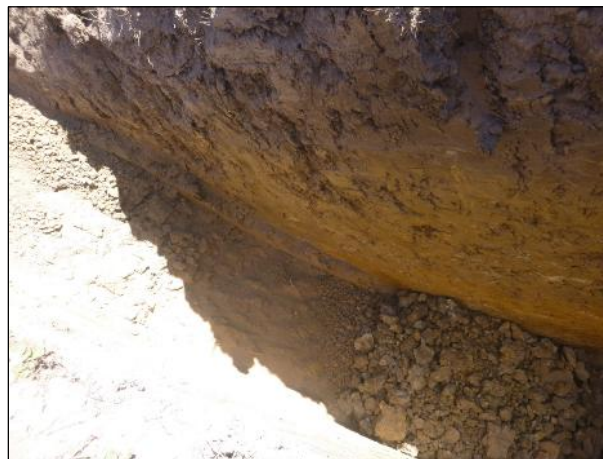
Pit 8 excavation.

SILTY CLAY - hard, dark brown, silty clay with some ironstone gravel, moist, FMC<PL (COLLUVIUM)		D	0.5		pp >600		
	0.8	SILTY CLAY - very stiff to hard, brown mottled grey and orange brown, silty clay with some sandy clay bands and sub-rounded to rounded gravel, moist, FMC<PL (COLLUVIUM)		D	1.0		pp >600		
	1.3	SILTY CLAY - very stiff to hard, grey mottled orange brown, moist, FMC<PL (RESIDUAL)		D	1.5		pp >600		
	1.6	SANDSTONE - low to medium strength, moderately weathered, grey, brown and orange brown, fine to medium-grained sandstone		D	2.0				
2	2.0	Pit discontinued at 2.0m (Refusal on medium strength sandstone)		D	2.0

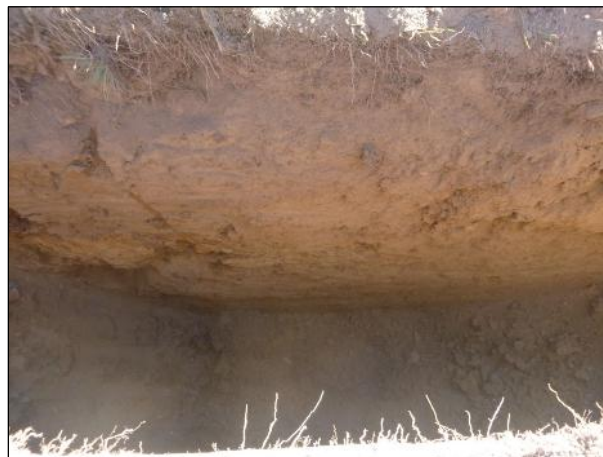
Pit 10 excavation.

RL	Depth (m)	Description of Strata	Graphic Log	Sampling & In Situ Testing				Water	Dynamic Penetrometer Test (blows per 150mm)			
				Type	Depth	Sample	Results & Comments		5	10	15	20
708	0.25	TOPSOIL - light brown, silty clay with some cobbles (syenite), moist, FMC<PL		D	0.1		pp >600  <b>PEL*</b>					
		SILTY CLAY - very stiff to hard, light brown mottled red brown, silty clay with trace ironstone gravel, moist, FMC<PL (RESIDUAL)		B	0.4							
1	1.0	SYENITE - very low strength, highly weathered, light brown, iron indurated syenite with extremely low strength, extremely weathered bands  - becoming low strength with very low strength bands below 1.4m		D	0.9							
				D	1.0							
707	1.8	Pit discontinued at 1.8m (Refusal on low strength syenite)		D	1.5

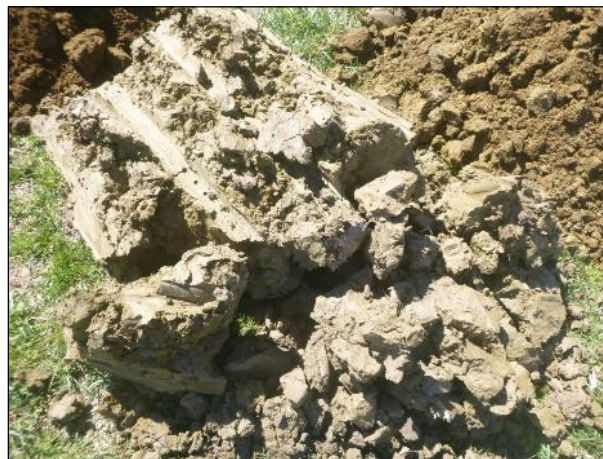
Pit 11 spoil.

RL	Depth (m)	Description of Strata	Graphic Log	Sampling & In Situ Testing				Water	Dynamic Penetrometer Test (blows per 150mm)
				Type	Depth	Sample	Results & Comments		
686	0.3	TOPSOIL - dark brown, silty clay with some root fibres, moist, FMC<PL		D	0.1				
		SILTY CLAY - stiff to very stiff, light brown, silty clay, moist, FMC~PL (POSSIBLE ALLUVIUM)		D	0.5		pp = 300-400		
685	1			D	1.0		pp = 300-400	1	
		- becoming slightly sandy below 1.5m (PROBABLE RESIDUAL) - becoming light brown mottled grey below 1.6m		D	1.5		pp = 300-400		
684	1.9			D	2.0			2	
		SANDSTONE - very low strength, highly weathered, grey medium to coarse-grained sandstone with extremely low strength extremely weathered bands							
	2.5	Pit discontinued at 2.5m (Limit of Investigation)		D	2.5

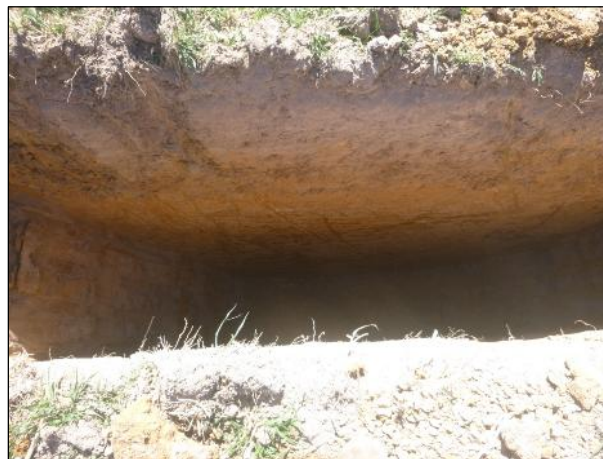
Pit 12 excavation.

RL	Depth (m)	Description of Strata	Graphic Log	Sampling & In Situ Testing				Water	Dynamic Penetrometer Test (blows per 150mm)
				Type	Depth	Sample	Results & Comments		
694 693	0.1	TOPSOIL - light grey, silty clay, moist, FMC<PL		D	0.1				
		SILTY CLAY - very stiff to hard, light brown mottled orange red grey, silty clay, moist, FMC<PL (RESIDUAL)		D	0.5		pp >600		
		- becoming grey mottled orange brown with trace ironstone gravel below 0.7m		D	1.0		pp >600	1	
		- becoming grey mottled light brown below 1.4m		D	1.5		pp >600		
				D	2.0		pp = 500-600	2	
692		- becoming slightly sandy, grey mottled light brown below 2.1m, moist, FMC~PL		D	2.5		pp = 200-300		
	2.5	- becoming very stiff below 2.4m Pit discontinued at 2.5m (Limit of Investigation)

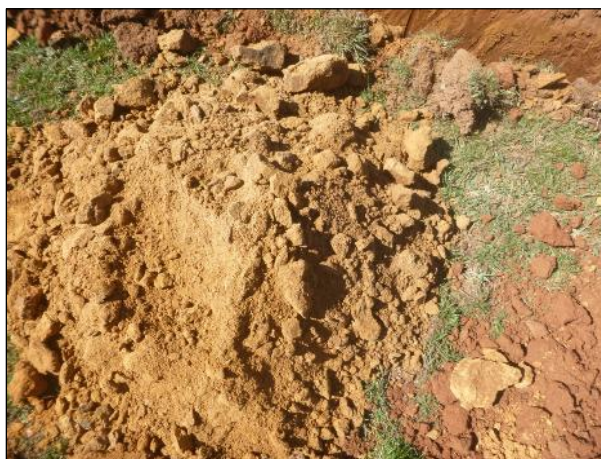
Pit 14 spoil.

RL	Depth (m)	Description of Strata	Graphic Log	Sampling & In Situ Testing				Water	Dynamic Penetrometer Test (blows per 150mm)
				Type	Depth	Sample	Results & Comments		
695	0.1	TOPSOIL - brown, silty clay, moist, FMC<PL		D	0.5				
		SILTY CLAY - very stiff to hard, red brown, silty clay with some ironstone gravel, and cobble and boulder-sized fragments (syenite), moist, FMC~PL (RESIDUAL)							
694	0.7	SILTY CLAY - very stiff to hard, red brown, silty clay with some gravel-sized ironstone fragments, moist, FMC<PL (RESIDUAL)							
1		- becoming orange red brown below 1.1m		D	1.0		pp >600		
		- becoming orange brown mottled grey below 1.4m							
693	2.0	SYENITE - very low strength, highly weathered, light brown syenite with extremely low strength, extremely weathered bands		D	2.0		PEL*		
	2.5	Pit discontinued at 2.5m (Limit of Investigation)		D	2.5

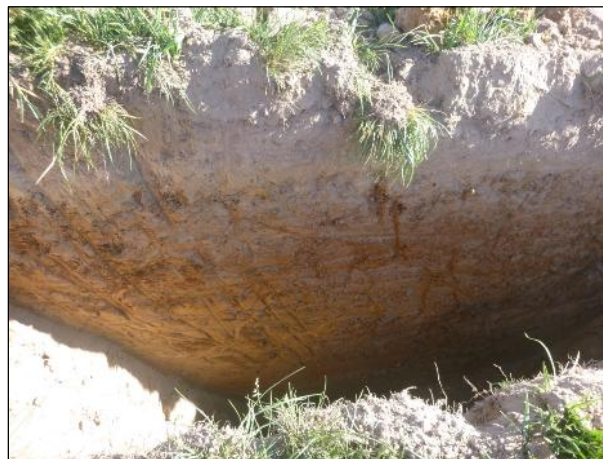
Pit 15 excavation.

D	2.5				
	2.5	Pit discontinued at 2.5m (Limit of Investigation)		D	2.5

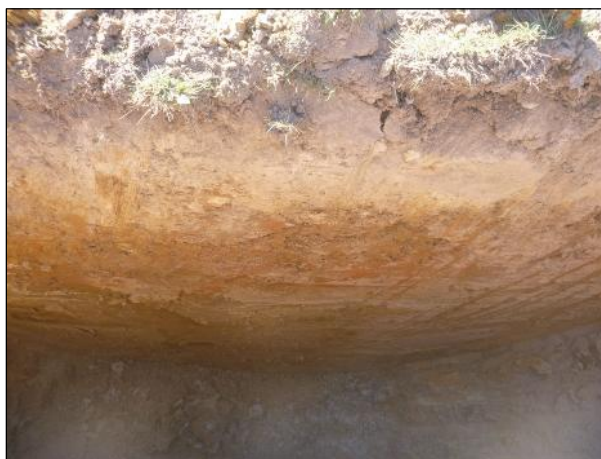
Pit 16 excavation.

- becoming hard below 1.5m		D	1.5		pp >600					
	2	- becoming slightly sandy with some very low to low strength, highly weathered, siltstone bands below 1.9m		D	2.0		pp = 500-600					
694	2.0	SILTSTONE - very low to low strength, highly to moderately weathered siltstone with extremely low strength, extremely weathered bands

2.5	Pit discontinued at 2.5m (Limit of Investigation)		D	2.5		pp = 400-500

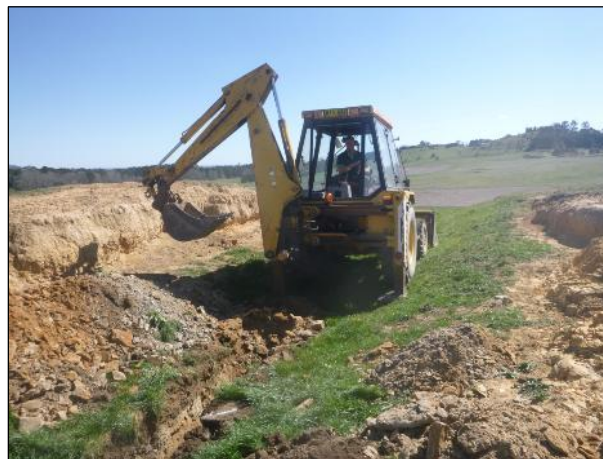
Pit 17 spoil.

RL	Depth (m)	Description of Strata	Graphic Log	Sampling & In Situ Testing				Water	Dynamic Penetrometer Test (blows per 150mm)
				Type	Depth	Sample	Results & Comments		
704	0.05	FILLING - dark brown, silty clay, moist, FMC~PL		D	0.1				
	0.3	FILLING - dark brown, silty clay with trace anthropogenic (bricks and concrete) and bones (probably cattle), moist, FMC~PL		D	0.5				
		SANDSTONE - very low to low strength, highly to moderately weathered, grey sandstone with extremely low strength, extremely weathered bands		D	1.0				
	1.0	Pit discontinued at 1.0m (Refused on low to medium strength sandstone)		D	1.0				
					2.9		PEL*		
					3.0

**Uncontrolled Filling** – present in Pit 17 and observed in access roads around the dwelling off 32 Lovelle Street and in walls of farm dams. The type of material should be expected to vary significantly between different areas of filling and include building rubble, coal washery reject and natural soils sourced from the site (ie for farm dams).

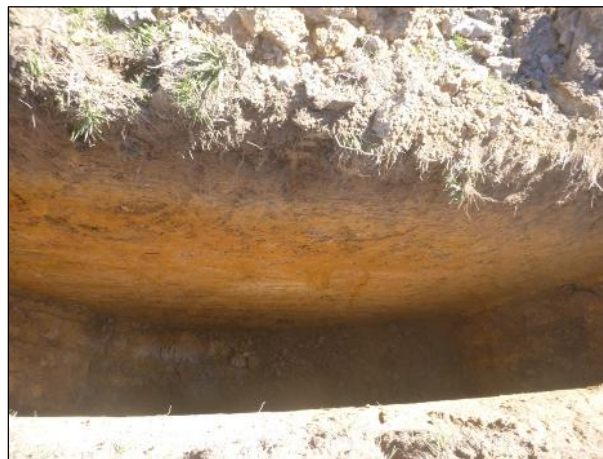
Pit 19 excavation.

D	2.0			2	
	2.5	Pit discontinued at 2.5m (Limit of Investigation)		D	2.5

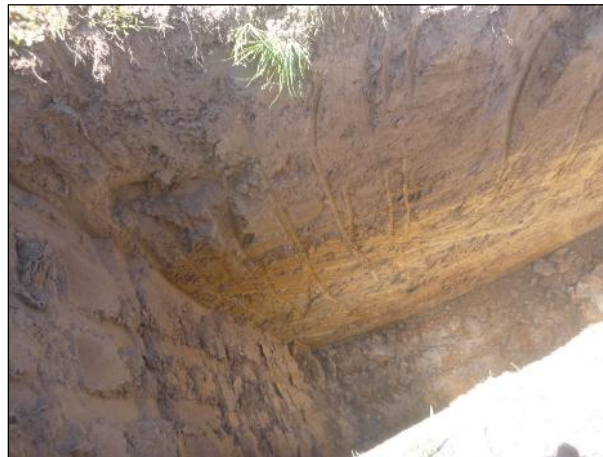
Pit 20 excavation.

RL	Depth (m)	Description of Strata	Graphic Log	Sampling & In Situ Testing				Water	Dynamic Penetrometer Test (blows per 150mm)			
				Type	Depth	Sample	Results & Comments		5	10	15	20
691	0.1	TOPSOIL - brown grey, silty clay, moist, FMC<PL		D	0.1							
		SILTY CLAY - very stiff to hard, orange brown grey, silty clay, moist, FMC<PL (PROBABLE RESIDUAL)		D	0.5		pp = 500-600					
	1	- becoming orange brown mottled grey below 0.9m		D	1.0		pp = 500-600	1				
		- becoming grey mottled orange brown below 1.2m		D	1.5		pp = 300-400					
	2			D	2.0			2				
689	2.5	- with extremely low strength, extremely weathered siltstone bands below 2.4m Pit discontinued at 2.5m (Limit of Investigation)

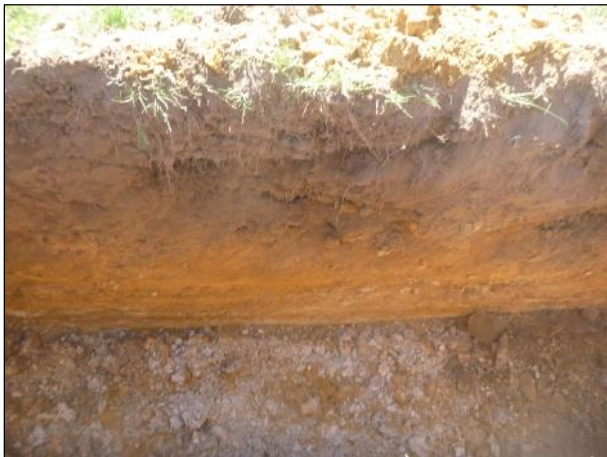
Pit 21 excavation.

RL	Depth (m)	Description of Strata	Graphic Log	Sampling & In Situ Testing				Water	Dynamic Penetrometer Test (blows per 150mm)
				Type	Depth	Sample	Results & Comments		
701	0.1	TOPSOIL - brown, silty clay, moist, FMC<PL		D	0.1				
		SANDY CLAY - stiff to very stiff, orange brown, sandy clay, moist, FMC<PL (RESIDUAL)							
	0.5			D	0.5				
		SANDSTONE - very low to low strength, highly to moderately weathered, light brown, fine-grained sandstone with extremely low strength, extremely weathered bands							
				D	0.9 1.0 1.0		PEL*		
	1.3	Pit discontinued at 1.3m (Refusal on low strength sandstone)

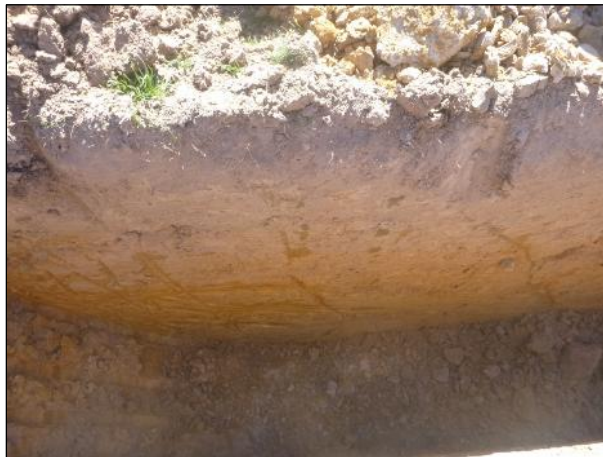
**Pit 22 excavation.**

RL	Depth (m)	Description of Strata	Graphic Log	Sampling & In Situ Testing				Water	Dynamic Penetrometer Test (blows per 150mm)
				Type	Depth	Sample	Results & Comments		
684	0.1	TOPSOIL- brown, silty clay, moist, FMC<PL		D	0.1		pp >600	1	
		D		0.5					
		D		1.0					
		D		1.5					
	1.5	SANDSTONE - low to medium strength, slightly weathered, grey and orange brown, fine-grained sandstone with some ironstone bands							
	1.7	Pit discontinued at 1.7m (Refusal on medium strength sandstone)

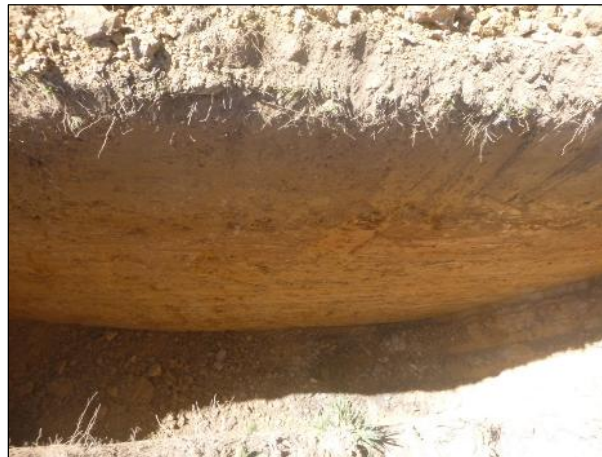
Pit 23 excavation.

RL	Depth (m)	Description of Strata	Graphic Log	Sampling & In Situ Testing				Water	Dynamic Penetrometer Test (blows per 150mm)
				Type	Depth	Sample	Results & Comments		
692	0.1	TOPSOIL - brown, silty clay, moist, FMC<PL		D	0.1				
		SILTY CLAY - very stiff, orange grey, friable, silty clay, moist, FMC<PL (RESIDUAL)		D	0.4		PEL*		
		- becoming very stiff to hard below 0.6m		D	0.5				
				D	0.5				
1		- becoming grey mottled with orange brown below 1.1m		D	1.0		pp >600		
				B	1.2				
	1.4	SILTSTONE - low to medium strength, slightly weathered, orange grey siltstone with very low strength, highly weathered bands		D	1.5				
				D	2.0				
2		- with some ironstone bands below 2.0m							
	2.2	Pit discontinued at 2.2m (Refusal on medium strength siltstone)

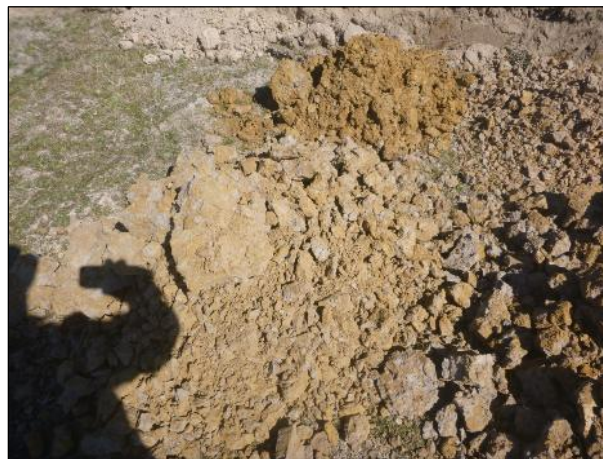
Pit 24 spoil.

RL	Depth (m)	Description of Strata	Graphic Log	Sampling & In Situ Testing				Water	Dynamic Penetrometer Test (blows per 150mm)			
				Type	Depth	Sample	Results & Comments		5	10	15	20
688	0.2	TOPSOIL - light brown, silty clay, moist, FMC<PL		D	0.1							
	SILTY CLAY - very stiff to hard, light brown grey mottled orange brown, silty clay, moist, FMC<PL (PROBABLE ALLUVIUM)											
		B		0.4								
		D		0.5		pp >600						
		D		0.6								
	1			D	1.0		pp >600	1				
687			D	1.5		pp >600						
	2		D	2.0		pp >600	2					
		- becoming stiff, grey mottled orange brown, moist, FMC~PL below 2.2m										
686	2.5	Pit discontinued at 2.5m (Limit of Investigation)		D	2.5		pp >600

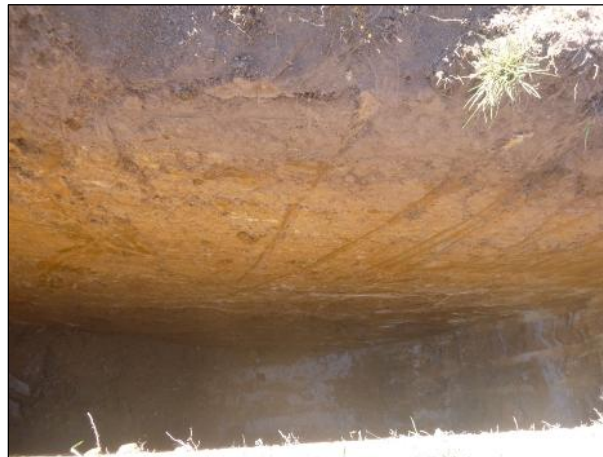
Pit 25 excavation.

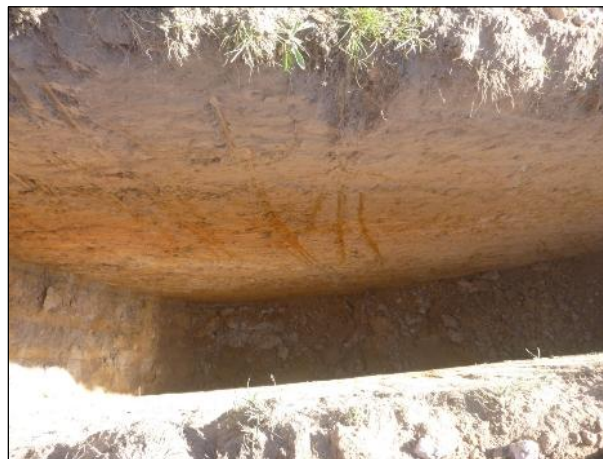
Pit 26 excavation.

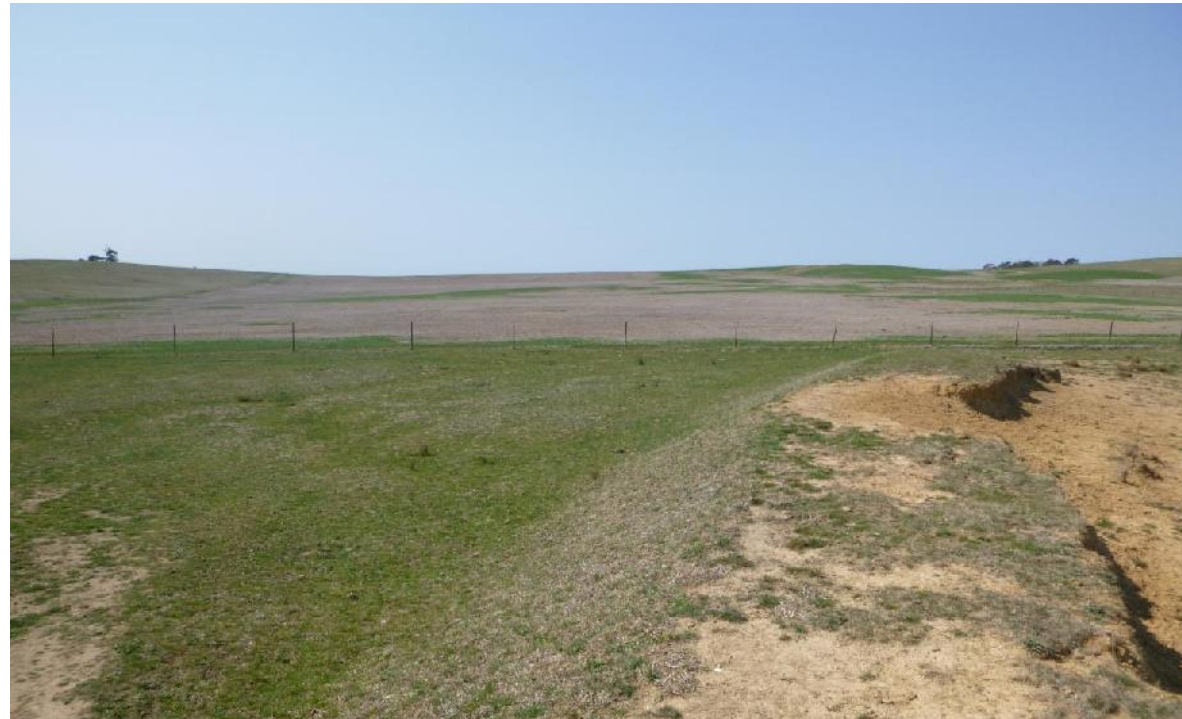
Photo 3: View looking east from the large farm dam in the central part of the site. Note: the low ridge line in the background of the photo.

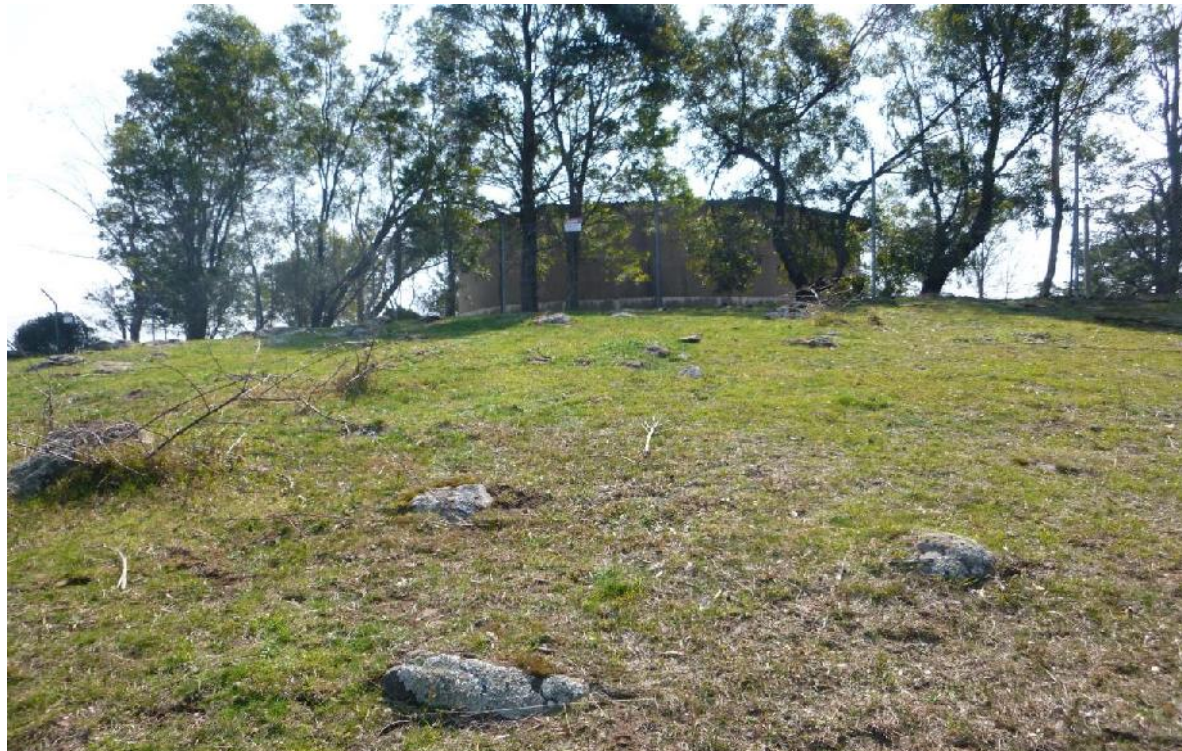
Photo 5: View looking north at the smaller of the two water reservoirs at the top of the hill iadjacent to the northern part of the site.

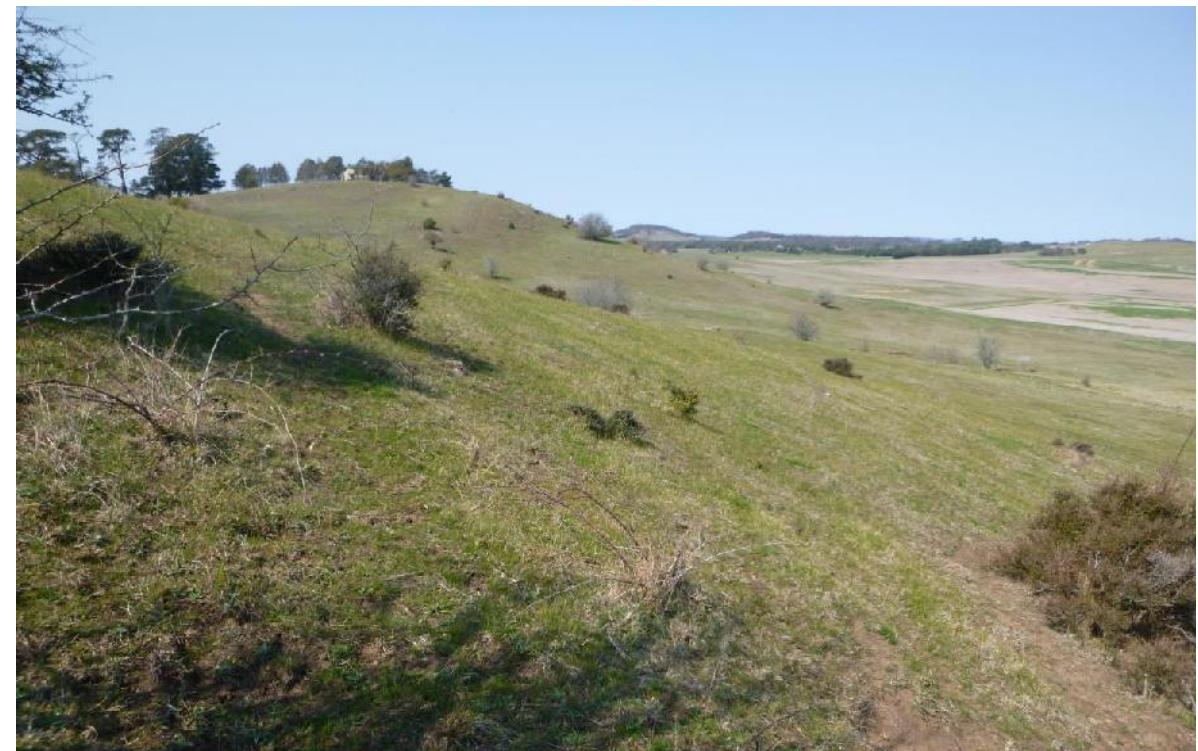
Photo 6: View looking southeast across the steep to very steep hillside in the northern part of the site.

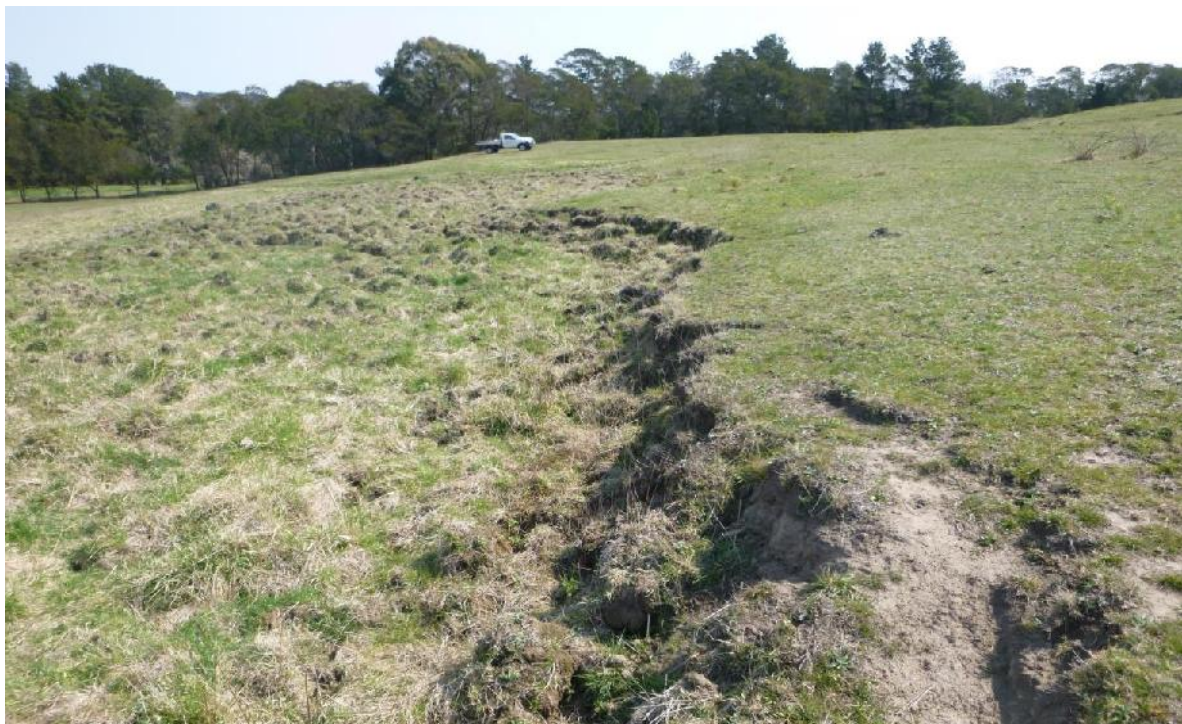
Photo 7: View looking northwest across the active scarp in the lower-middle part of the hillside in the northern part of the site.

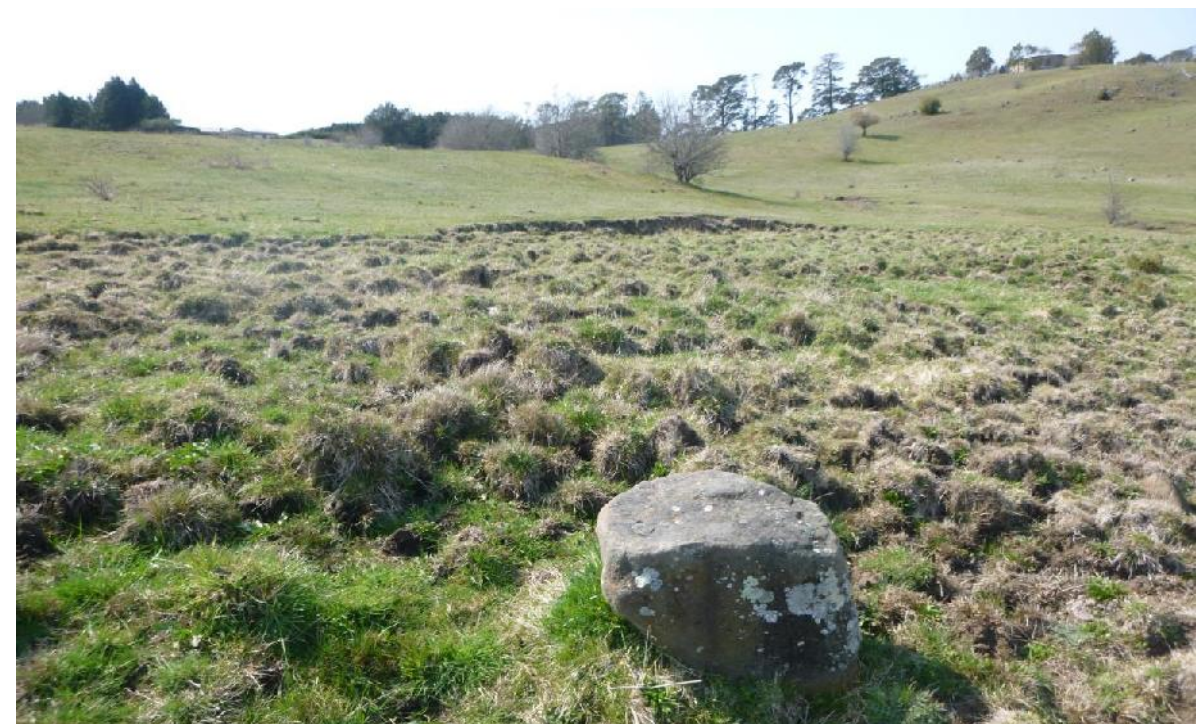
Photo 8: View looking northeast across the active scarp in the lower-middle part of the hillside in the northern part of the site. Note: the igneous boulders lying on the surface.

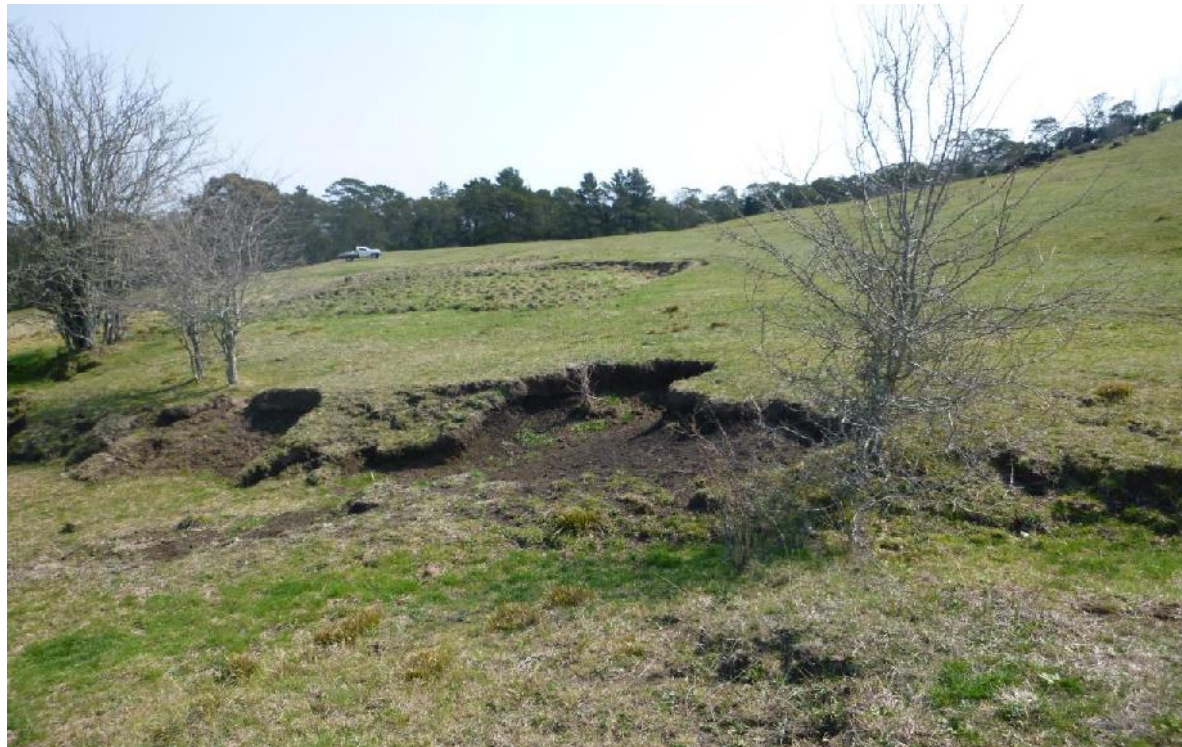
Photo 9: View looking at slumping in a drainage depression in the steep to very steep hillside in the northern part of the site.

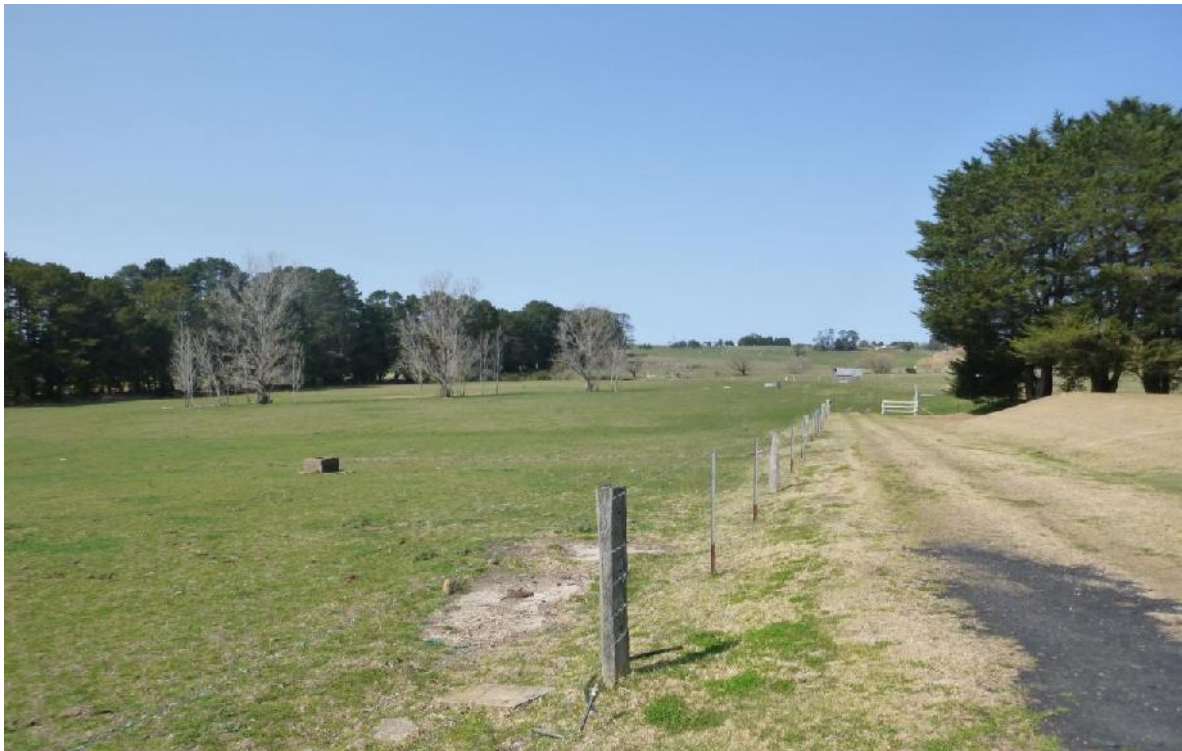
Photo 10: View looking south across the northwestern part of the site. Note the coal washery reject filling in the raise roadway.

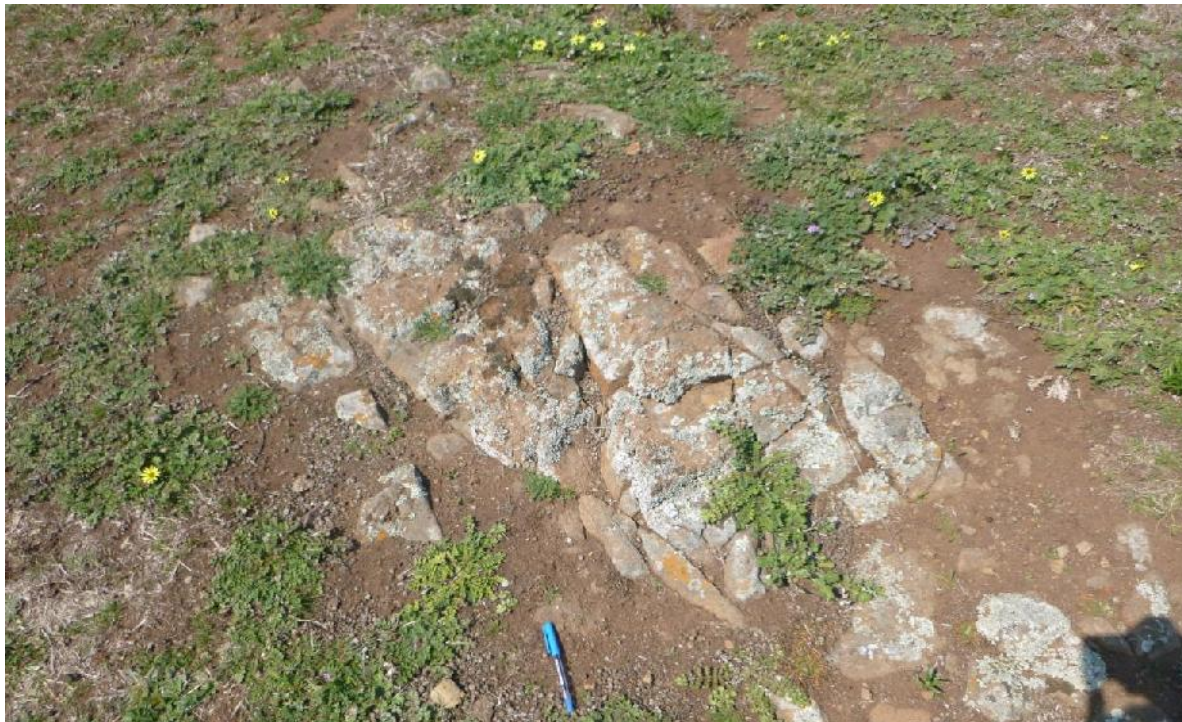
- Bedrock comprising medium to high strength, slightly fracture dolerite at discrete locations in the steep to very steep hillside in the northern part of the site, below the existing water reservoirs (refer Photo 11).
- Bedrock comprising fine-grained sandstone in an excavated trench through the gently-sloping hillsides in the eastern part of the site (refer Photo 12).
- Numerous igneous cobbles on the surface of a gently sloping to moderately steep slope in the south-western part of the site (refer Photo 14).

Photo 11: View looking at bedrock exposed near the crest of the steep to very steep hillside near the small water reservoir in the northern part of the site.

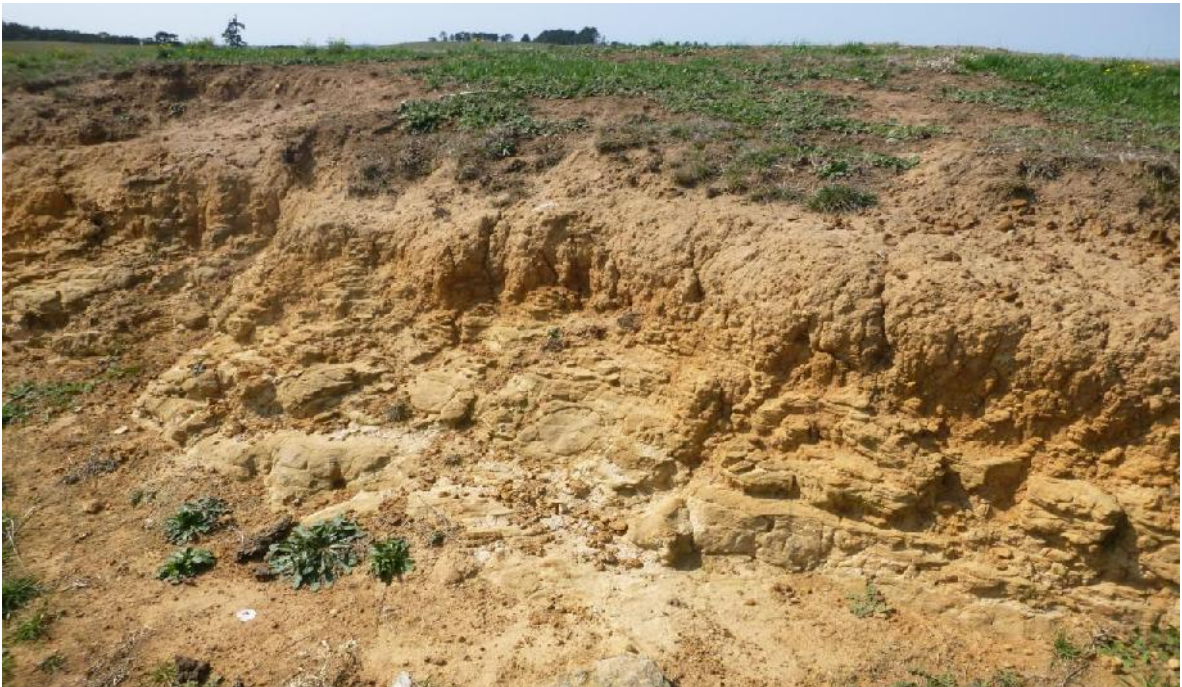
Photo 12: View looking at fine-grained sandstone exposed in a cutting in the eastern part of the site.

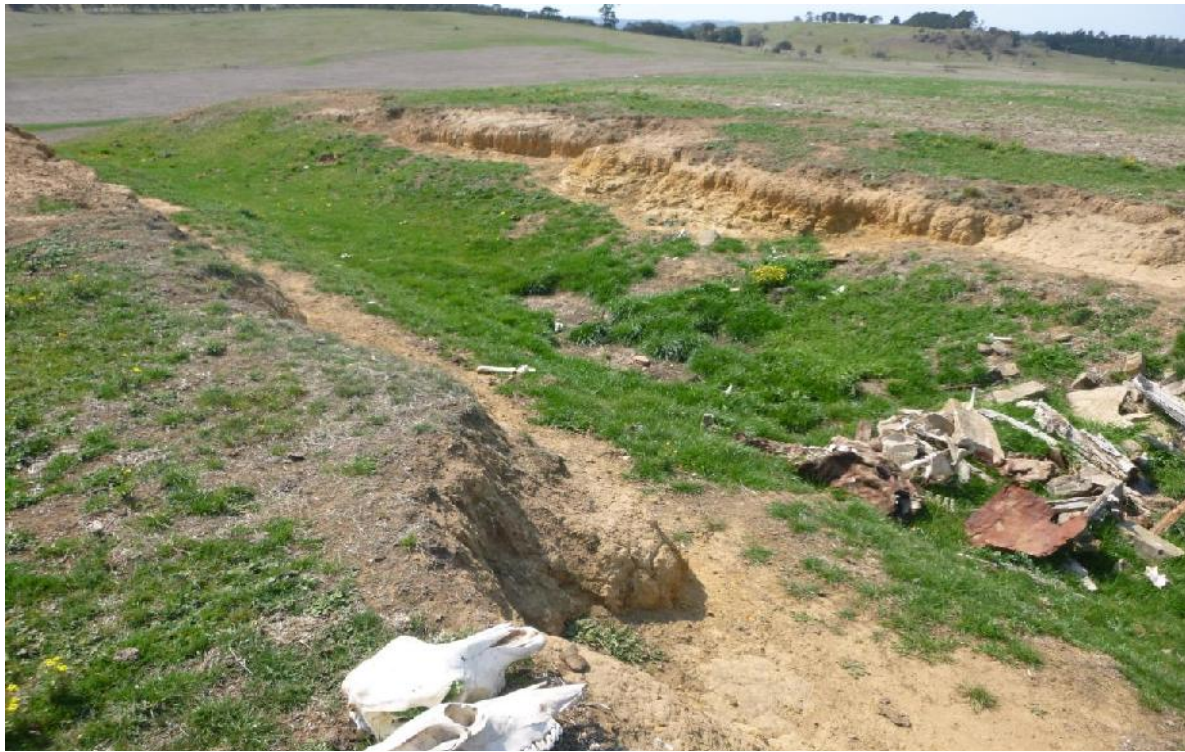
Photo 13: View looking at a cutting in the low ridgeline in the eastern part of the site. Note: the anthropenic material in the right of the photo.

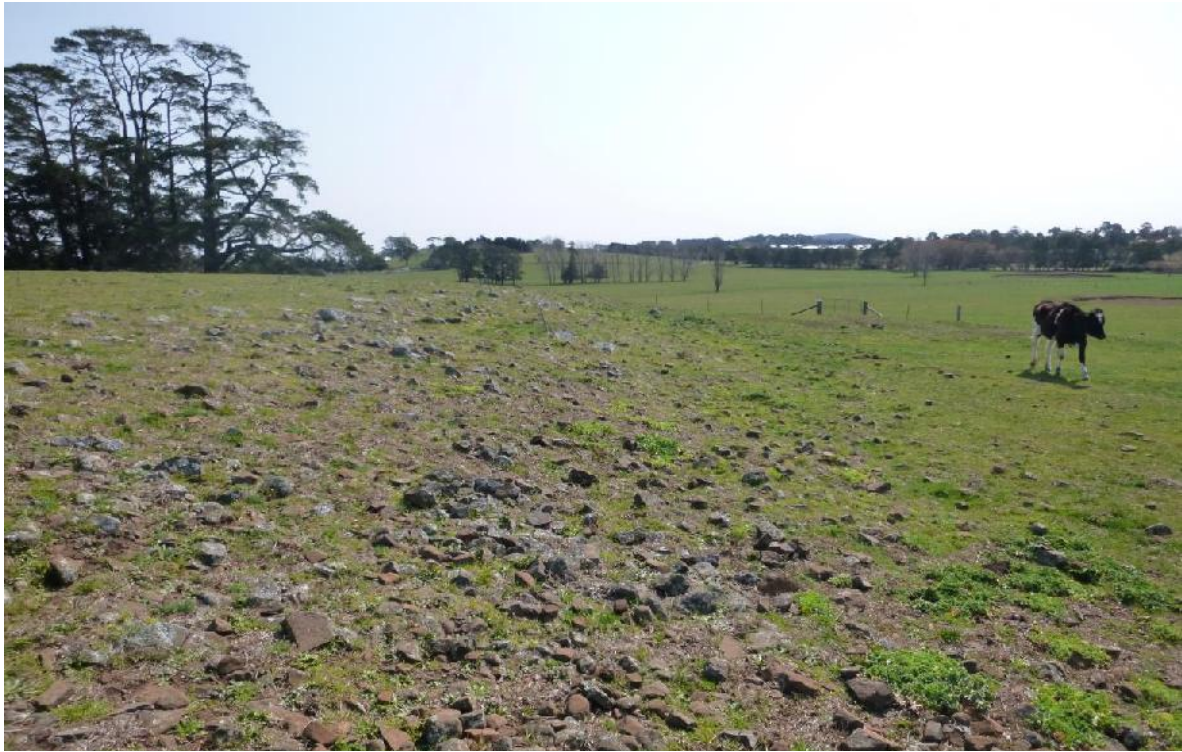
Photo 14: View of looking at igneous cobbles exposed at the surface along a low natural batter in the southern part of the site.

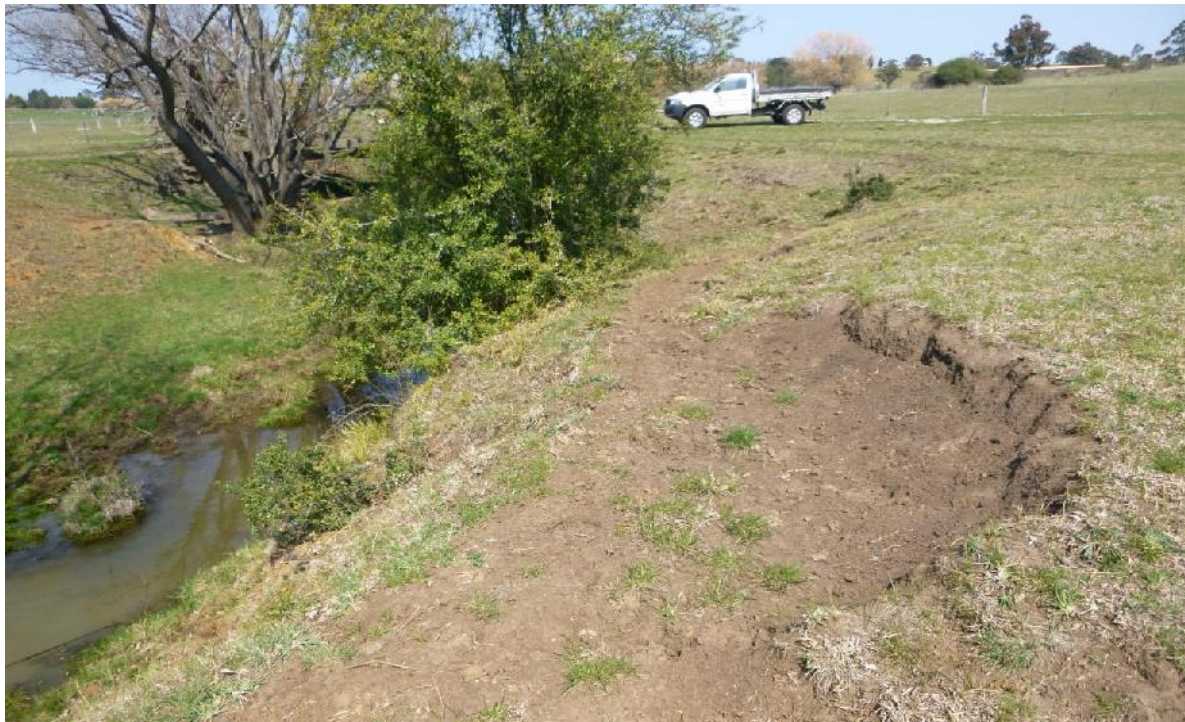
Photo 15: View looking at a back scarp in the creek bank in the northern part of the site..
