Report on  
Geotechnical Investigation

Proposed Residential Subdivision  
32 Lovelle Street and 141 Yarrowa Road,  
Moss Vale

Prepared for  
Prime Moss Vale Pty Ltd

Project 40494.03  
April 2020

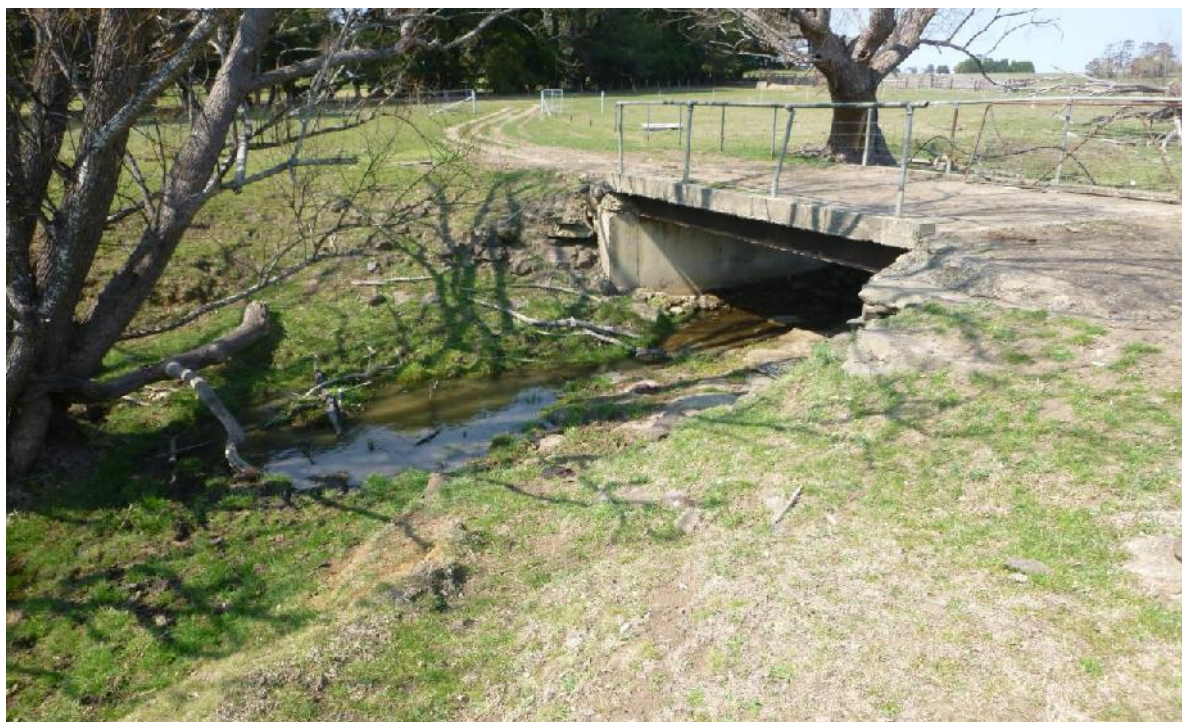
Photo 16: View looking at the bridge over the unnamed tributary of White Creek in the northern part of the site.
