# Narara Eco Village

## Water Reservoir

### Initial Sampling Report

Appendix 4.1.1.1  
A0072

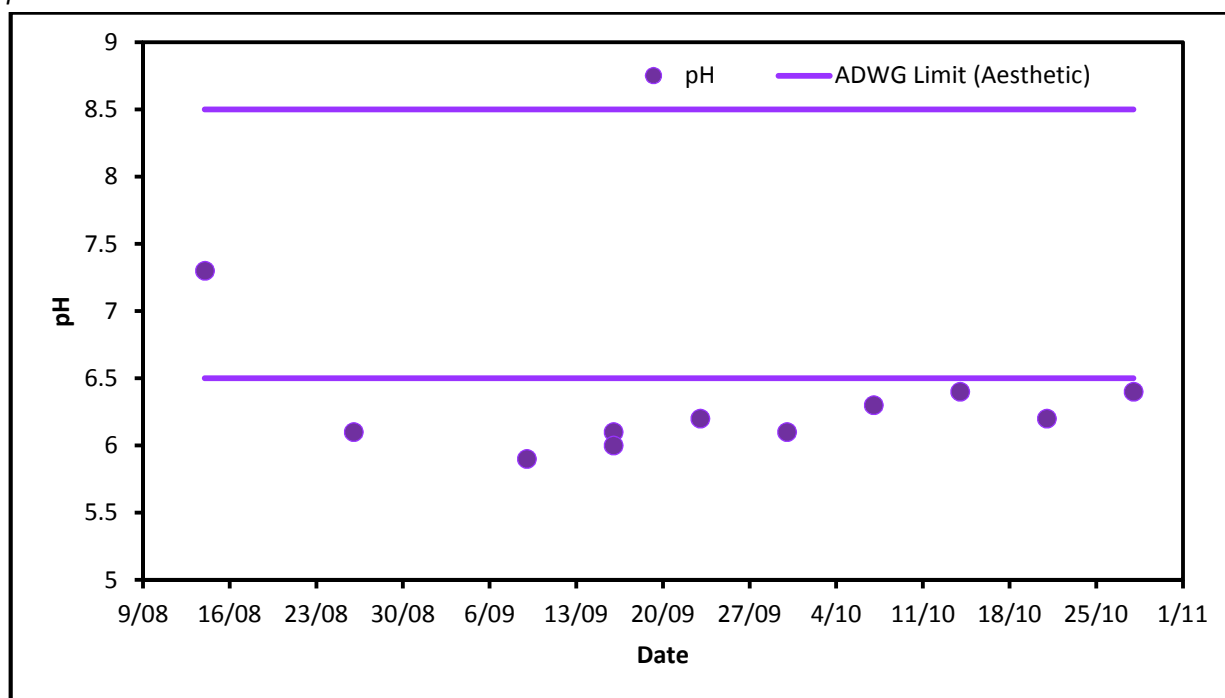
Both the raw water pH and alkalinity are low and will require adjustment. Alkalinity is a measure of a waters ability to buffer changes in pH. A low pH and alkalinity (especially in combination with low hardness) can mean the water has an unstable pH during treatment and distribution and may also be corrosive to metals.

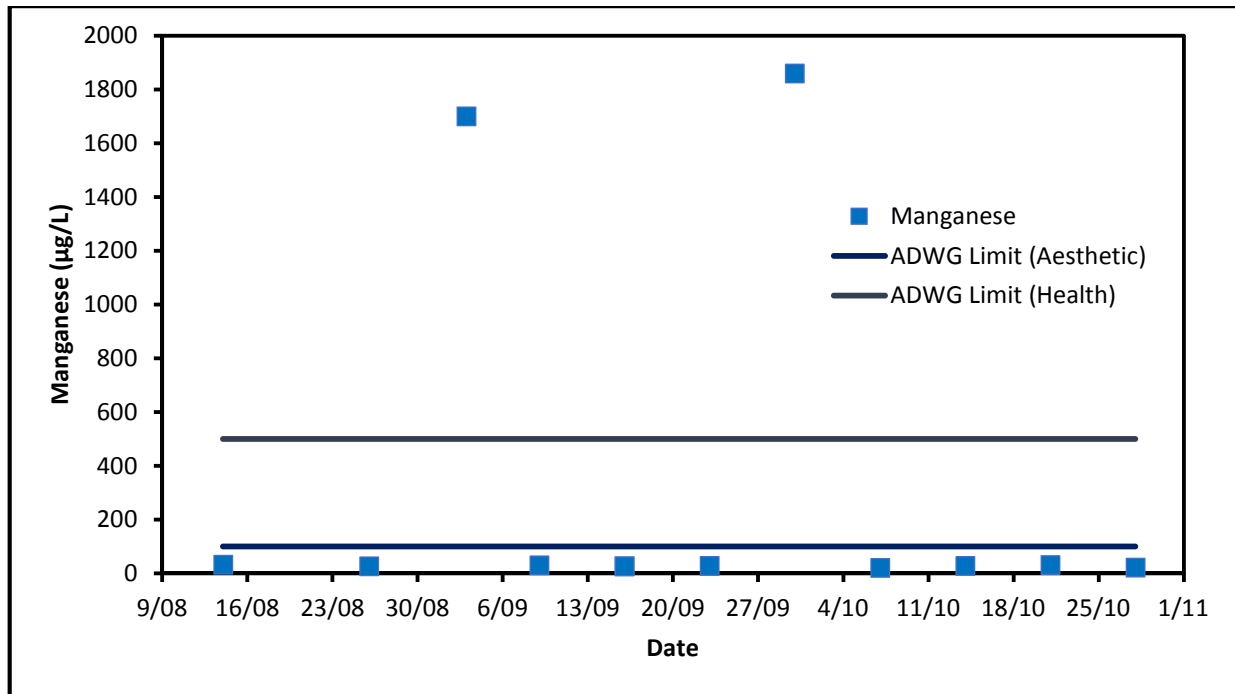
#### *Manganese concentration*

The manganese levels found ranged from 0.022 mg/L to 1.86 mg/L. This is no doubt partly due to the low pH which increases solubility of manganese, and may well be partially removed by increasing the pH and alkalinity. However, the very high levels observed in some samples means that it must be a consideration in the treatment process.

The most effective methods for removing manganese involve oxidation to manganese dioxide (which has very low solubility) with subsequent filtration. This can be achieved using a range of oxidants, but the most cost effective will likely be the addition of potassium permanganate. This is a strong oxidant and is dosed into the water at the beginning of the treatment process.

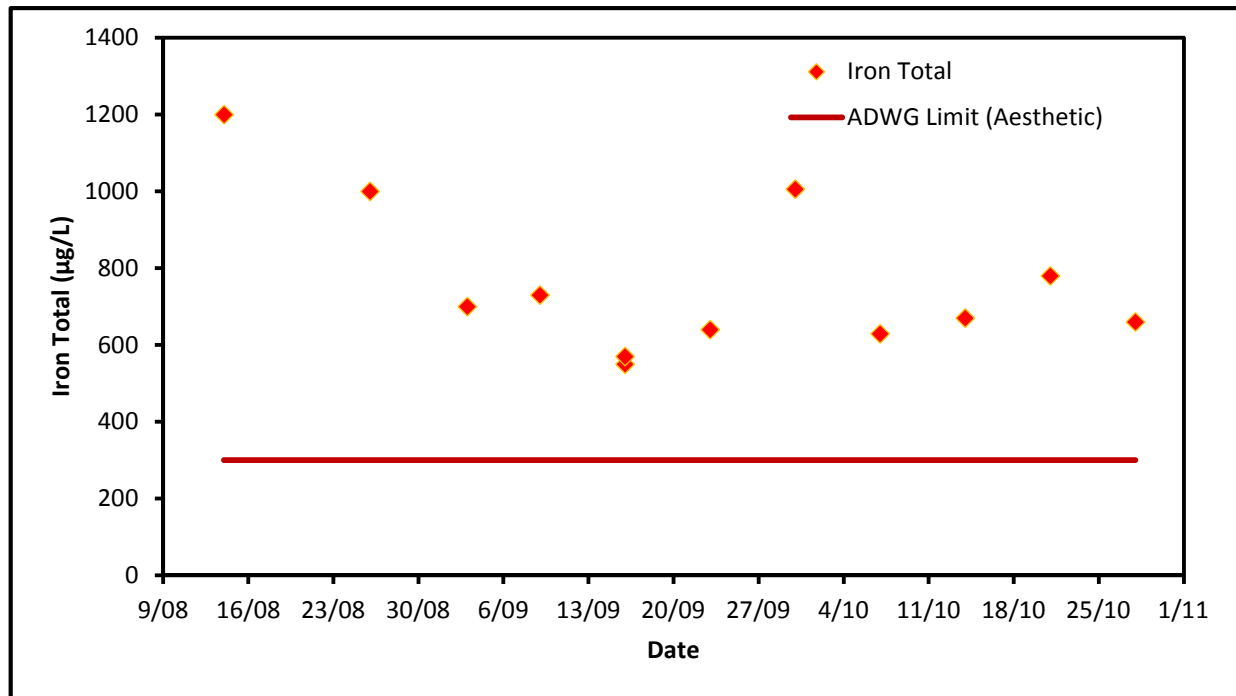
#### Iron concentration

Iron levels ranged from 0.55 mg/L to 1.2 mg/L. Iron has a taste threshold of about 0.3 mg/L in water, and becomes objectionable above 3 mg/L. High iron concentrations give water an undesirable rust-brown appearance and can cause staining of laundry and plumbing fittings, fouling of ion-exchange softeners, and blockages in irrigation systems. (ADWG). It is therefore a treatment objective to reduce iron to < 0.3 mg/L in the treated water.

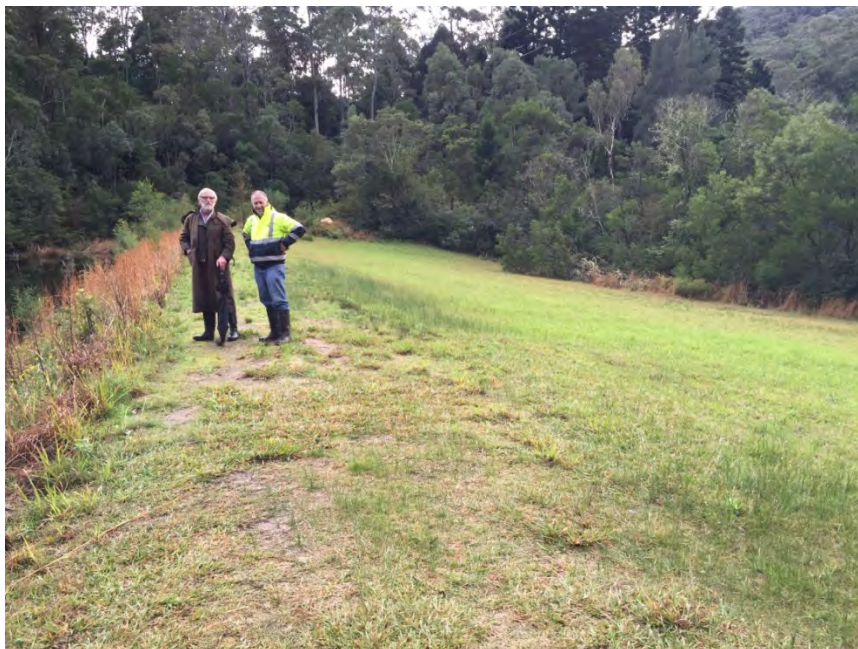
Figure 3 - Raised crest and gentle (approx. 1V:5H) downstream face

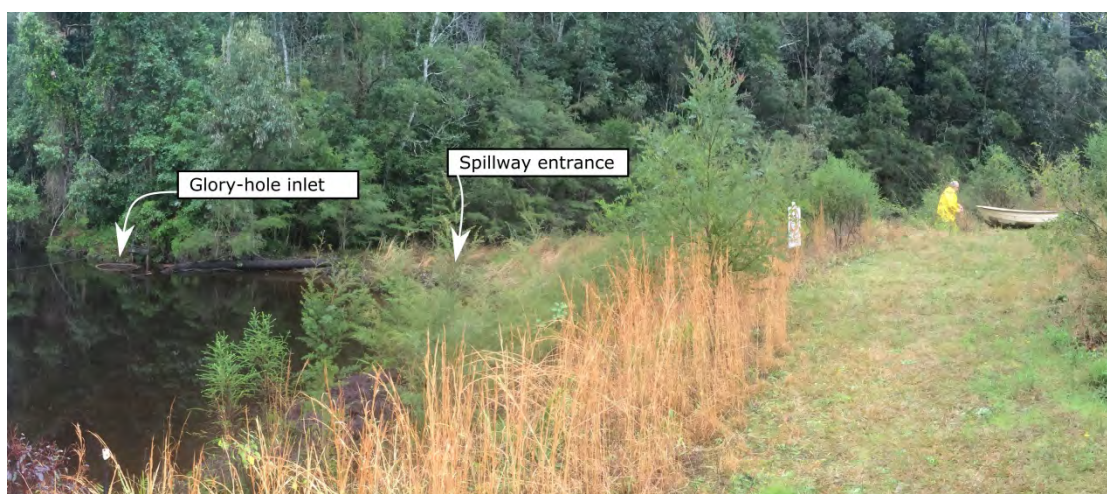
**Figure 5 - View along crest toward spillway entrance and glory-hole inlet**

The outlet works shown in plan in Figure 2 comprises a 1200mm diameter glory-hole inlet located near the entrance to the side channel spillway (Figure 5). A close up photograph of the gloryhole is shown in Figure 6. This gloryhole feeds a 400 mm diameter pipe, which exits via a similar 1200mm riser (Figure 7) amongst trees on the left side of the downstream face (Figure 8).

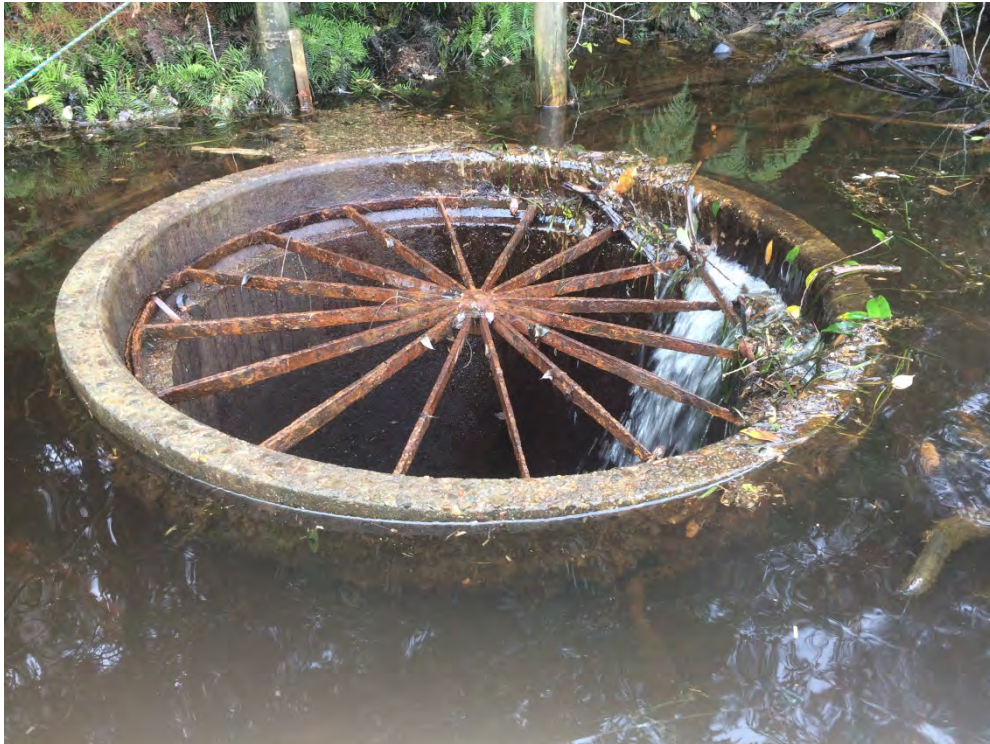
**Figure 6 - Close-up photograph of the glory-hole inlet**

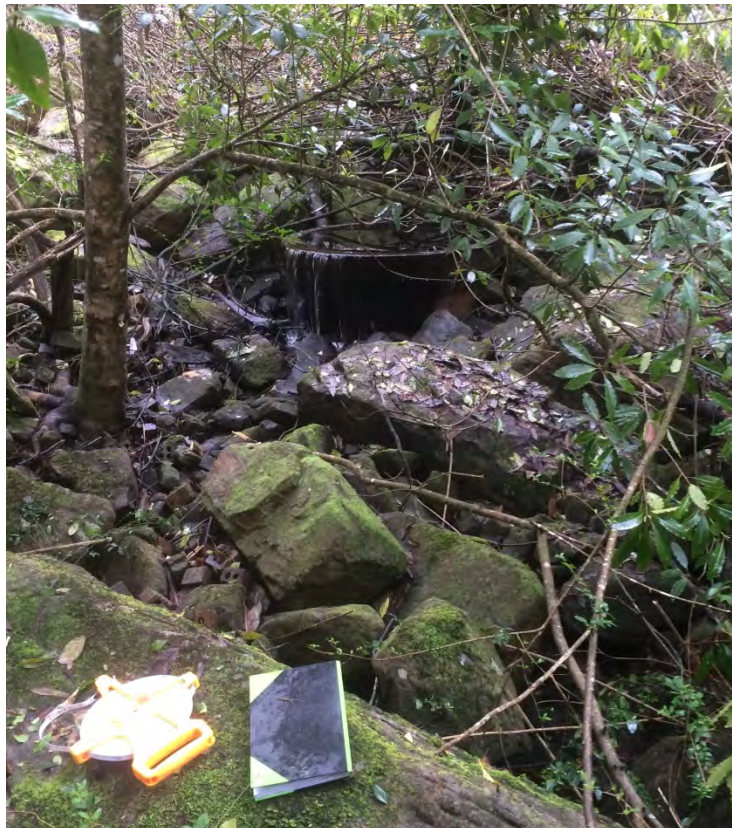
**Figure 7 - Photograph of the outlet of the outlet works**

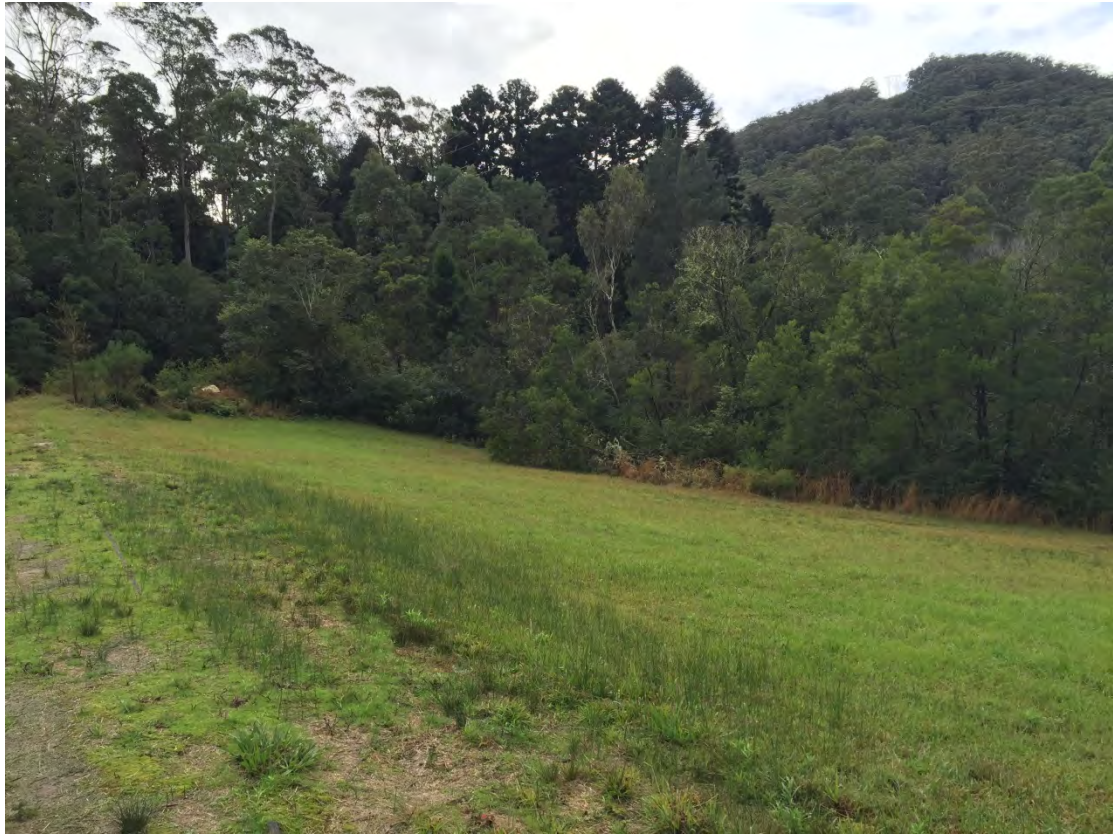
**Figure 8 – The end of the outlet works is within the trees / scrub on the right hand side of this photograph**

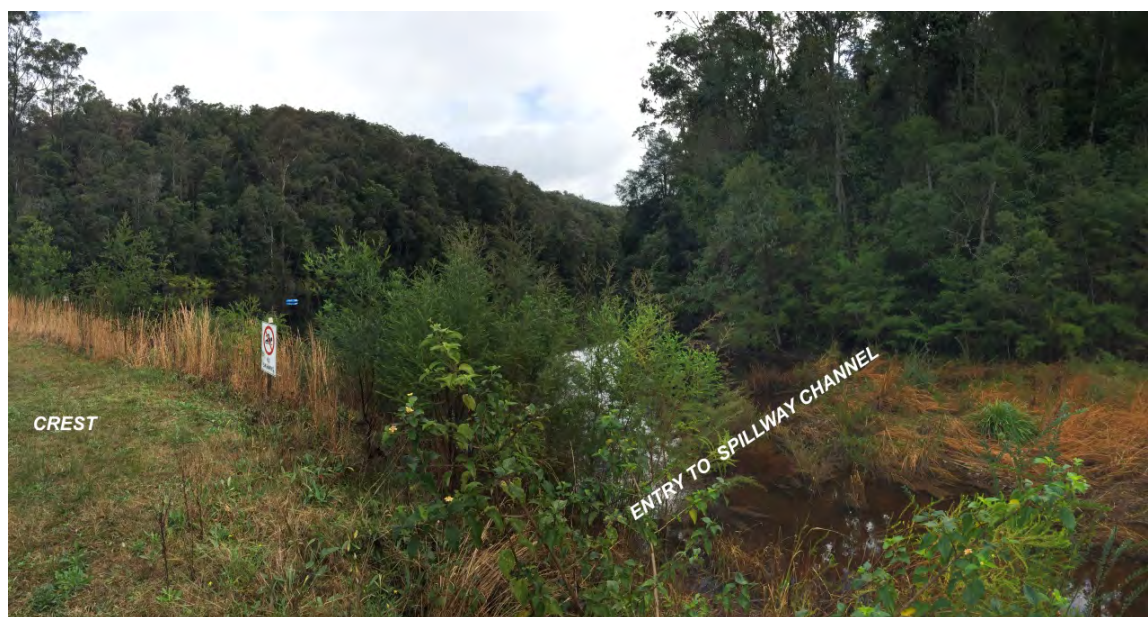
**Figure 11 - Entrance to the side-channel spillway**

A side channel spillway is cut into the left abutment. As stated above, it is understood that this channel was widened sometime in the past. Approximately half the width of the channel (on the embankment side) from 16 to 45 m downstream of the channel entrance is covered with shotcrete. The remainder of the spillway is unlined. Photographs of the spillway, progressing downstream, are presented in Figure 11 to Figure 16.

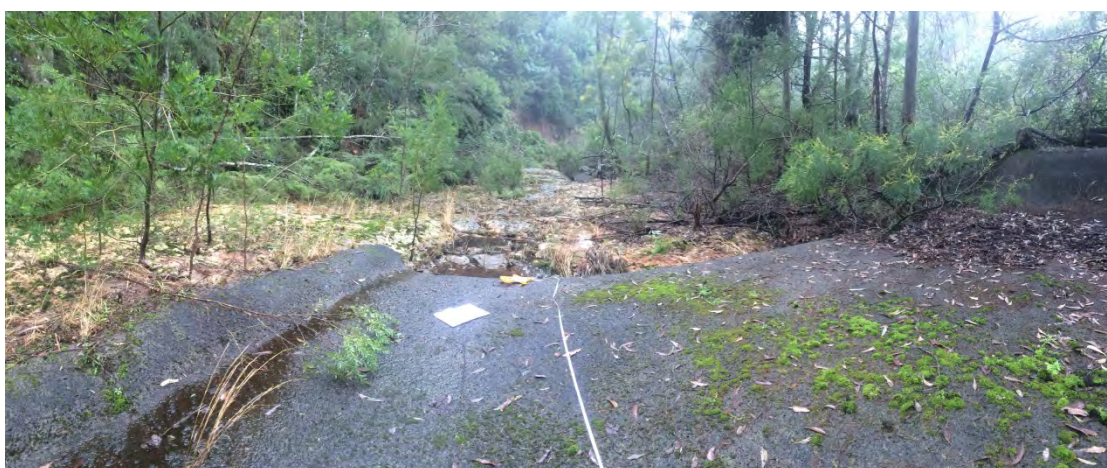
**Figure 13 - Looking downstream toward the end of the lined section**

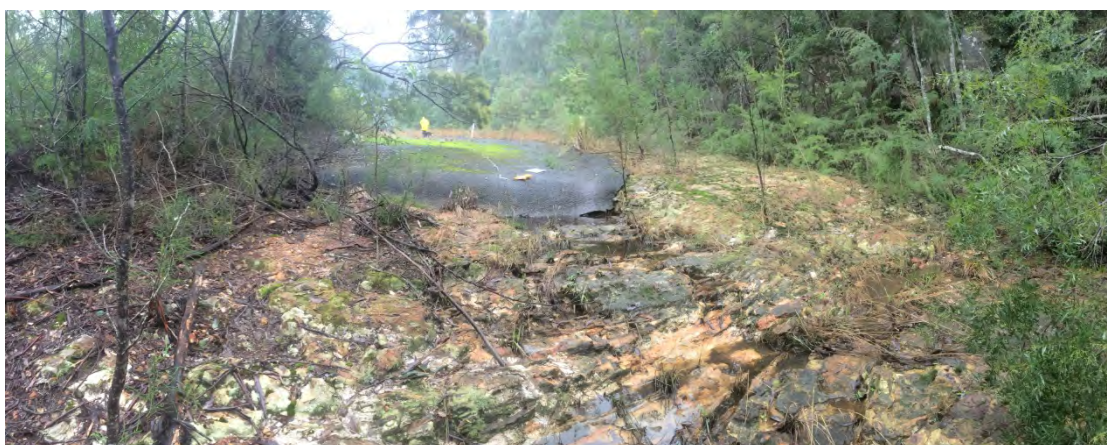
**Figure 14 – Looking upstream toward the end of the lined section**

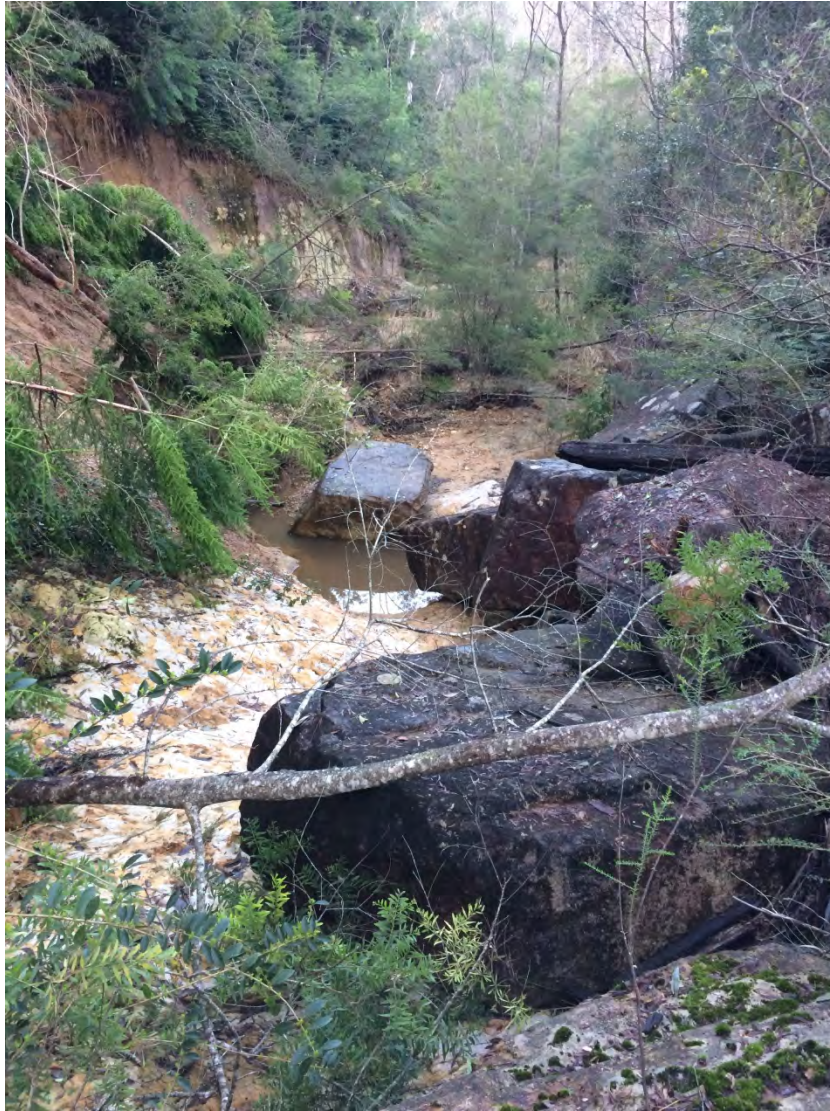
**Figure 15 - Looking downstream toward the spillway exit**

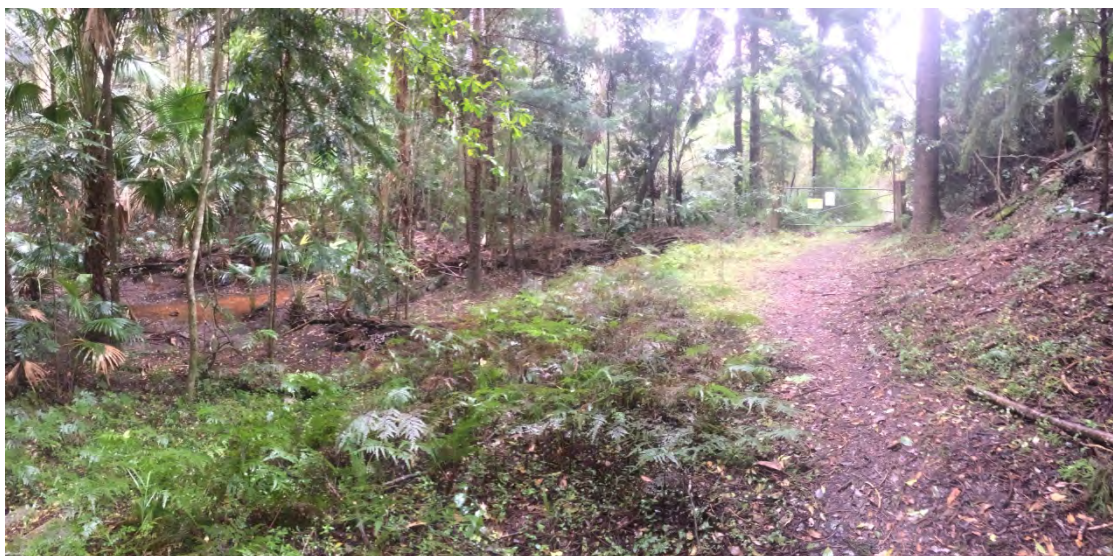
**Figure 16 - Section of Narara Creek just below the spillway**

Note, the creek is flowing from left to right. Spillway flows enter the creek from the right hand side, at the far downstream side of this photograph

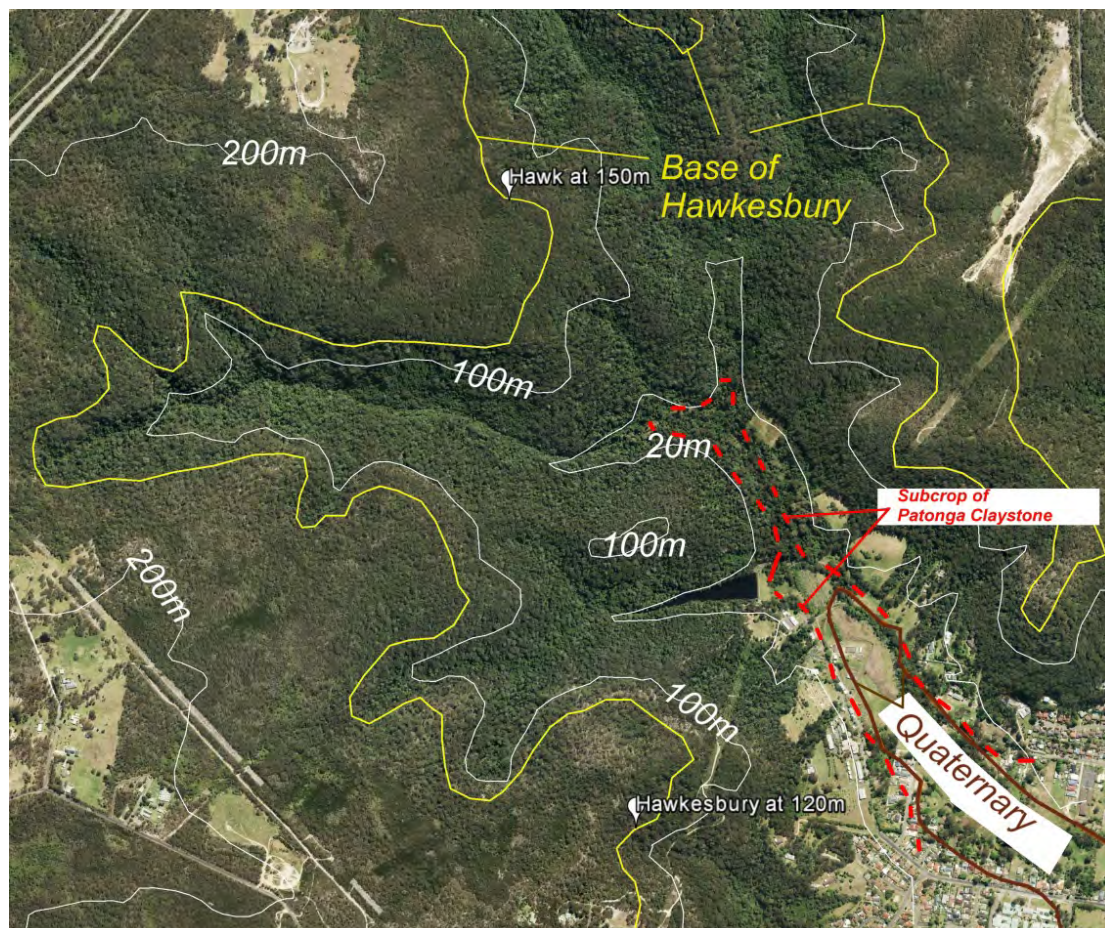
Figure 20 - Geology from 1:25000 geological map with our interpretation of the possible upper surface of the Patonga Claystone.

However, if further investigation shows that the claystone revealed in the lower part of the spillway channel is not the top of the Patonga Claystone, it is certainly the thick siltstone/claystone stratum that occurs in the lower part of the Terrigal Formation (see Figure 20 and Figure 34)

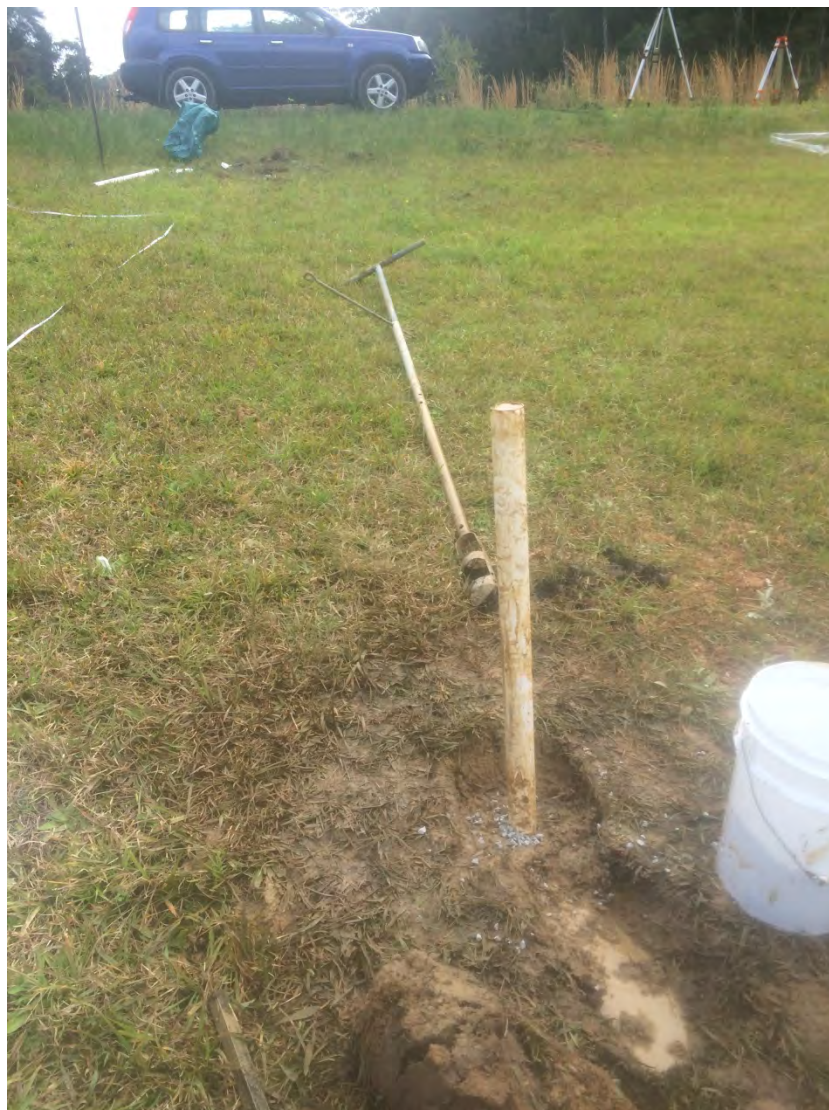
**Figure 23 - Three boreholes with standpipe piezometers were installed in the embankment**

To assist with appraisal of the embankment, three boreholes, with standpipe piezometers (Figure 23), were installed by Pells Consulting on 24 June 2015. A summary of bore construction details is given in Table 1, and field-logs of the boreholes are attached in Appendix B. Measurements of standing water levels in the standpipes are also summarised in Table 1.

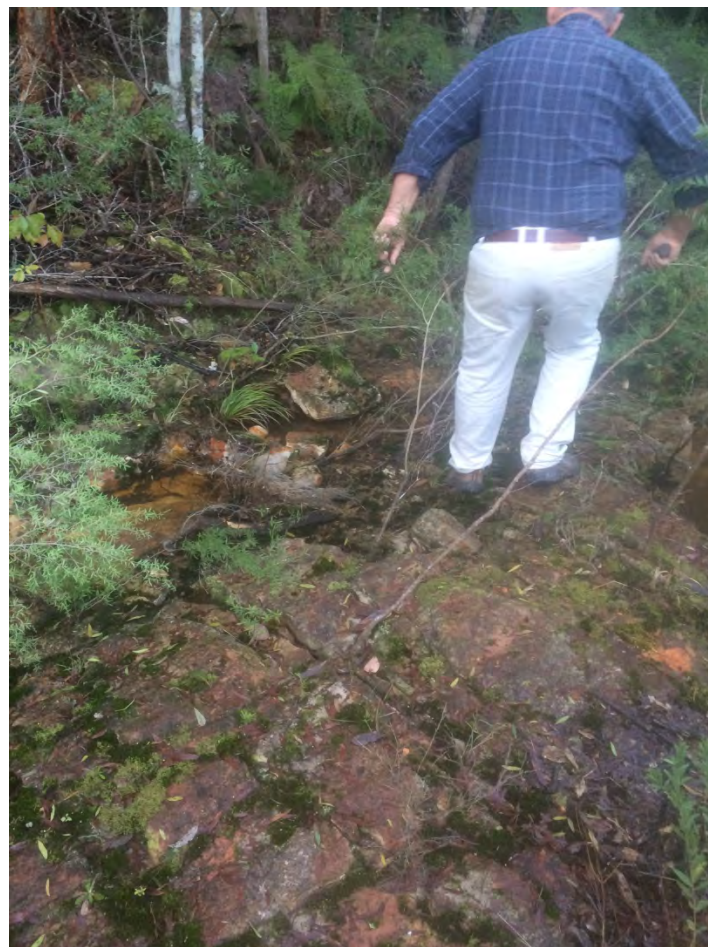
**Figure 29 - Unlined widened section of spillway adjacent to concrete (Region “HA1”  
~10 to 40 m from spillway entrance)**

ID	Location <i>Desc.</i>	<i>m d/s sill</i>	Observed erosion
HA1	Upper spillway and adjacent to lined section	< 40m	Mild gullying on spillway LHS, < 0.3 m depth
HA2	End of lined section	45m	Erosion of soft rock at end of concrete. Some channelization. <0.4 m depth
HA3	End of rock	60 - 70 m	Formation of channel headcut, likely to progress upstream. Up to 1.5 m depth Undermining of rock strata, plunging flows, toppling of corestones. Erosion depth up to 3 m
HA4	Alluvium / colluvium	70m to end (~115m)	Active erosion of alluvium / colluvium

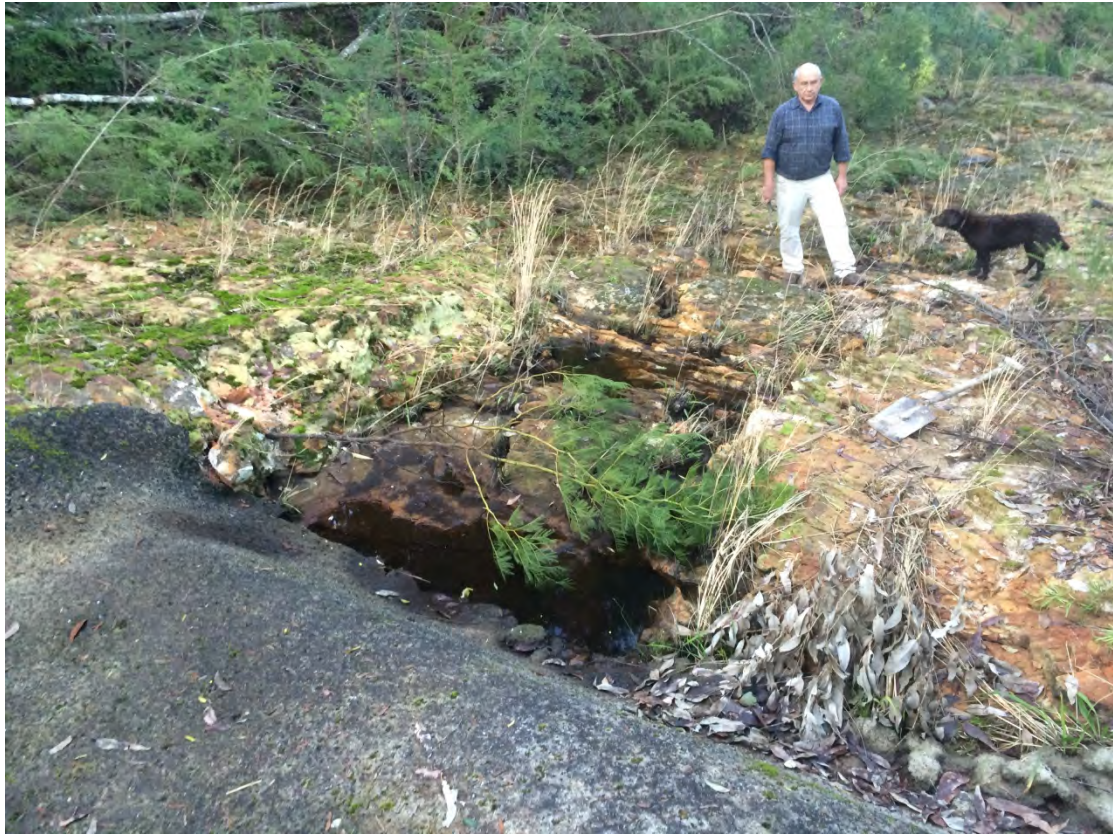
**Figure 30 – Erosion of soft rock at end of lined section (Region “HA2” ~ 45 m from spillway entrance)**

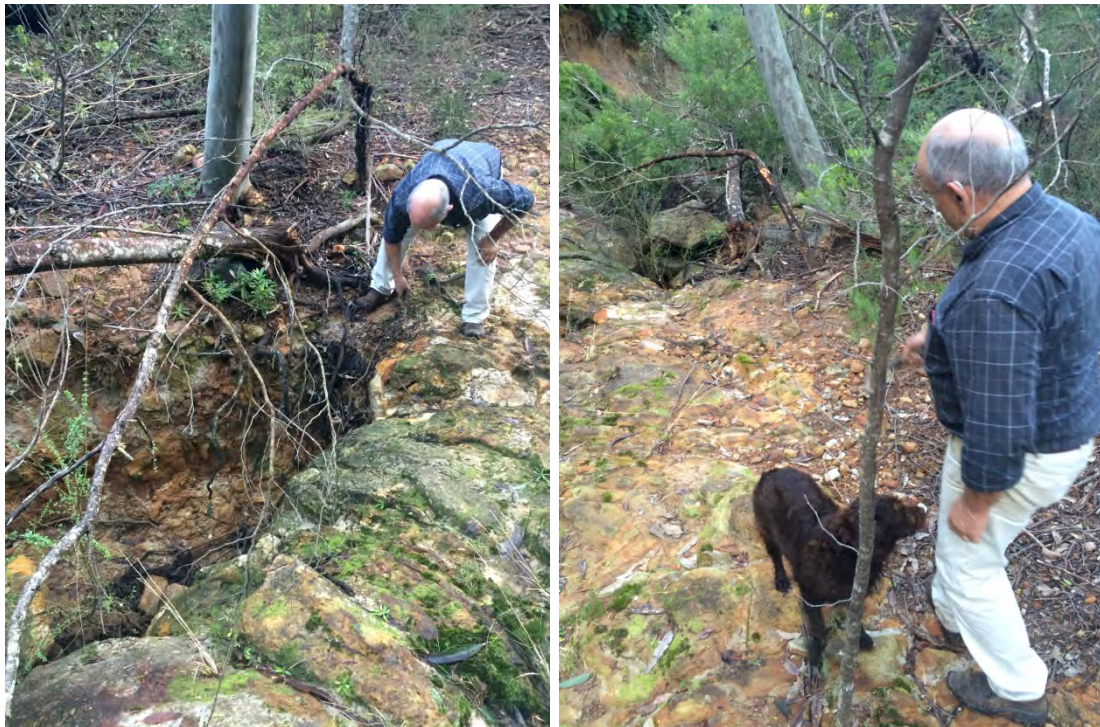
**Figure 31 - Headcutting erosion channel at end of rock spillway (Region “HA2/HA3” ~60m from spillway entrance)**

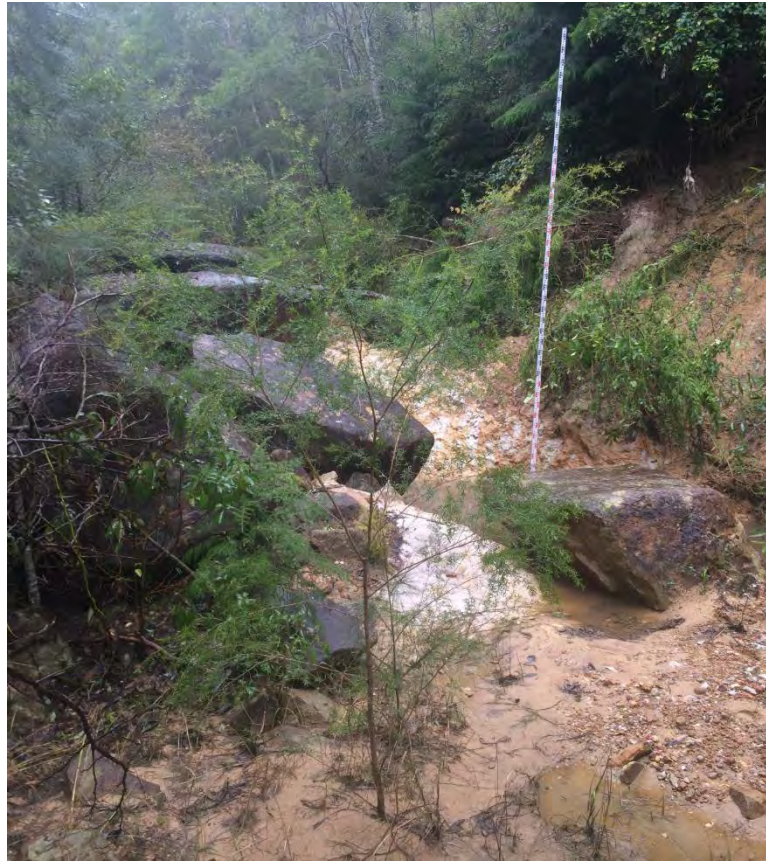
**Figure 32 - Erosion of soft, highly weathered claystone, causing plunging flows and toppling of sandstone corestones (Region “HA3” between 60 and 70 m from spillway entrance)**

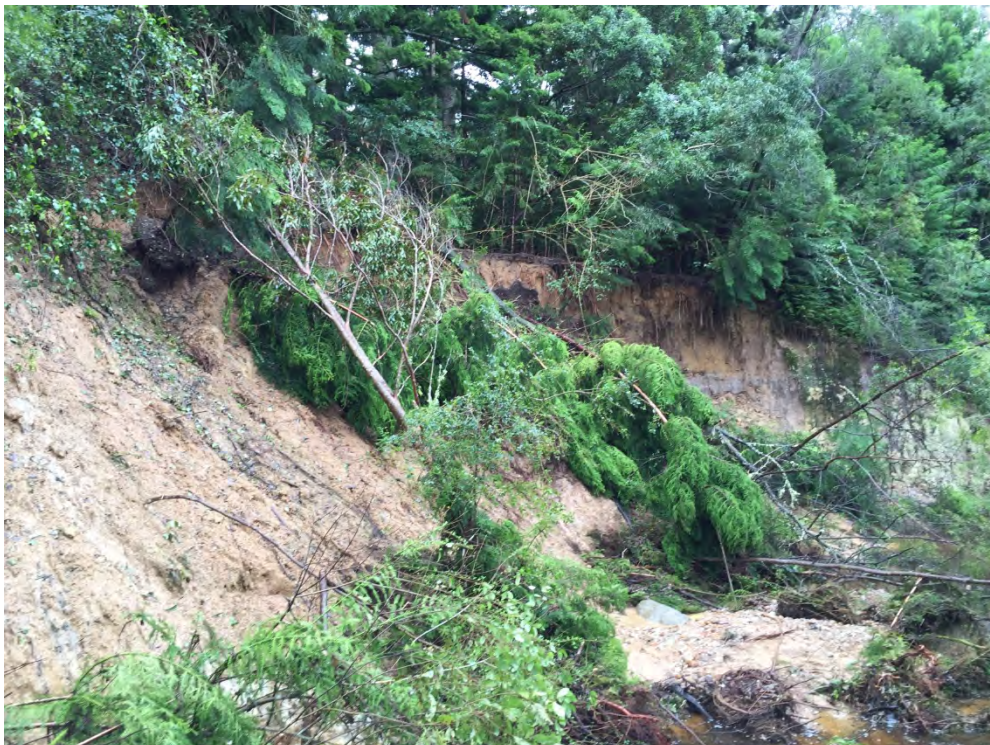
**Figure 33 – Erosion of soil (alluvium / colluvium) (Region “HA4” - 70 to 100 m from spillway entrance)**

It is expected that, during spillway flood events, the spillway downstream of the plunge section will continue to erode away the loose alluvium / colluvium. This represents a potential issue with unstable slopes and falling trees that may affect development plans at the site, but is considered to have no impact on dam safety.

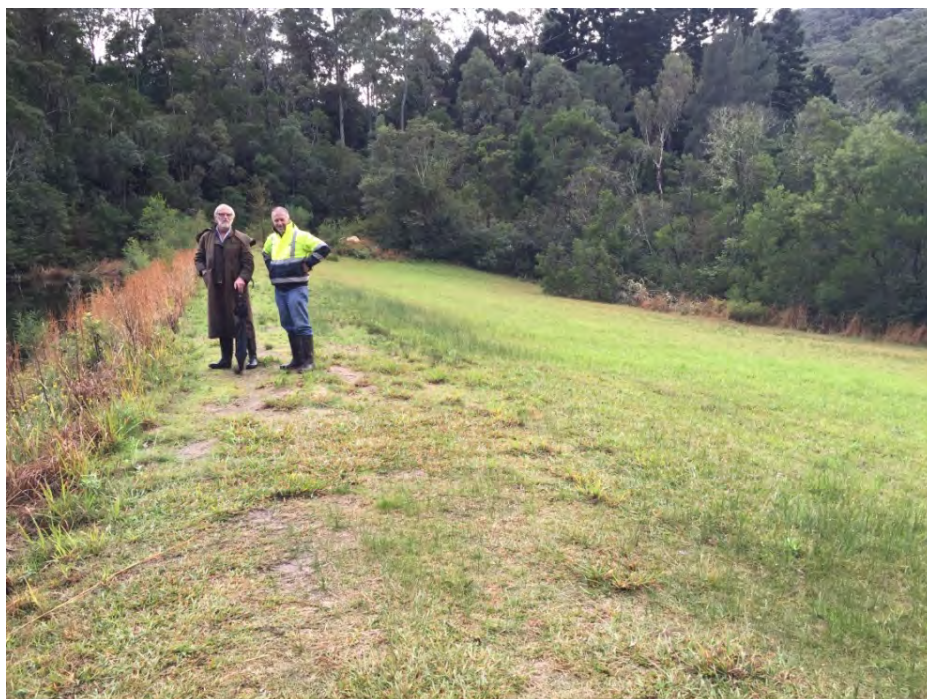
Figure 8 - Raised crest and gentle (approx. 1V:5H) downstream face.

The embankment has a relatively flat downstream face and a narrow crest which seems indicative of original crest being raised by almost a metre (see Figure 8).

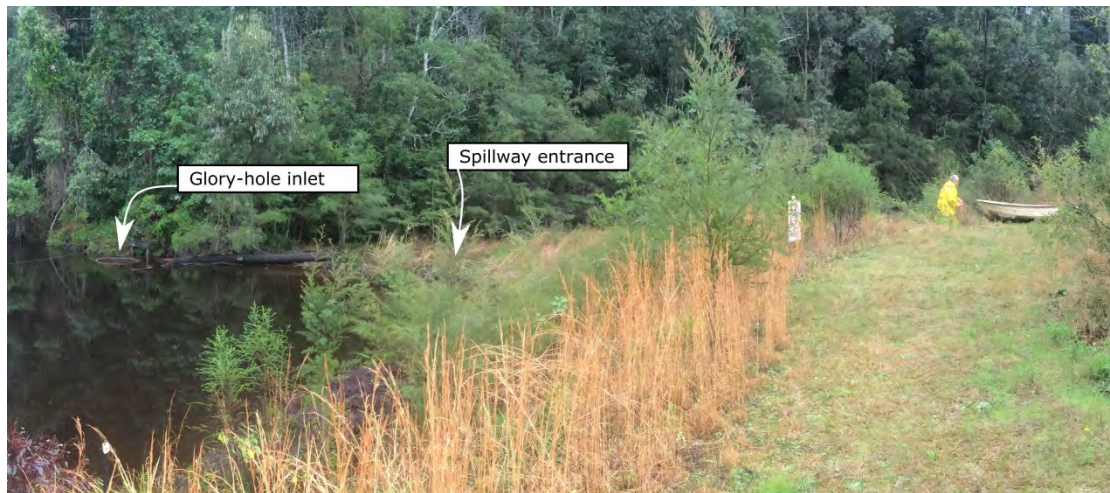
Figure 15 - View along crest toward spillway entrance and glory-hole inlet.

The NEV dam has an outlet pipe as shown in plan in Figure 7. The outlet comprises a 1200mm diameter glory-hole inlet located near the entrance to the side channel spillway (Figure 15). A close up photograph of the gloryhole is shown in Figure 16. This gloryhole feeds a 400 mm diameter pipe, which exits via a similar 1200mm riser (Figure 17) amongst trees on the left side of the downstream face (Figure 18).

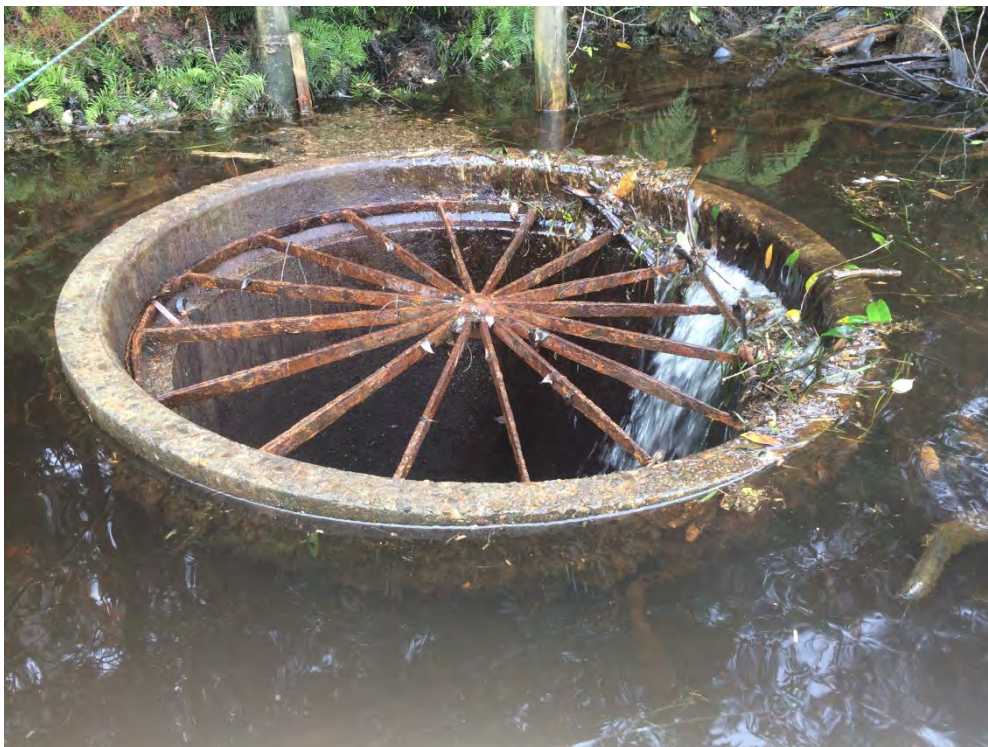
Figure 16 - Close-up photograph of the glory-hole inlet.

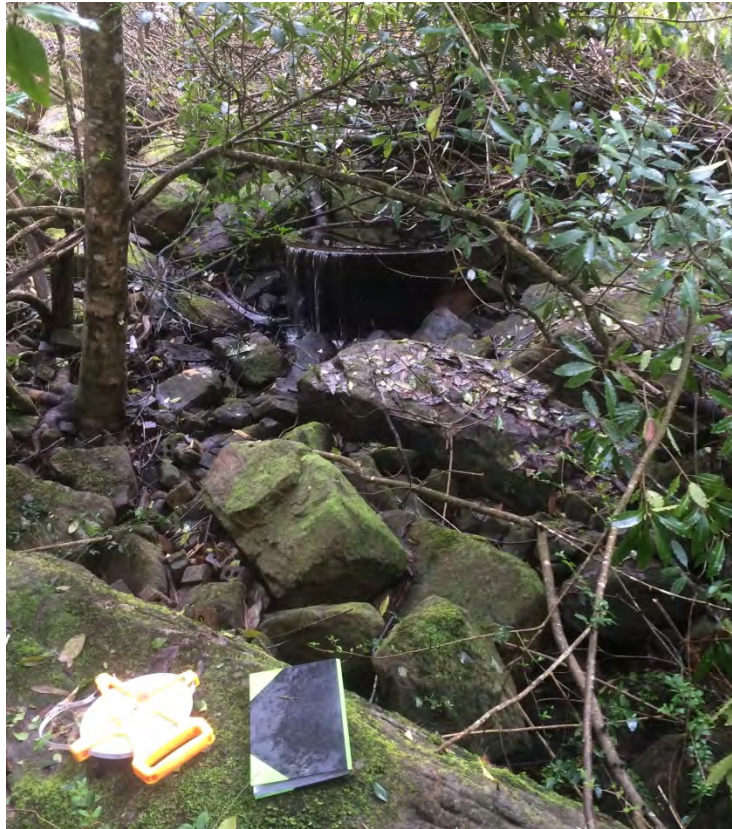
**Figure 17 - Photograph of the outlet of the outlet works.**

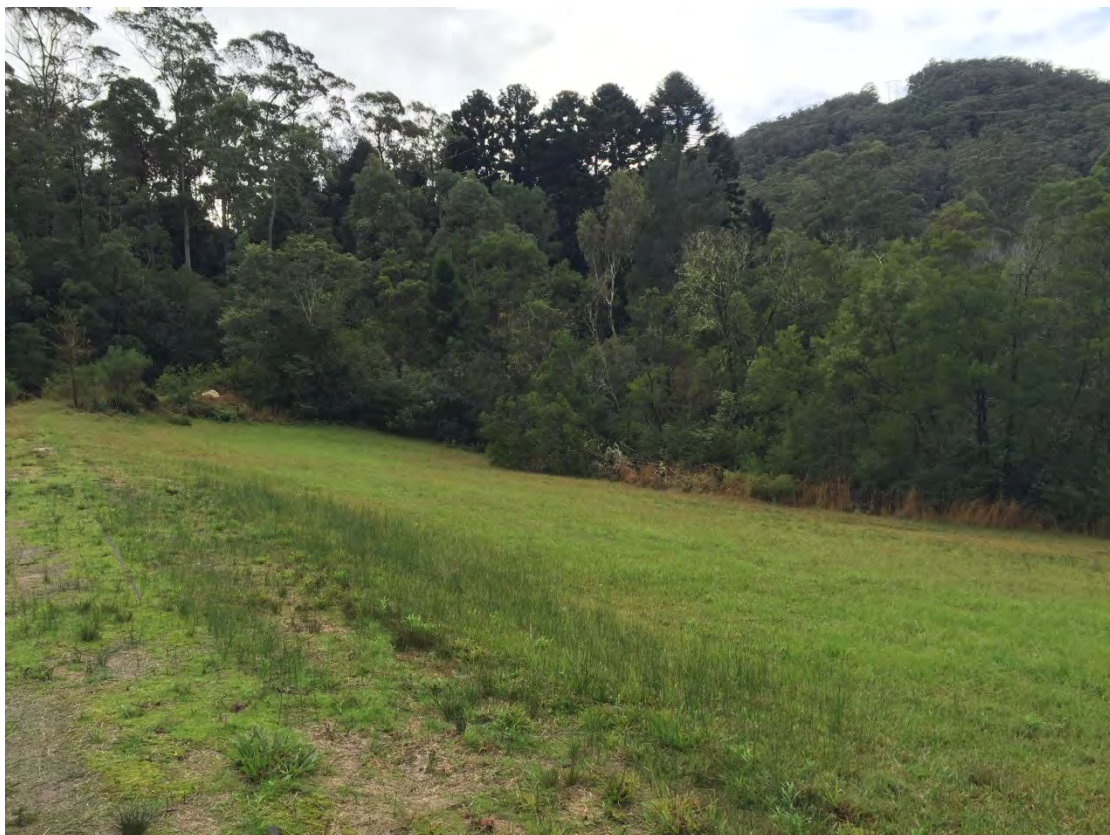
**Figure 18 – The end of the outlet works is within the trees / scrub on the right hand side of this photograph.**

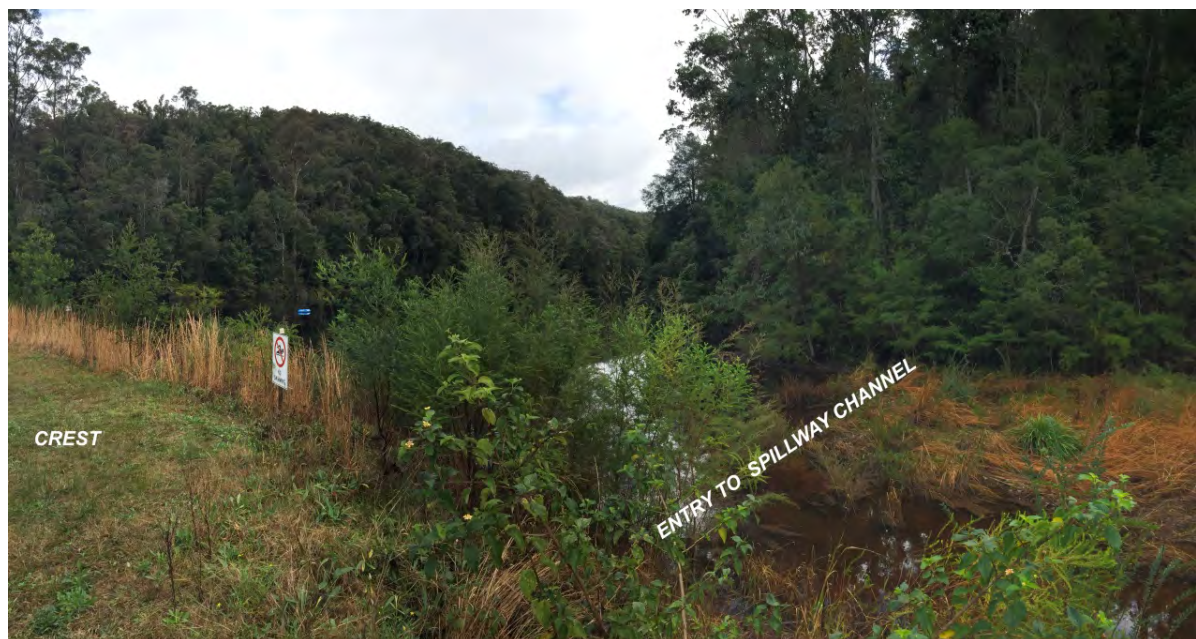
**Figure 21 - Entrance to the side-channel spillway.**

A side channel spillway is cut into the left abutment. As stated above, it is understood that this channel was widened sometime in the past. Approximately half the width of the channel (on the embankment side) from 16 to 45 m downstream of the channel entrance is covered with shotcrete. The remainder of the spillway is unlined. Photographs of the spillway, progressing downstream, are presented in Figure 21 to Figure 26.

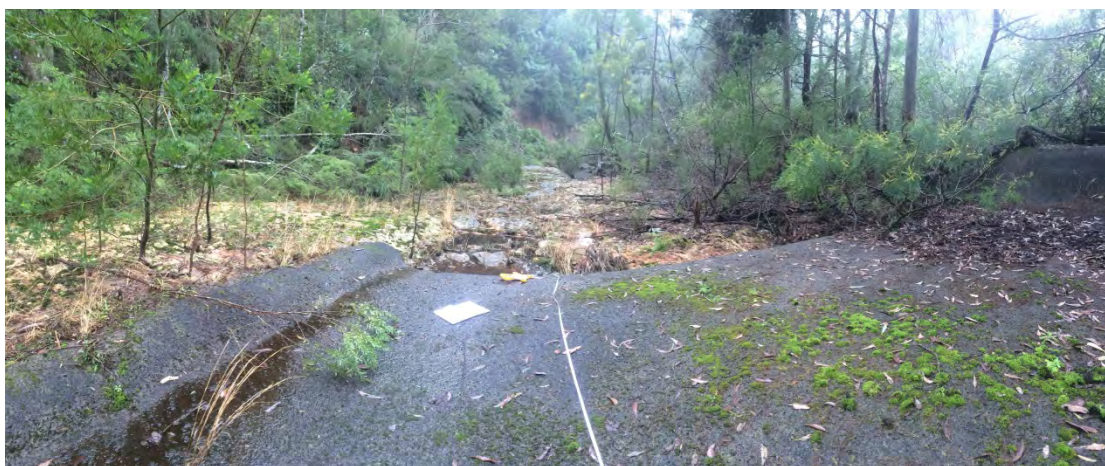
**Figure 23 - Looking downstream toward the end of the lined section.**

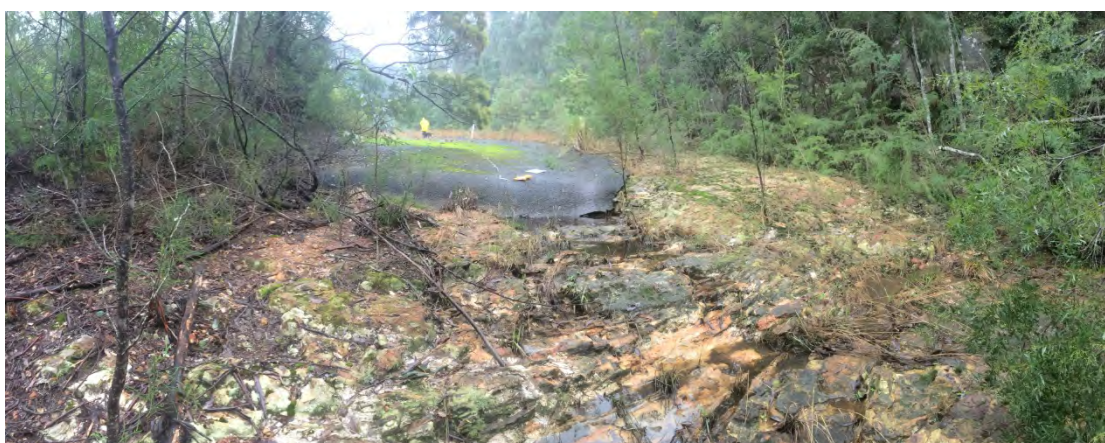
**Figure 24 – Looking upstream toward the end of the lined section.**
