# Narara Eco Village

## Water Reservoir

### Initial Sampling Report

Appendix 4.1.1.1  
A0072

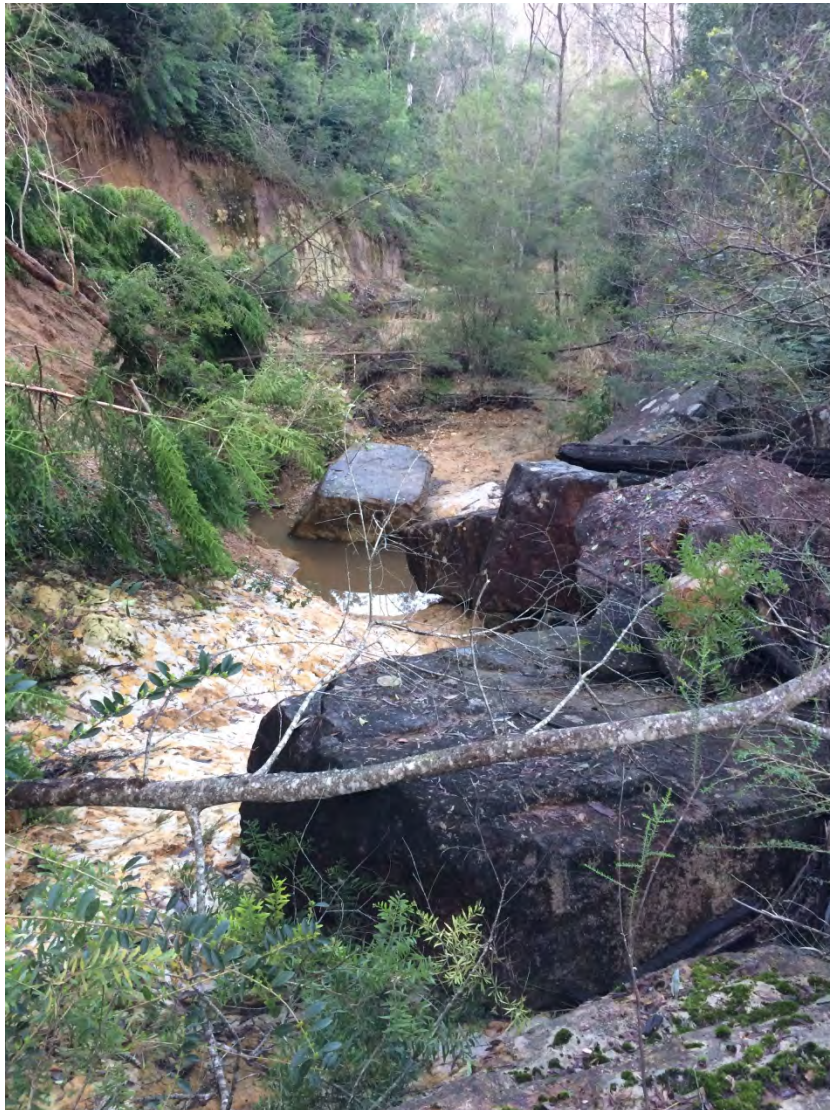
**Figure 25 - Looking downstream toward the spillway exit.**

A side channel spillway is cut into the left abutment. As stated above, it is understood that this channel was widened sometime in the past. Approximately half the width of the channel (on the embankment side) from 16 to 45 m downstream of the channel entrance is covered with shotcrete. The remainder of the spillway is unlined. Photographs of the spillway, progressing downstream, are presented in Figure 21 to Figure 26.

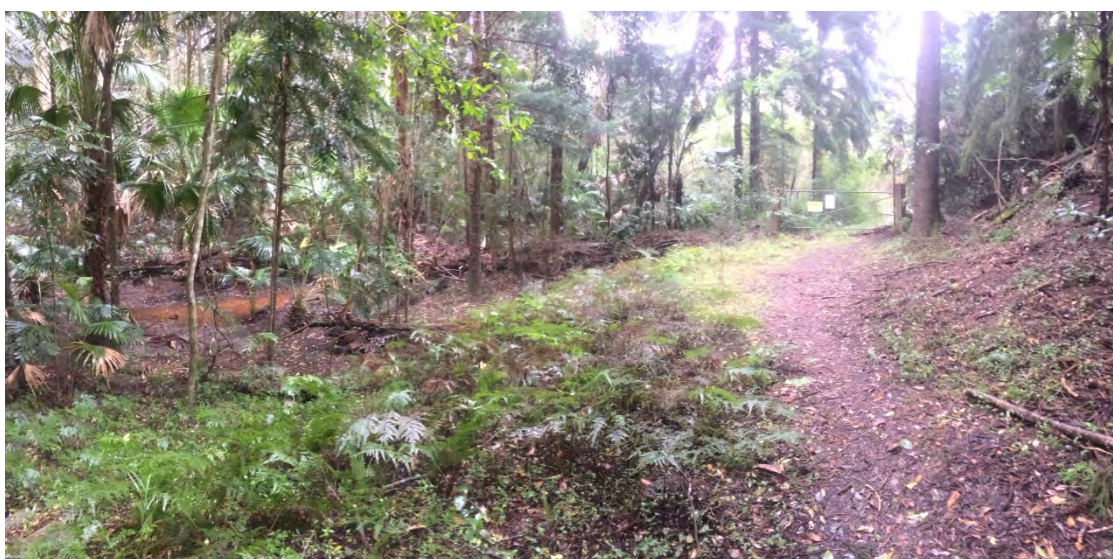
**Figure 26 - Section of Narara Creek just below the spillway.**

Note, the creek is flowing from left to right. Spillway flows enter the creek from the right hand side, at the far downstream side of this photograph.

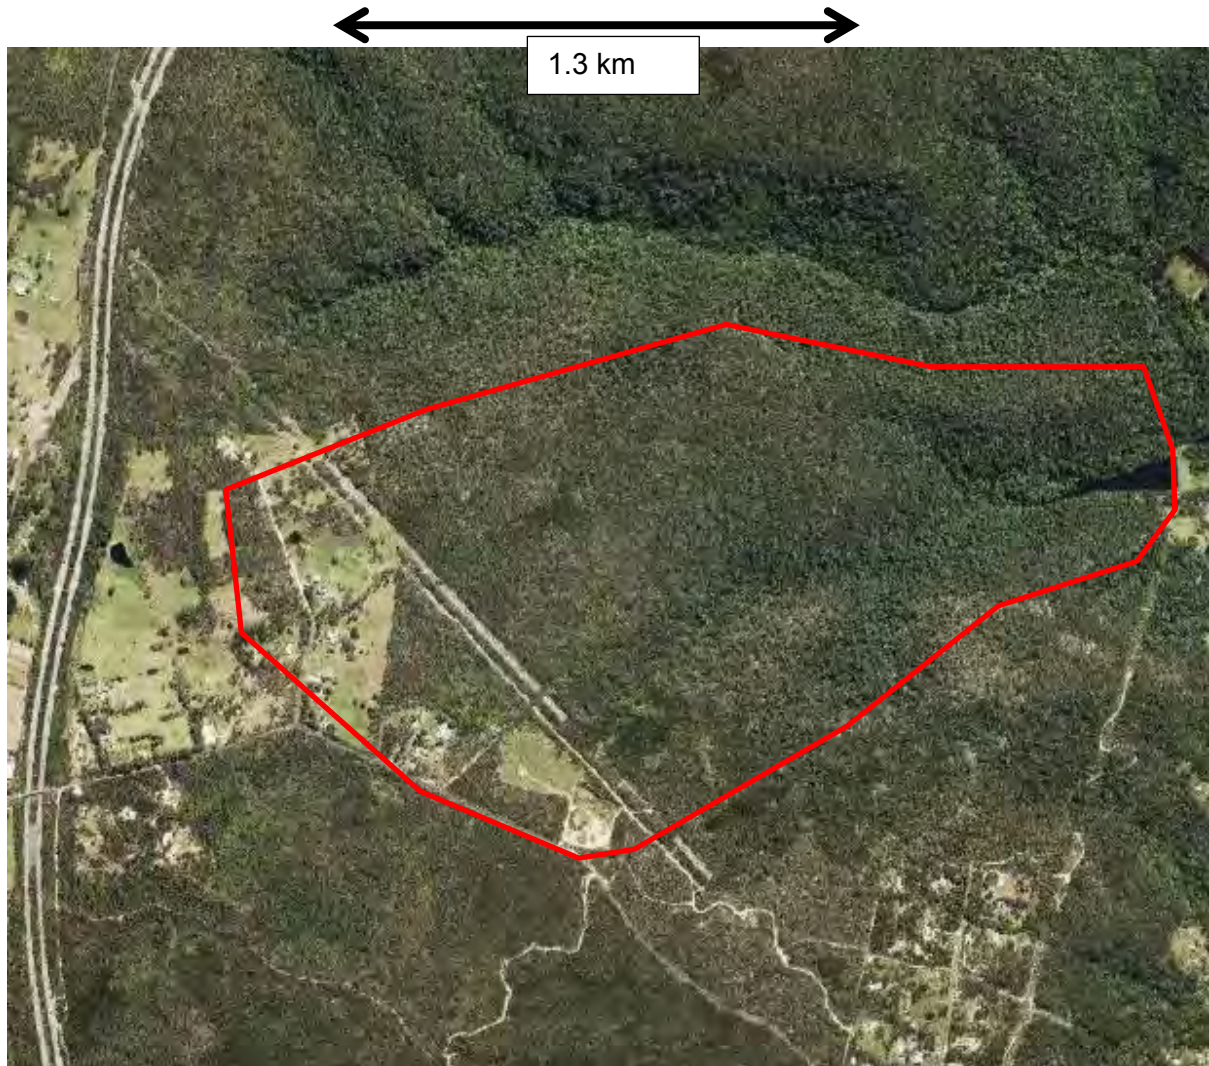
**Figure 3.4. Indicative catchment boundaries superimposed onto a satellite view. The only developed area in the catchment is in the extreme west portion. (Image source NSW Dept Lands, 2015).**

Figure 3.4, below, shows that all but the western extremity of the catchment consists of natural forest/woodland. There is a minimum of one kilometre between developed areas and the edge of the water surface in the reservoir.

This is important as it suggests relatively low risk of reservoir contamination (WSAA, 2015)..

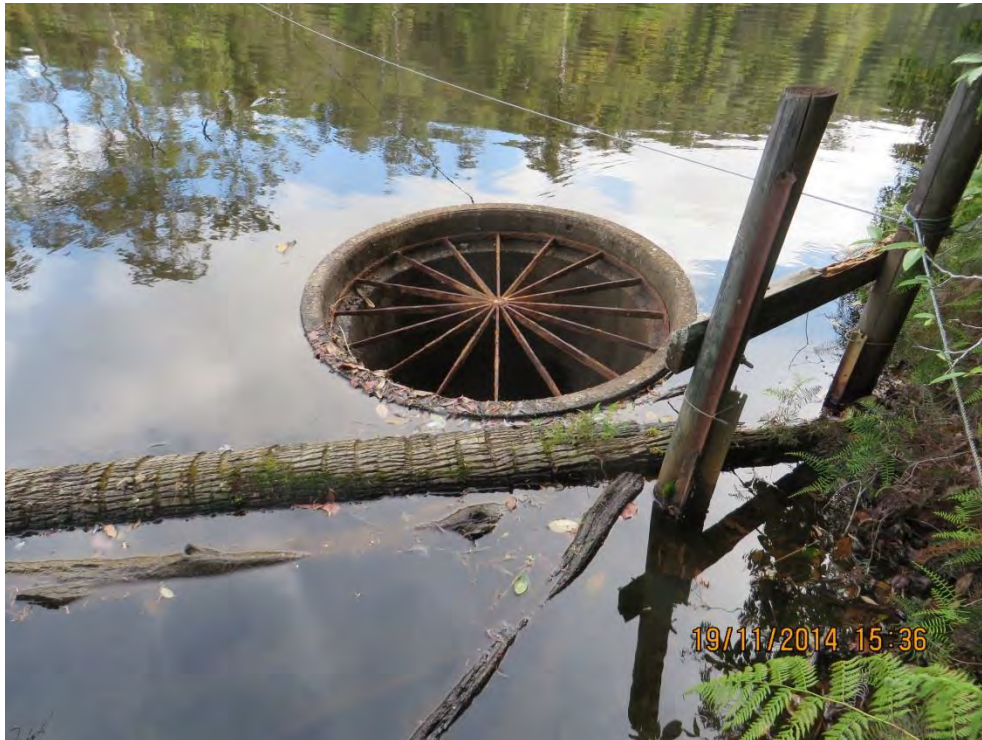
**Figure 5.2. Low to medium flows exit the dam via this glory hole. There is a need for safety fencing to prevent people being caught on the grill. The safety fencing would also reduce the quantity of floating debris being caught on the grill. Additionally the hole needs anti-vortex vanes to maximise out-flow capacity.**

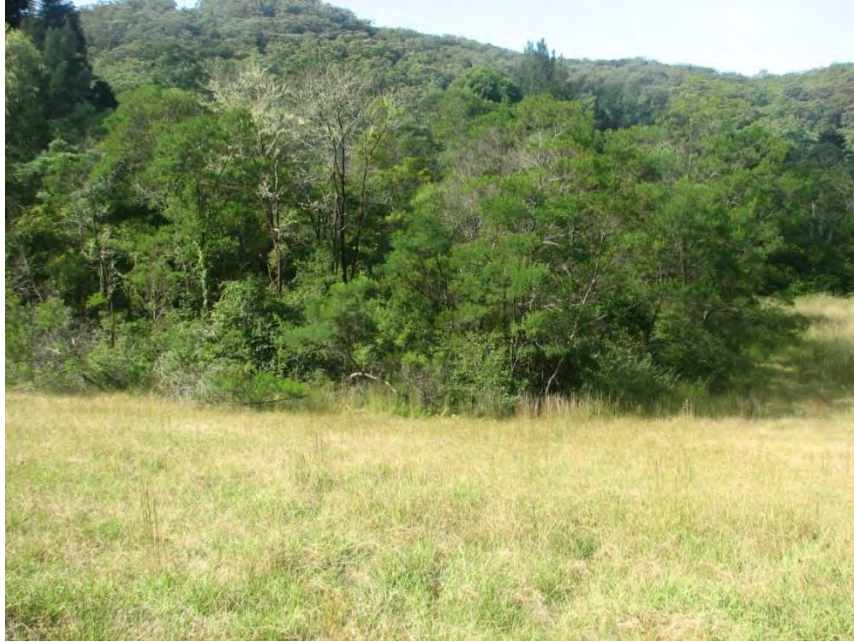
**Figure 5.3. The glory hole pipe discharges into a drainage line located in this bush near the toe of the embankment, some 30 m downslope of the top of the embankment.**

- Firstly, the dam overflow under low to moderate rainfall conditions is conveyed via a pipe from a glory hole (figure 5.2), and it emerges well downstream, and close to the

confluence with Narara Creek (figure 5.3). So the current system largely bypasses the creek bed between the dam and the confluence.

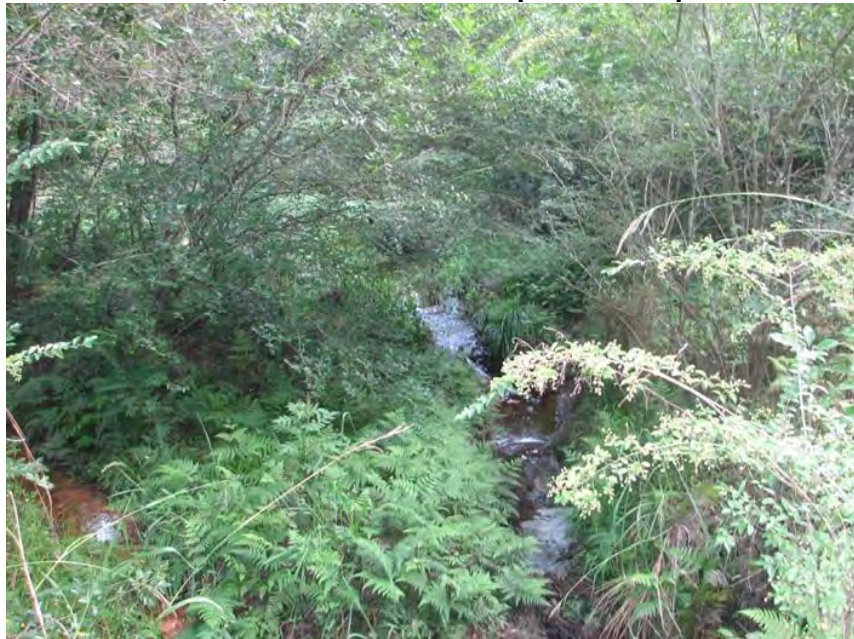
**Figure 5.4. The water that exits the dam reaches Narara Creek some 165m downslope of the glory hole.**

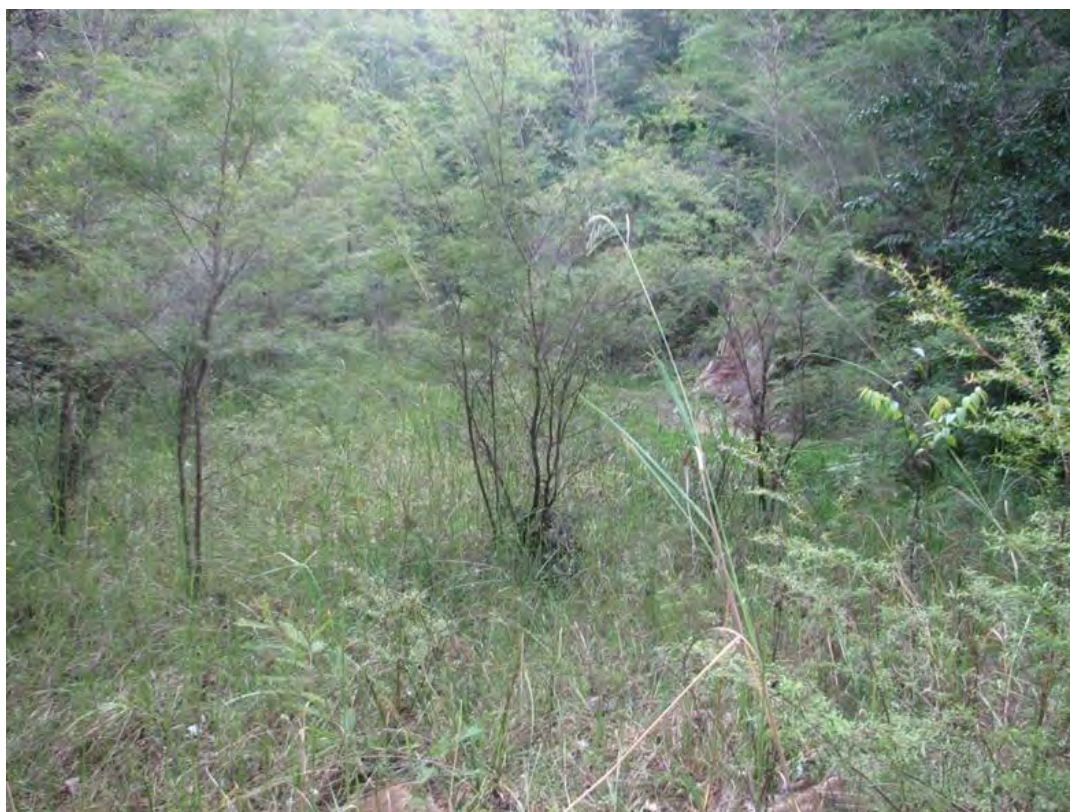
**Figure 5.6. There is a high flow spillway adjacent to the right hand abutment. The condition of the vegetation on the spillway indicates scouring flows rarely occur.**

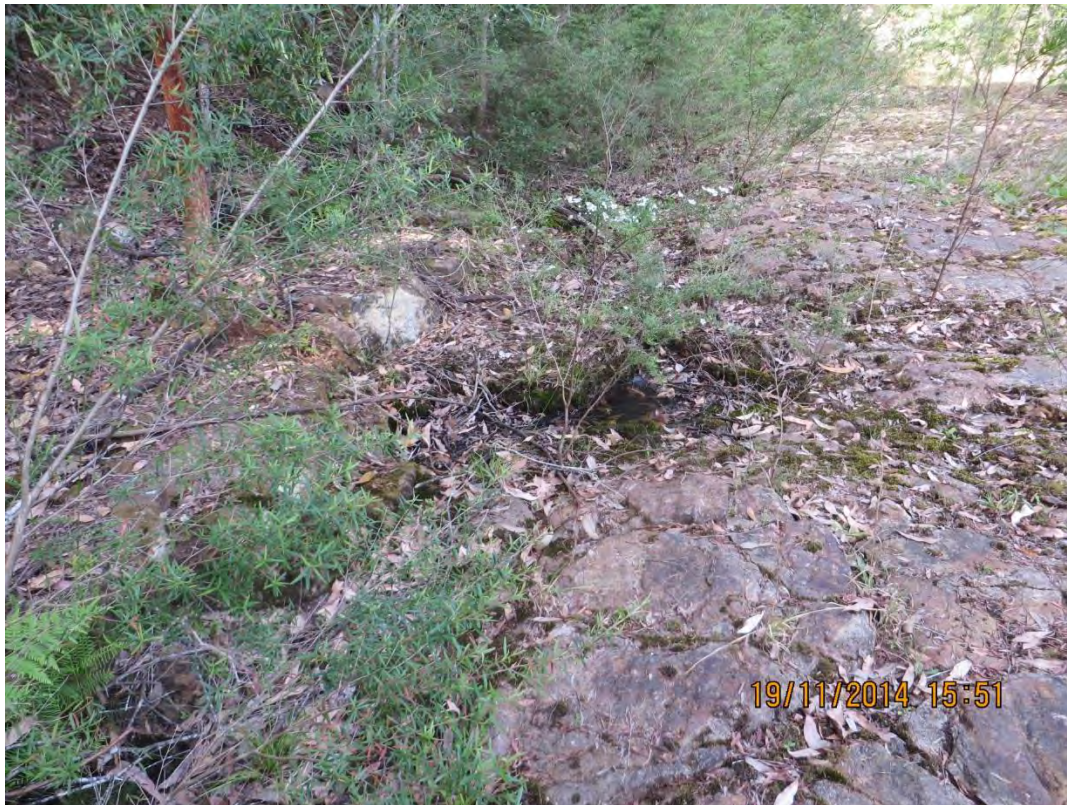
**Figure 5.7. The sandstone bedding of the overflow route provides a resistant surface to high flow discharges.**

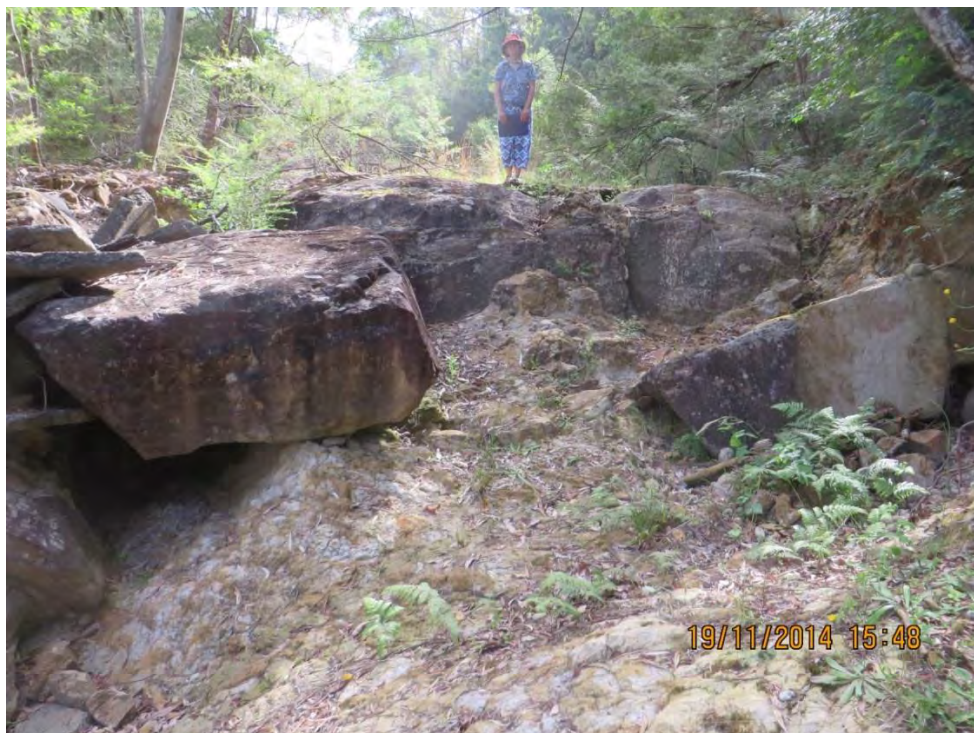
**Figure 5.8. The nick point in figure 5.5. Rocks over 2 cubic m in width have been displaced.**

There is evidence that the nick point is continuing to move 'upstream'. The need for stabilisation has been assessed by Pell Consulting (2015).

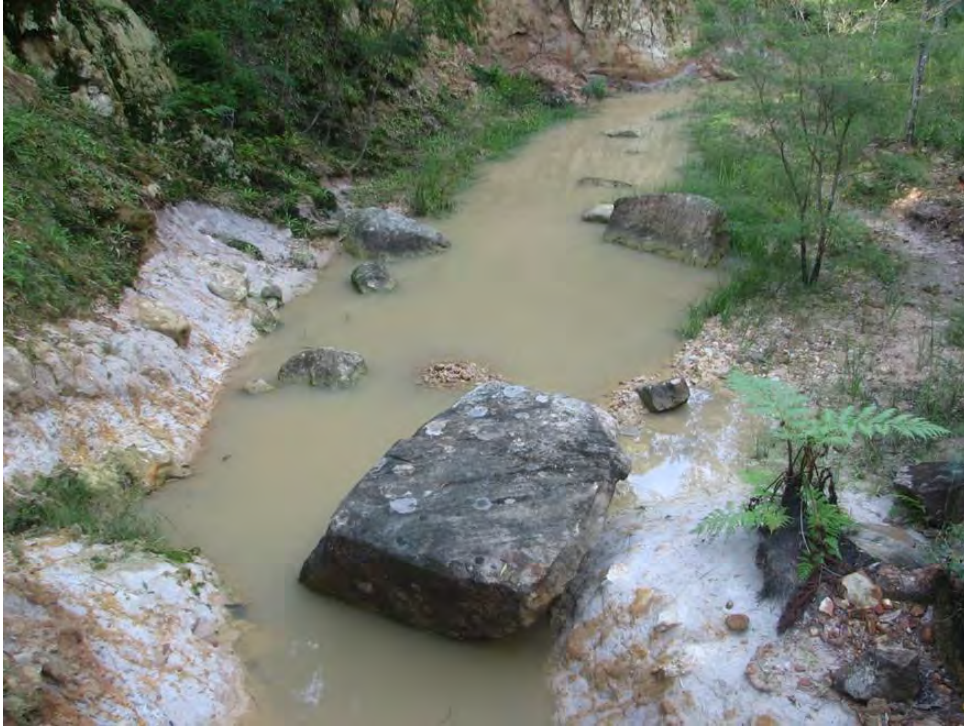
**Figure 5.9. The water downslope of the nick point is very turbid. This indicates dispersing conditions and low ecological value. This drainage line only flows during major overtopping events. Most of the time the entire overflow is conveyed down the glory hole and then by pipe.**

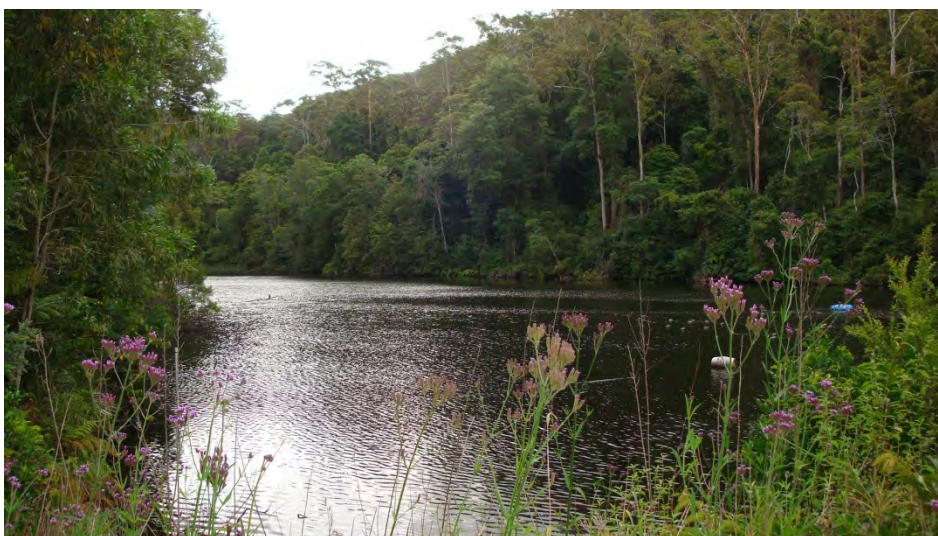
**Figure 13:** The dam- view from eastern edge looking north-west. Strickland State Forest is in the background.

An existing dam is located in the north-western corner of the site and was previously used for onsite irrigation for the Gosford Horticultural Research and Advisory Station. The dam has a capacity of approximately 43.3 mega litres.

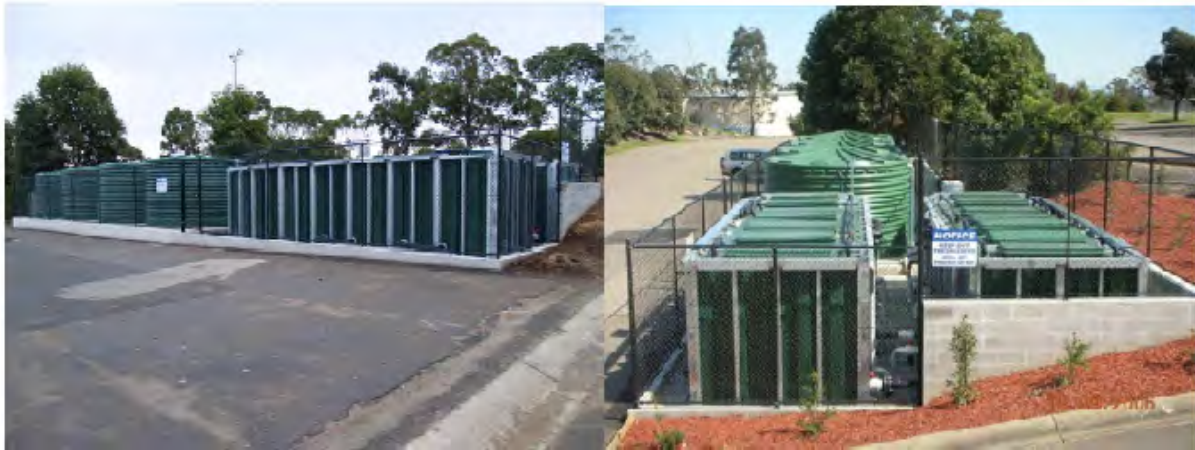
**Figure 27:** Example of the MBR which has been installed at the Blacktown Workers Club (Source: Aquacell)

2. **Wastewater treatment and recycled water system (waste water treatment plant)**- this will comprise the installation of a Membrane Bioreactor (MBR) as the primary treatment technology- although, the final treatment process selected will be determined in consultation with NSW Health and its operation will be subject to a WICA license. This infrastructure will combine biological treatment with ultra filtration to produce high quality treated water.  
The MBR is proposed to be located on the eastern boundary of the site adjacent to the 6(a) zoned land and directly to the south-east of the Fisheries Building. The treated water will be sent to two (2) treated water storage tanks (each 100 kilolitres in volume) for reuse within the NEV community and for irrigation. An example of the scale and visual appearance of an MBR is provided in **Figures 27** and **28** below.

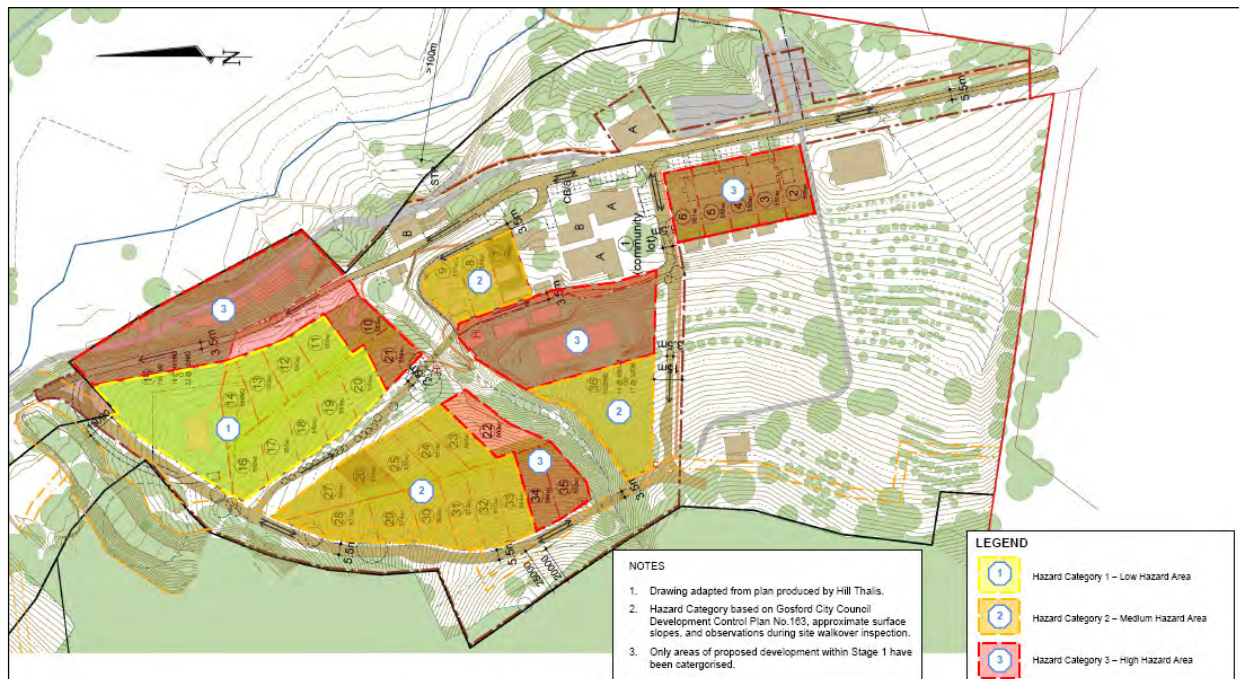
The slope classifications across the site are illustrated in **Figure 37** below. In accordance with DCP 163, those sites which have been assigned a classification of either Category 2 or 3 will be subject to further slope stability assessment and risk assessment at the individual DA stage.

**Figure 37:** Slope Classifications across the Stage 1 site.

- the northern group of residential lots and part of Lot 15 have slopes ranging from 5°-10°. The slope is therefore classified as Category 1- Low Hazard Area.
- The residential lots that are located away from the existing gully and do not include existing building terraces, fall to the north-east at about 12° – 15°, and are classified as Category 2- Medium Hazard Area.
- A number of areas across the site which include retaining walls and batters and lots that are located close to the inner western gully are classified as Category 3- High Hazard Areas.

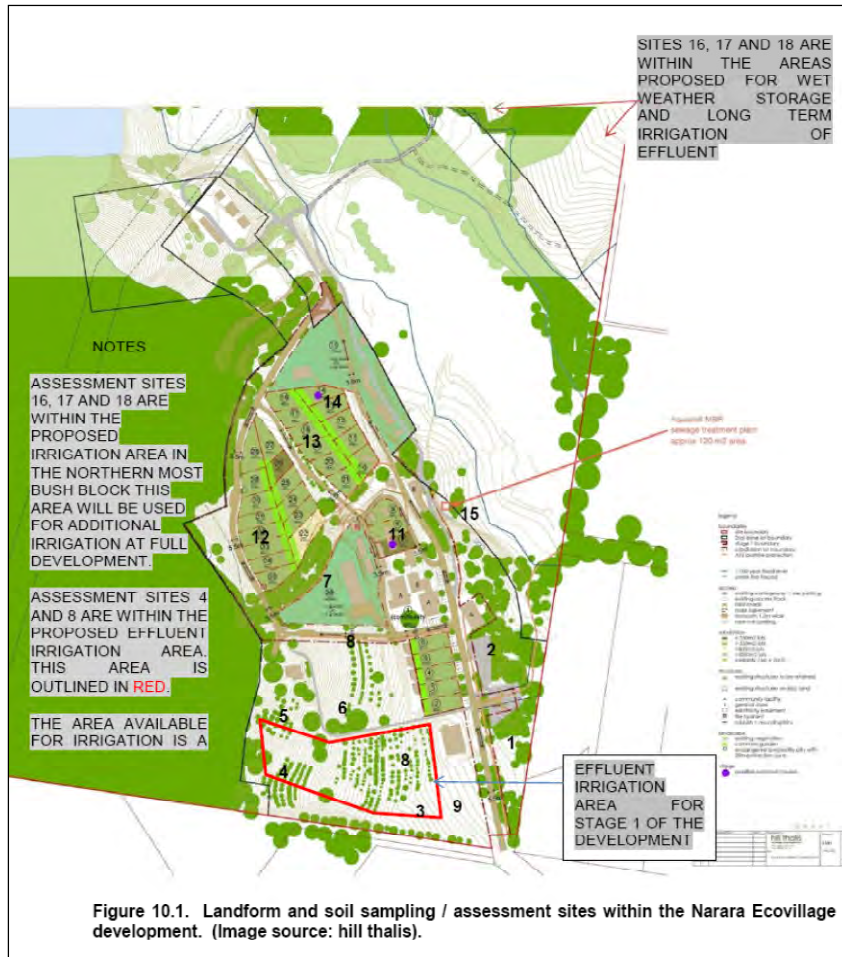
**Figure 39:** Landform and soil sampling assessment sites (Source: Woodlots & Wetlands)

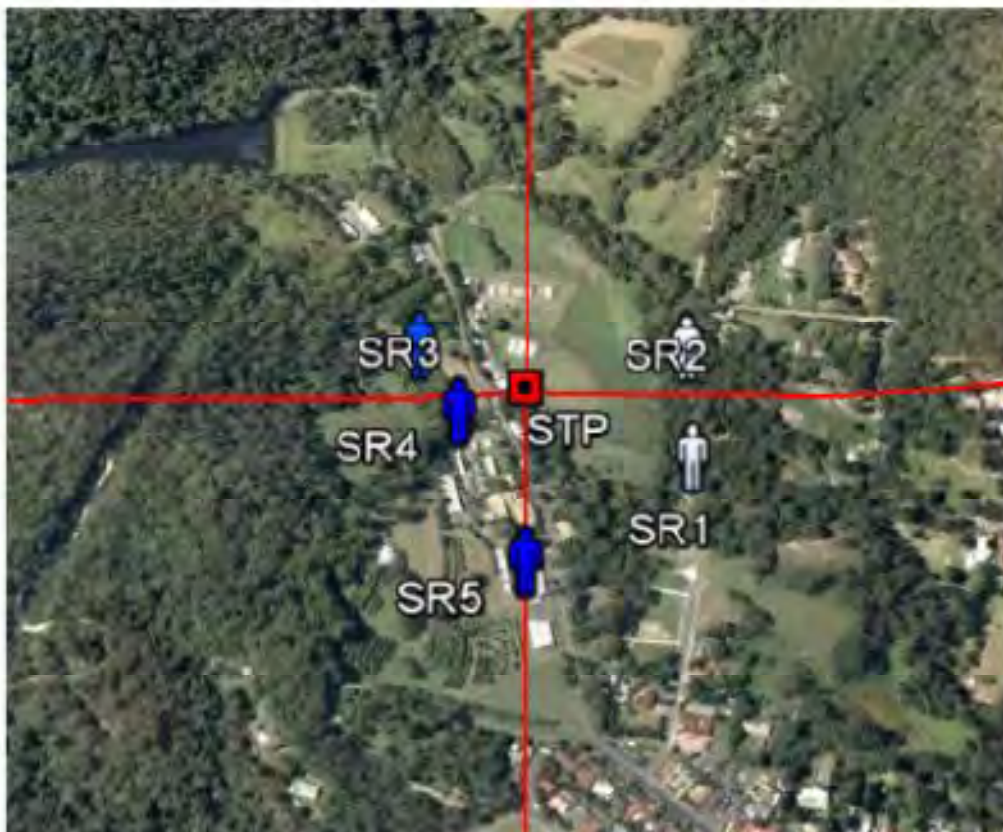
The AQA Report includes an assessment of impact of potential emissions from the STP to the surrounding area using AUSPLUME v6 dispersion model in accordance with the methodology in the *NSW EPA's Technical Framework: Assessment and Management of odour from stationary sources in NSW* (November 2006). The Ausplume model was configured to measure the maximum ground level concentrations at each junction of a grid that spans 1km x 1km around the STP and to determine the worst impact to the nearest sensitive receptors. This is based on ground level concentrations at each grid intersection within the assessment area for every hour in one calendar year. The area covered by the dispersion assessment is shown in **Figure 41** below and includes residential development to the east of the NEV site (SR1 & SR2), and residential development within the NEV site itself (SR3- SR5).

**Figure 41:** Area included in the dispersion assessment (Source: Aubin Environmental)

The modelling showed that in all instances, the results of the testing were significantly lower than the assessment criteria. Based on the odour assessment criteria adopted for the site of '4', it was determined that the ground level concentrations at sensitive receptors SR1 and SR2 were 0.6 and 0.8, respectively. Within the NEV site itself, the levels are slightly higher but still remain well below the assessment criteria. In this regard, the concentrations at ground level for SR5 and SR3 ranged from 0.5 to 1.5, respectively. SR4 had an estimated concentration of 1.1, as illustrated in **Figure 42** below. It is noted that the ground level concentrations at the STP are estimated to be above '4' and that this level was detected at 5 out of the 448 locations assessed in the modelling. However, the

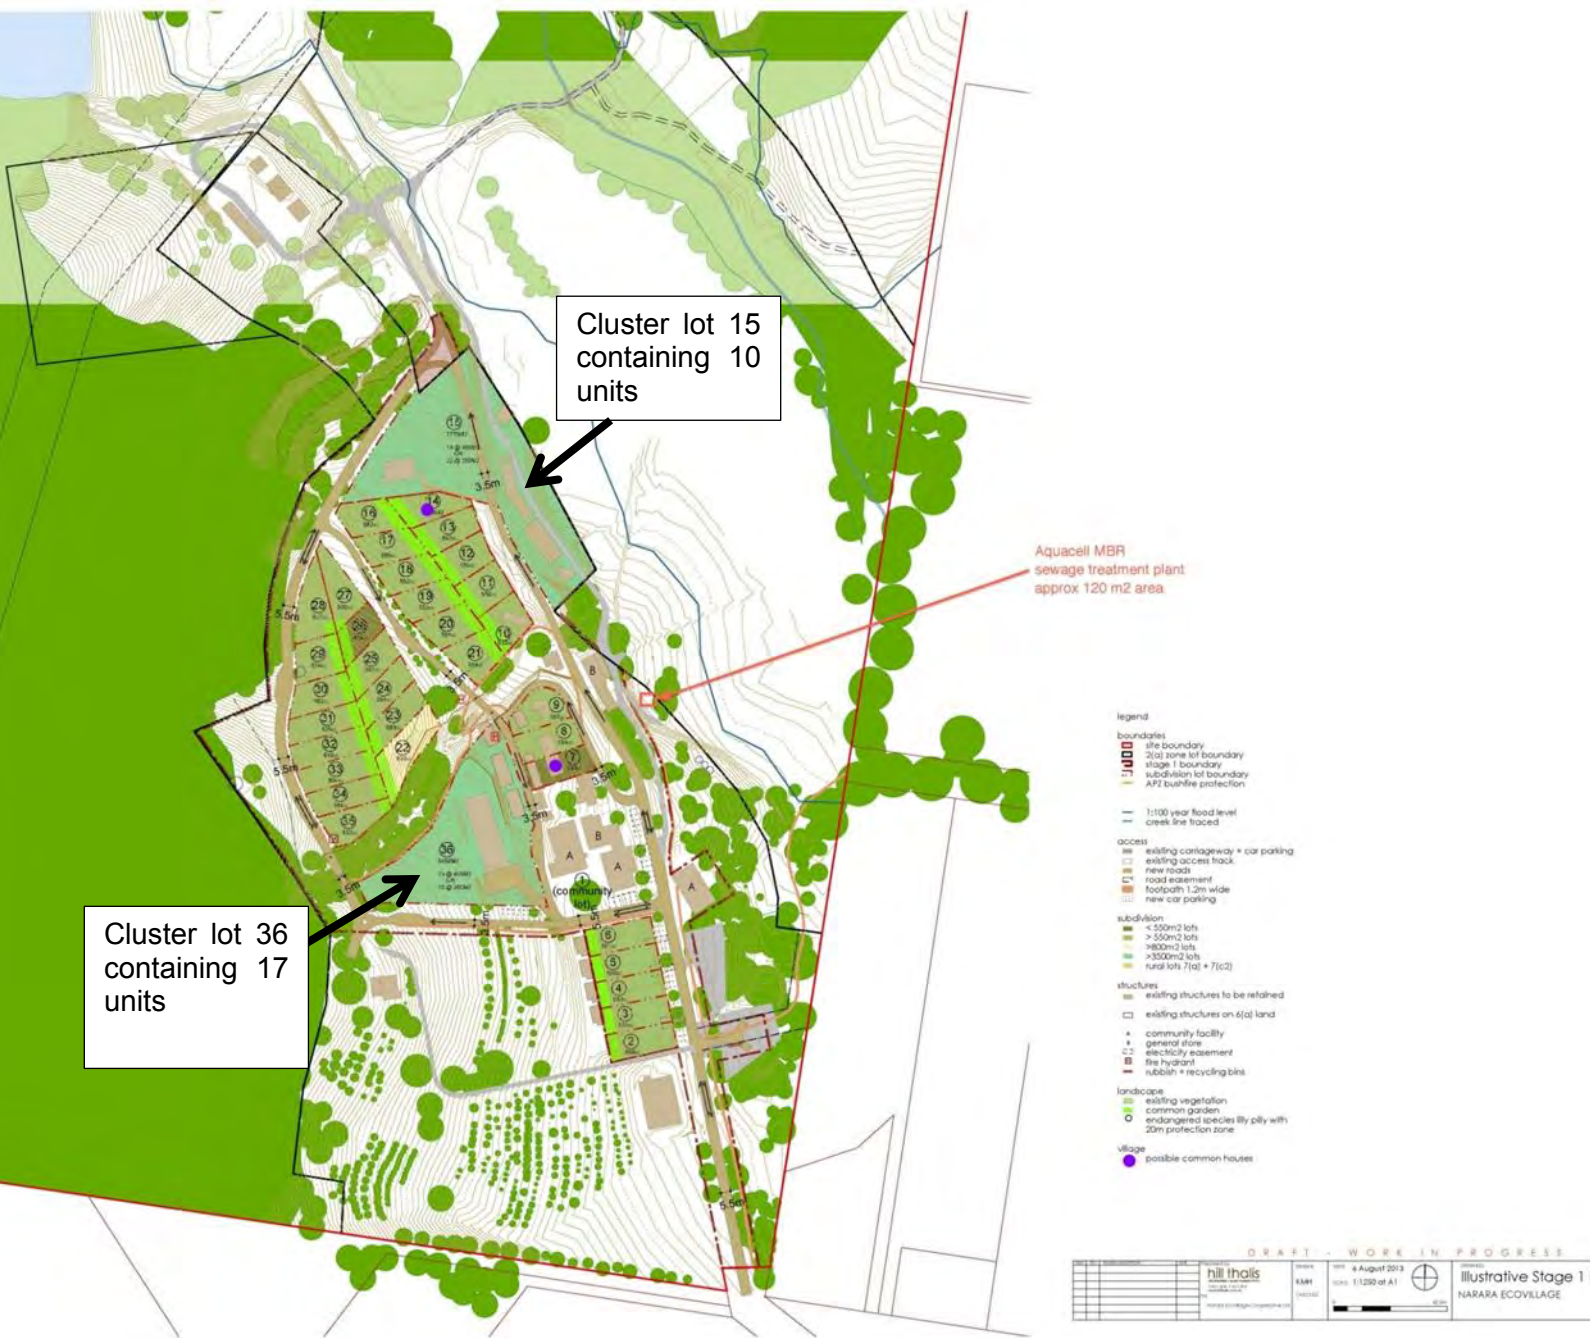
**Figure 1.3. Stage 1 of the development. Eventually areas to the south and north of the first stage will be developed. (Image source: hill thalis). Full development will comprise approximately 110 to 130 dwellings.**

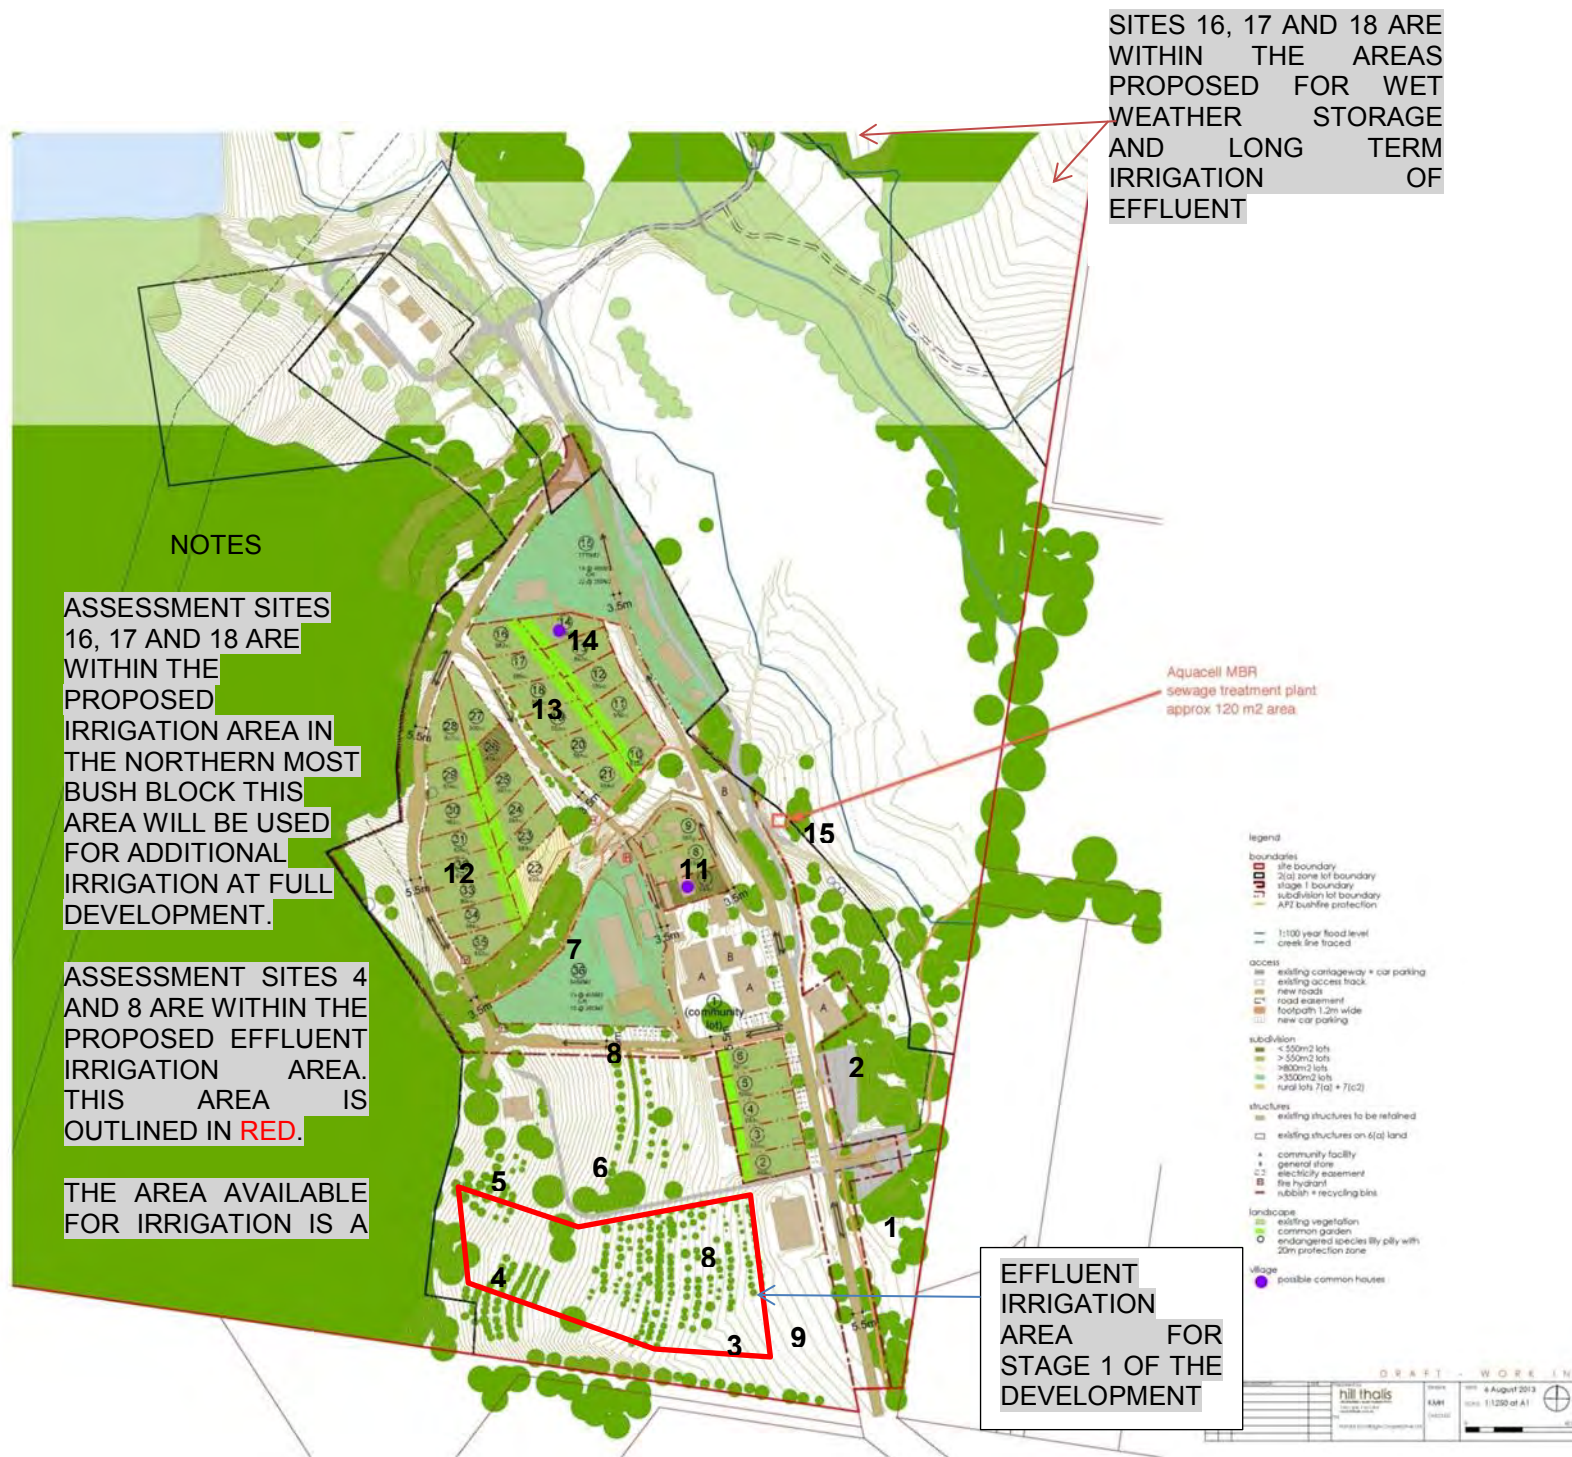
**Figure 10.1. Landform and soil sampling / assessment sites within the Narara Ecovillage development. (Image source: hill thalis).**

Figure 10.1 shows the 15 localities within the proposed development area which were assessed for landform and soil characteristics. The sampling areas were either under orchard or volunteer grass. It is proposed that the majority of the site will be developed for housing; however the orchard to the south of the stage 1 development will be used for effluent irrigation of excess effluent from the first stage.

A back hoe was used to excavate 15 pits within the development area. The locations were geo-positioned and are shown in figure 10.1. DEC (2004) suggests 4 sampling depths. Our soil sampling was based on sampling horizons to at least the surface 2 metres unless rock was encountered. The sample depths varied slightly to reflect the differences in horizon thickness at individual sites. Up to 5 horizons were noted. The results of the field assessment are shown in table 11.1.

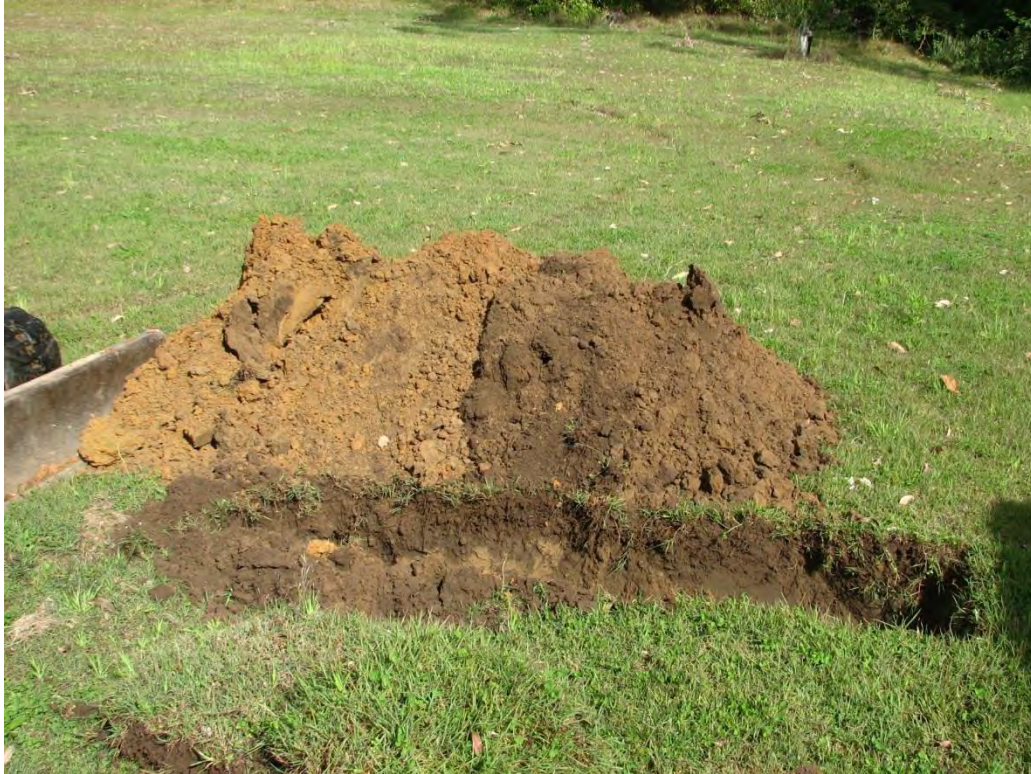
**Figure 11.1. Pit 7. The profile changes from loamy sand near the surface (right hand side) to light clay below 2m.**

The typical profile has loamy sand overlying light to medium clay at 2m depth.

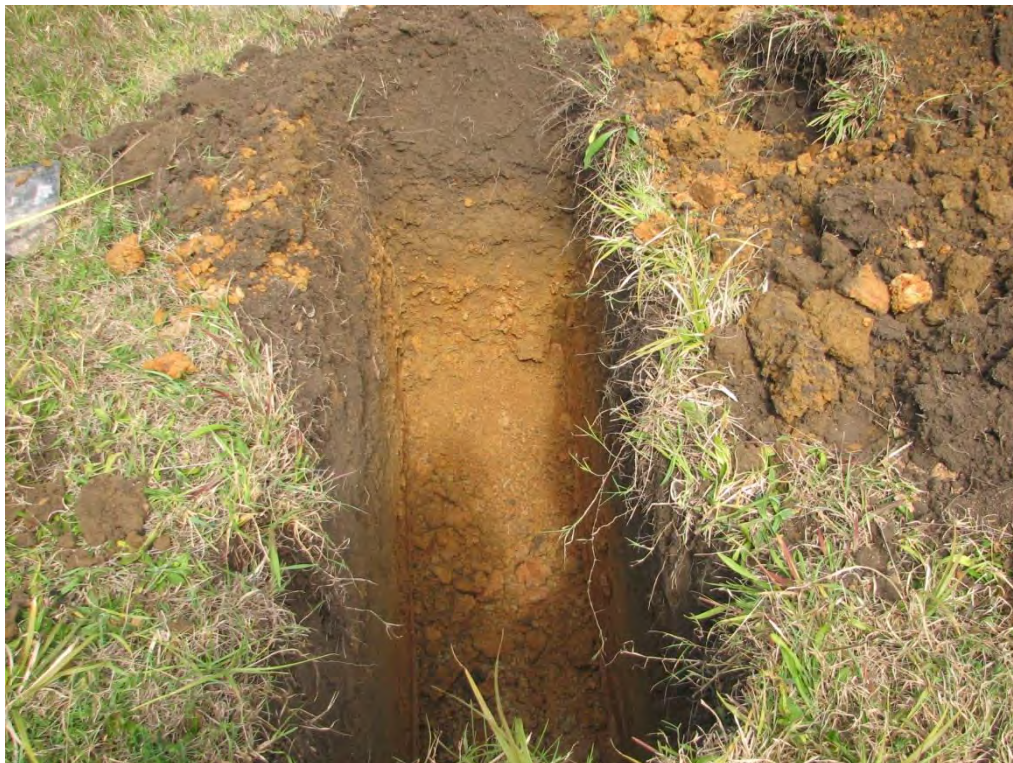
**Figure 11.2. Pit 13. The profile has a similar change in colour and texture as the other profiles.**

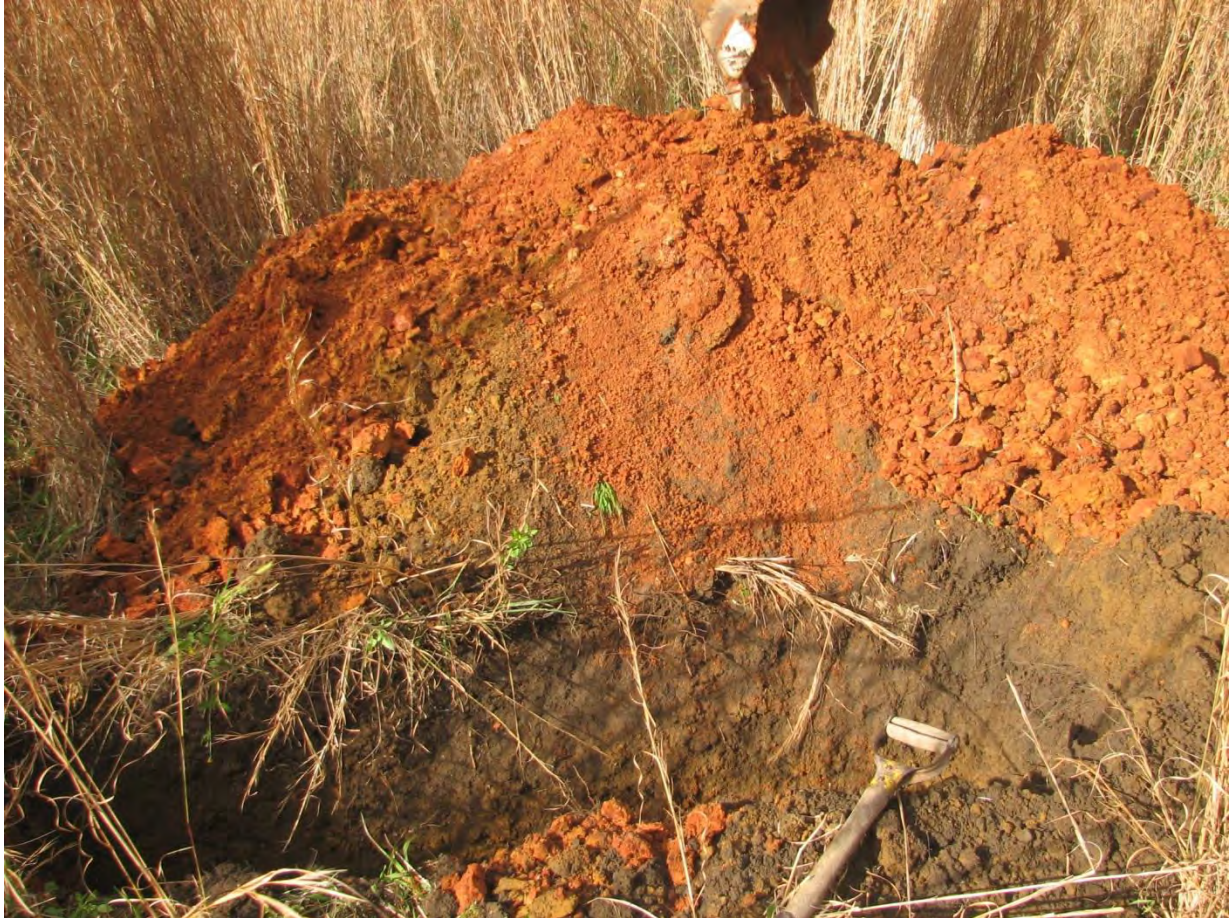
**Figure 11.3. Pit 18. The soil has a higher clay content than the soil in the development area. It will be suitable for dam construction.**

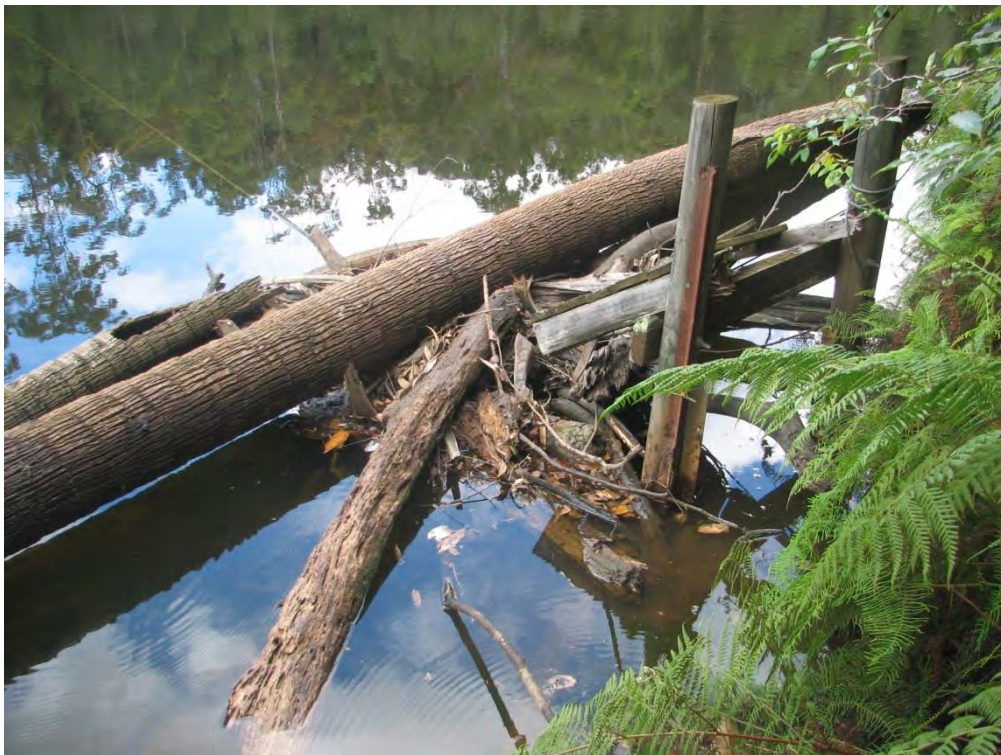
**Figure 12.5.** Low to medium flows exit the dam via this partly blocked glory hole. The debris needs to be removed.

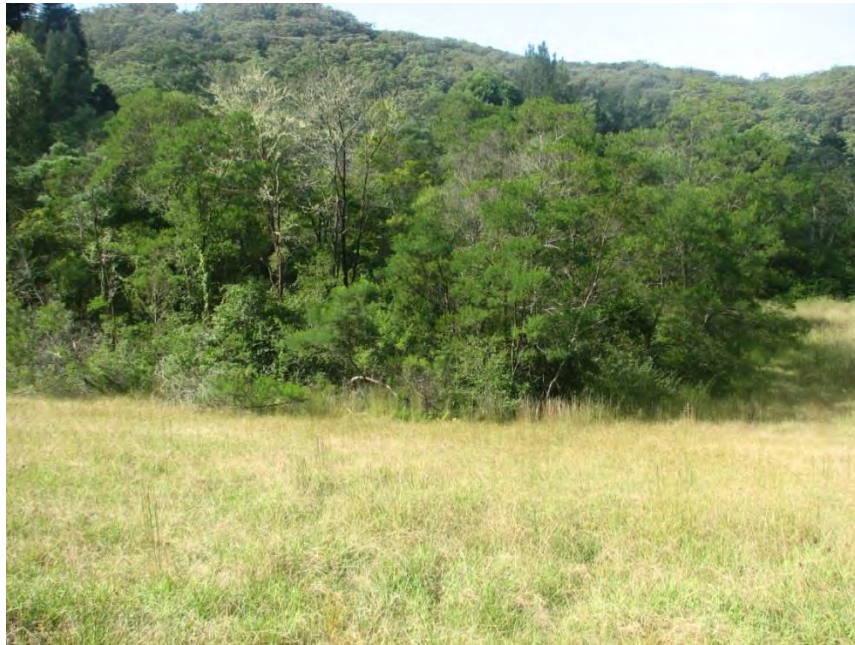
**Figure 12.6.** The glory hole pipe discharges into a drainage line located in this bush near the toe of the embankment, some 30 m downslope of the top of the embankment.

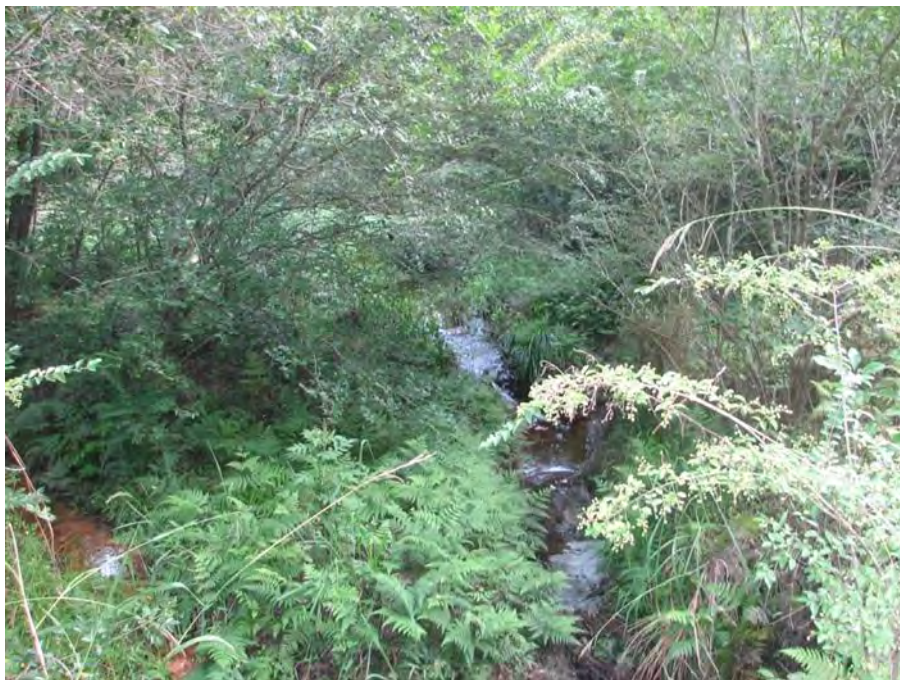
**Figure 12.7.** The water that exits the dam reaches a stream some 165m downslope of the glory hole.
