# Narara Eco Village

## Water Reservoir

### Initial Sampling Report

Appendix 4.1.1.1  
A0072

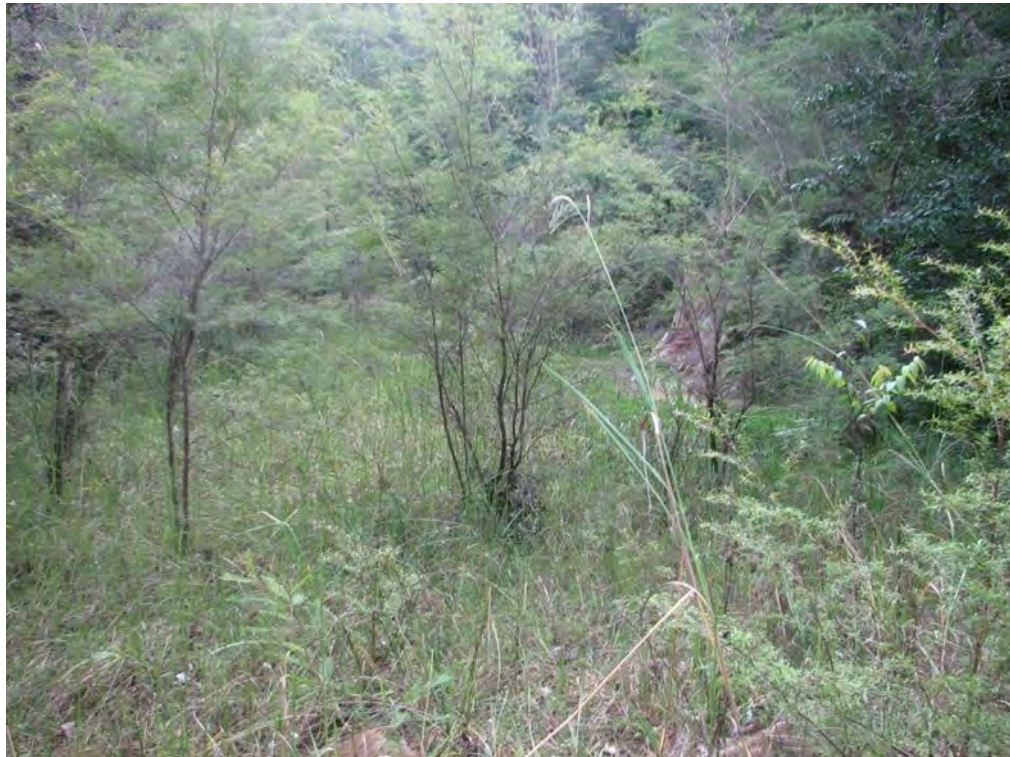
**Figure 12.8.** There is a high flow spillway adjacent to the right hand abutment. The condition of the vegetation indicates scouring if flows rarely occur.

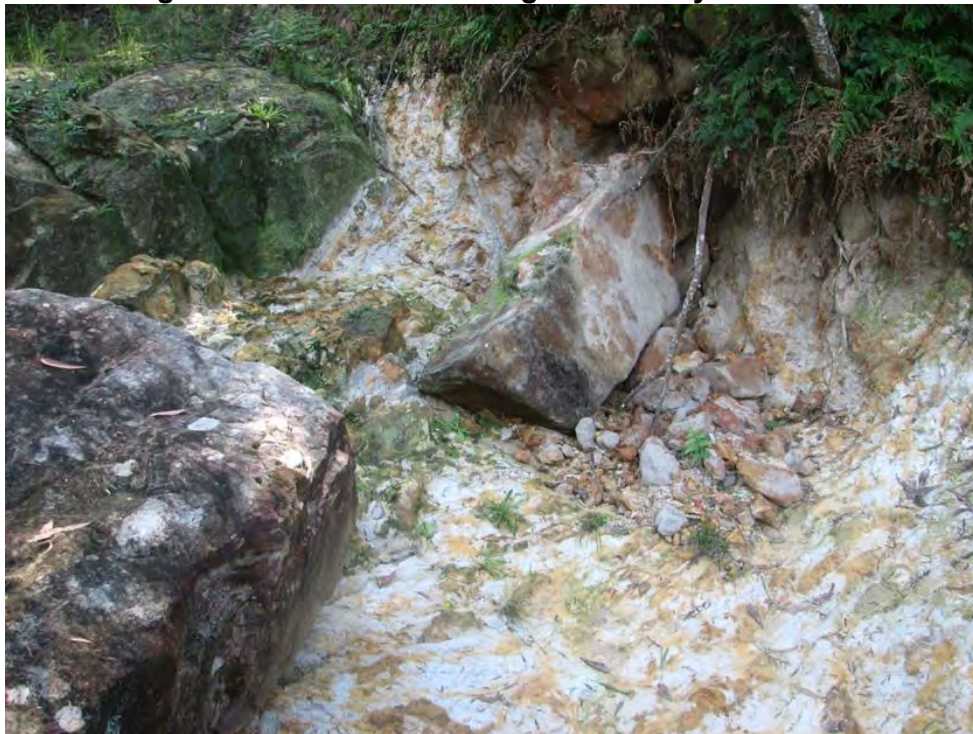
**Figure 12.9.** There is a nick point at the base of the high flow spillway. The spillway is largely protected by an armoured layer of sandstone. The location of the nick point needs to be marked and any future advance monitored.

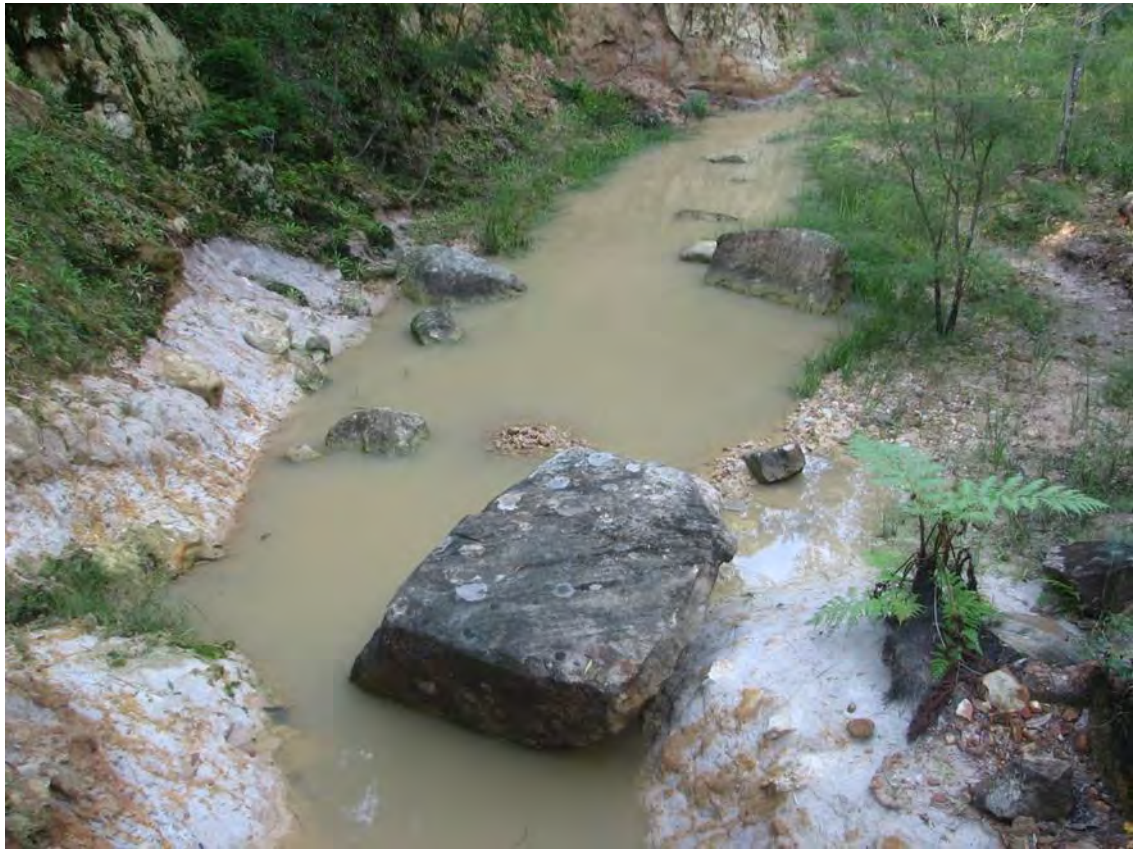
**Figure 12.10. The water downslope of the nick point is very turbid. This indicates dispersing conditions and low ecological value. This drainage line only flows during major overtopping events. Most of the time the entire overflow is conveyed by pipe.**

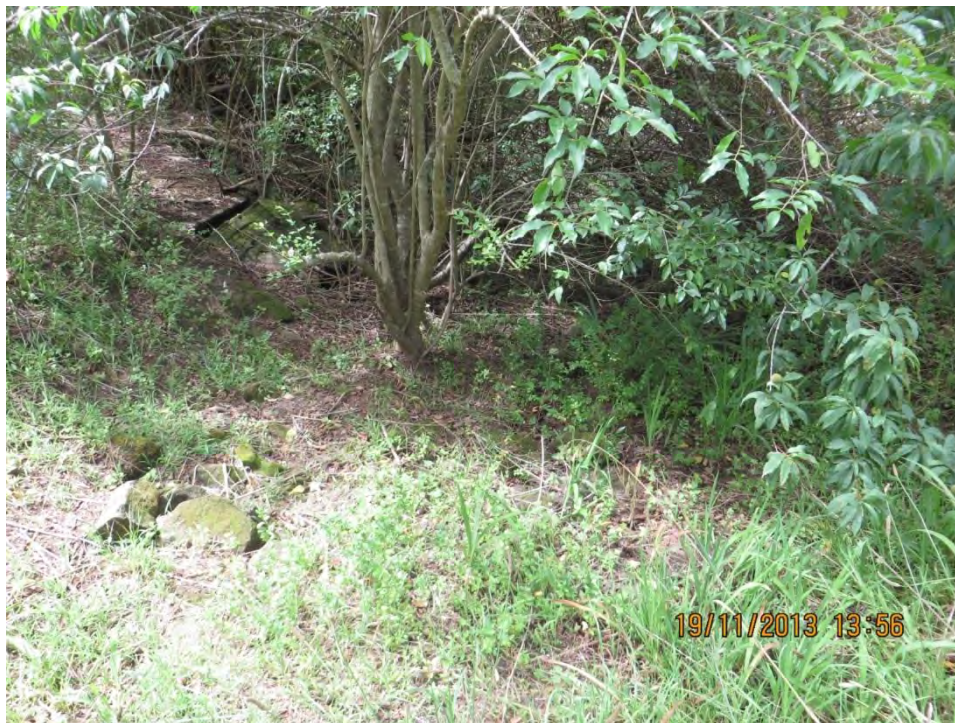
For example in November 2013, a total of 101 mm of rainfall fell in the 4 days prior to the photo shown below as figure 14.3 was taken. The rainfall quantities were: 16<sup>th</sup> Nov 19 mm, 17<sup>th</sup> Nov 9 mm, 18<sup>th</sup> Nov 45 mm, 19<sup>th</sup> Nov 28 mm (Station 61319, Glennie St., Gosford). That is, there was no free water in the base of the gully on the afternoon of the 19<sup>th</sup> Nov despite the 101 mm of rainfall in the previous 4 days.

**Figure 14.3.** There was zero free water in this gully despite over 100 mm of rainfall in the previous 4 days. The evidence suggests that occur following rare, very intense rain events. A HEC-RAS analysis will have little relevance in this situation as the ‘capacity’ of the gully will far exceed the likely flows.

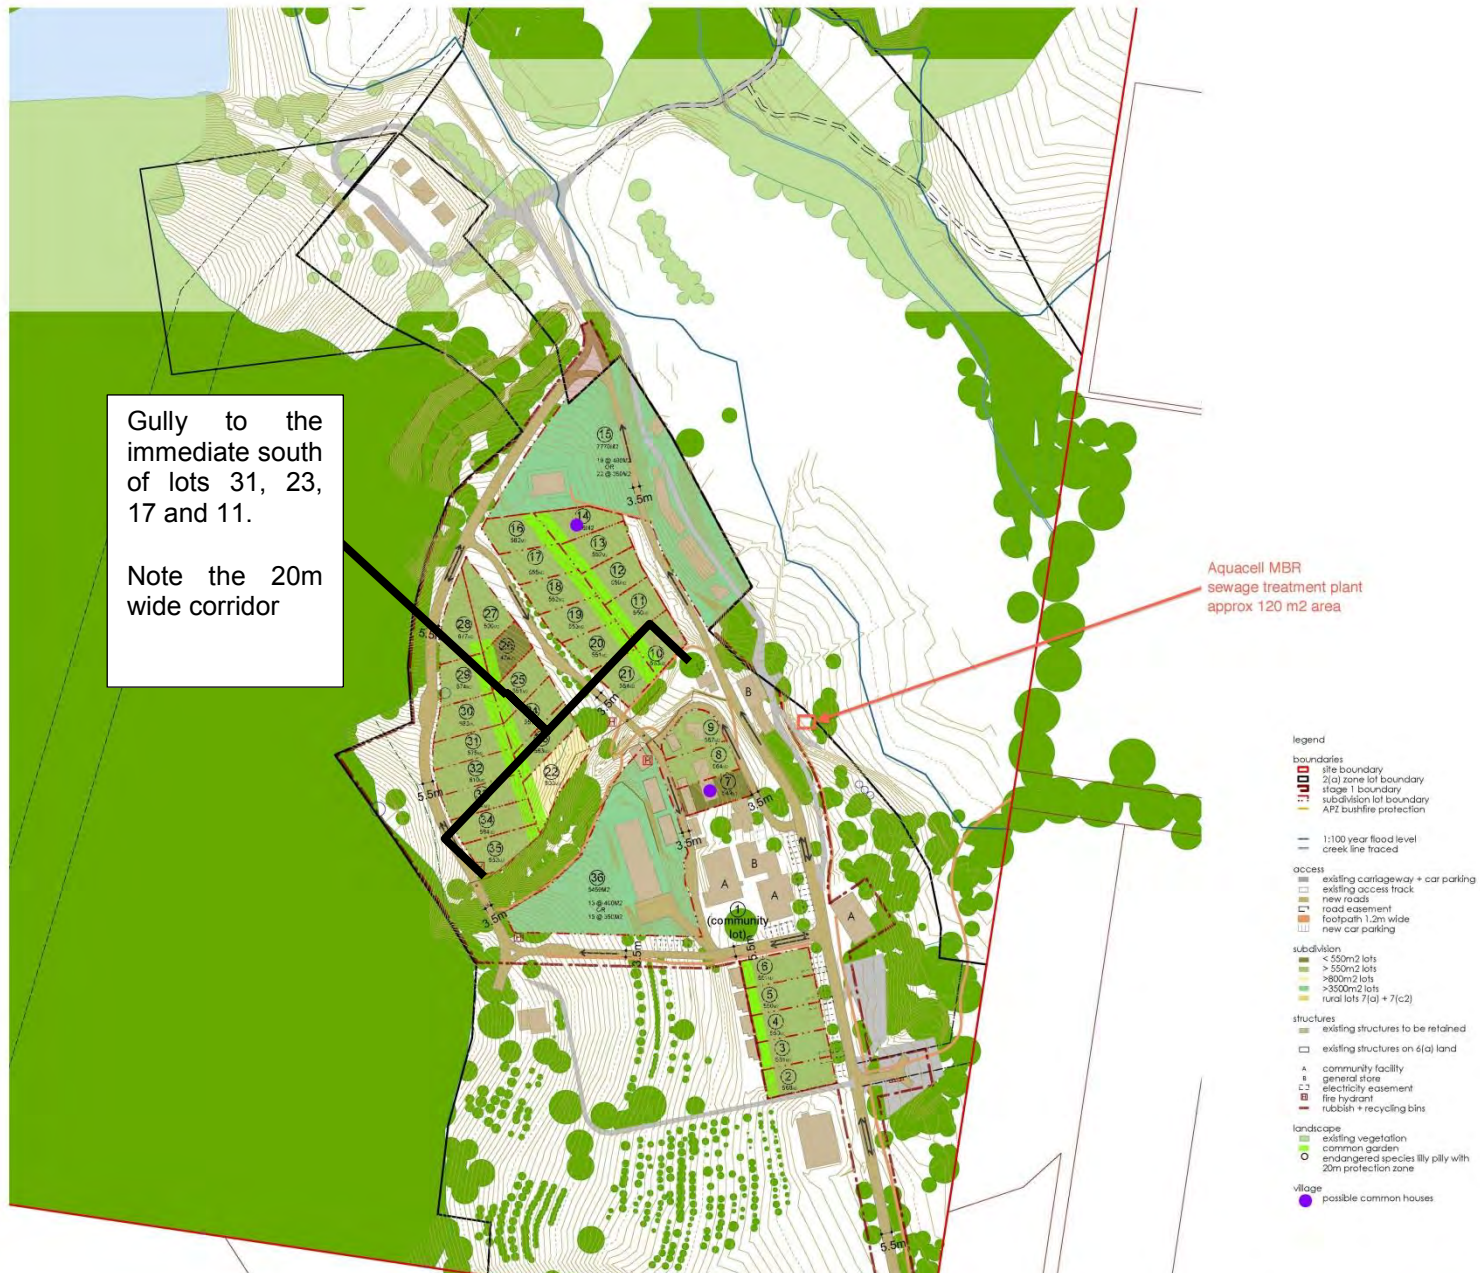
Figure 1 shows the proposed stage 1 of the urban development. There is a discontinuous line of vegetation shown to the immediate south of lots 35, 22, 21 and 11. This 'line' approximates a gully.

**Figure 1. Development details showing the individual lots in Stage 1 and the gully to the south of lots 35, 22, 21 and 10. The location of a vegetated gully is also shown.**

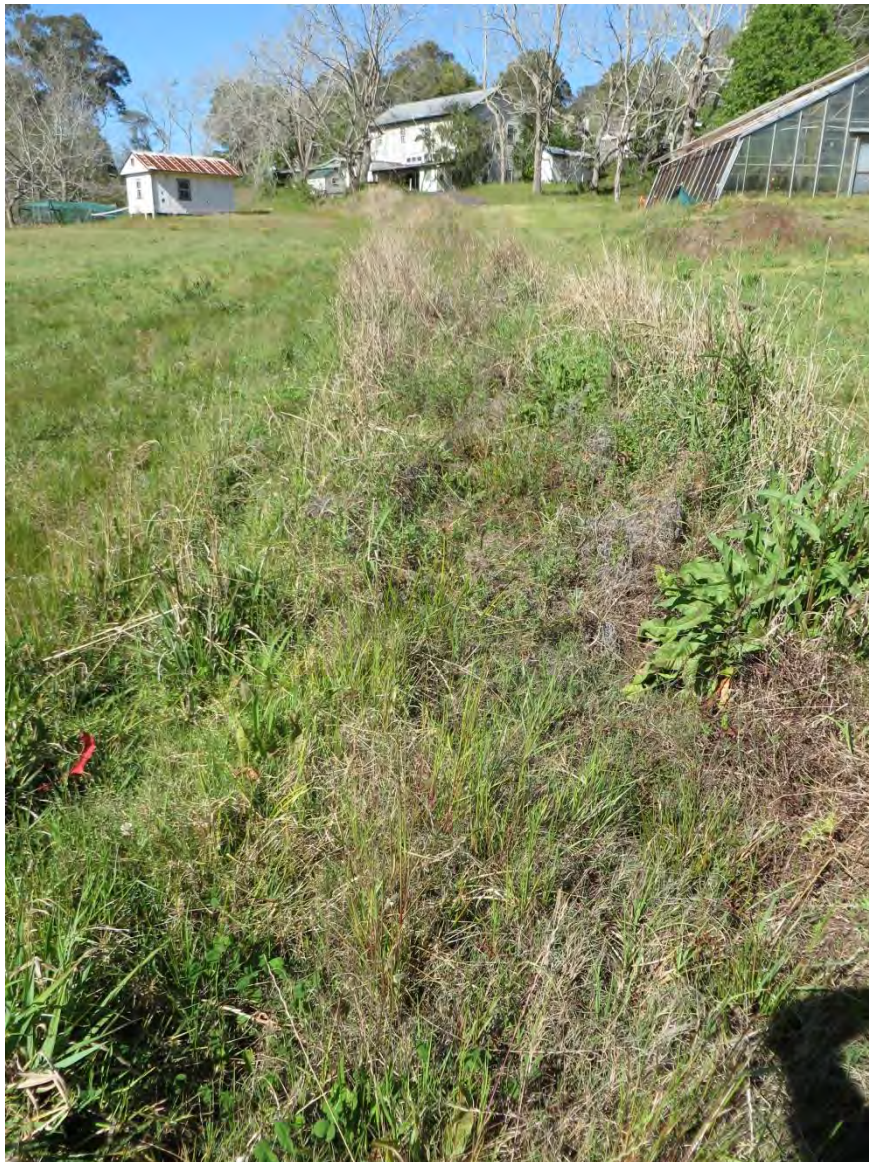
**Figure 5. AP 1.**

The photo below is taken looking up the drainage line from a point some 30m above the catchment's discharge into a typha dominated wetland. The drain is thickly vegetated with terrestrial grasses such as (Lambs tongue) *Plantago lanceolata* and ryegrass. Dock, an indicator of wet conditions, is also present.

The channel is ill-defined and appears to have been straightened. There was no evidence of scouring, sediment or debris deposition or lodging of vegetation. There was no evidence of water upslope of this point. This is despite recent heavy rainfall (22 mm), 5 days before this assessment. Table 2 shows the

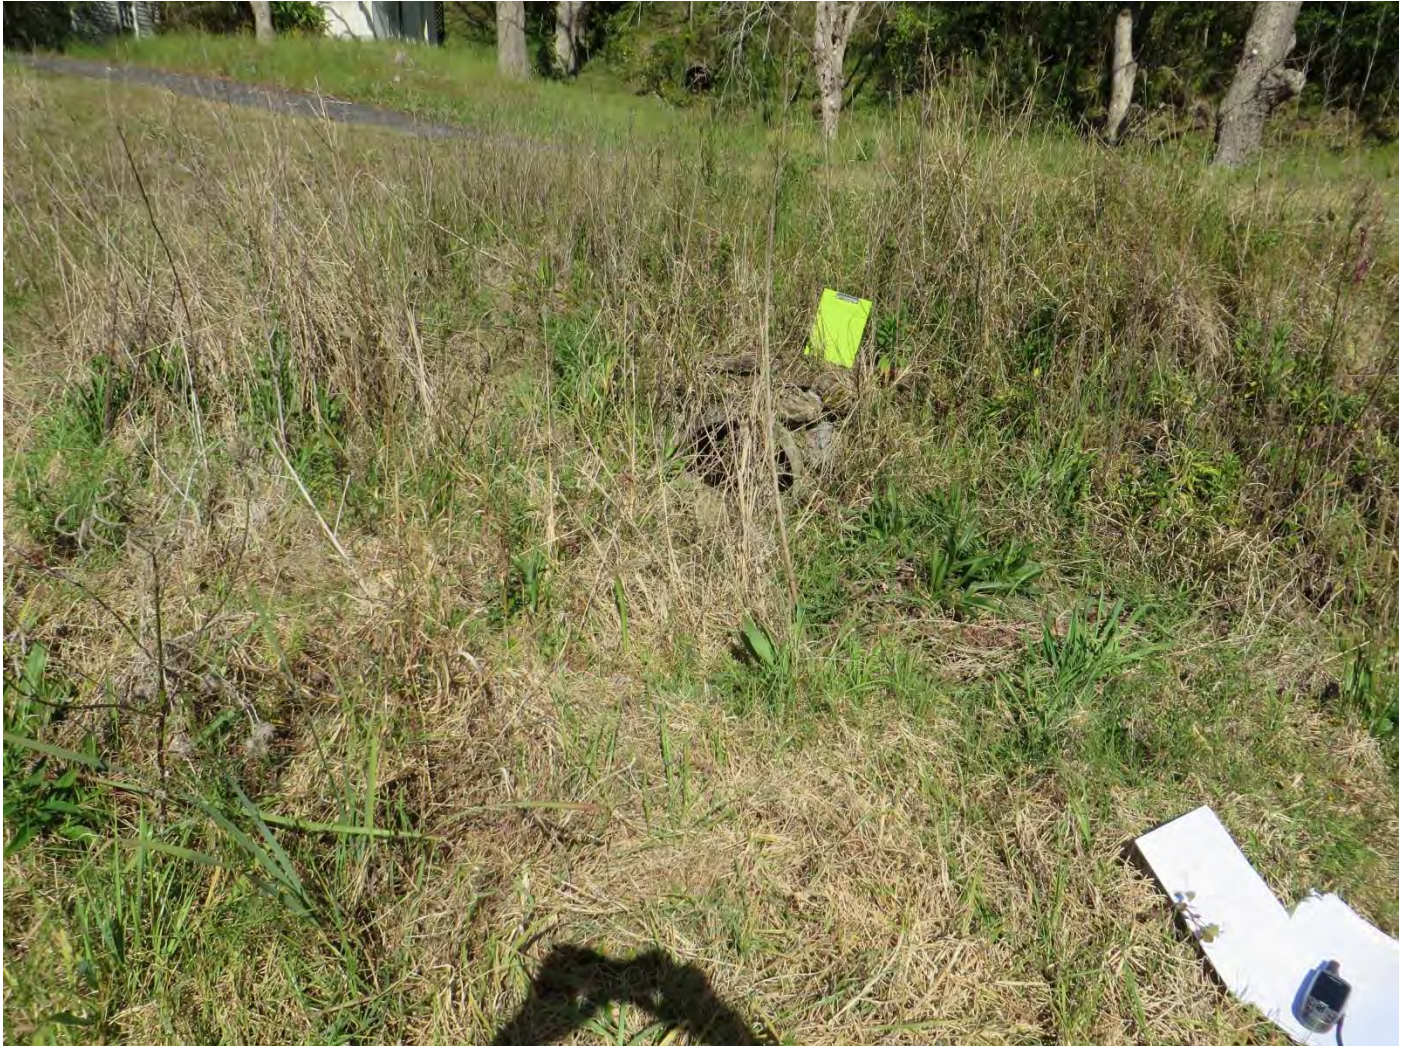
**Figure 6. AP 2.**

The photo below is the discharge point of the gully onto the floodplain (see figure 4). .

The channel is virtually indistinguishable from the surrounding lands at this point. There is no evidence of significant discharges from this 600 mm pipe (no sediment, no lodging of vegetation, no debris. It therefore cannot be considered a 'stream' at this location. The assessment against fluvial criteria in table 2 supports this conclusion.

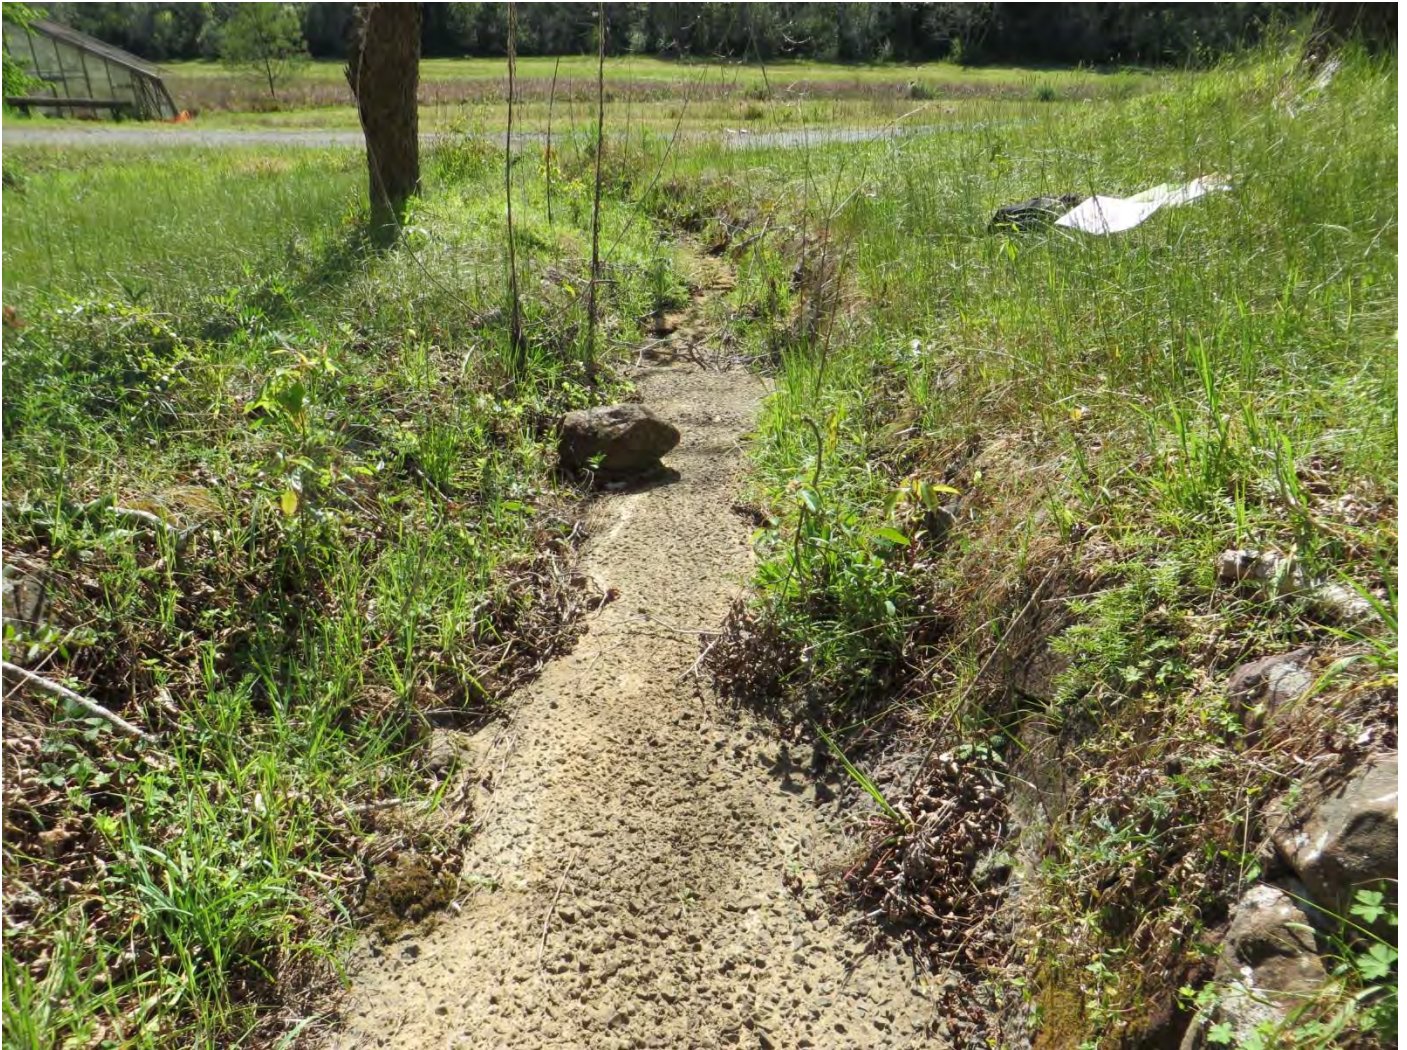
**Figure 7. AP 3.**

The photo below is immediately downslope of the lower road (see figure 4).

This photo looks downslope from the lower road. The drainage line has a concrete bed.

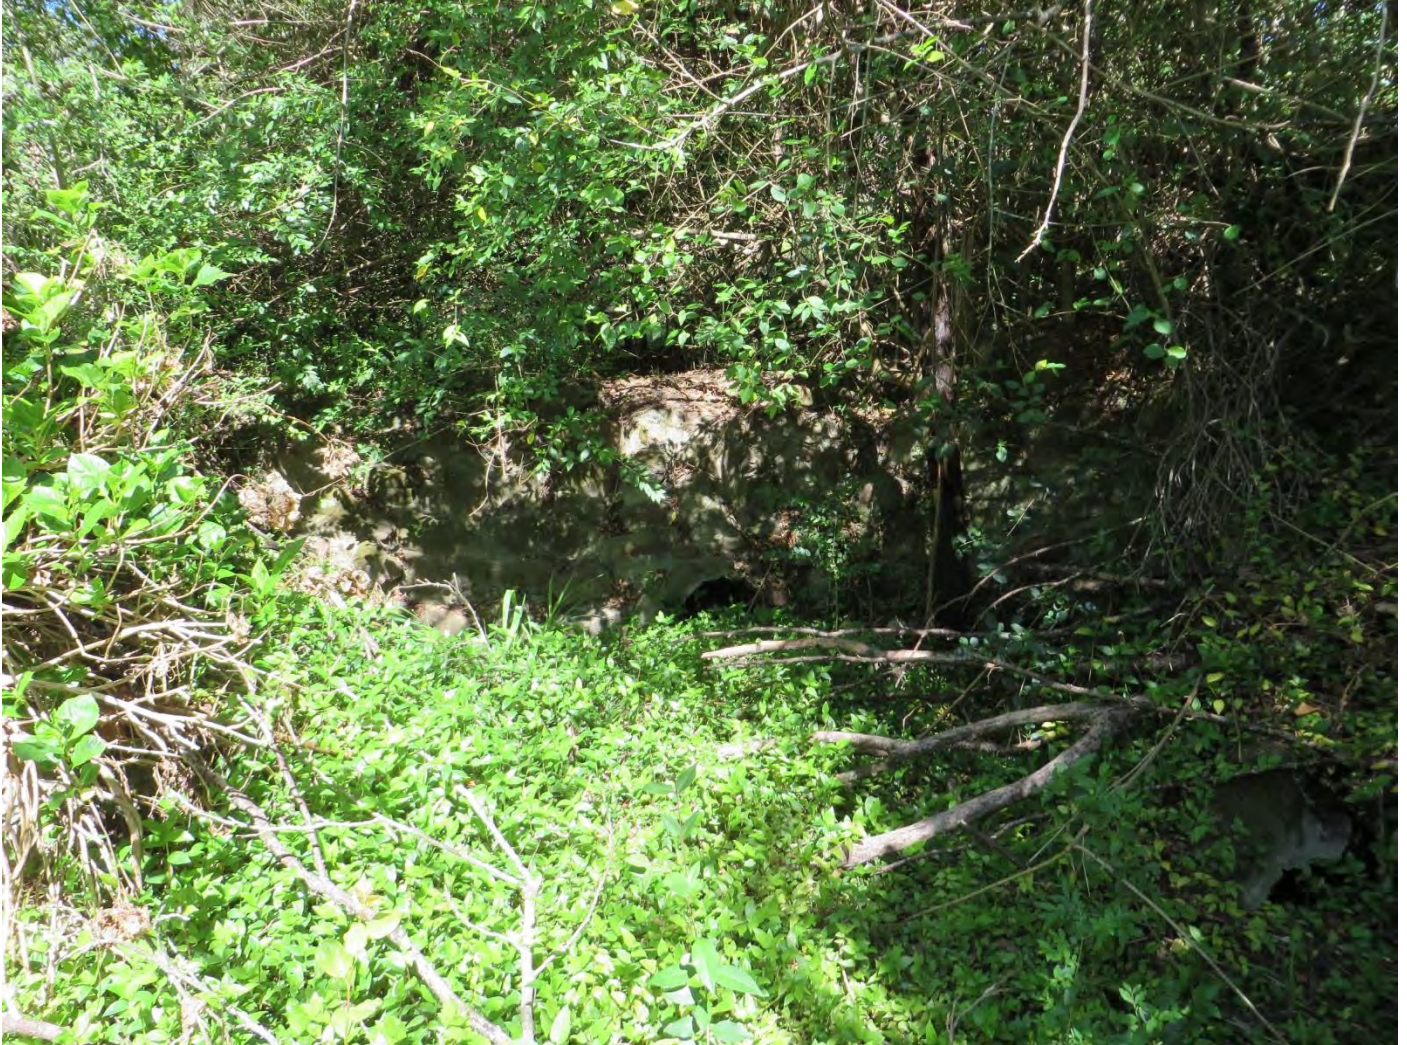
**Figure 8. AP 4.**

The photo below is taken of the drainage line looking upstream above the upper road. There is a small walking track bridge immediately upslope.

The base of the drainage line is covered with *Tradescantia fluminensis* (Wandering Jew). This is a creeping plant common in low light, moist conditions. Note that there is no evidence of disturbance or litter deposition in this relatively large, flat area, despite the antecedent rainfall. This again suggests that the drainage system seldom has free water in it.

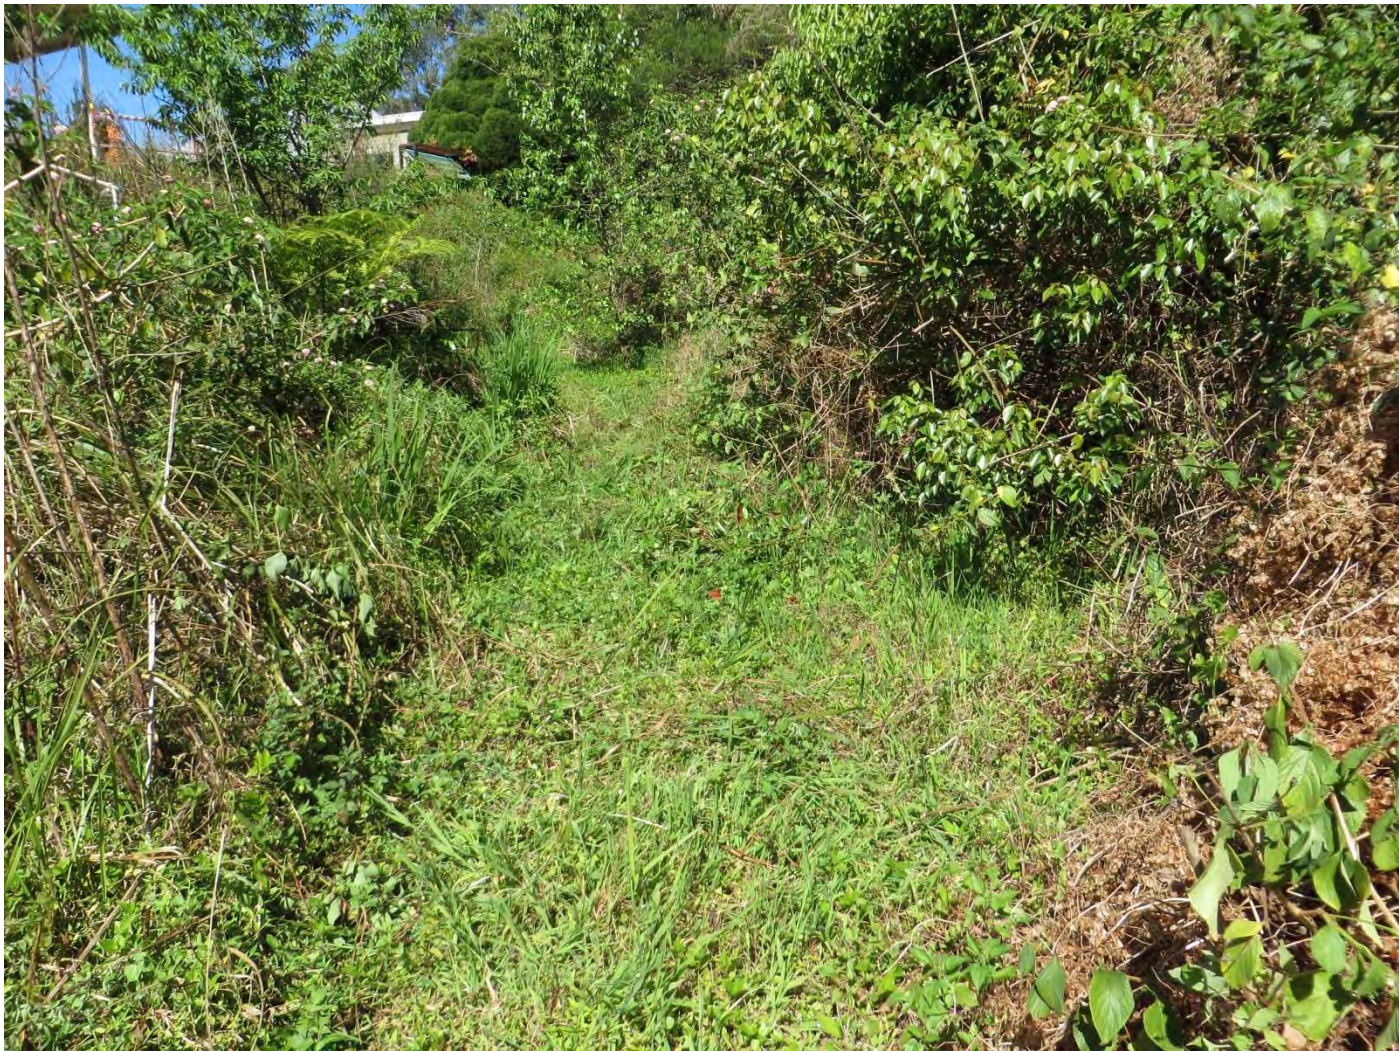
**Figure 9. AP 5.**

The photo below is taken of the drainage line upstream of the small walking track. It looks like a grassed swale rather than a drainage line. It has a 'floor' with minimal curvature or cross slope. There are no defined banks, there are simply sides of the gully. The vegetation on the 'floor' is basically terrestrial grasses and forbs. There are no aquatic plants evident. The vegetation on the sides of the gully consists of terrestrials such as lantana and camphor laurel. There is no evidence of sediment or vegetative debris being mobilised. There is no evidence of water in recent times. There were no sedges or other aquatic flora present. Aquatic fauna would be unlikely to survive.

The vegetation mix and the lack of any evidence of flowing water despite, antecedent heavy rainfall suggests that the drainage line is not a stream.

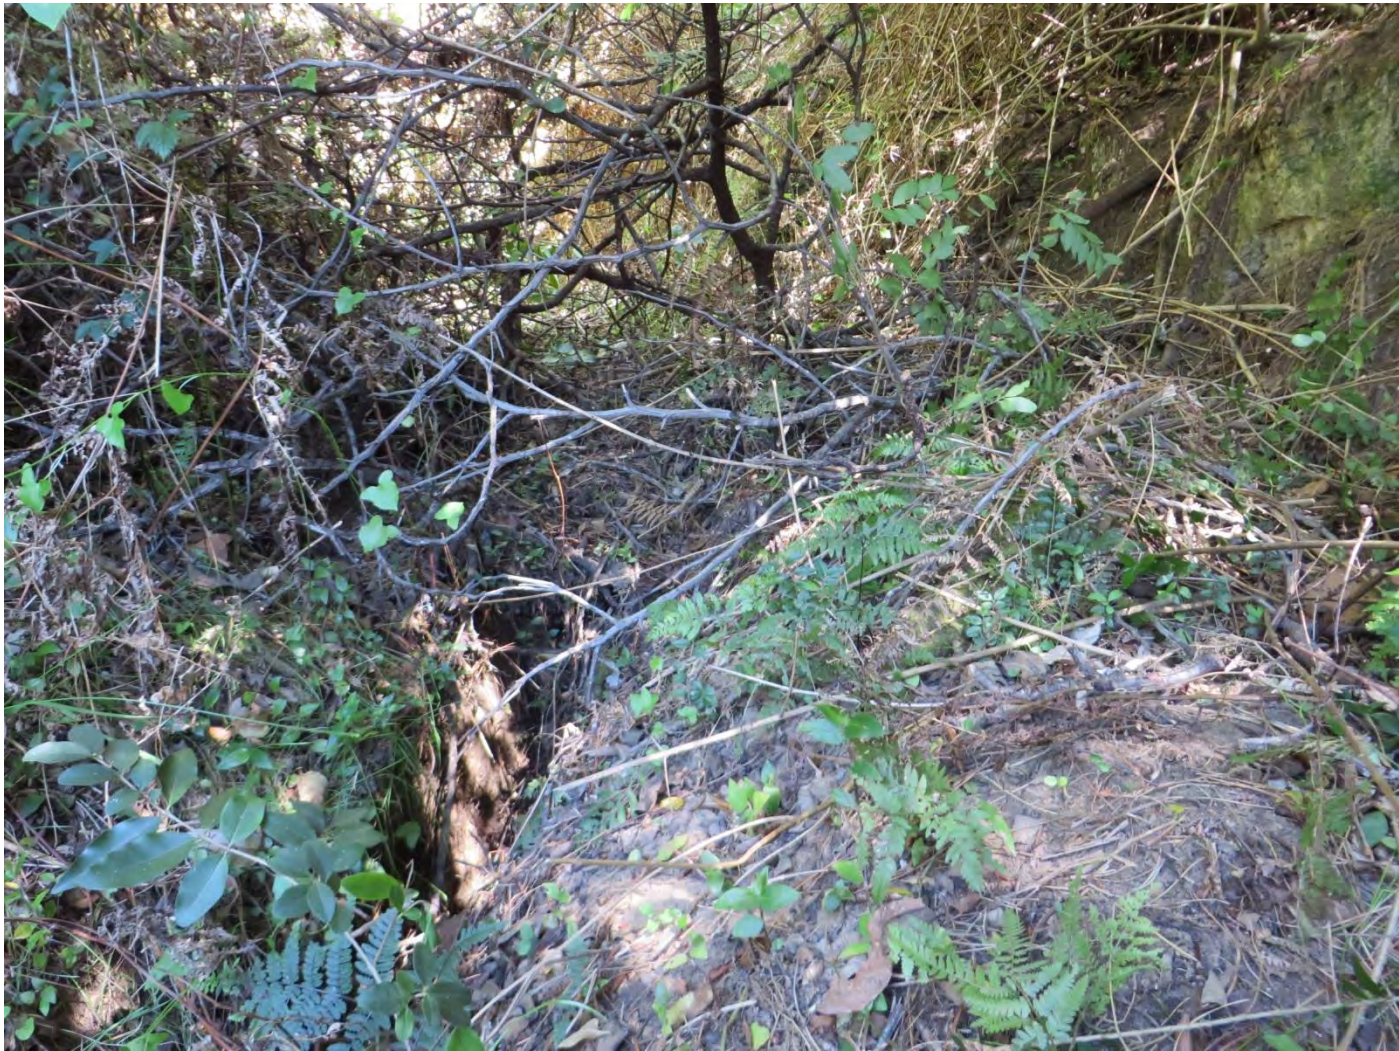
**Figure 10. AP 6.**

The ground cover is sparse and largely consists of ferns. There are no sedges or other aquatic flora present.

Immediately upslope of the nick point, there is some plant litter entangled in lantana branches. This suggests there has been some recent flow on the base of the gully. However the area was completely dry 5 days after heavy rainfall. Aquatic fauna would be unlikely to survive.

The vegetation mix and dry conditions despite heavy antecedent rainfall suggests that the drainage line is not a stream at this point.

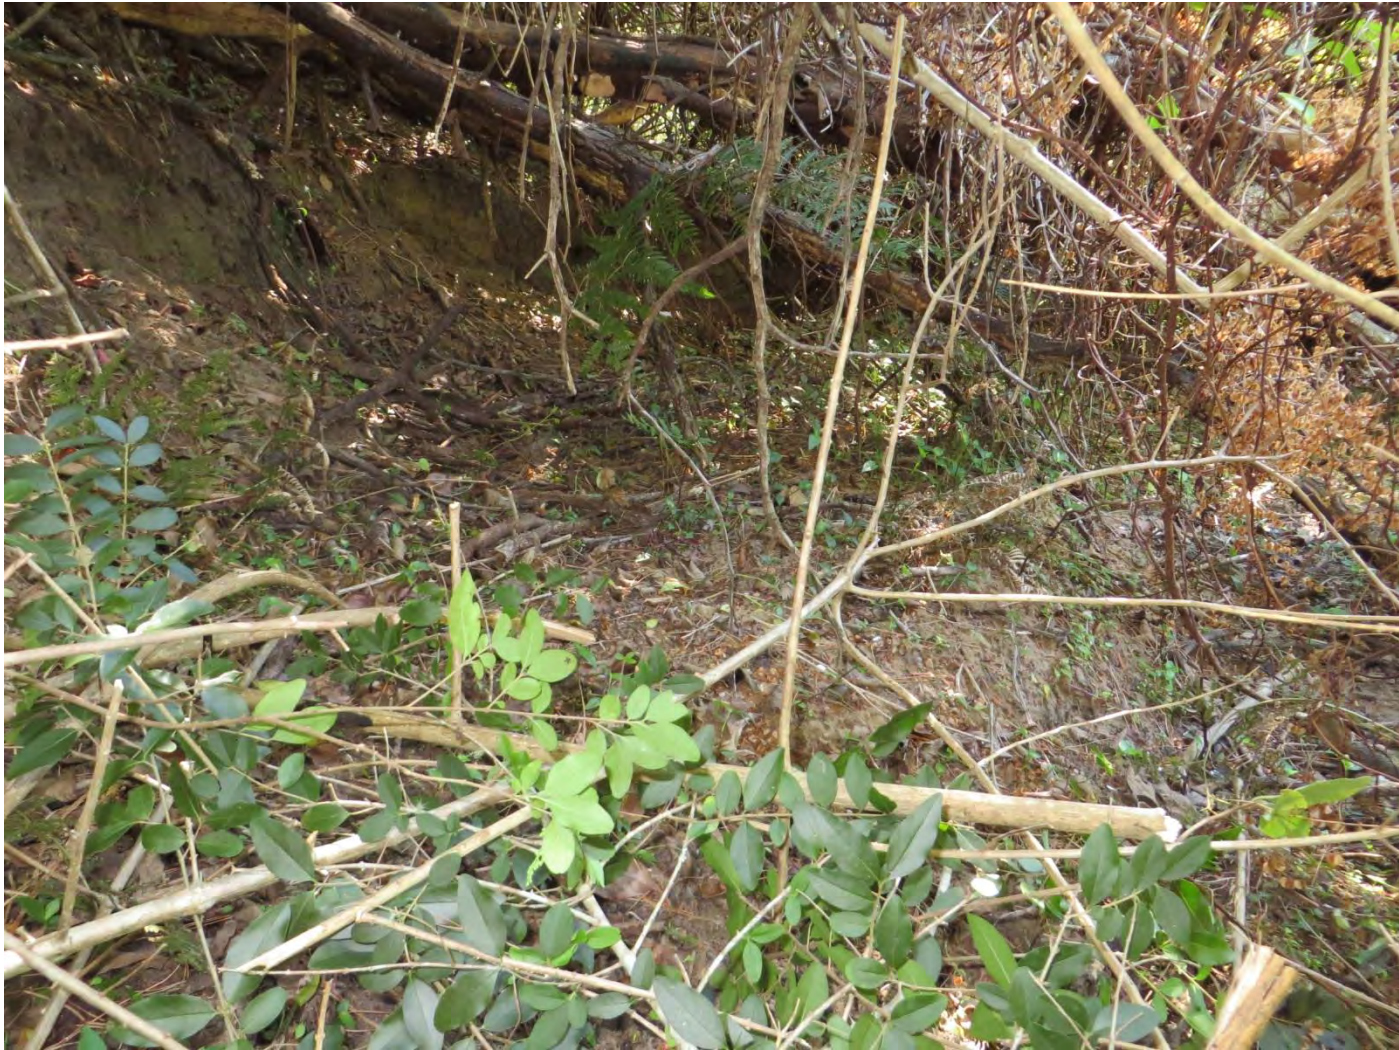
Figure 11. AP 7.

The photo below is taken of the drainage line approximately 26 m upslope of AP 6. The gully floor is bare except for plant litter and the occasional fern. The litter has not been mobilised by antecedent rainfall. This suggests that significant flows are extremely rare. Lantana branches droop onto the bed of the gully, but there is no evidence of litter pack mobilisation.

There are no sedges or other aquatic flora present. Aquatic fauna would be unlikely to survive.

The vegetation mix, the lack of litter disturbance and the dry conditions, despite heavy antecedent rainfall, suggests that the drainage line is not a stream at this point.

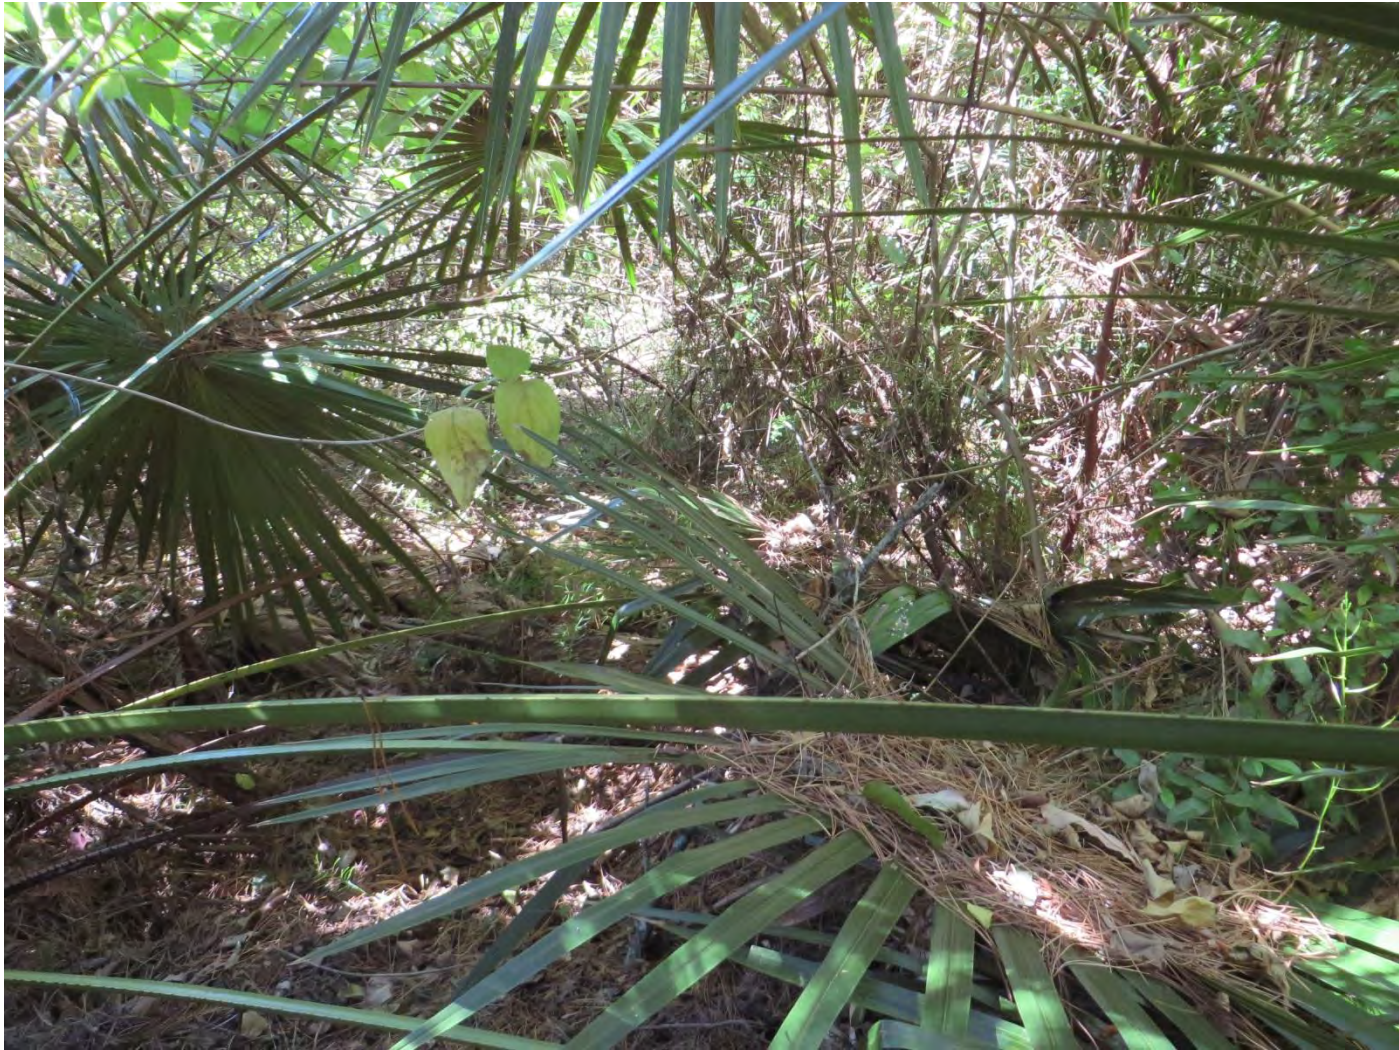
**Figure 12. AP 8.**

The photo below is taken of the drainage line approximately 23 m upslope of AP 7. Palms are the major vegetation along the gully floor. There is considerable litter fall. However this has not been mobilised by antecedent rainfall. This suggests that significant flows are extremely rare.

There are no sedges or other aquatic flora present. Aquatic fauna would be unlikely to survive.

The vegetation mix and dry conditions despite heavy antecedent rainfall suggests that the drainage line is not a stream at this point.

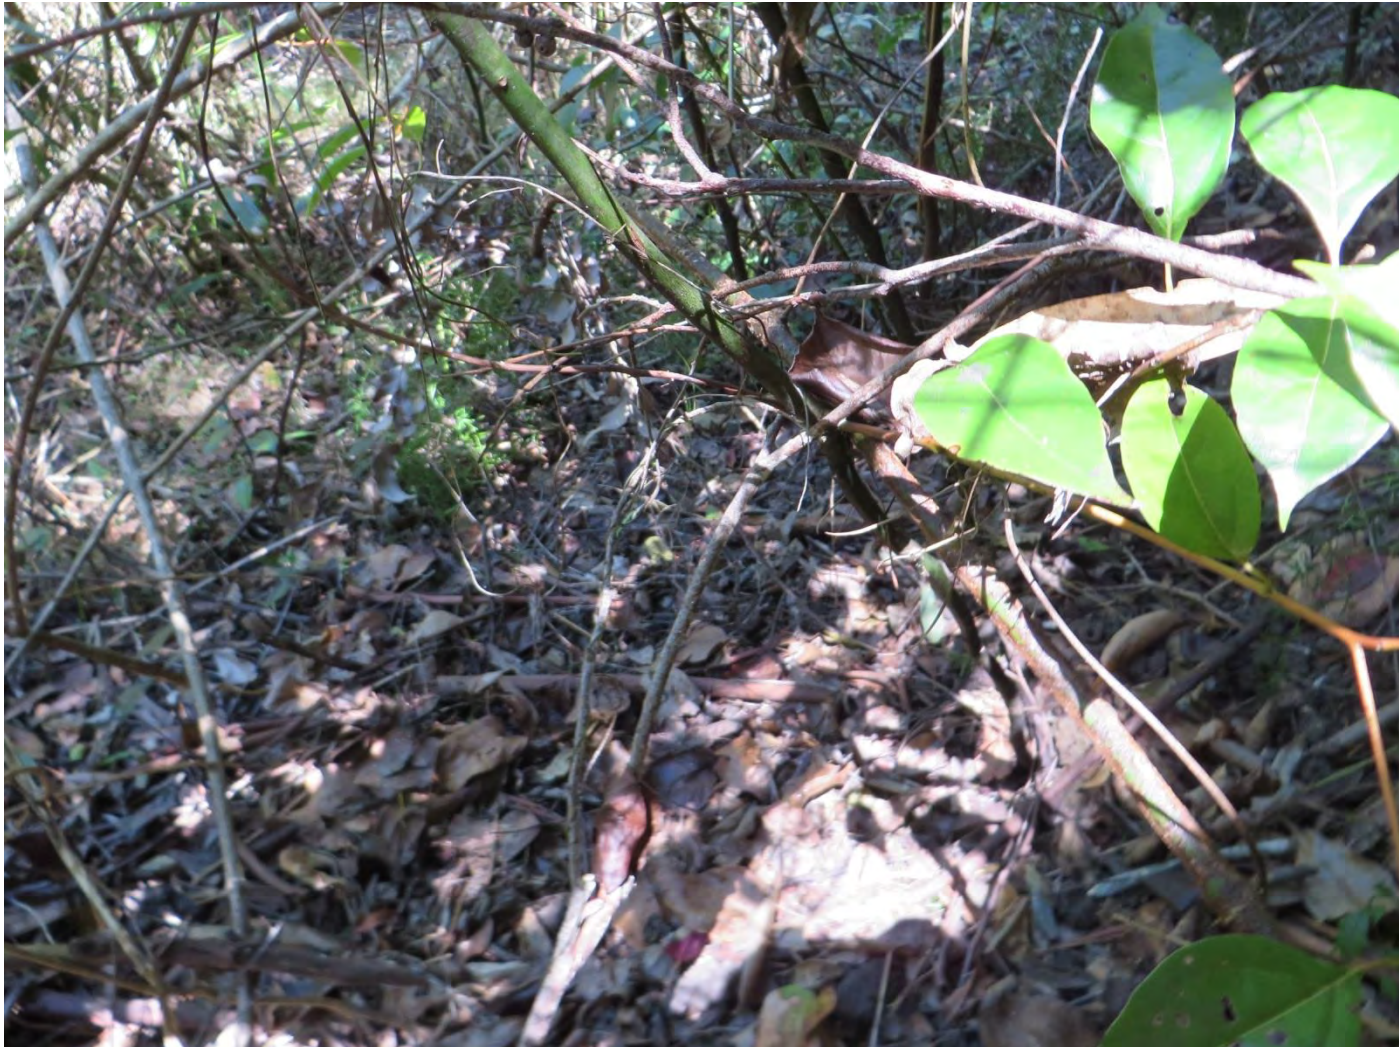
**Figure 13. AP 9.**

The photo below is taken of the drainage line approximately 40 m upslope of AP 8. There is almost no vegetation of the floor of the gully. There is a thick litter layer. There is also a considerable mass of loose soil. However neither the soil nor the litter show signs of mobilisation despite recent heavy rainfall. This suggests that significant flows are extremely rare.

There are no sedges or other aquatic flora present. Aquatic fauna would be unlikely to survive.

The vegetation mix and dry conditions despite heavy antecedent rainfall suggests that the drainage line is not a stream at this point.

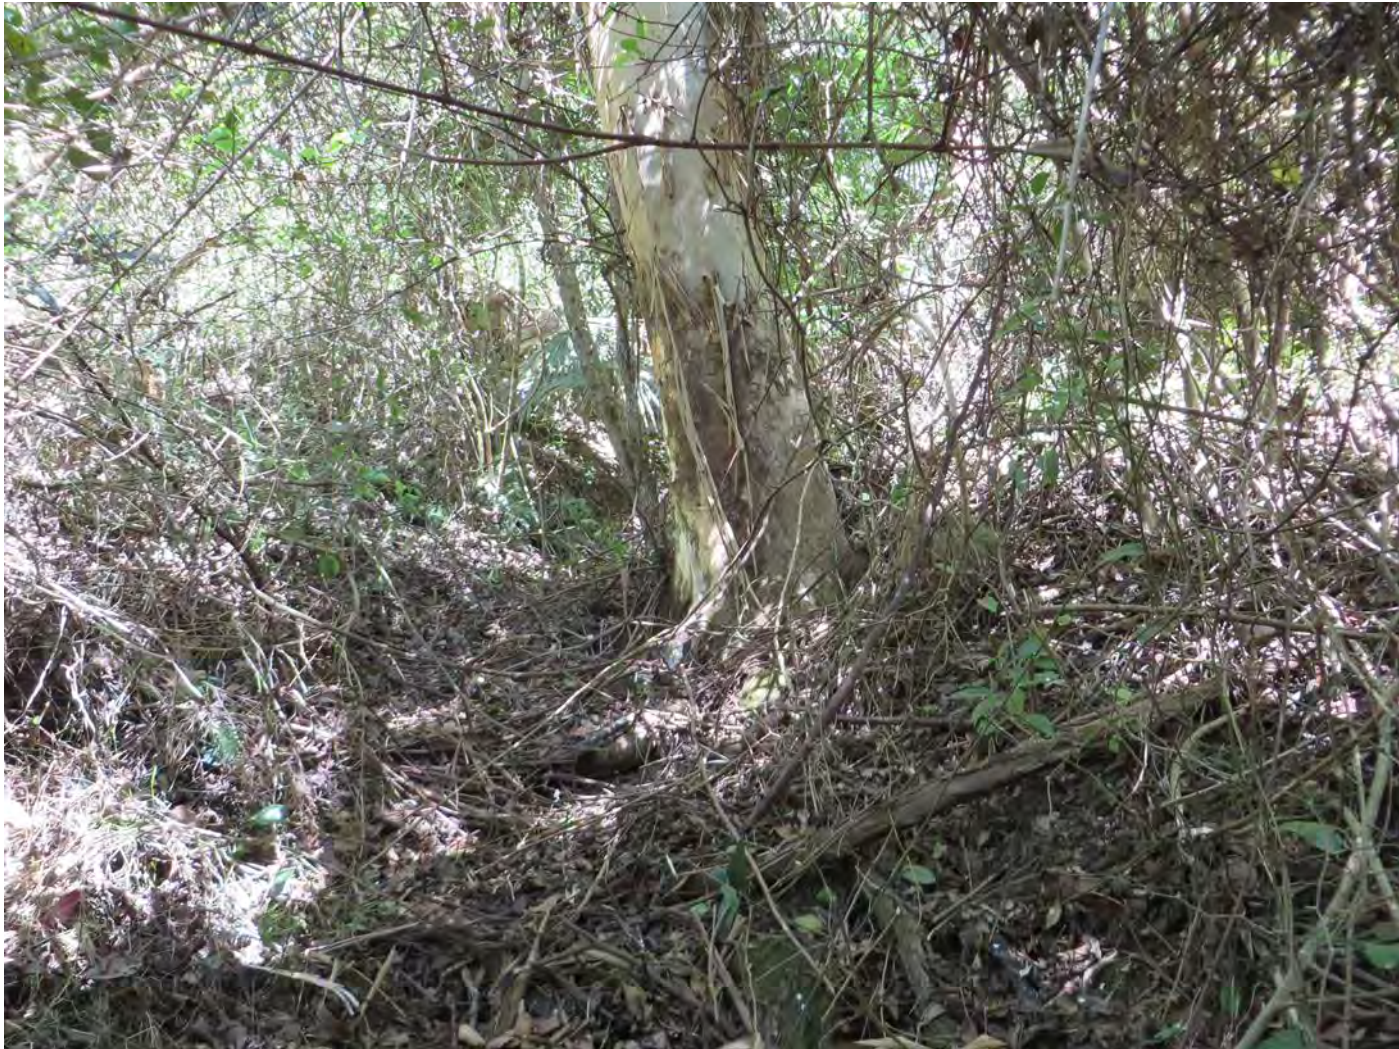
**Figure 14. AP 10.**

The photo below is taken of the drainage line upslope of AP 9. There is a thick litter layer adjacent to a Sydney Blue Gum tree. However, there is no defined bed and banks, possibly because of the slope is very steep. There are no sedges or other aquatic flora present. Aquatic fauna would be unlikely to survive.

The vegetation mix and dry conditions despite heavy antecedent rainfall suggests that the drainage line is not a stream at this point.

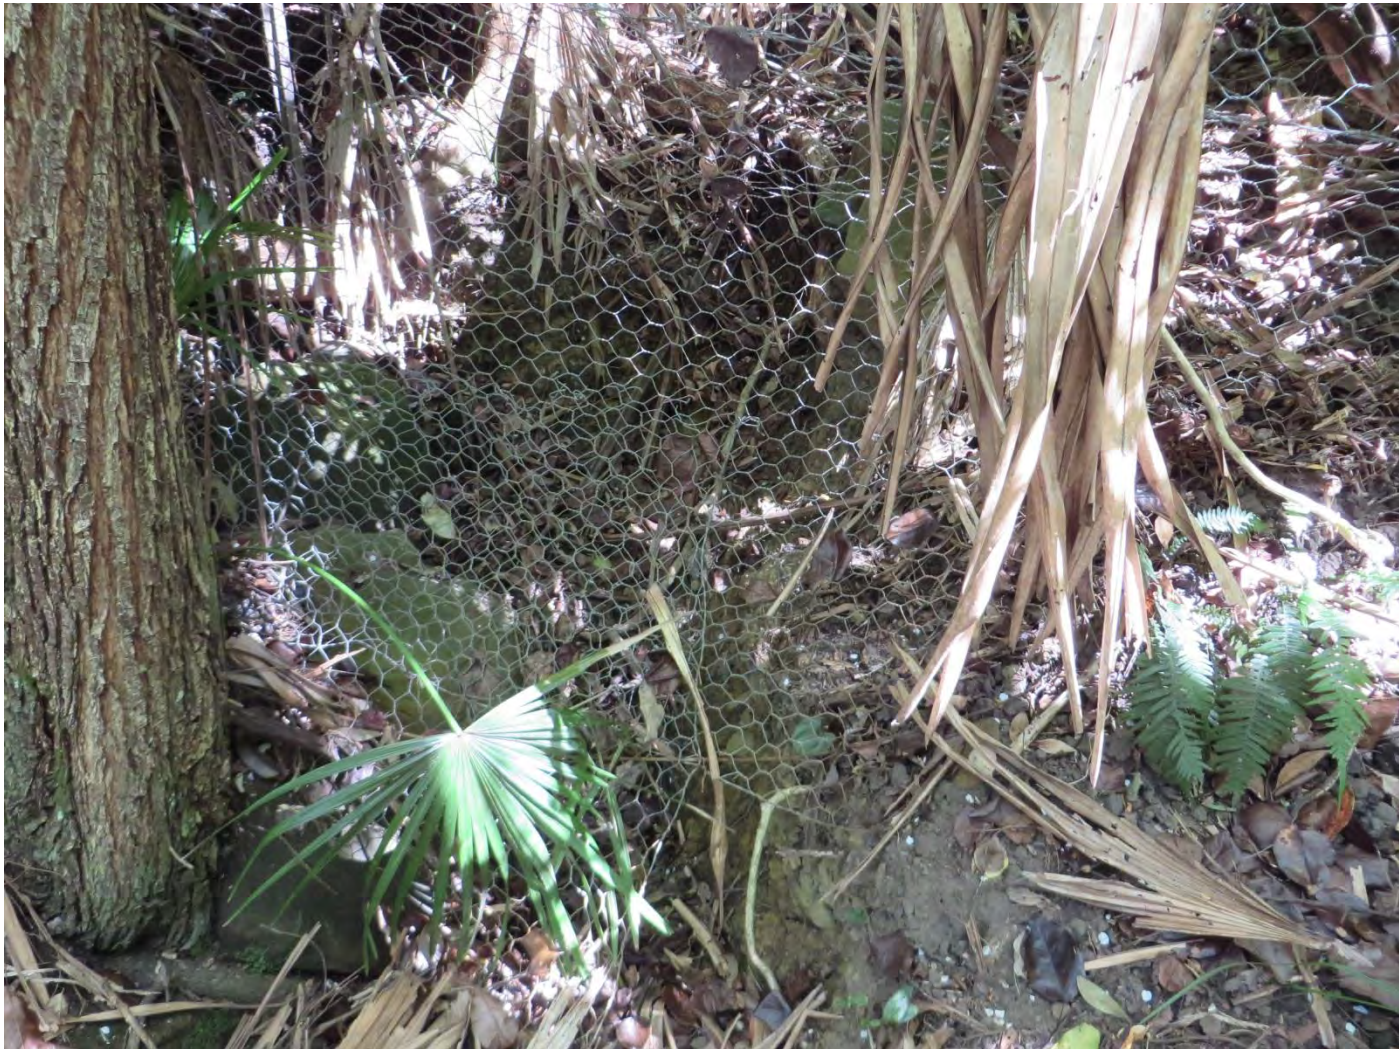
**Figure 15. AP 11.**

The photo below is of the drainage line some 23 m upslope of AP 10. There is a considerable area of bare earth, however there is no litter against the chicken wire fence (see below). This suggests there has been little or no flow in recent times.

There are a few ferns and palms on the floor of the gully, however there are no aquatic sedges. Aquatic fauna are unlikely to survive in this portion of the gully.

The vegetation mix and dry conditions despite heavy antecedent rainfall suggests that the drainage line is not a stream at this point.
