# Narara Eco Village

## Water Reservoir

### Initial Sampling Report

Appendix 4.1.1.1  
A0072

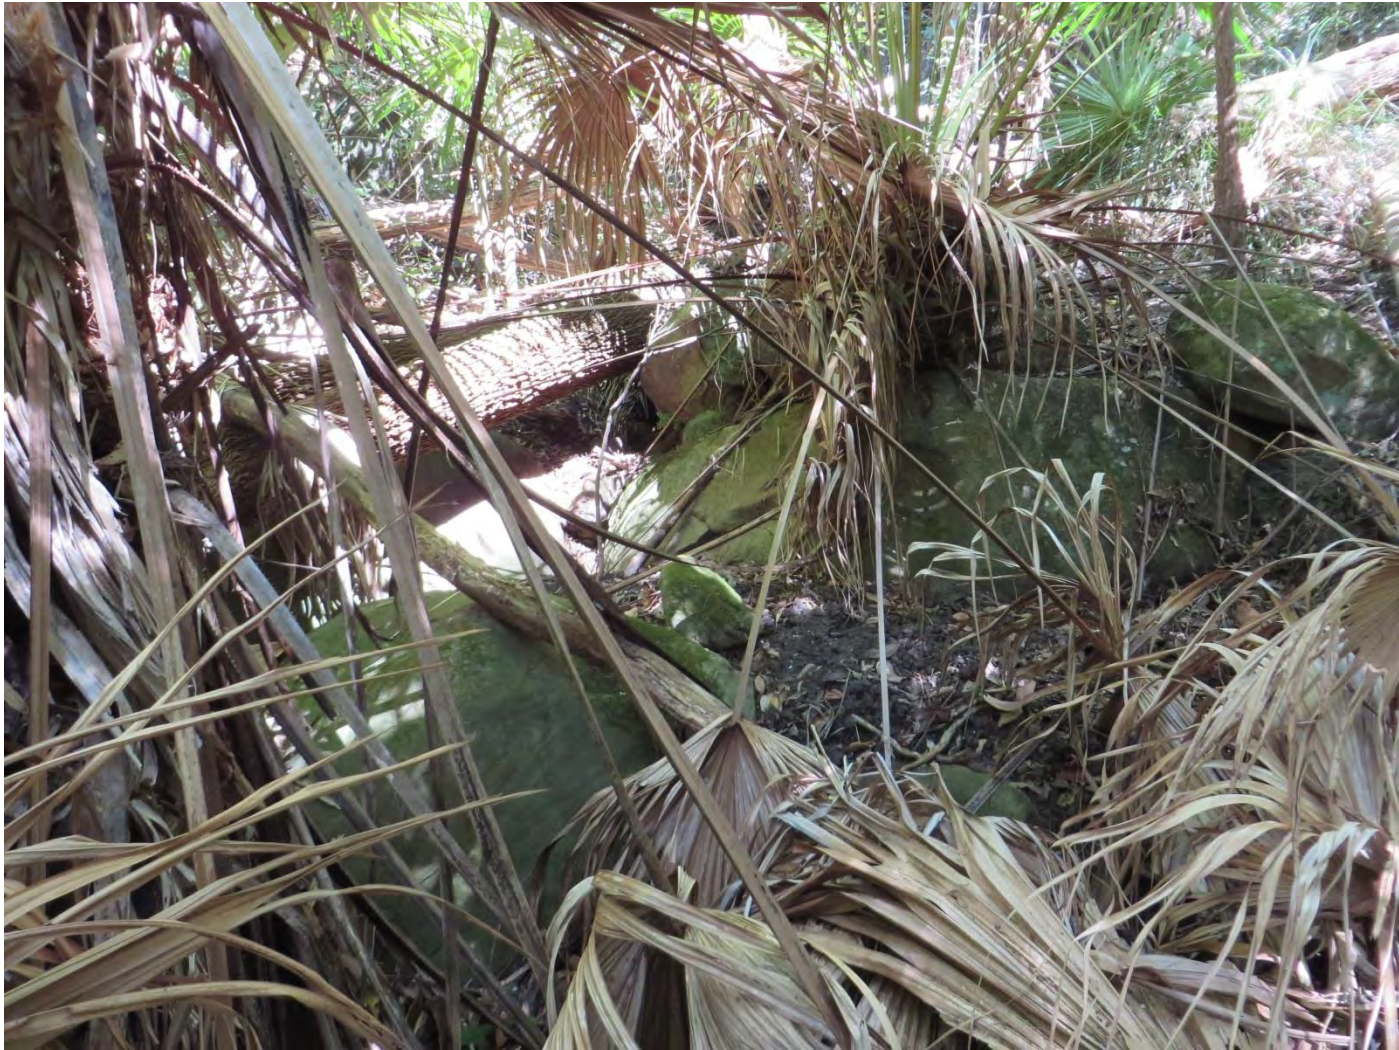
**Figure 167. AP 12.**

The photo below is of the drainage line in the 'forest' upslope of AP 11. The drainage line 'bed' consists of smooth boulders. There is litter on the ground among the boulders. This litter has not been mobilised by recent rainfall runoff. This suggests there has been little or no flow in recent times.

The vegetation is largely palms. There are no aquatic sedges. Aquatic fauna are unlikely to survive in this portion of the gully.

The vegetation mix and dry conditions despite heavy antecedent rainfall suggests that the drainage line is not a stream at this point. Any flow would need to be conveyed around the boulders. However there is no evidence of scouring or litter pack development and mobilisation.

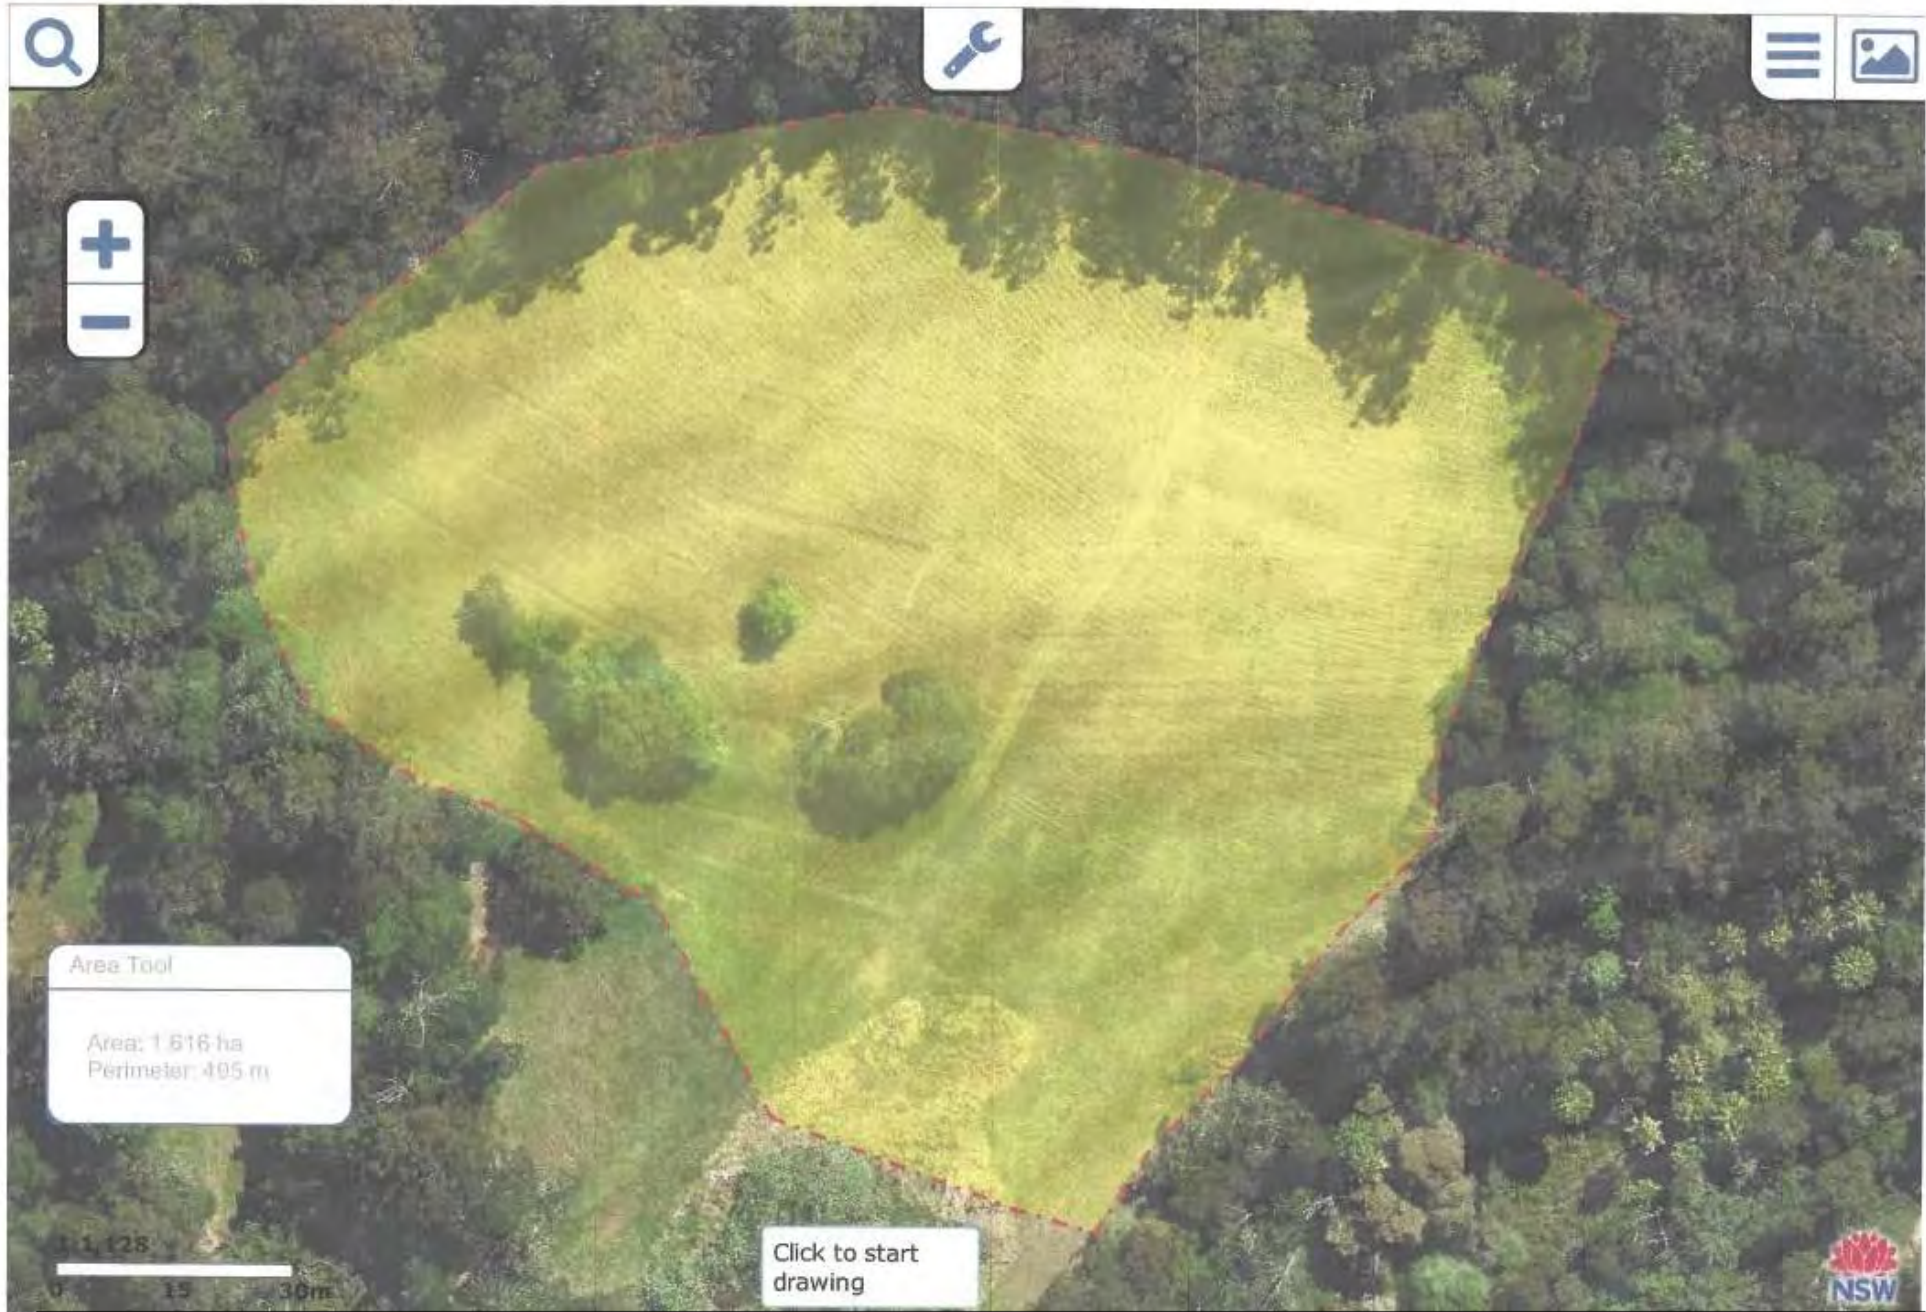
The figure below indicates that this area can be accommodated within the middle rural lot on the left hand side of Narara Creek.

Figure 5.2. The maximum area available for effluent irrigation in the middle lot is 1.62 ha. (Image source: NSW Government).

$23.75 \text{ cubic m/day} / 0.0015 \text{ m /day irrigation rate} = 15,833 \text{ msq of irrigation.}$
