Process Flow Diagram of Kurrajong Hamlet Water Treatment Plant

'On-site Wastewater Management Report'

Lot 19 Vincent Rd., KURRAJONG, NSW

Report No.: REP-21408-A

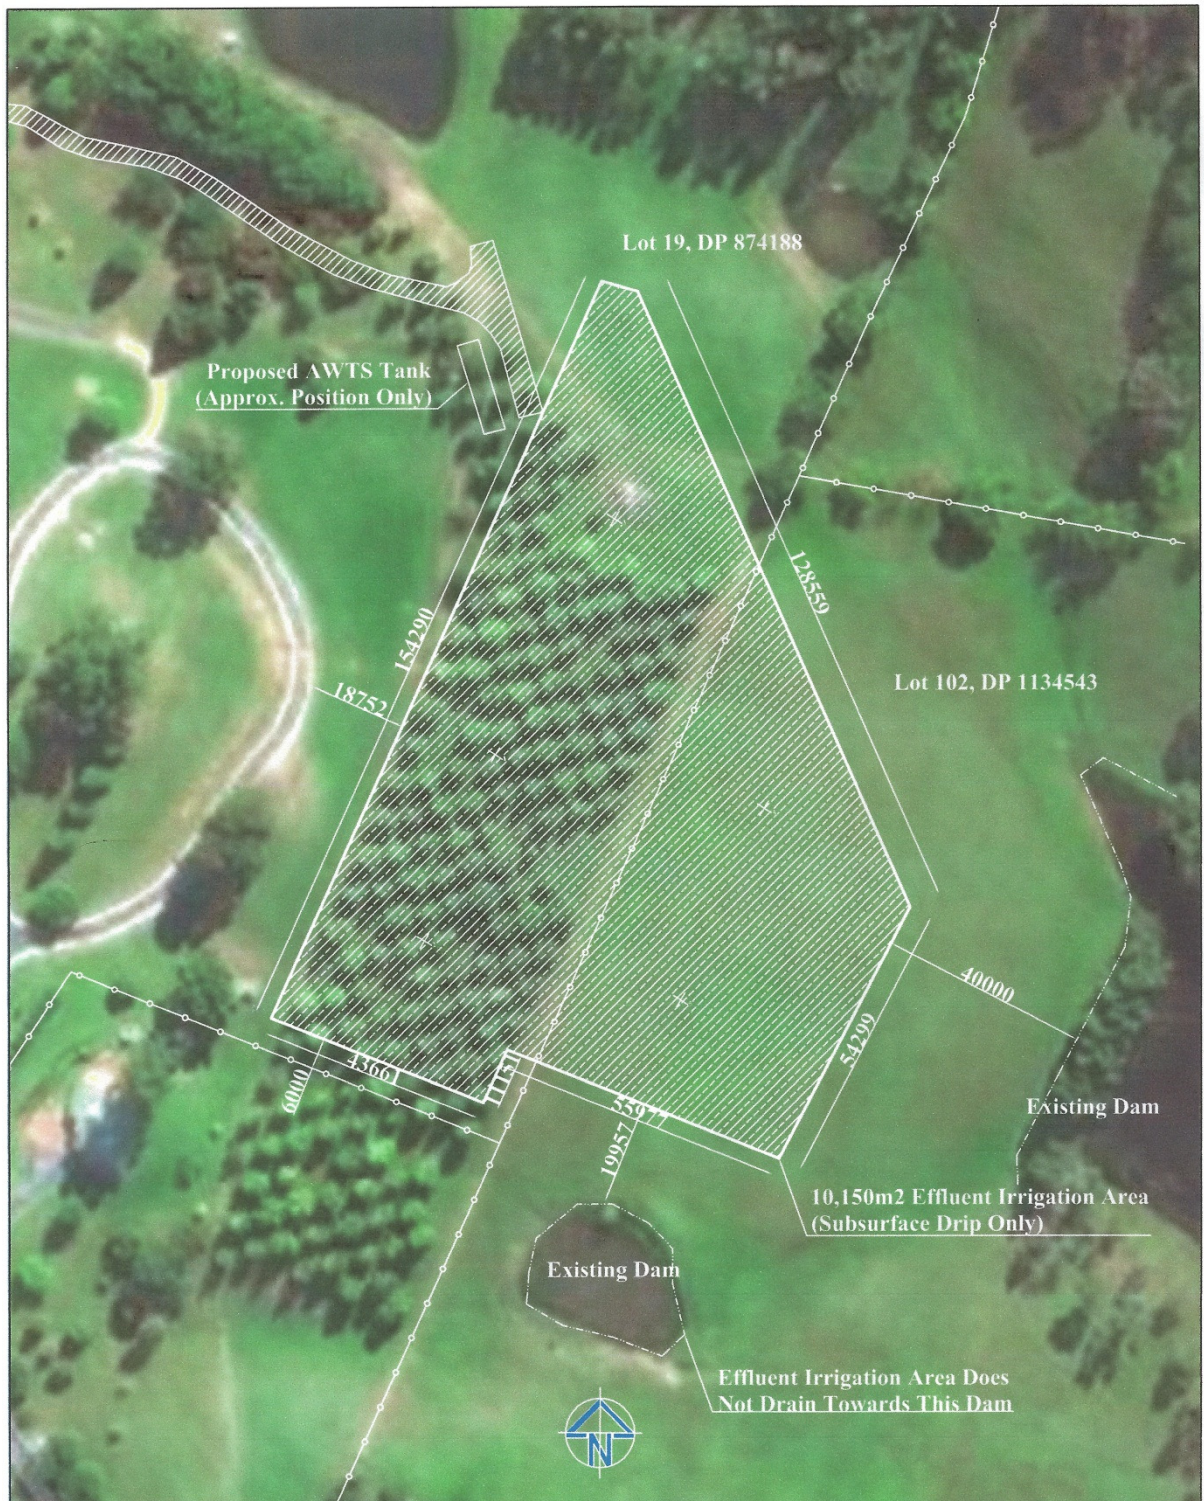
Figure 1.2. Detail of irrigation area (Source :Envirotech, 2012).

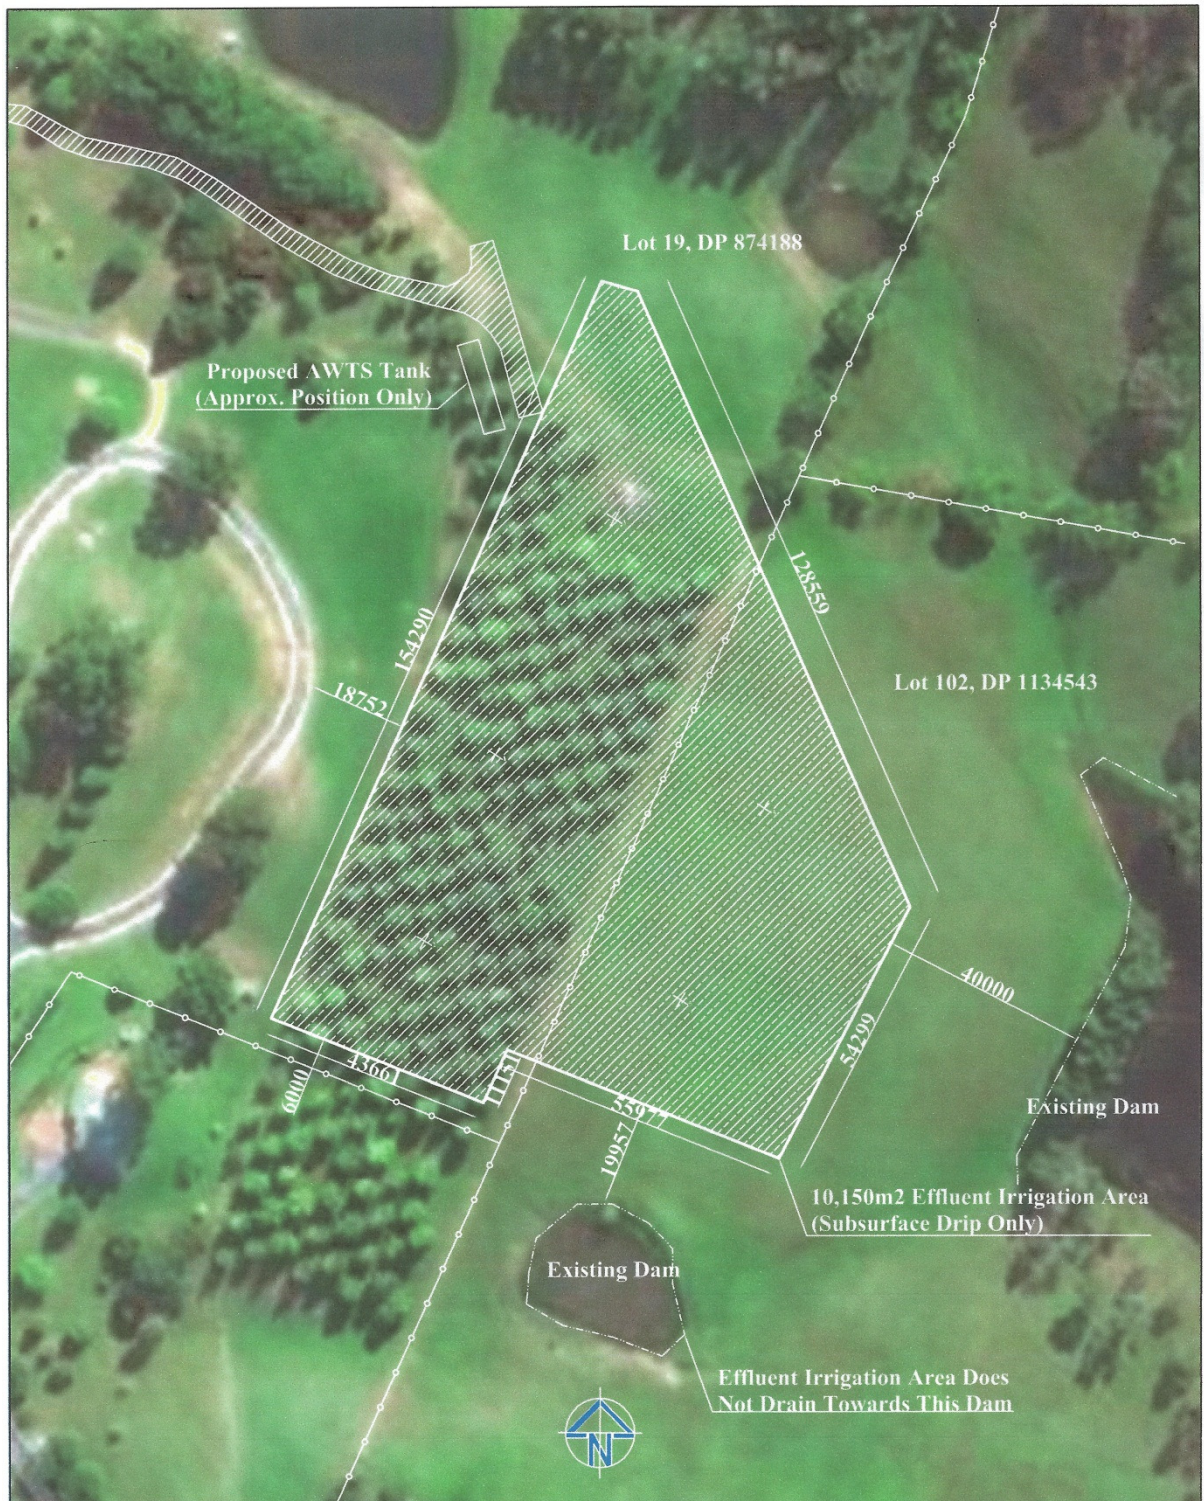
Figure 1.2. Detail of irrigation area (Source :Envirotech, 2012).
