Correct Planning & Consultation for Mayfield Group

Draft Decision released for NSW Rail Access Undertaking

Complaint from CPCFM

Additional Information and evidence to support our formal complaint.

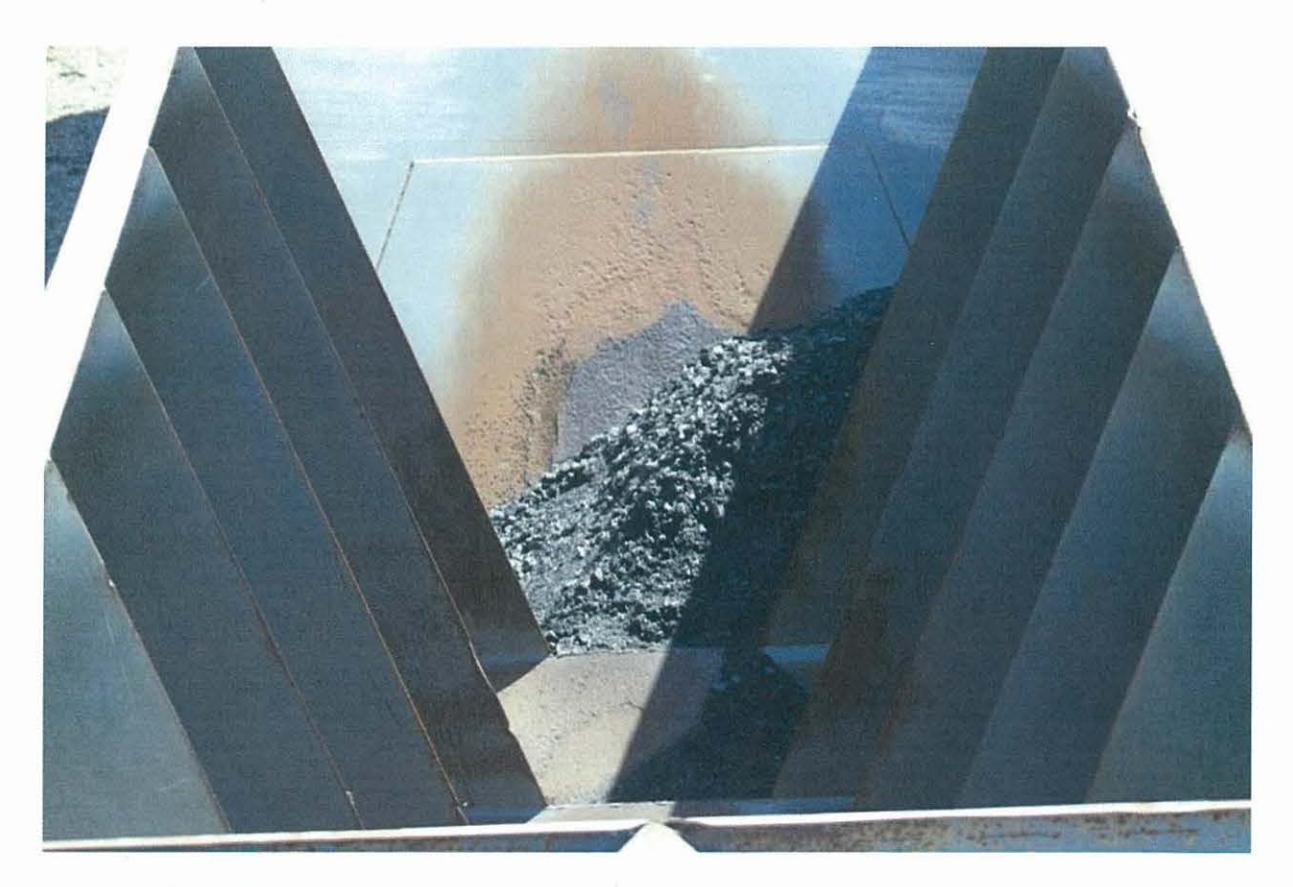
13 / 10 /2013 Carrington.

23/10/2013 Selwyn St3/11/2013 Selwyn StPhoto showing no freeboard and coal pouring down the wagon side.

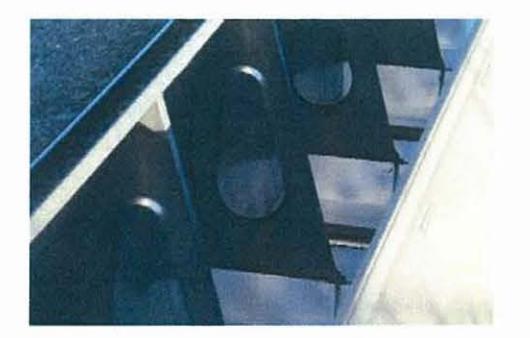
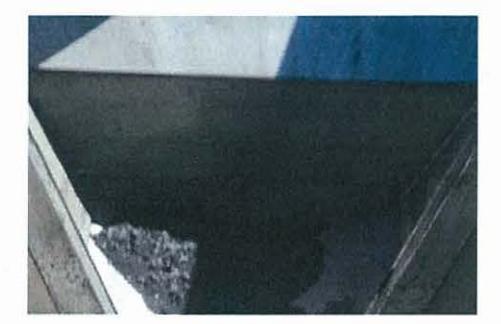
The excessive loading of a coal wagon to the point where the load pours down the side of the wagon could only be described as irresponsible. This material once in the corridor is free to flow into our streams and rivers or for the smaller particles to be recirculated into the atmosphere.
