# Preliminary Site Investigation

## **Rosehill Recycled Water Scheme Extension**

Smithfield, Wetherill Park and Horsley Park, NSW

**Project No. 25284**

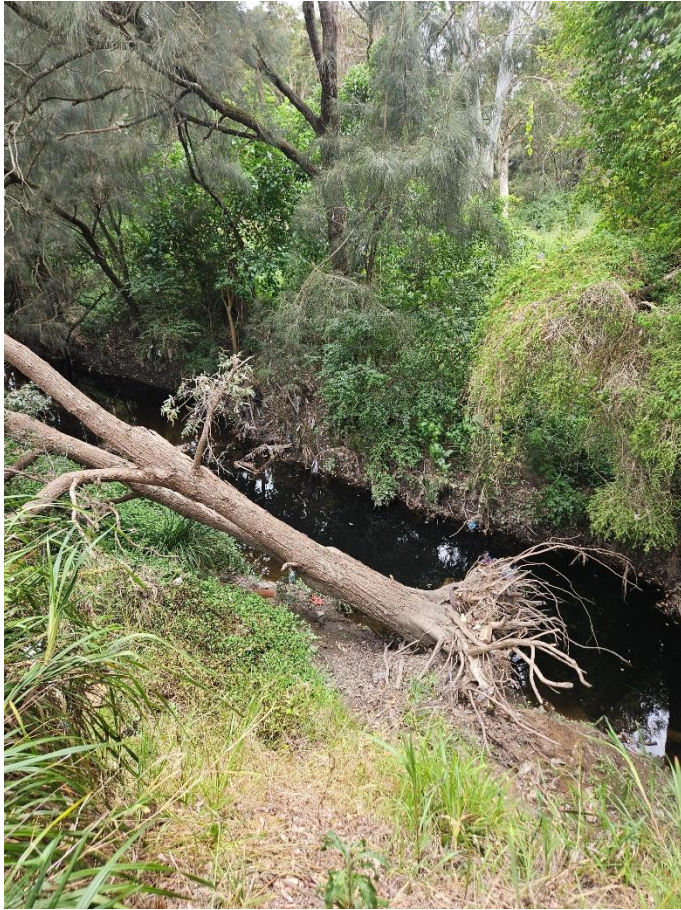
Latitudem Longitude: -33.8544189, 150.9469938

**Photo Description: Fallen tree, evidence of severe bank erosion.**

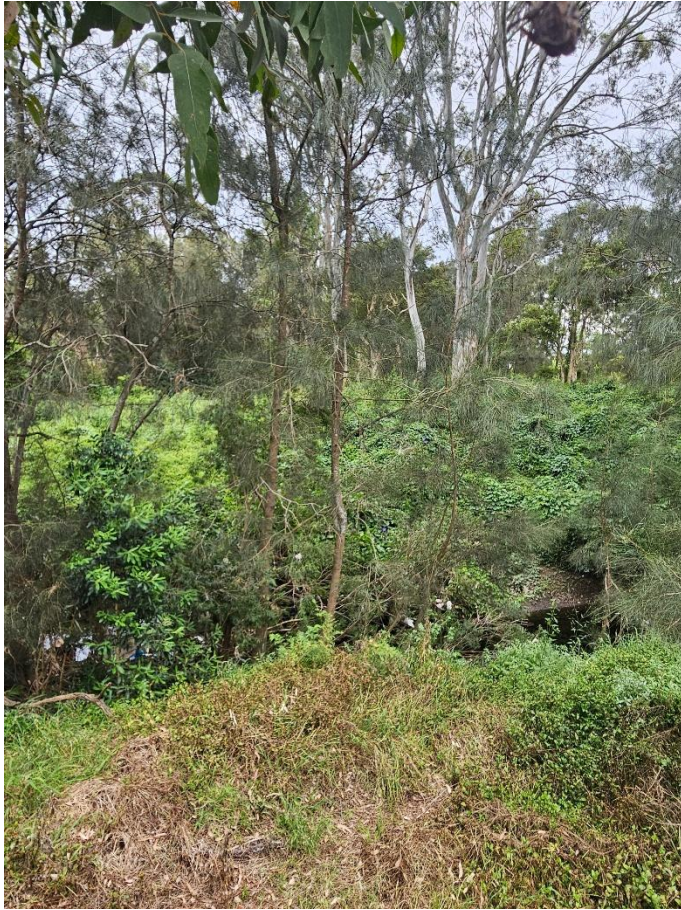
Latitudem Longitude: -33.8537889, 150.9475688

**Photo Description: Extensive weed growth**

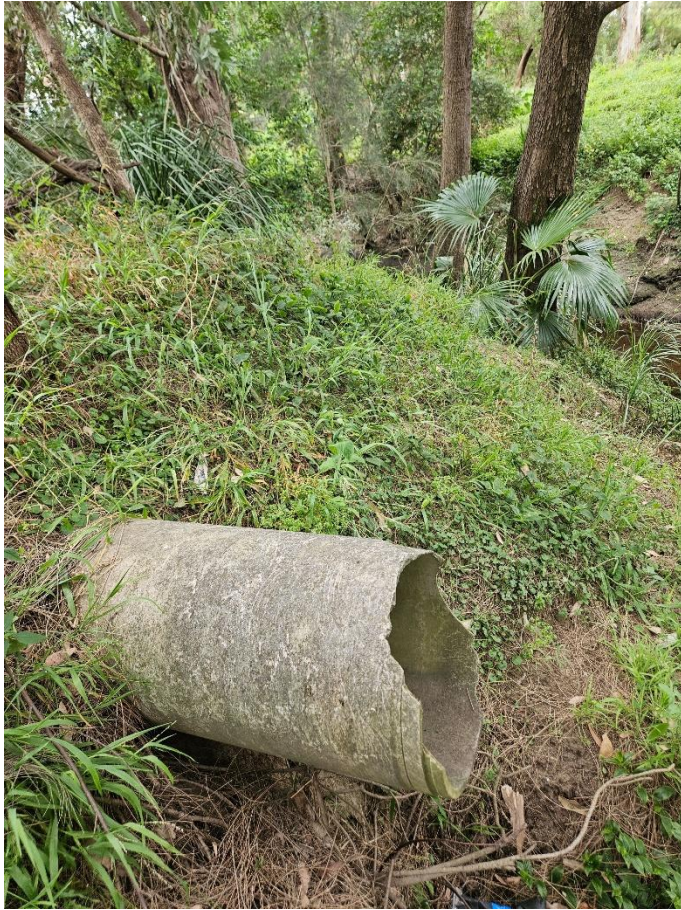
Latitudem Longitude: -33.8516977, 150.9449072

**Photo Description: Derelict PACM stormwater outlet**

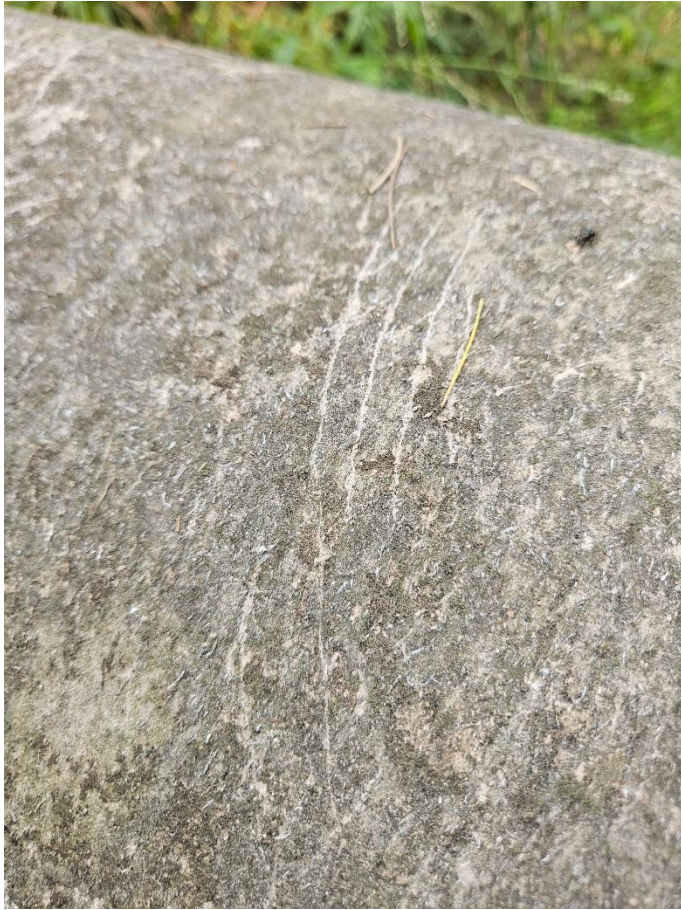
Latitude Longitude: -33.8517035, 150.9449110

**Photo Description: Derelict PACM stormwater outlet surface**

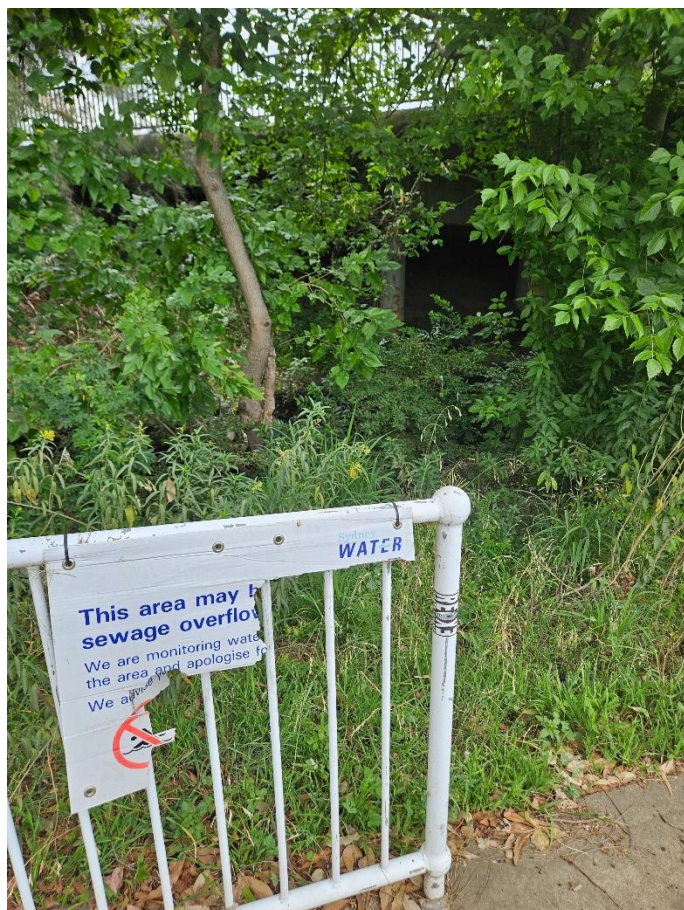
Latitudem Longitude: -33.8503837, 150.9451177

**Photo Description: Sewage overflow contributes to the creek**

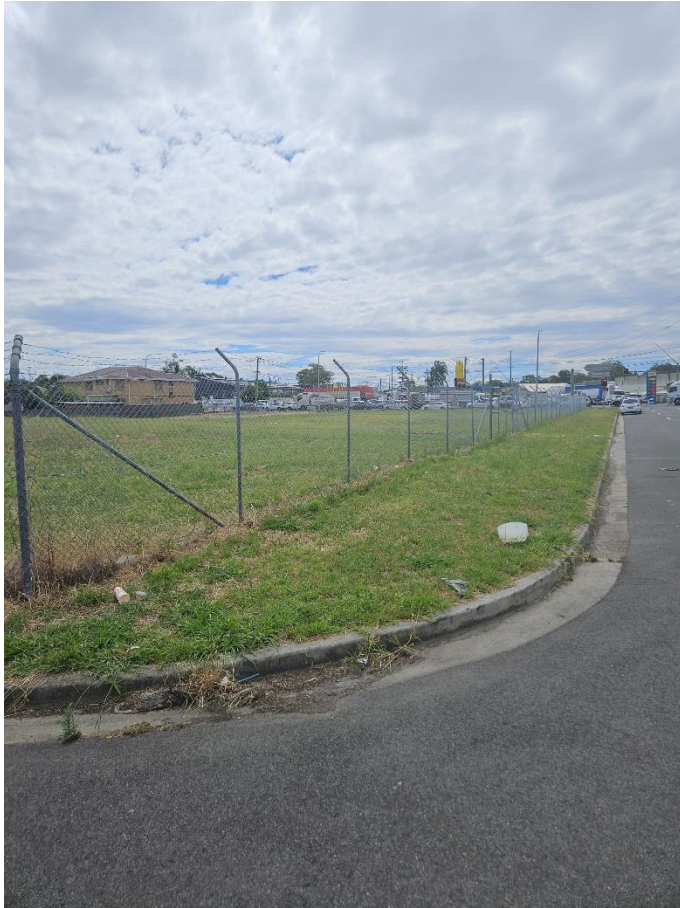
**Photo Description: Potential pump station site**

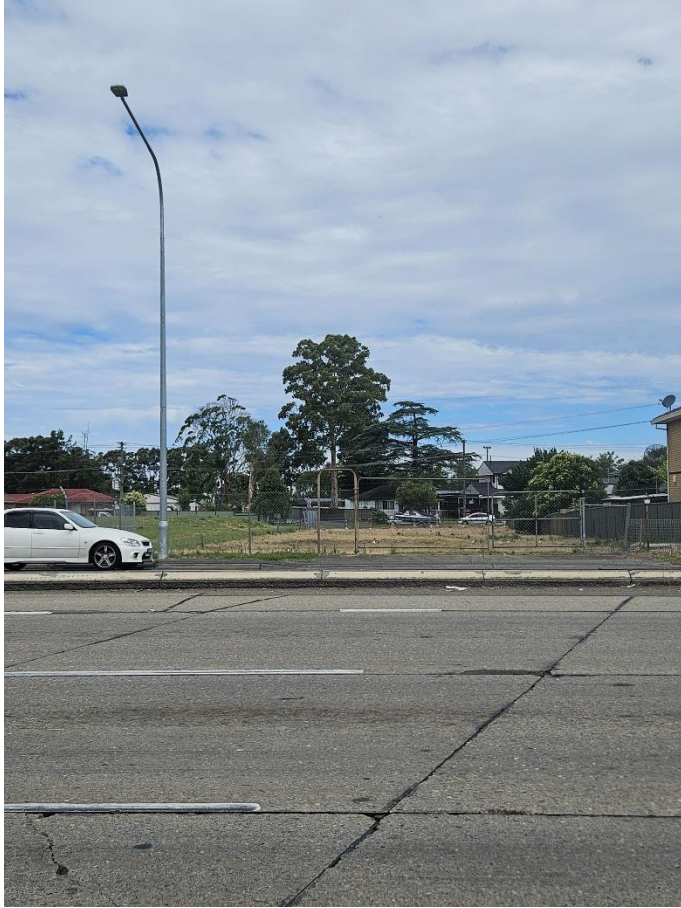
**Photo Description: Illegal dumping outside of fence**

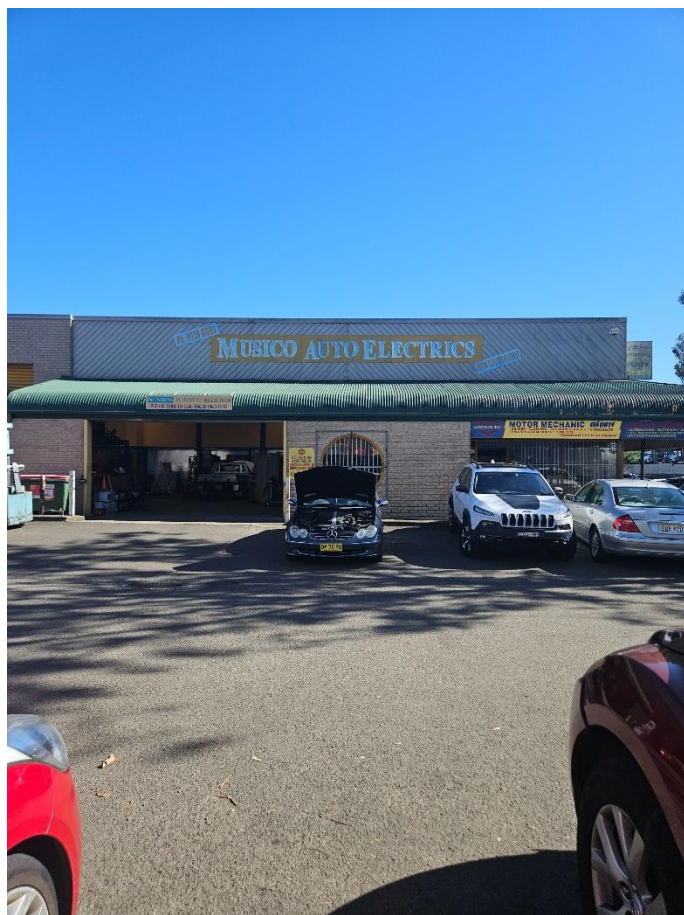
**Photo Description: Mechanic business located in carpark of Smithfield Square**

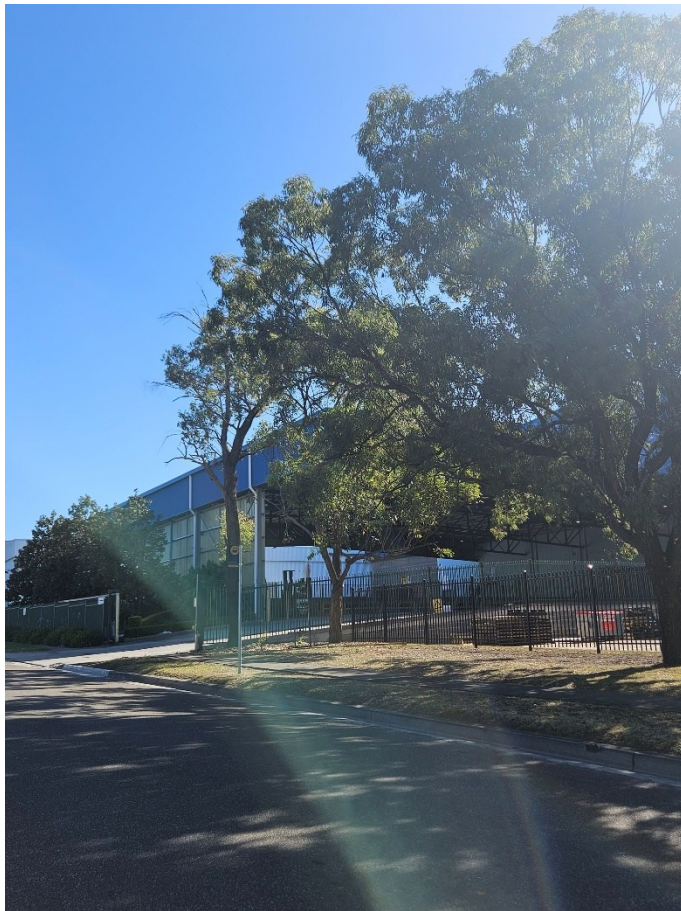
**Photo Description: ABC Tissue Products**

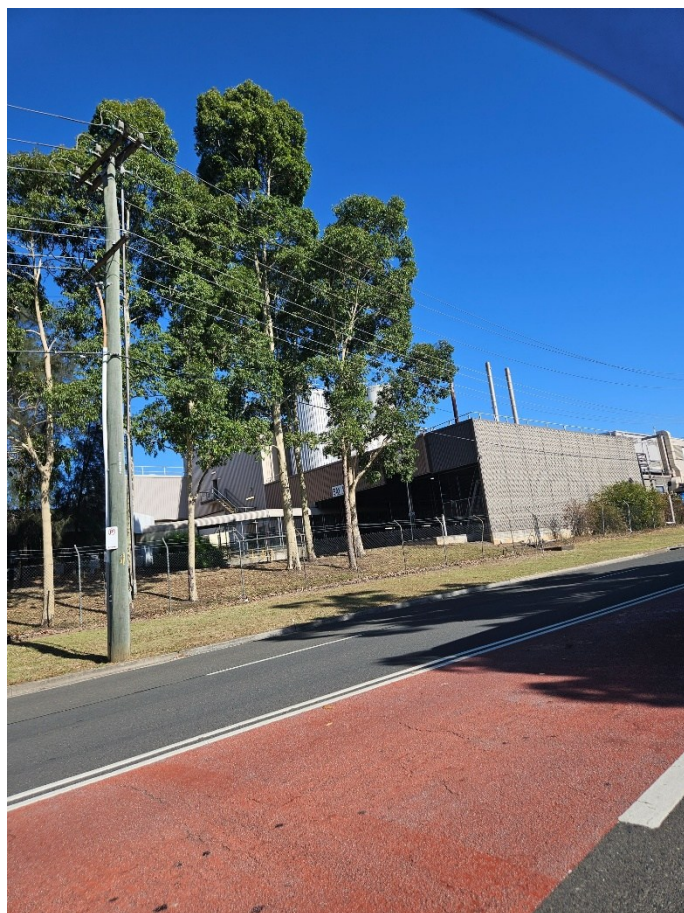
**Photo Description: Bega facility**

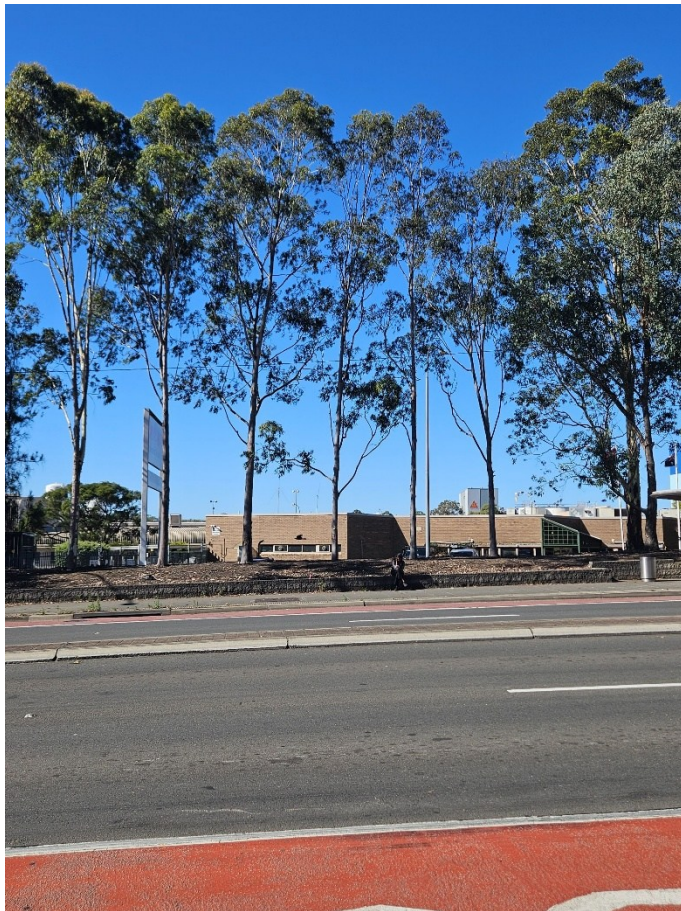
**Photo Description: ASTs at BOC facility**

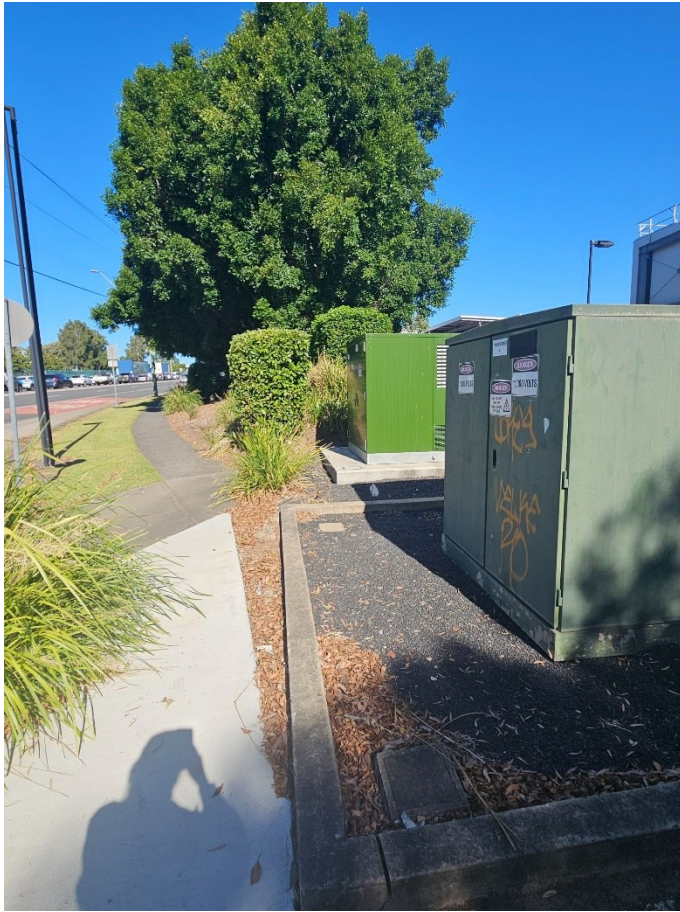
Photo Description: Transformers x2 outside Bega facility

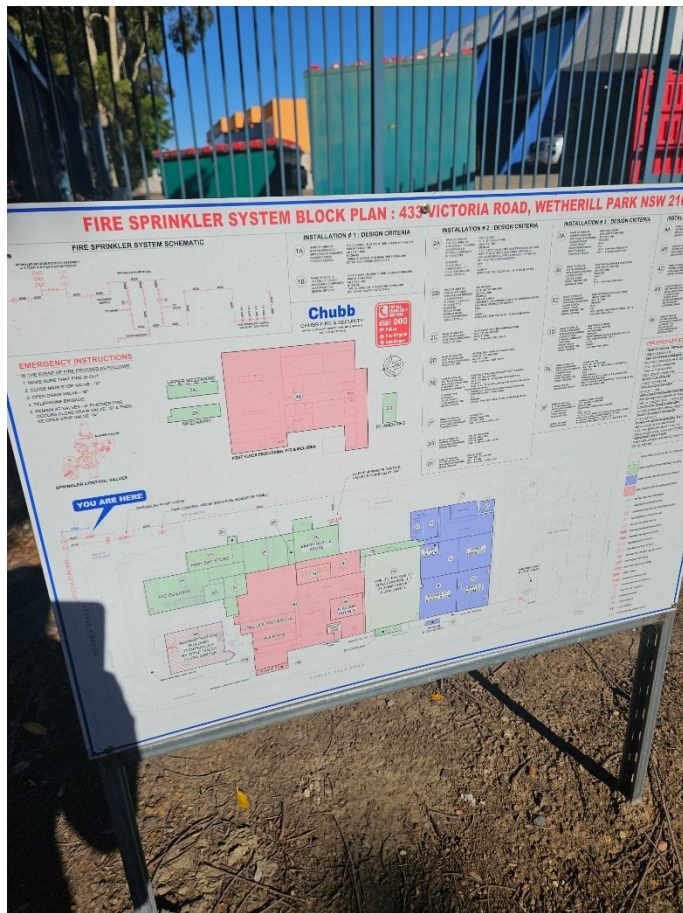
**Photo Description: Bega facility fire plan**

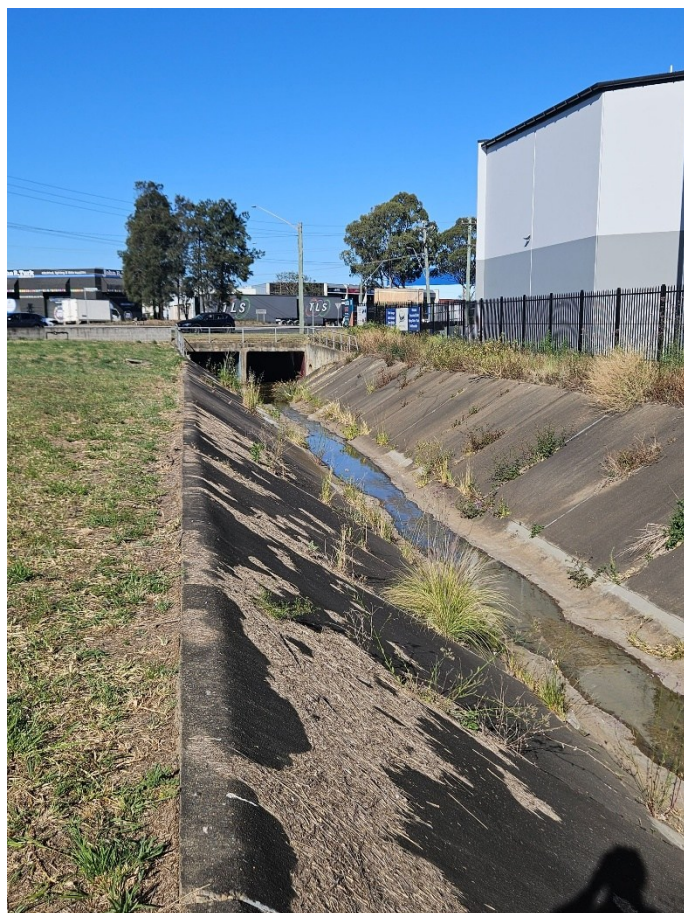
**Photo Description: Concreted drainage channel flowing north to the Victoria St two lane roundabout**

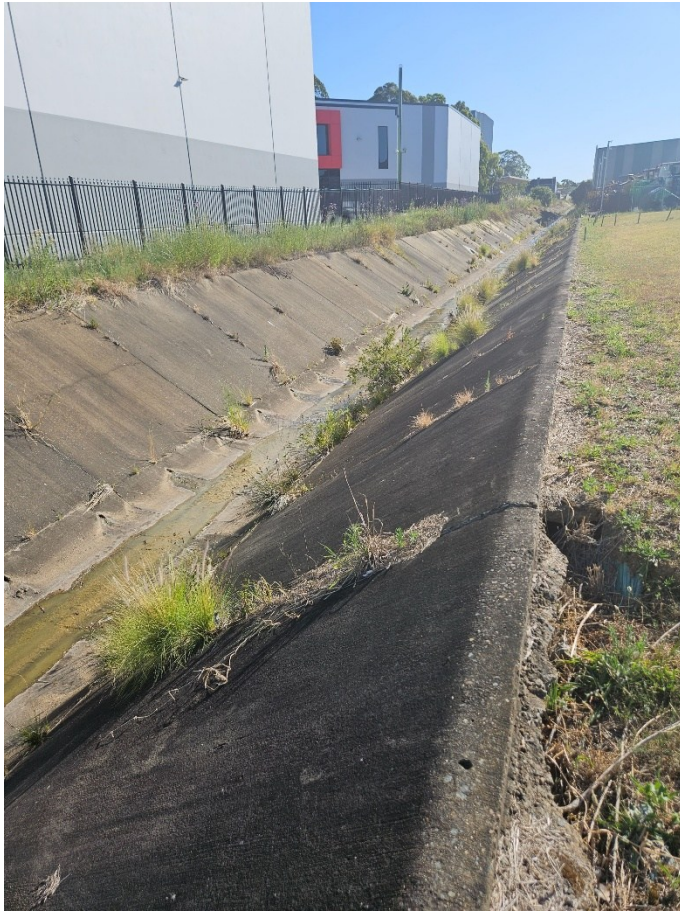
**Photo Description: Stormwater drainage channel, Southwest facing**

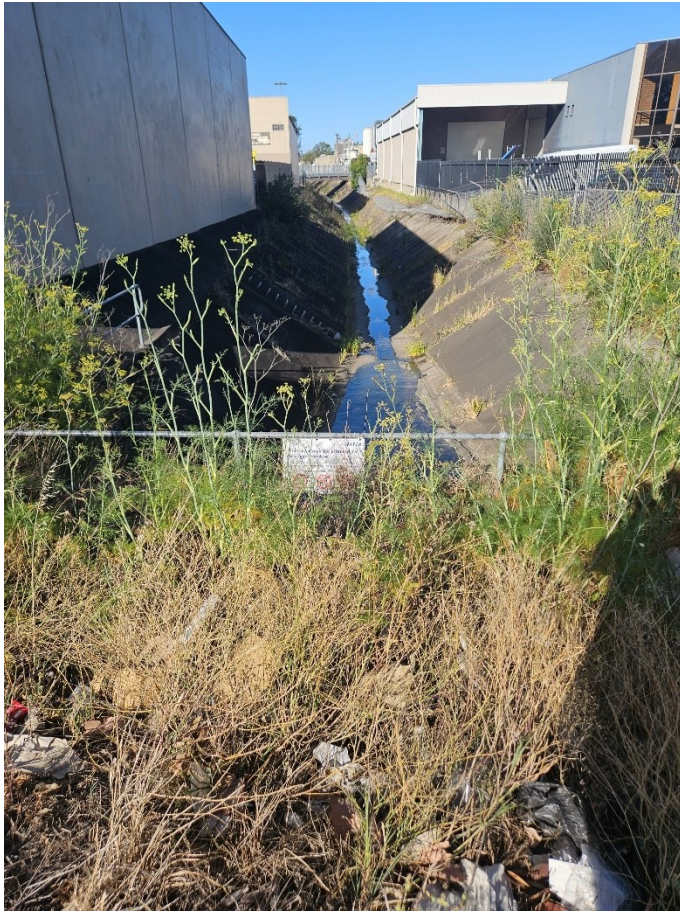
**Photo Description: Drainage channel, sign warning of sewage overflow, fence torn down, BOC adjacent the channel in the background, direction facing north-east.**

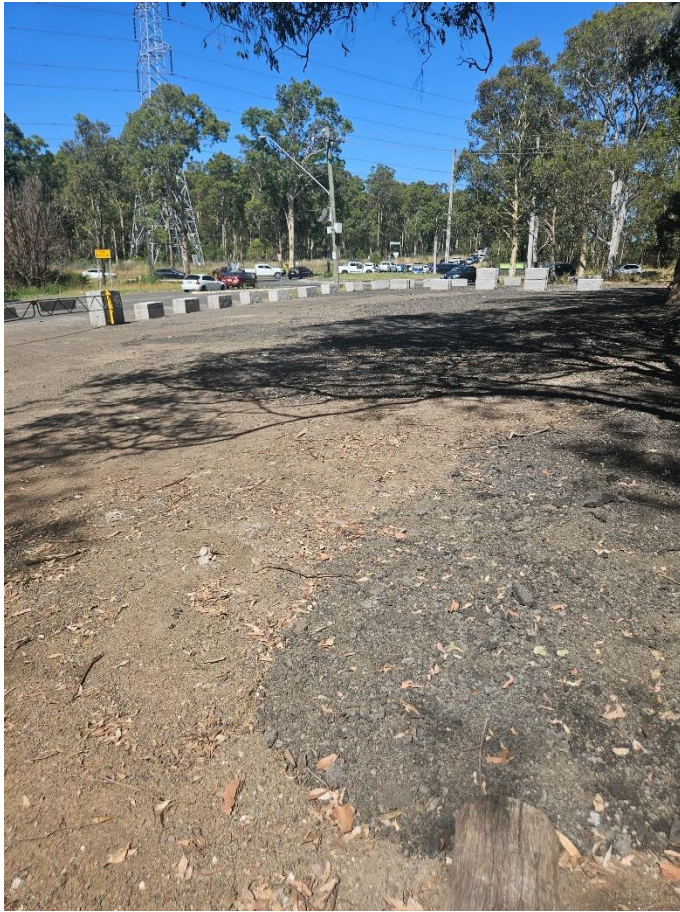
**Photo Description: Sealed turnaround bay adjacent roundabout, evidence of fill.**

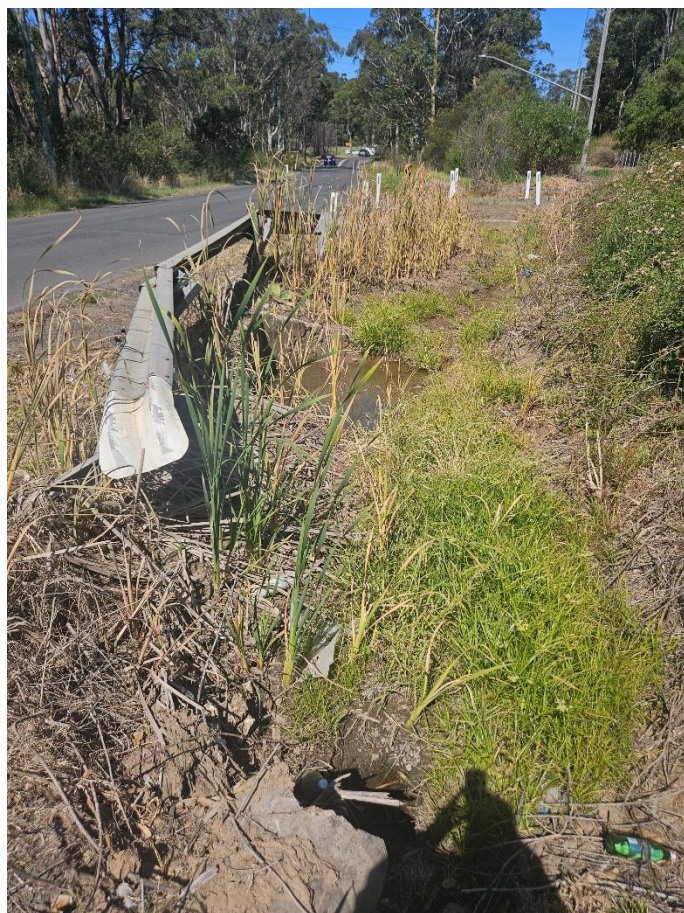
**Photo Description: Offside, Stagnant drainage channel with stormwater input**

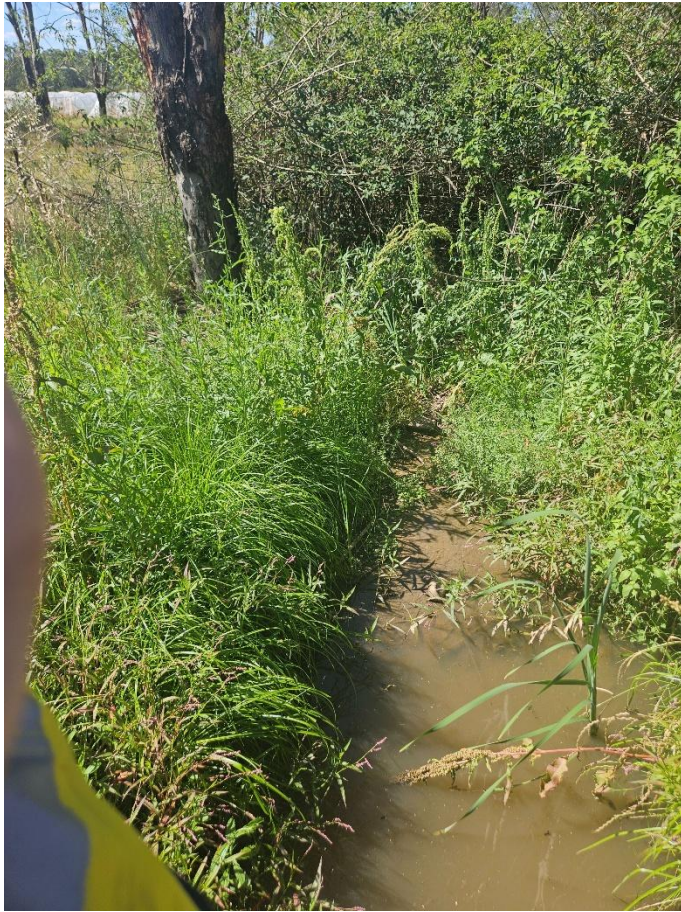
**Photo Description: Offside Stagnant surface Water under Chandos Rd (to the west)**

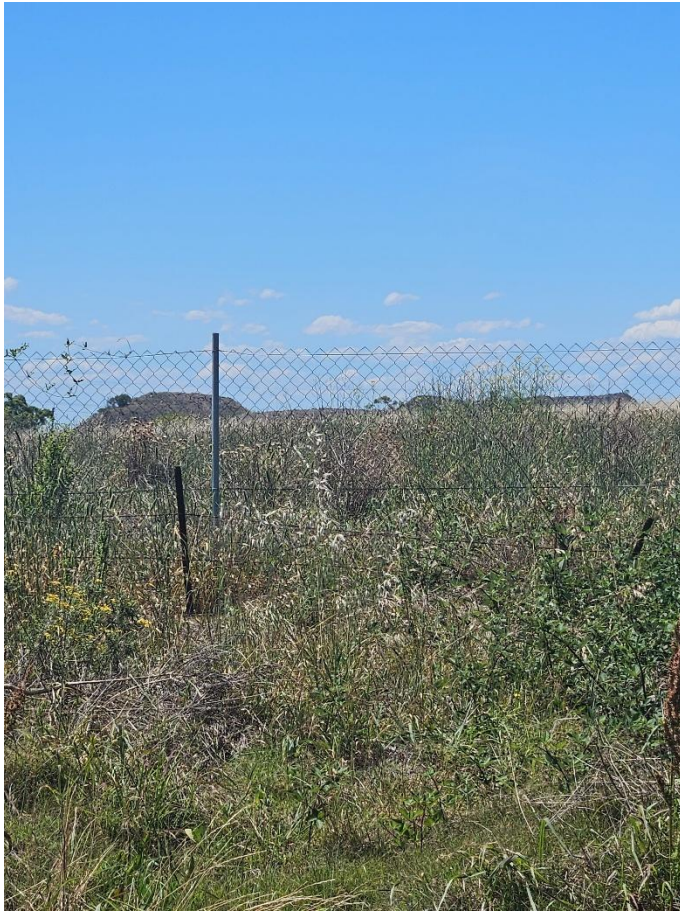
**Photo Description: Stockpiling at adjacent property to the north**

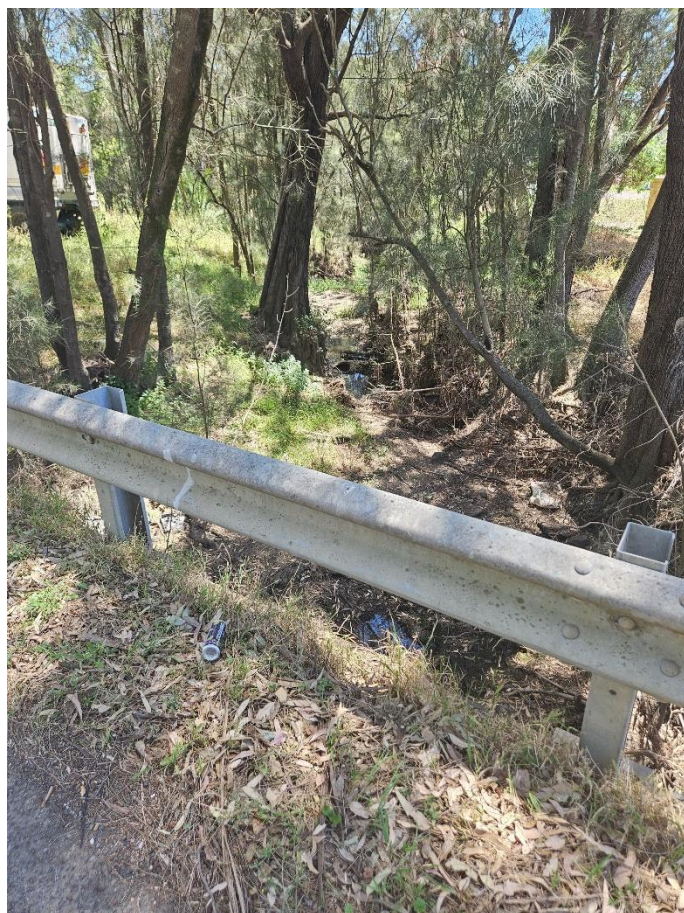
**Photo Description: Reedy Ck (east branch) looking north, discontinuous with debris present but no other indicators of contamination.**

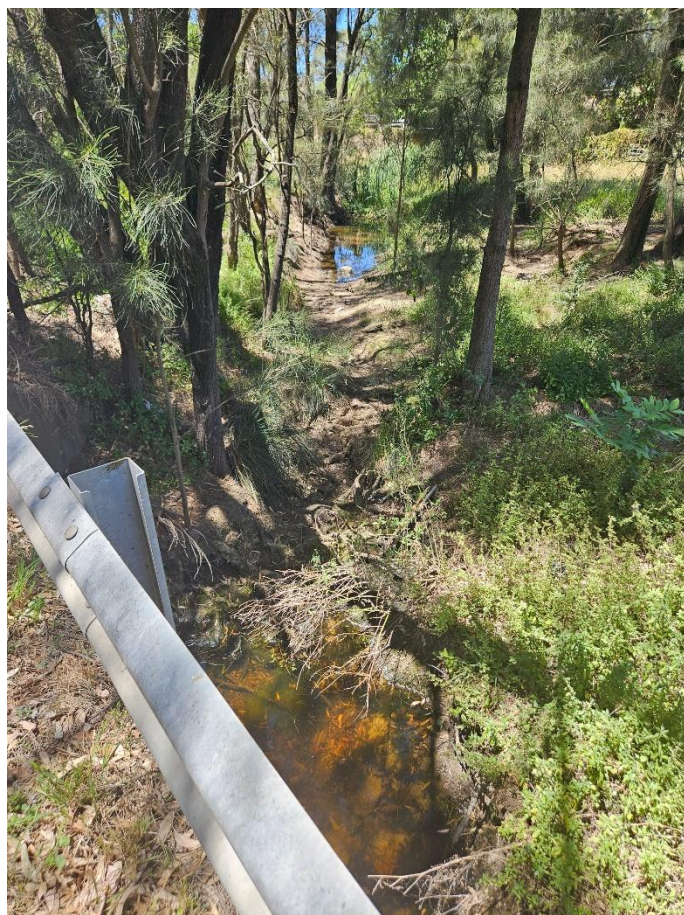
**Photo Description: Reedy Ck looking south from Burley St, stagnant and discontinuous**

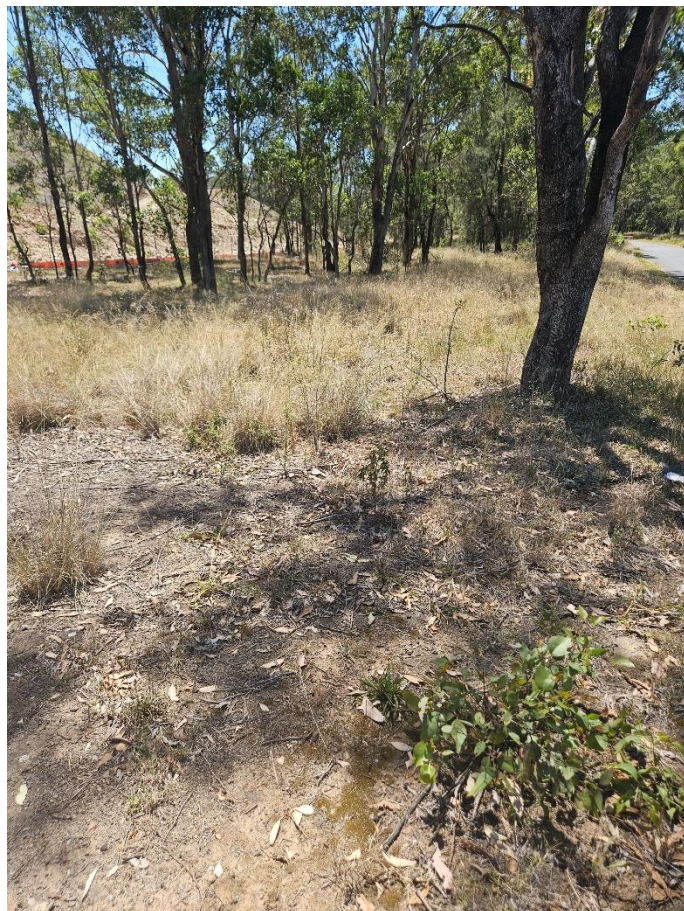
**Photo Description: Bushland with some concrete, beyond which is an adjacent stockpiled with goats**

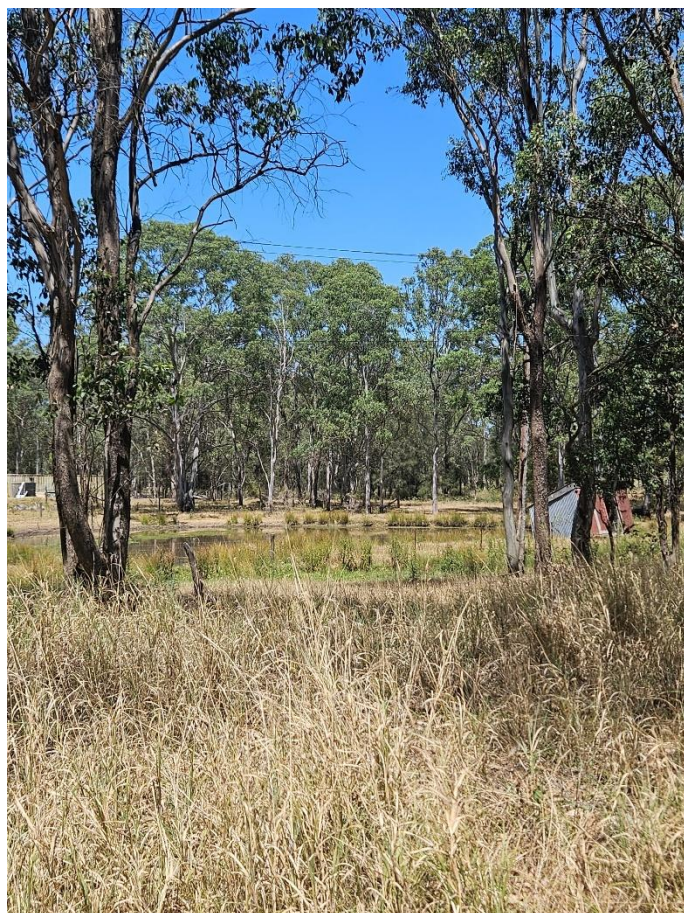
**Photo Description: Private dam with algal growth**

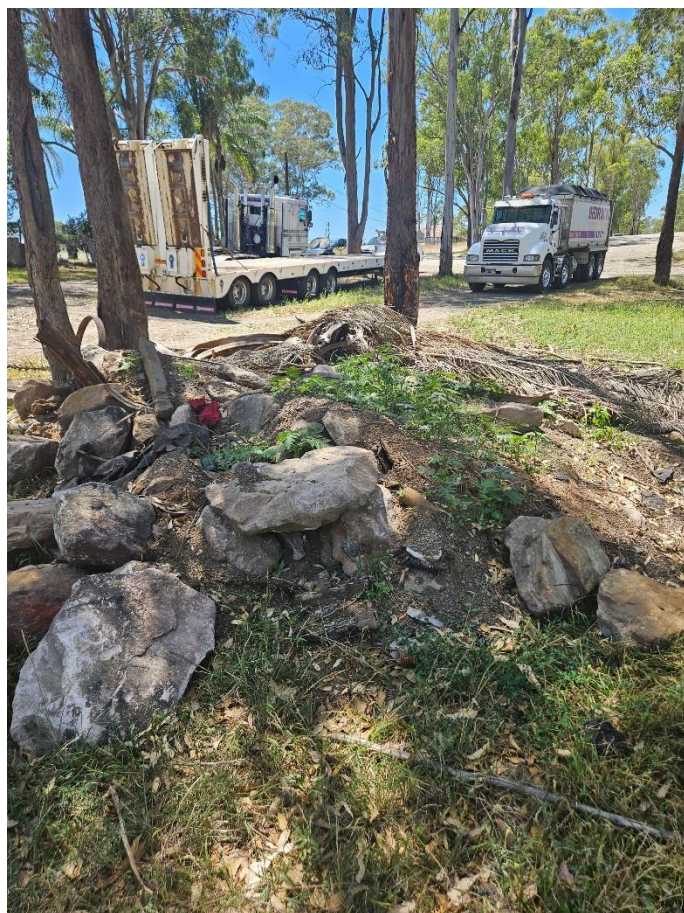
**Photo Description: Stockpiled soil and boulders with Bedrock Quarry Products and Bulk Transport truck**

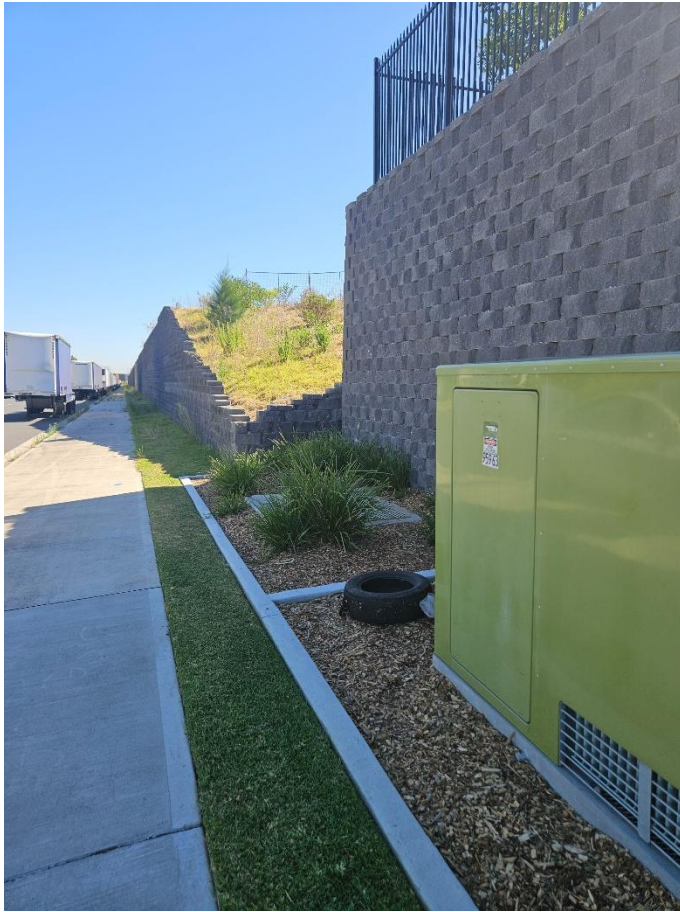
**Photo Description: Transformer and retaining wall adjacent Amazon data centre and Johnston Cres, facing north at far southwestern corner of buffer**

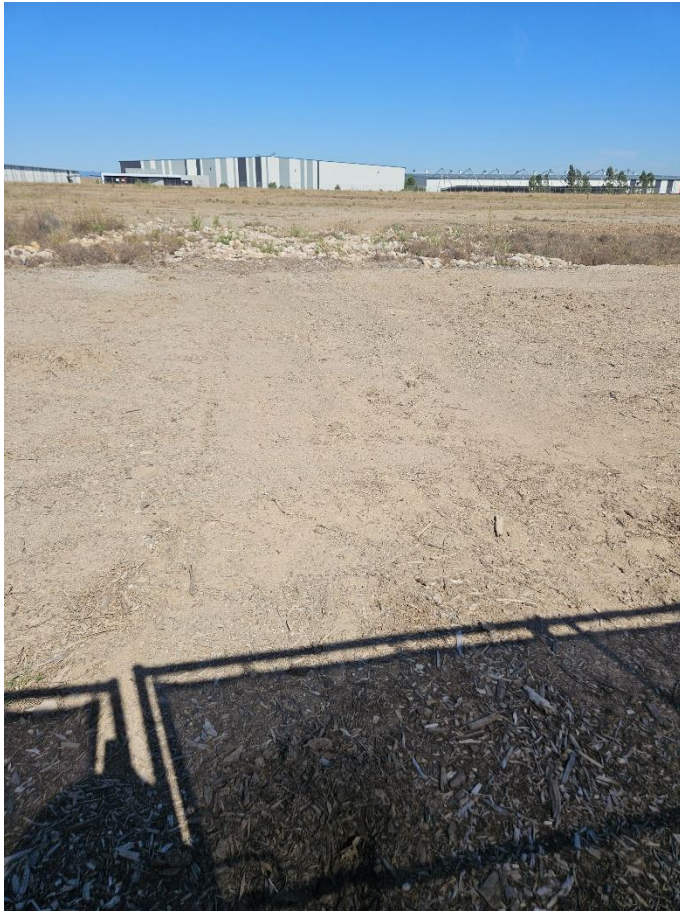
**Photo Description: Onsite drainage channel and sandstone boulder bridge located on Pipeline End Lot.**

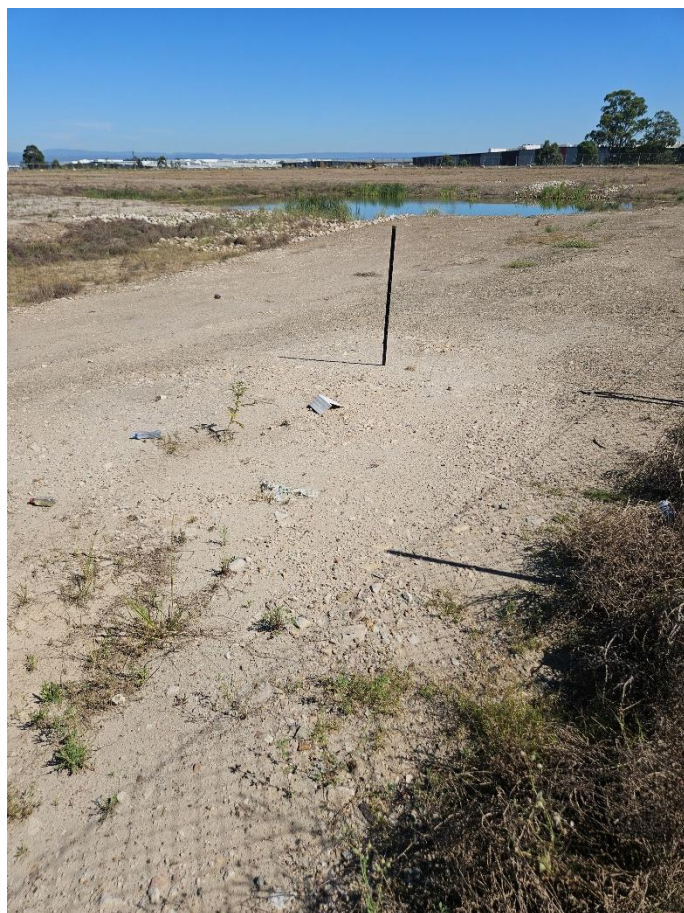
**Photo Description: Onsite drainage channel and surface water body (no indicators of potential contamination)**

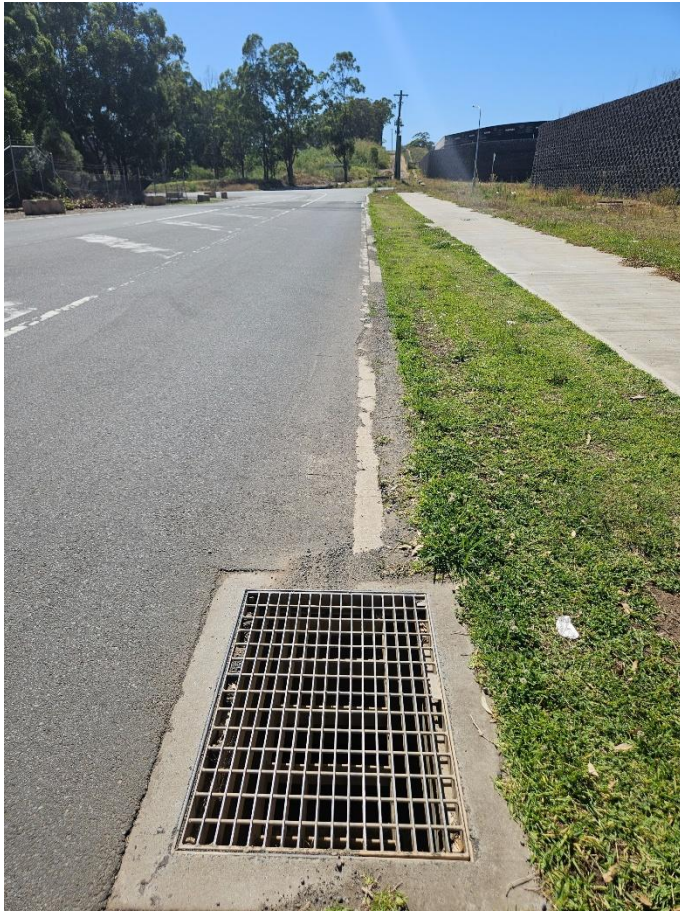
**Photo Description: Approximately 10m deep stormwater pit on Burnley St, facing east**

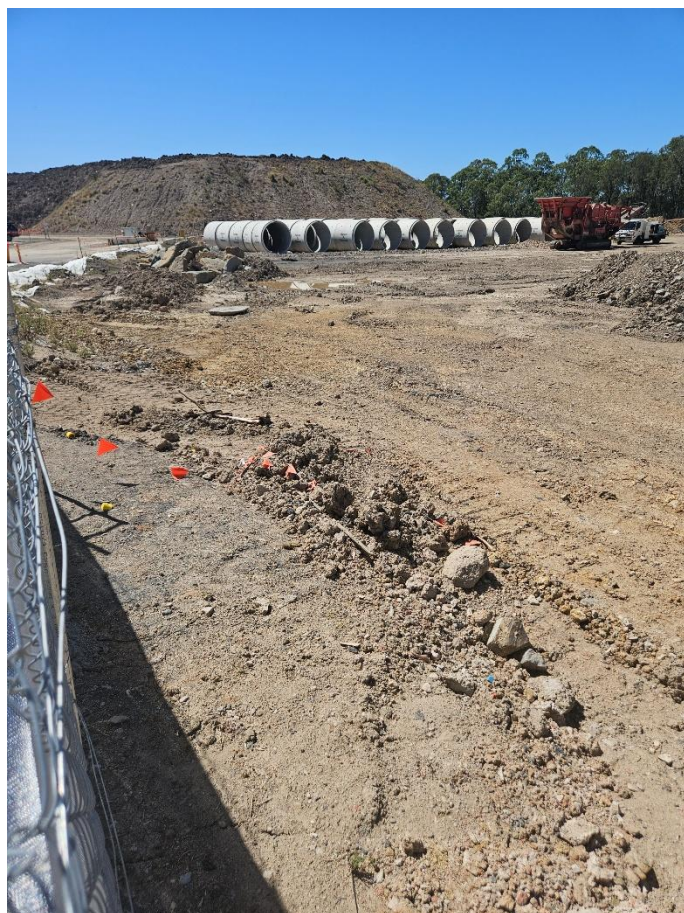
**Photo Description: Oakdale aeast construction including stockpiling and pipeline.**

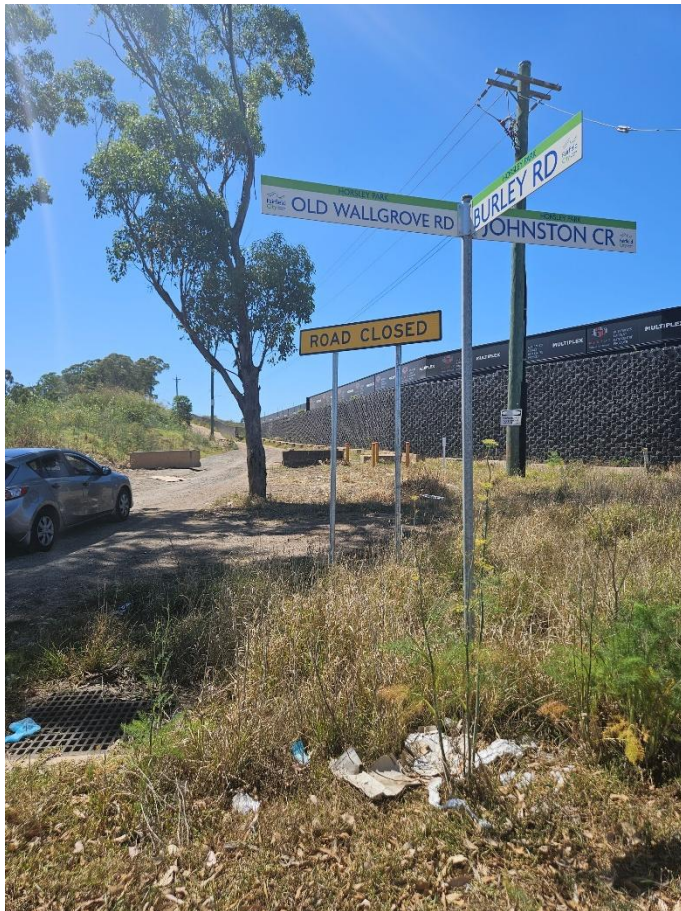
**Photo Description: Facing west, location of pipeline on unnamed road. Evidence of surface water run-off, underground services, overhead electricity and stockpiling to the right (north)**

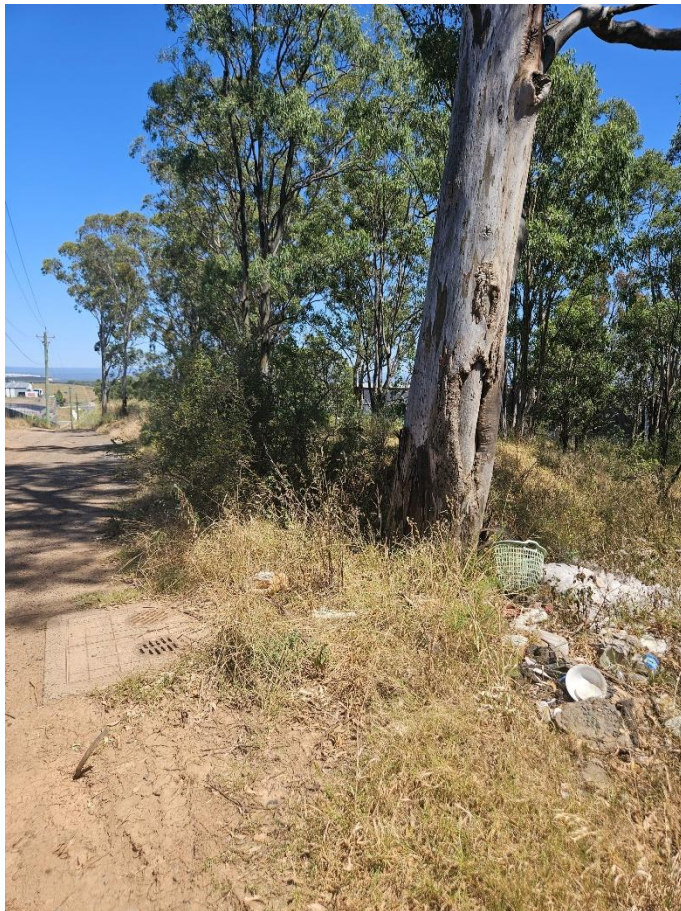
**Photo Description: Illegal dumping, stockpiles and fire remains.**

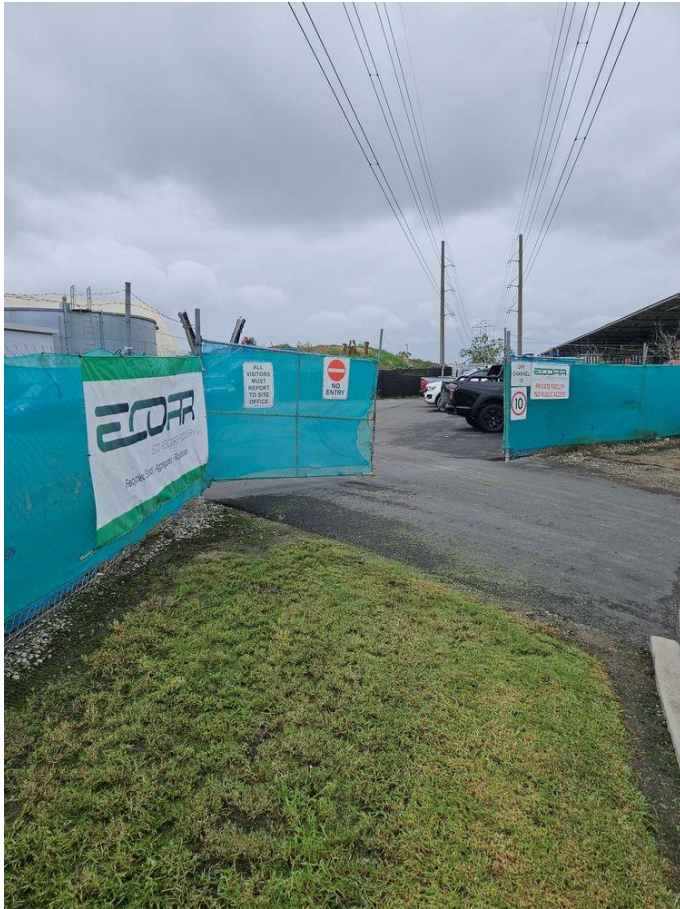
**Photo Description: Easement at McKay Rd facing east. ECO RR - ECO RESOURCE RECOVERY, recycled sand, aggregates and road-bases. Multiple large stockpiles (>5m height), storage of large truck tires.**

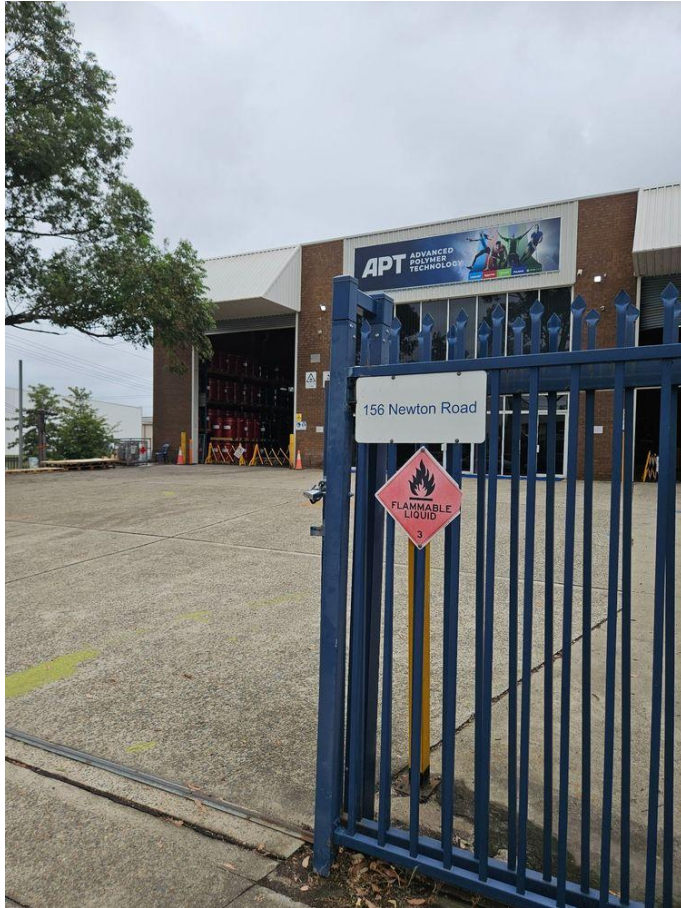
**Photo Description: Chemical storage at commercial property**

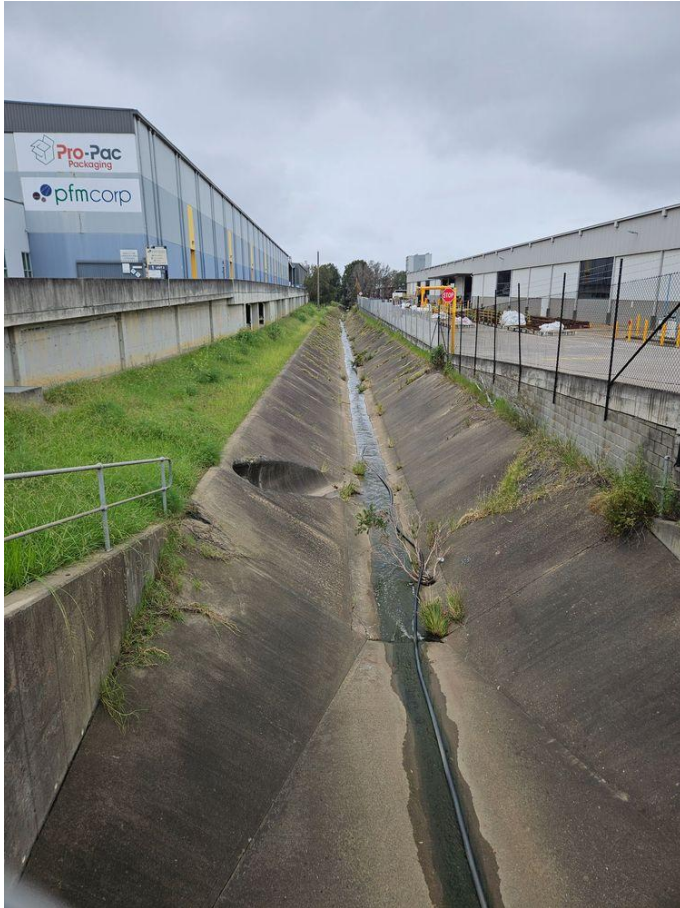
**Photo Description: High velocity (but low flow) channel, flowing east, with stormwater culvert ingress.**

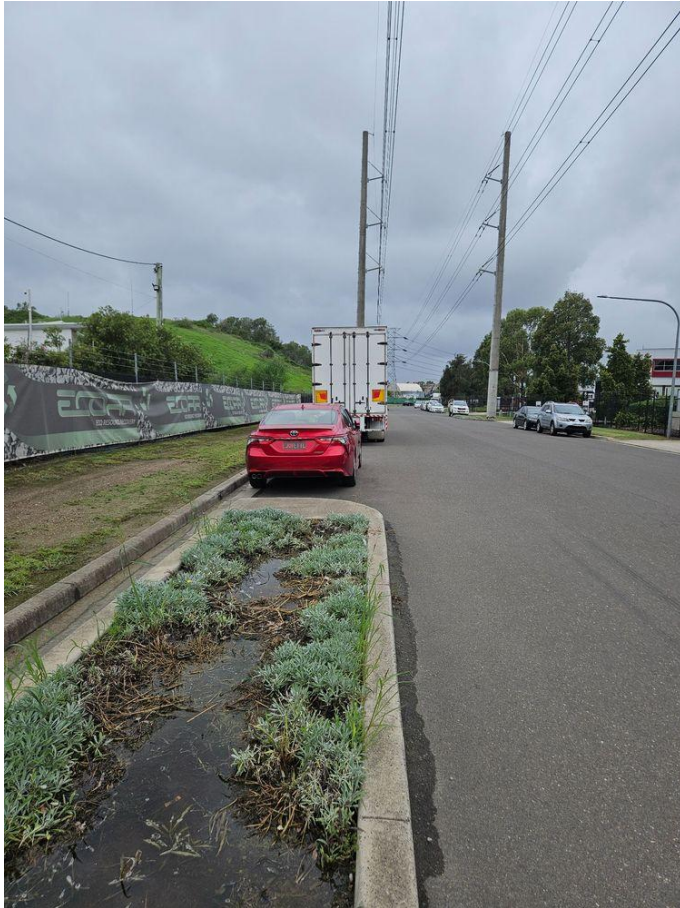
**Photo Description: Stockpiling at ECORR. Noise pollution.**
