# Preliminary Site Investigation

## **Rosehill Recycled Water Scheme Extension**

Smithfield, Wetherill Park and Horsley Park, NSW

**Project No. 25284**

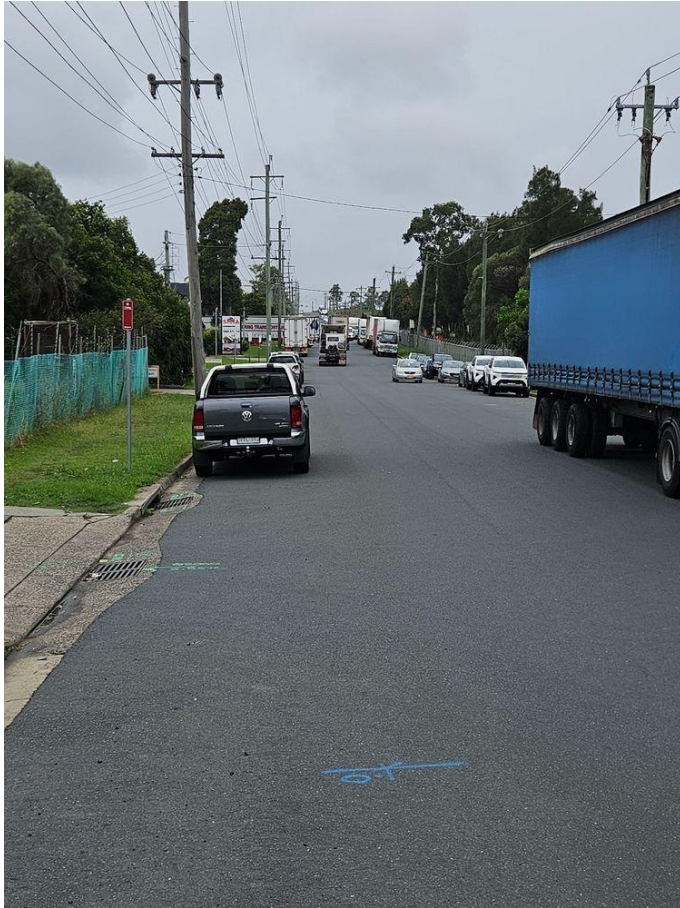
**Photo Description: Gently undulating topography**

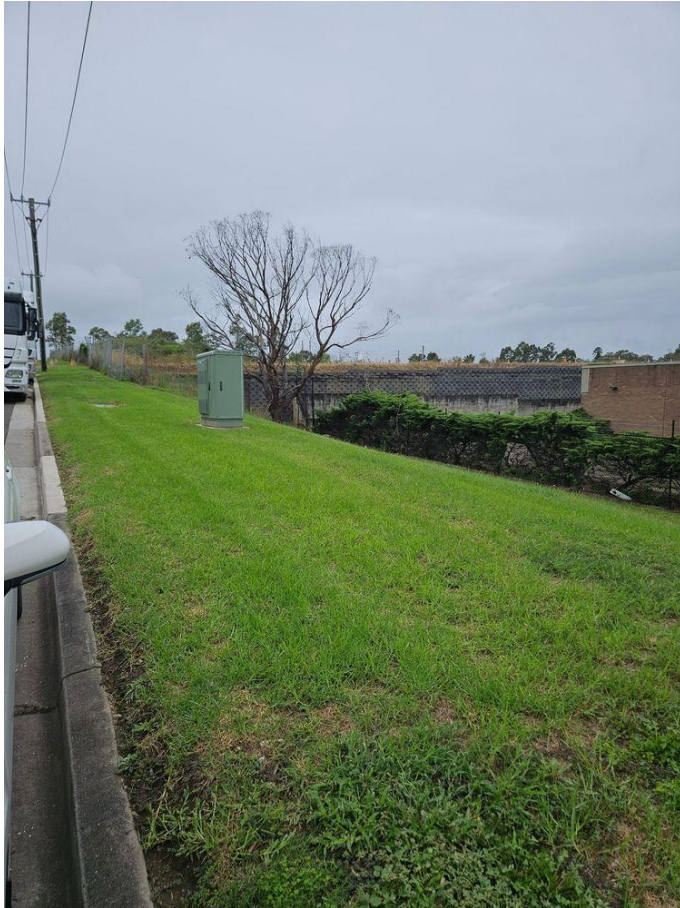
**Photo Description: 10m retaining wall**

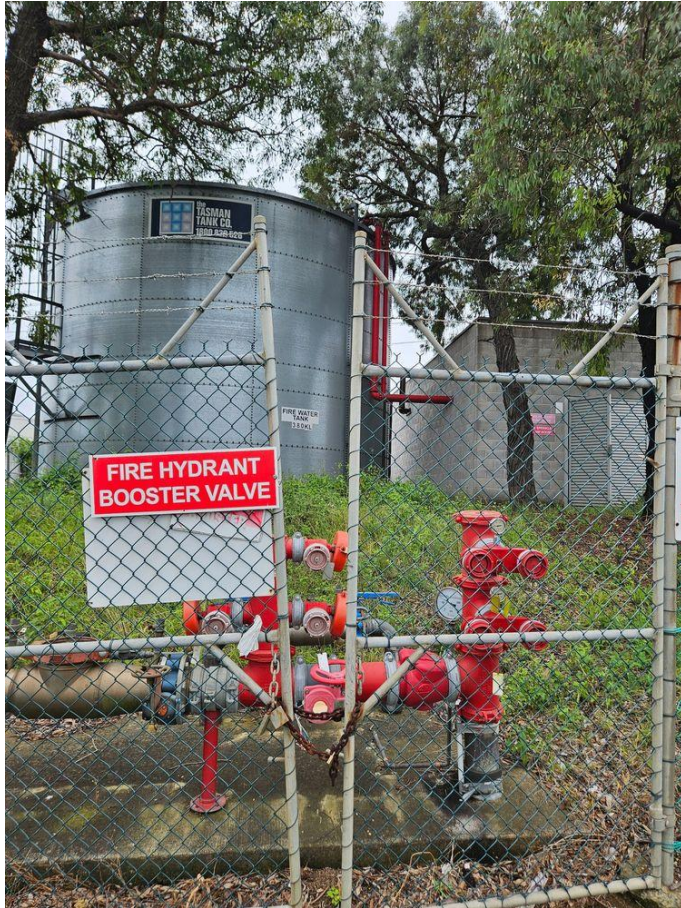
**Photo Description: 380 KL fire water tank and fire pump room at Vellex**

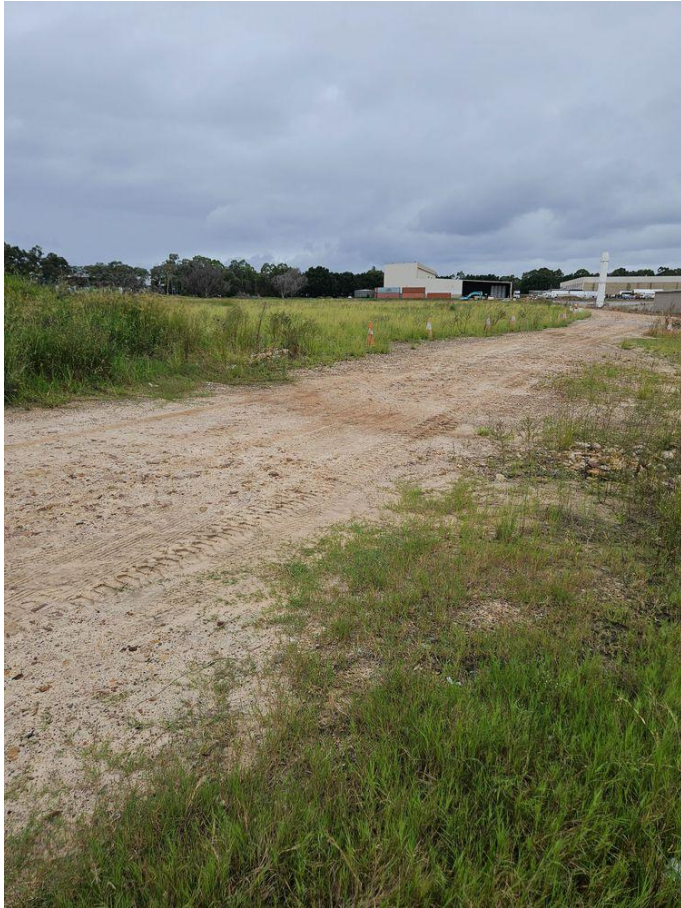
**Photo Description: Vacant lot with cut and fill activities**

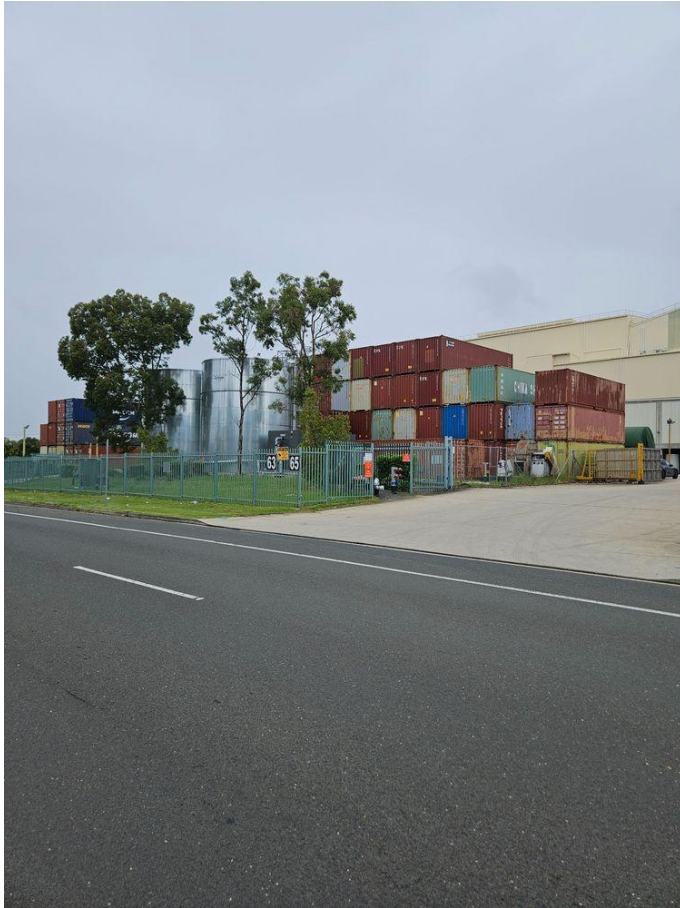
**Photo Description: ASTs and shipping container storage**

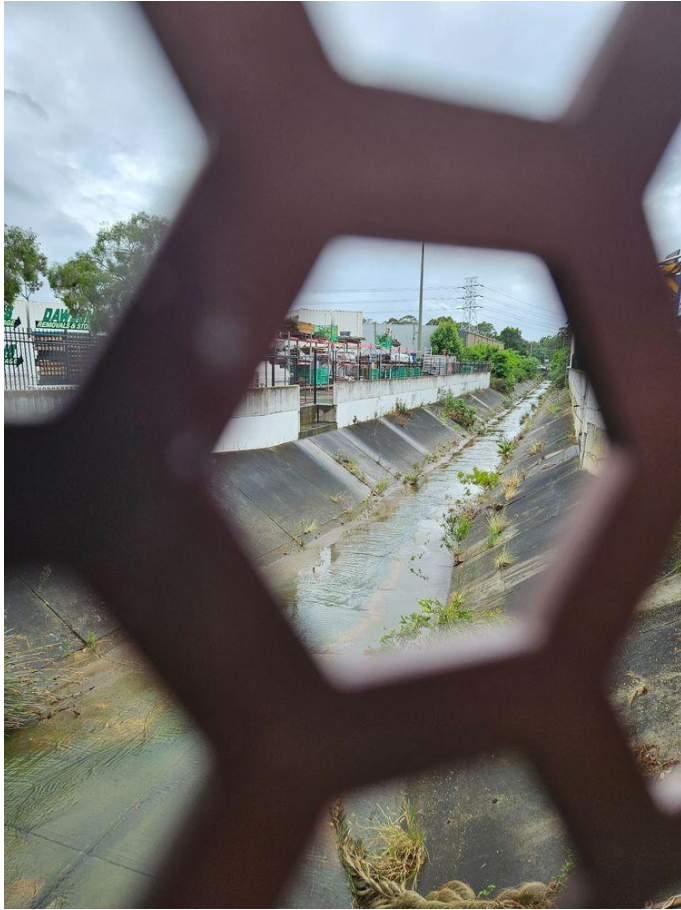
**Photo Description:** Stormwater culvert looking north from the road, some native tree growth.

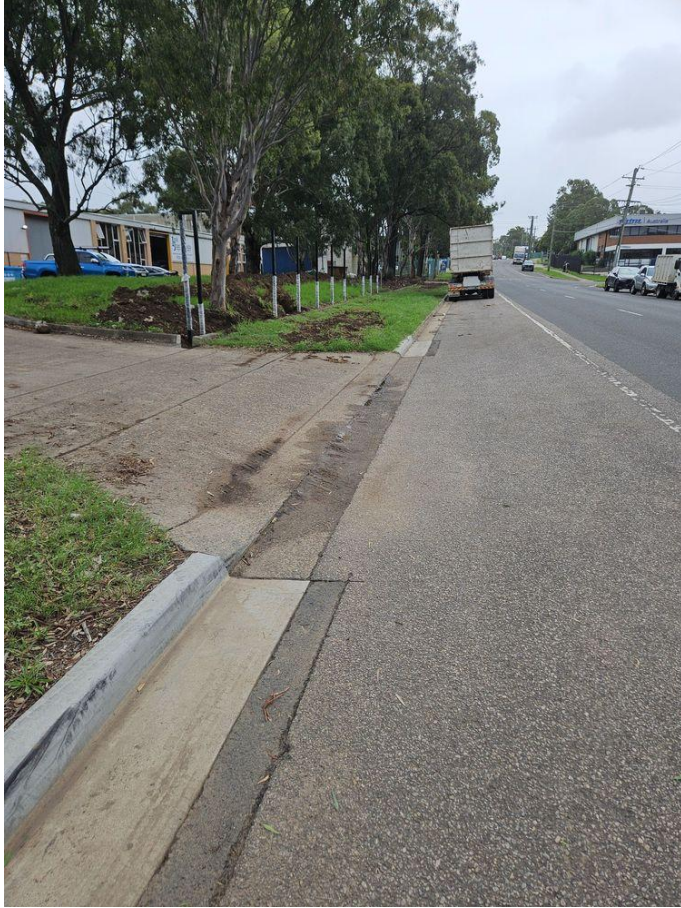
**Photo Description: Earthworks**
