Report on  
Geotechnical Investigation

Proposed Residential Subdivision  
32 Lovelle Street and 141 Yarrowa Road,  
Moss Vale

Prepared for  
Prime Moss Vale Pty Ltd

Project 40494.03  
April 2020

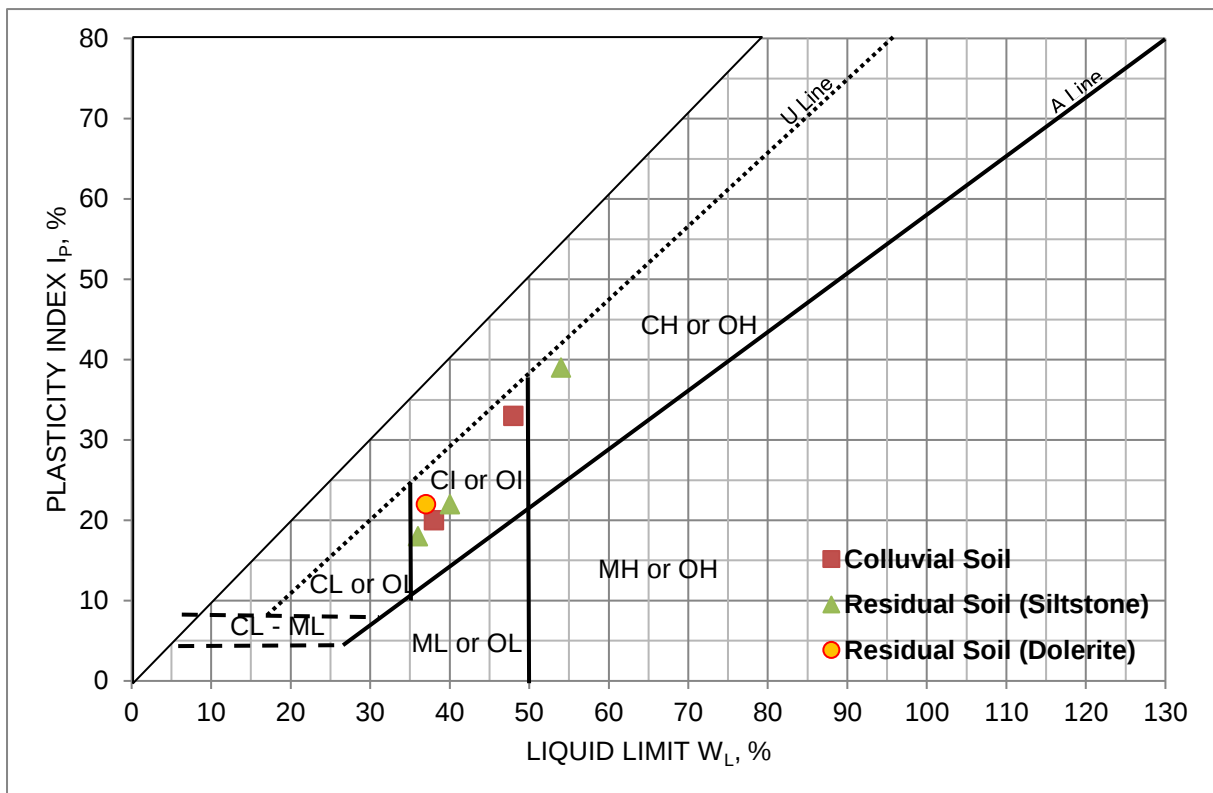
**Figure 1: Results of plasticity testing plotted on a Modified Casagrande Chart.**

The results indicate that the samples tested are of generally intermediate plasticity, with one sample (Pit 19 at 0.4 – 0.5 m) being of high plasticity. The results are summarised in a modified Casagrande chart in Figure1 (following page).

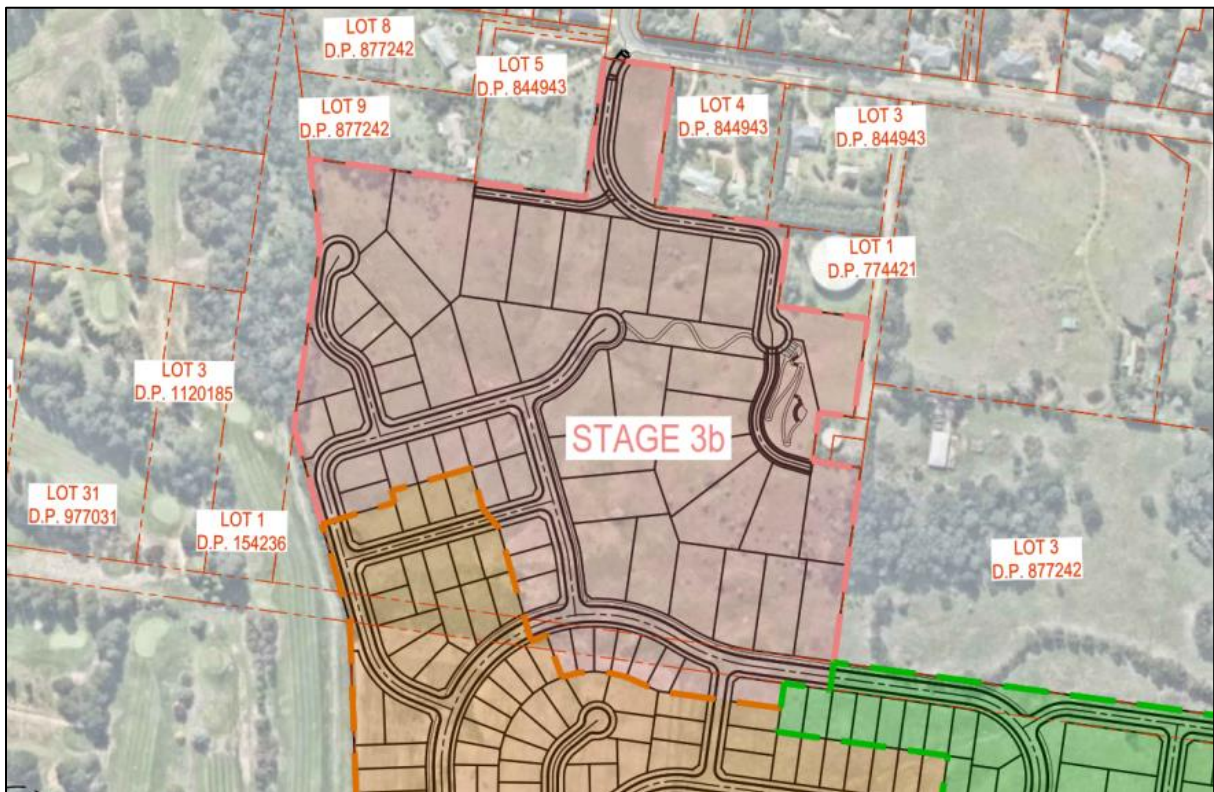
Figure 2: Excerpt of the concept plan for development of the steep hillside.

The concept plan for development of the steep hillside (refer Figure 2, following page), dated September 2019, includes proposed residential lots of varying sizes, access roads, areas for public recreation and environmental conservation. Access for the proposed subdivision will be developed from the overall subdivision to the south, with a few lots at the crest of the steep hillside accessed from Hill Road.

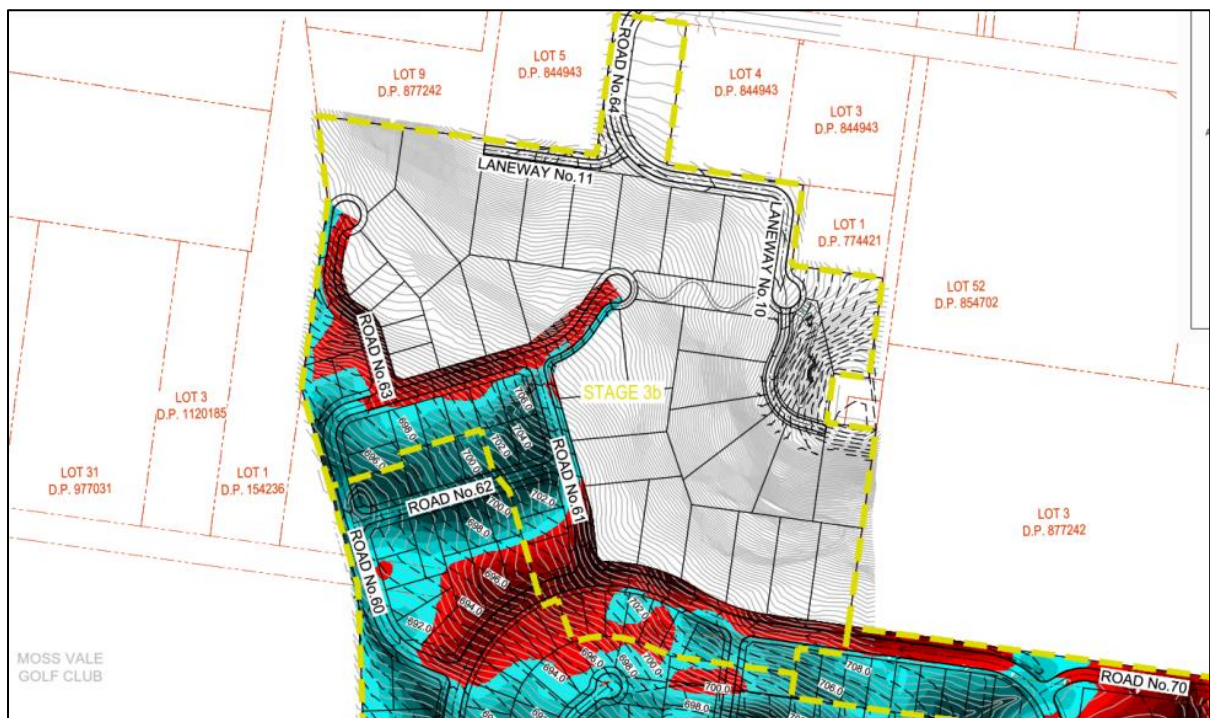
Figure 3: Excerpt of the bulk earthworks plan for the steep hillside.

At the time of preparing this report, concept bulk earthworks plans had been provided for the proposed development of the lower hillside only (refer Figure 3, following page). The plans indicated cut and fill in the order of 3 m in the lower hillside. The extent of potential earthworks in the middle and upper slopes of the northern hillside will be guided by the recommendations of this report.

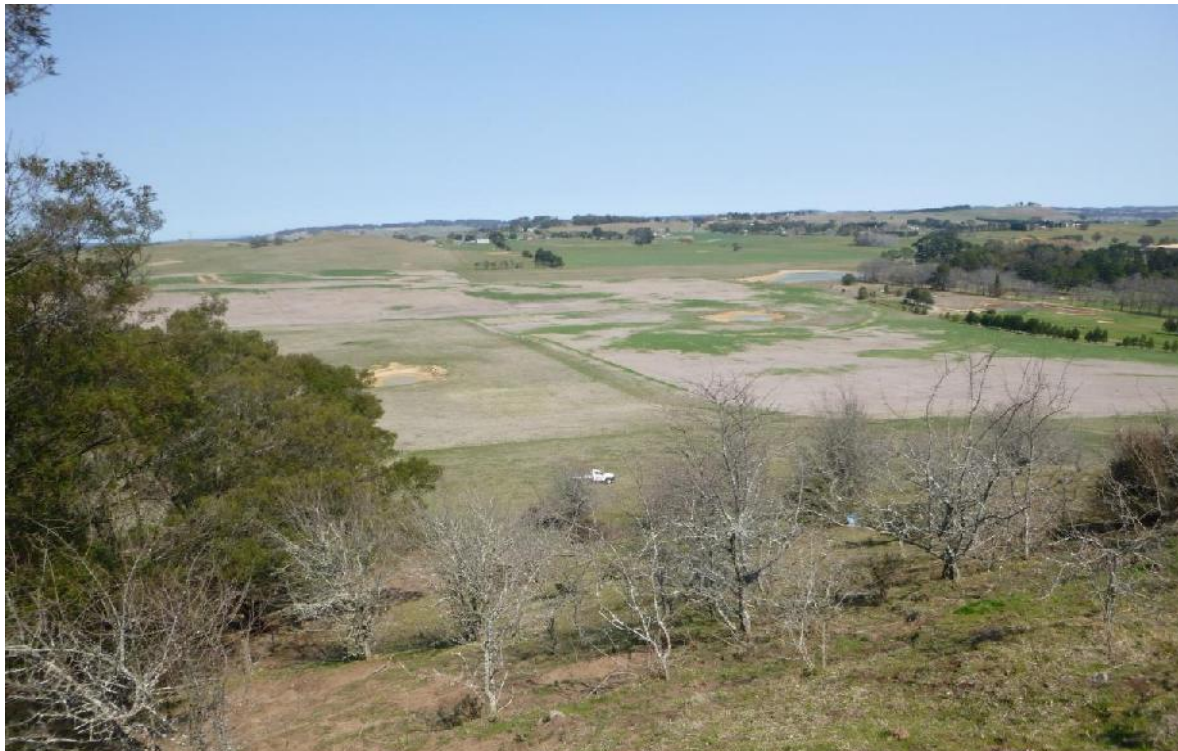
Photo 1: View looking south across the central part of the site from the very steep hillside in the northern part of the site.

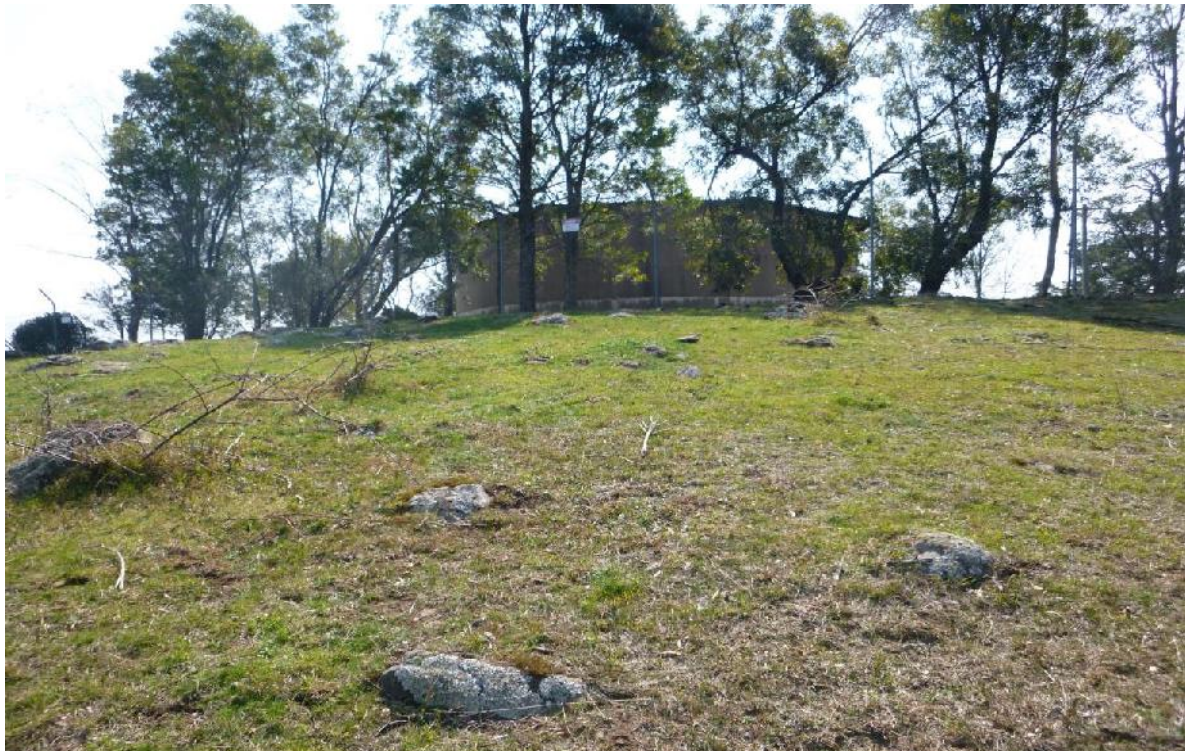
Photo 2: View looking north at the smaller of the two water reservoirs at the top of the hill iadjacent to the northern part of the site.
