SYDNEY DESALINATION PLANT PIPELINE

ASSET MANAGEMENT PLAN REVIEW

29 July 2016

SEG604-TD-WE-REP-1001 Rev 0

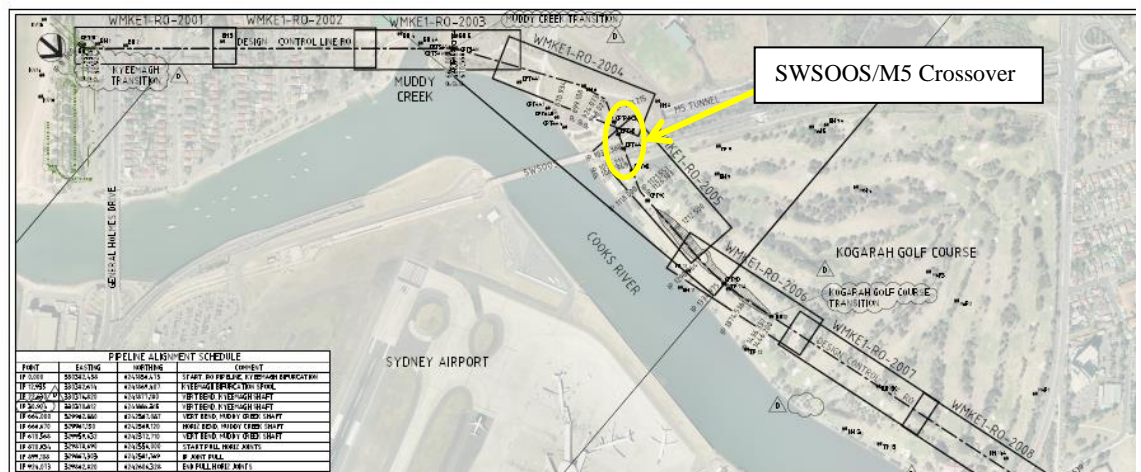
Figure 1 - Above-Ground Pipeline at SWSOOS/M5 Crossover

9. Several bird spikes are missing from the top of the pipe at the M5/SWSOOS crossover and Alexandra Canal. While this is not a significant risk for the pipe the bird spikes would be part of the requirement of SACL to manage and control the presence of birds in the vicinity of the airport in accordance with CASA regulations. It is assumed the bird spikes are a requirement of SACL's "Bird Hazard Management Guidelines" which is referred to in the SACL Maintenance Plan.

10. Graffiti was observed the M5/SWSOOS crossover on the pipe and anchor blocks and pipe supports and, to a lesser extent, along Alexandra Canal.

Recommendation	Priority	Key Driver
Replace missing bird spikes on top of pipe sections at the M5/SWSOOS crossover and Alexandra Canal. Some bird spikes found on the ground nearby could be re-used.	High	Safety / Compliance
Consider whether it is appropriate to install and maintain rated fall-arrest anchor points on pits accessed occasionally, with normal opening less than 1m x 1m. Cover grates and temporary anchor points (tripod) may be more suitable.	Medium	Safety / Compliance
As anchor points fail, replace with an improved design that is not prone to being submerged in water. The new anchor points specified for the Erko Pit are recommended. These are drop-in anchors (Hilti HKD SR M16 65 or approved equivalent) 316 stainless steel / length 65mm X 16mm, to suit RUD VLBG M16 Eyebolt WLL 1.5T.	Medium	Safety / Compliance

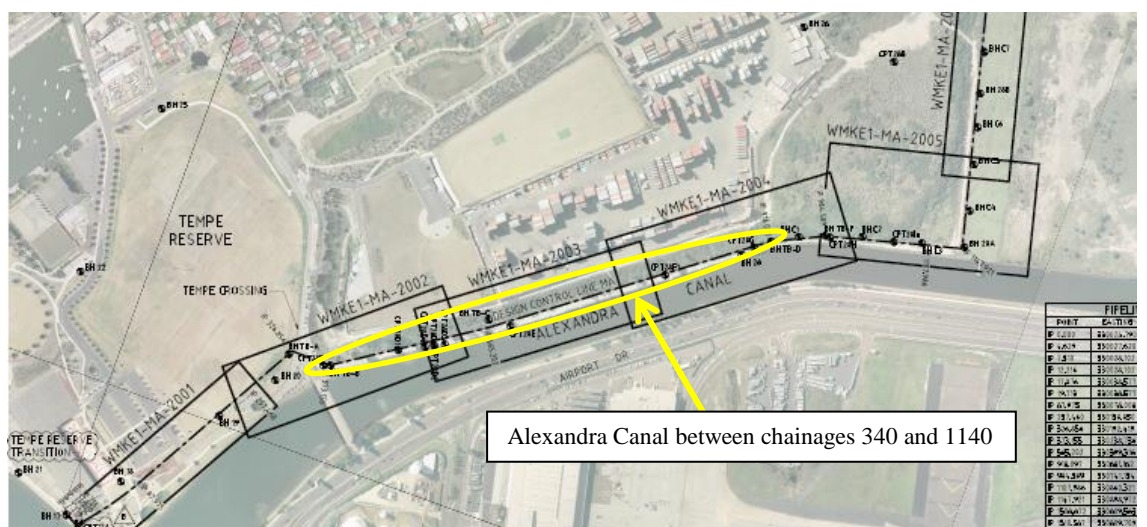
Figure 2 - Above-Ground Pipeline at Alexandra Canal

6. Heat shrink wrapping at several pipe joints had come loose in places, especially in the area where the shrink wrapping overlaps. However what was observed of the underlying Denso tape appeared to be in good condition and no bare metal was exposed under the joint wrapping. The worst of the joint wrapping was observed at the downstream end of the above-ground pipe section along Alexandra Canal. The joint wrapping will be reviewed in more detail in a separate report.

11. Some short and bent bolts were found on pipe footings along Alexandra Canal. While the risk to the pipeline is low, a short bolt means that the full design strength of the bolt is not able to be realised and thread stripping is more likely to occur if the pipe footing is subjected to stresses closer to the upper end of its design.

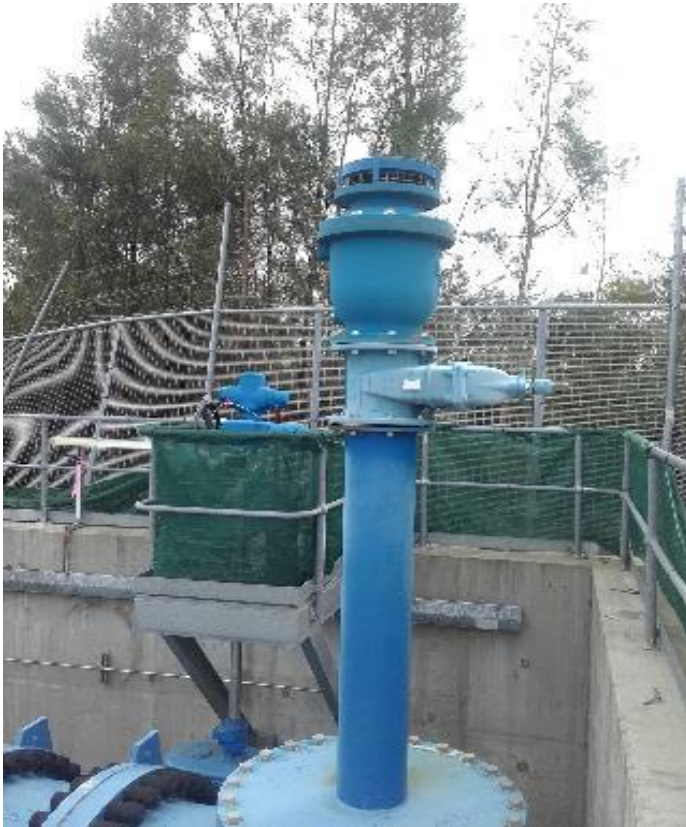
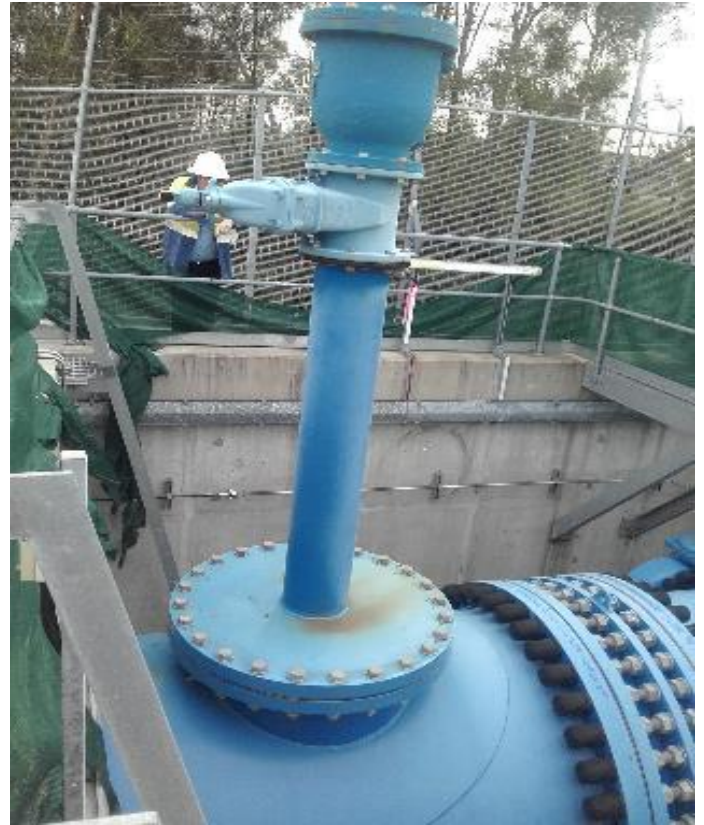
Item	Rating (1 - 5)	Comments	Photo #
External Protective Coating	2	Minor wear and tear	
Pipe Joints including Isolation Gasket (where applicable)	2	Cracking around some fasteners on large flange underneath air valve	
Isolation Valve	2		
Fasteners (loose, missing, corroded)	2		
Ease of Operation	N/A	Valve not operated	
Spindle (including surface box)	2		
Gland and seals (where applicable)	2		
Pit Cover and Seat (where applicable)	N/A		
Internal Pit Structure (where applicable)	2	Minor cracks and chips	
Stairs, Ladders and Access Platforms (where applicable)	2	Minor corrosion on handrails	
Other (specify) - Anchor Points	N/A

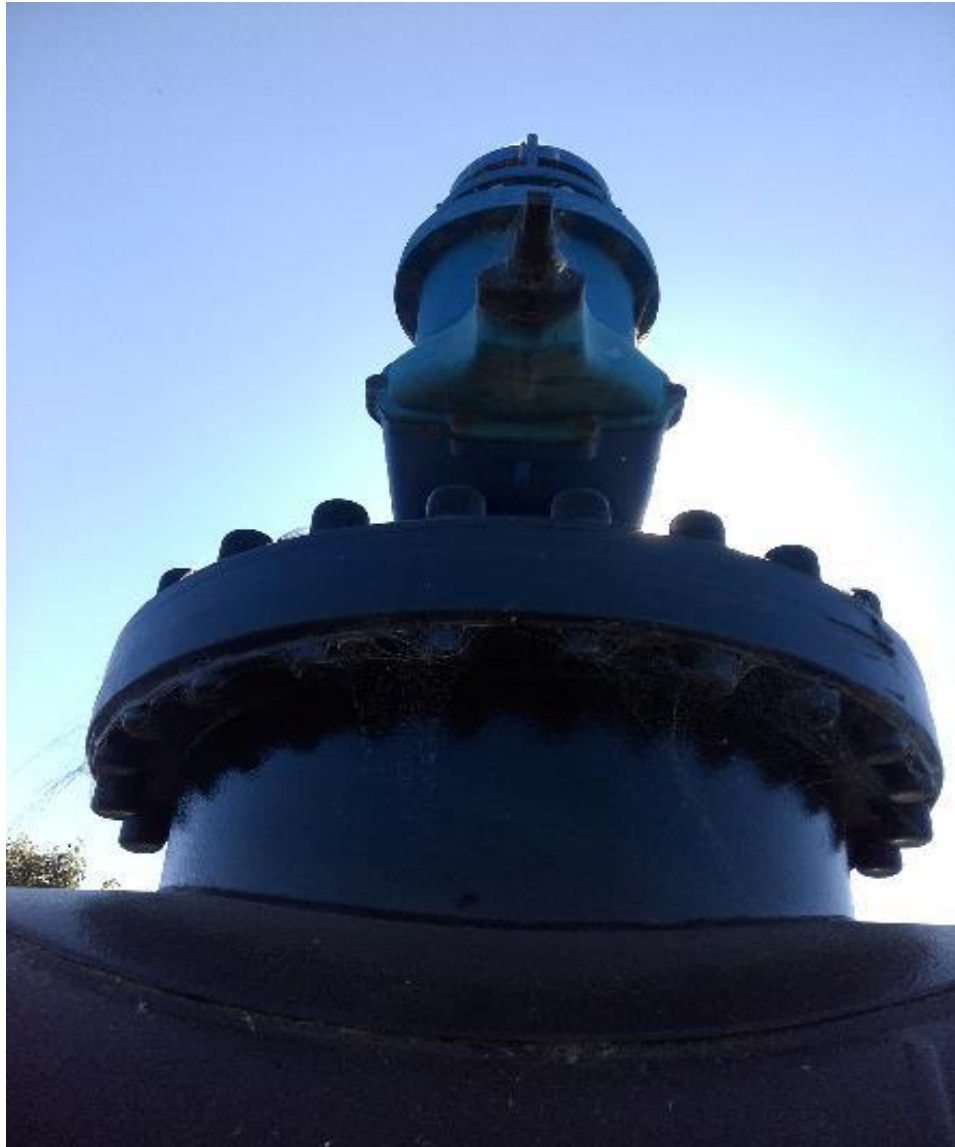
Item	Rating (1 - 5)	Comments	Photo #
External Protective Coating	2	Minor cracking around top flange	12.52pm
Pipe Joints including Isolation Gasket (where applicable)	2	Wrapping is in tact	
Isolation Valve	2	No evidence of leaks	
Fasteners (loose, missing, corroded)	2	Most fasteners are wrapped	
Ease of Operation	N/A		
Spindle (including surface box)	2		
Gland and seals (where applicable)	2		
Pit Cover and Seat (where applicable)	N/A		
Internal Pit Structure (where applicable)	N/A		
Stairs, Ladders and Access Platforms (where applicable)	N/A		
Other (specify)	N/A

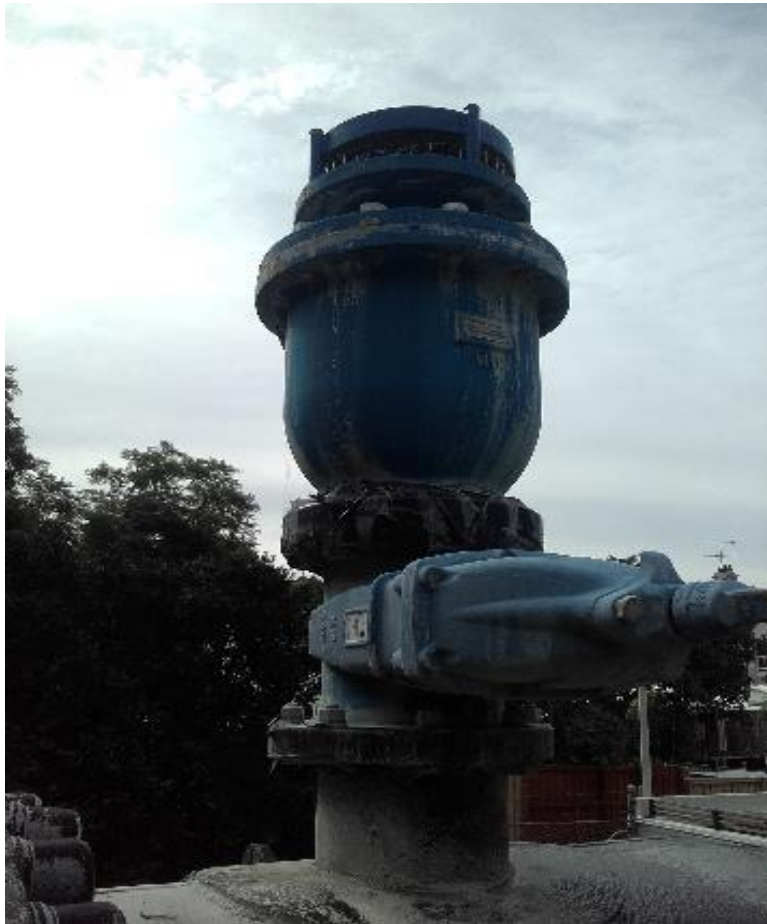
1. Water is pooling on top of the large flanges under some of the air valves. Approximately 50% of the coating has failed on the large flange under ROAV5 (above SWSOOS).

Item	Rating (1 - 5)	Comments	Photo #
External Protective Coating	3	Some minor cracking on flange	
Pipe Joints including Isolation Gasket (where applicable)	3	Tape coming loose on flanges	
Isolation Valve	2		
Fasteners (loose, missing, corroded)	2		
Ease of Operation	N/A		
Spindle (including surface box)	2		
Gland and seals (where applicable)	2		
Pit Cover and Seat (where applicable)	N/A		
Internal Pit Structure (where applicable)	N/A		
Stairs, Ladders and Access Platforms (where applicable)	N/A	Refer to pipeline condition assessment sheet	
Other (specify)	N/A

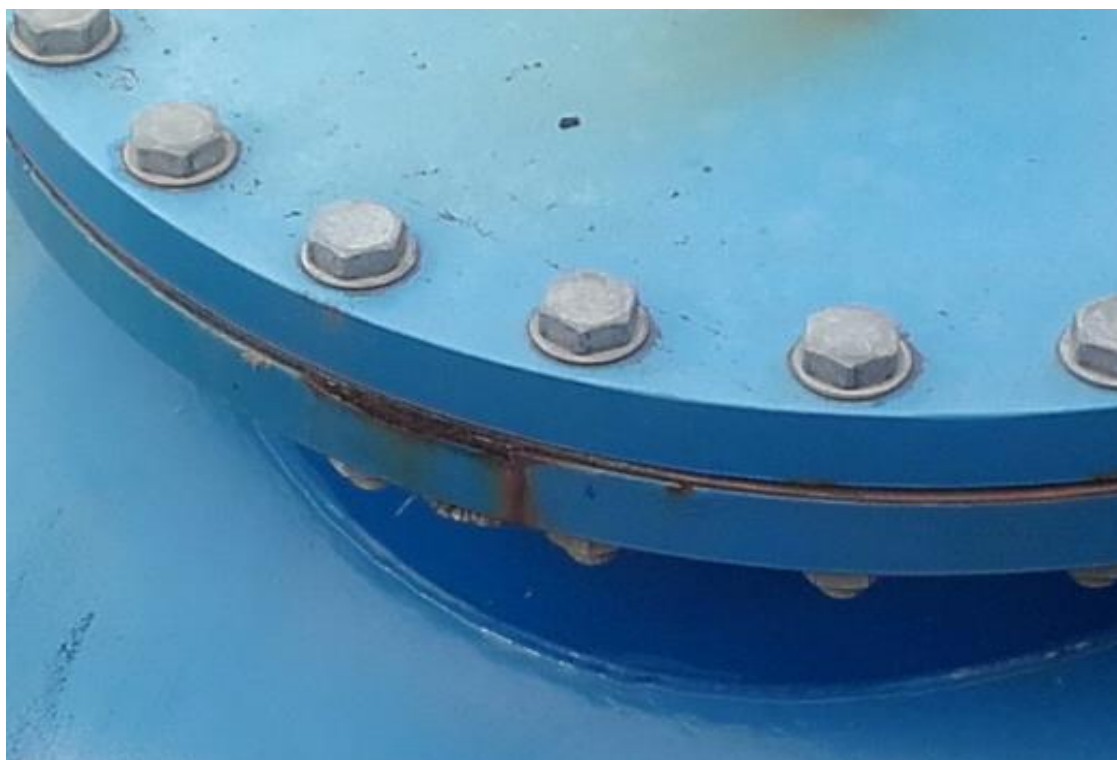
Item	Rating (1 - 5)	Comments	Photo #
External Protective Coating	3	Cracking around some flange fasteners & top of large flange below air valve	11.15am
Pipe Joints (Welded)	N/A		
Expansion Joints	N/A		
Anchor Blocks	N/A		
Pipe Cradles / Footings / Rockers / Sliding Supports	N/A		
Fasteners (loose, missing, corroded)	2		
Drainage	2		
Pipeline Cutting / Embankment / Retaining Walls	N/A		
Access Roads / Tracks	N/A		
Armco Railing	N/A		
Fences, Gates and Padlocks	N/A		
Stairs, Ladders and Access Platforms	2		
Corrosion Protection Test Points	N/A

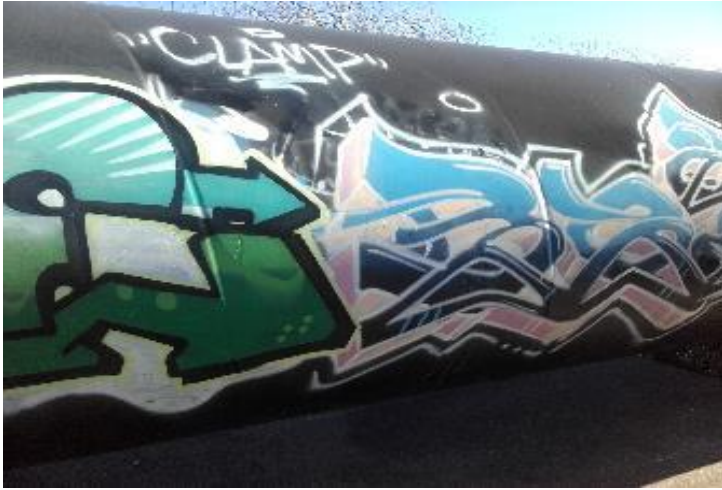
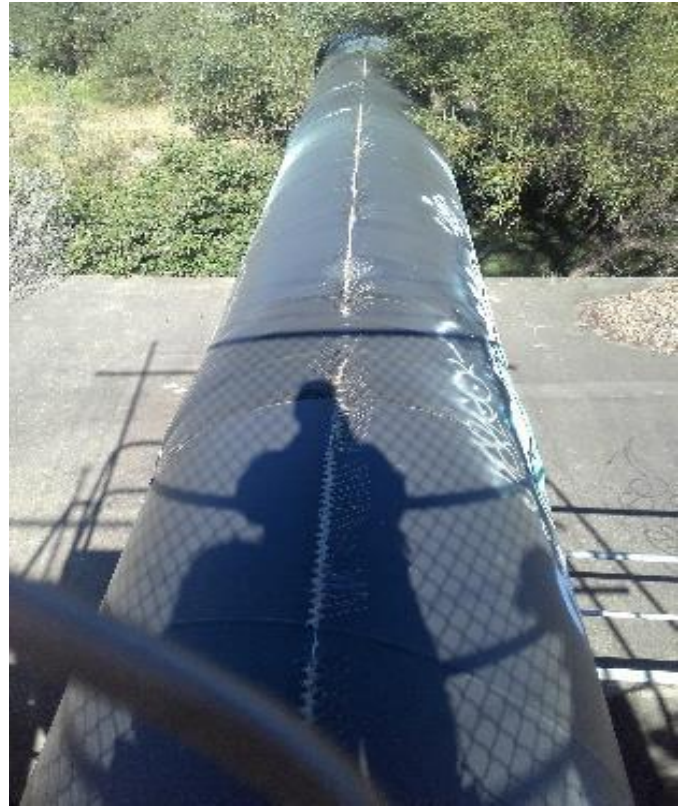
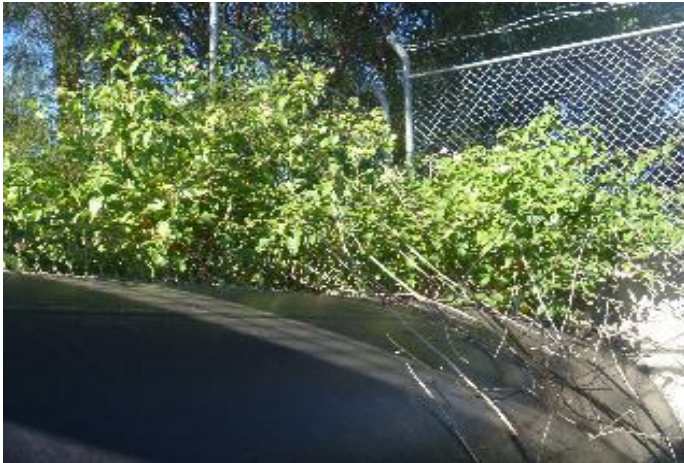
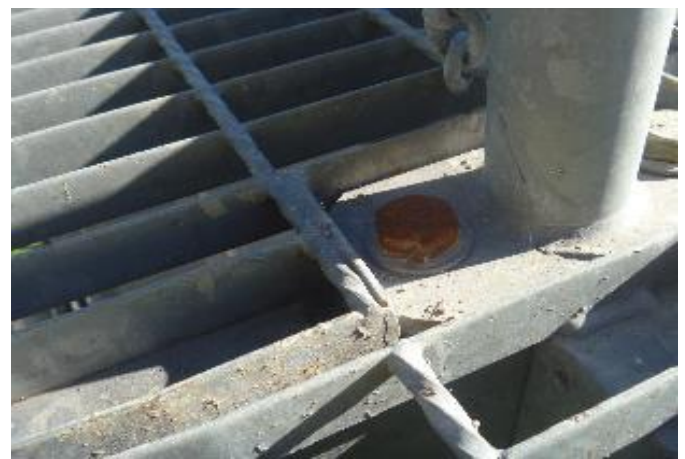
Item	Rating (1 - 5)	Comments	Photo #
External Protective Coating	2	Some bird spikes missing. Minor wear and tear. Graffiti. Acrylic paint used to cover graffiti is flaking	1,8,13-15
Pipe Joints (Welded)	N/A	No visibility under wrapping	
Expansion Joints	N/A		
Anchor Blocks	2	Minor chips and cracks, overgrown vegetation, graffiti	9,11,12,16-18
Pipe Cradles / Footings / Rockers / Sliding Supports	2	Graffiti, minor wear and tear	19-23
Fasteners (loose, missing, corroded)	2	Minor corrosion	
Drainage	2	No signs of pooling near anchor blocks or pipe footings	
Pipeline Cutting / Embankment / Retaining Walls	N/A		
Access Roads / Tracks	3	Overgrown vegetation in parts, but access generally OK	
Armco Railing	N/A		
Fences, Gates and Padlocks	3	Minor corrosion, some damage	11
Stairs, Ladders and Access Platforms	2	Minor spot corrosion, some corroded fasteners and chain hooks	2-7
Corrosion Protection Test Points	2

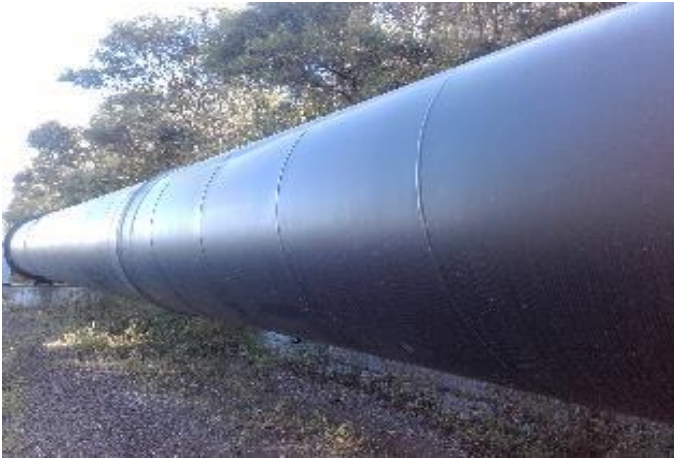
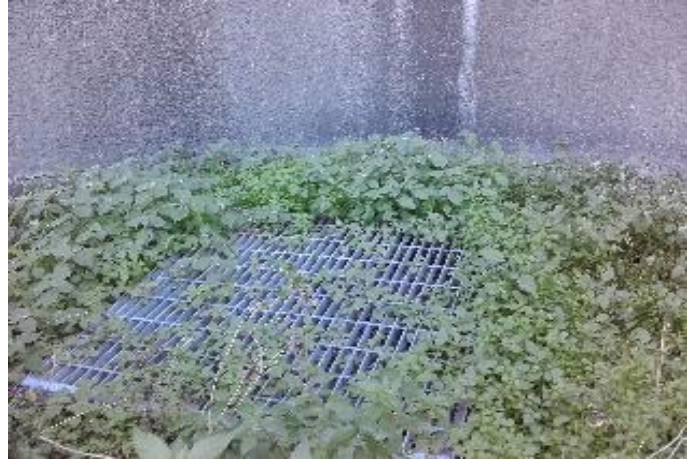
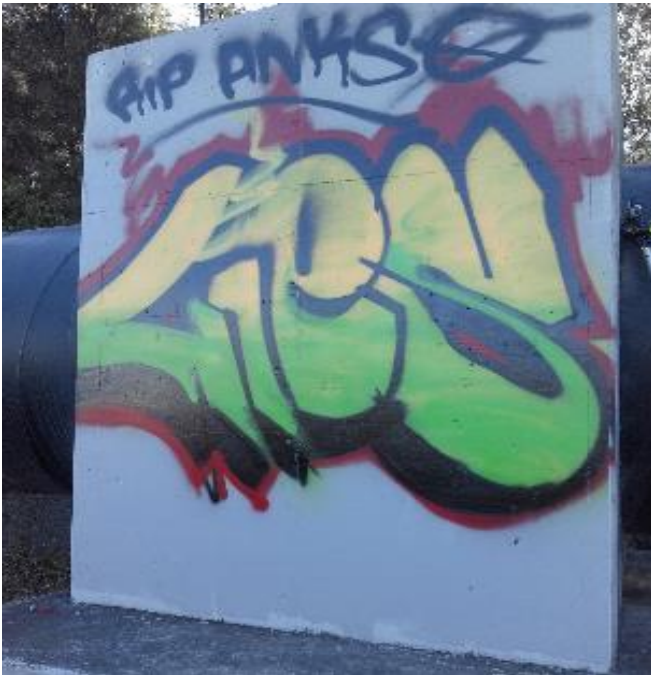
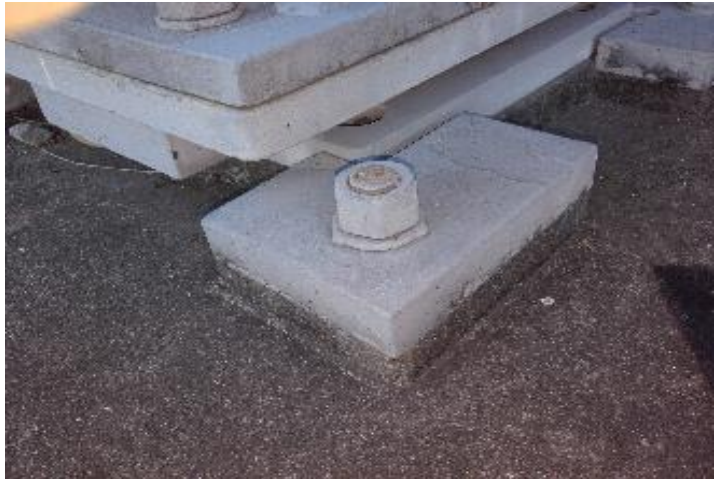
Item	Rating (1 - 5)	Comments	Photo #
External Protective Coating	2		
Pipe Joints (Welded)	N/A	No visibility under wrapping	
Expansion Joints	2	EJ1 - No leaks. 23mm remaining take-up in joint	
Anchor Blocks	2	Graffiti	
Pipe Cradles / Footings / Rockers / Sliding Supports	2		
Fasteners (loose, missing, corroded)	2	2 x short bolts found	
Drainage	2		
Pipeline Cutting / Embankment / Retaining Walls	2	Some overgrown vegetation in parts	
Access Roads / Tracks	2	Some overgrown vegetation in parts	
Armco Railing	N/A		
Fences, Gates and Padlocks	N/A		
Stairs, Ladders and Access Platforms	N/A		
Corrosion Protection Test Points	N/A

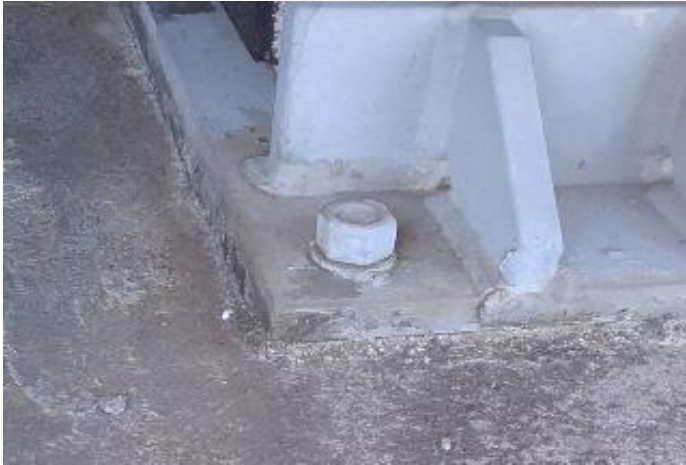
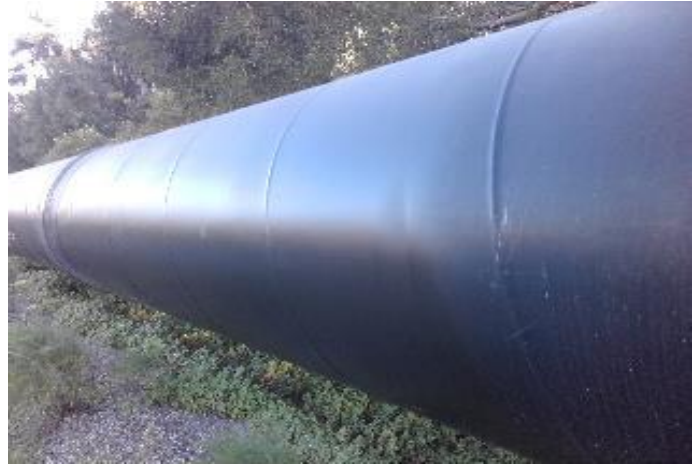
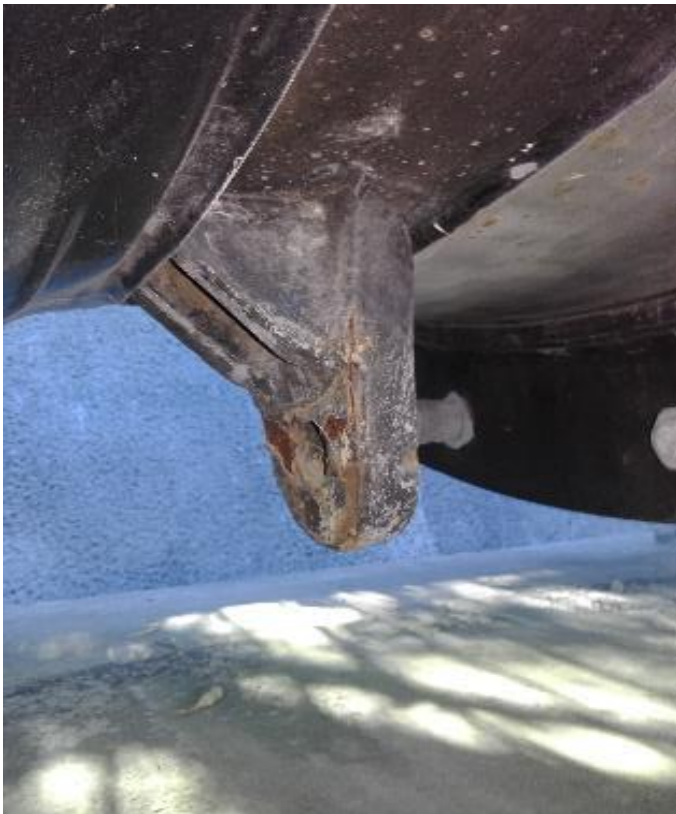
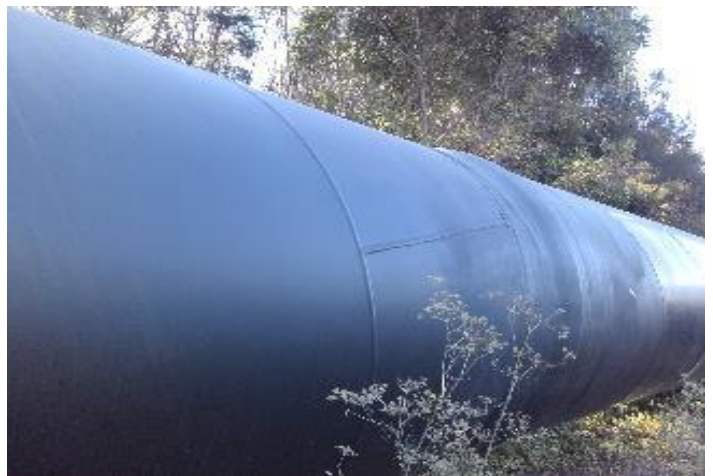
Item	Rating (1 - 5)	Comments	Photo #
External Protective Coating	2		1.13pm
Pipe Joints (Welded)	N/A	No visibility under wrapping	
Expansion Joints	2	Expansion Joint # 2 - No leaks. 26mm take-up remaining. Minor surface corrosion. Moderate corrosion on lifting lug on bottom of expansion joint	1.32pm
Anchor Blocks	N/A		
Pipe Cradles / Footings / Rockers / Sliding Supports	2		
Fasteners (loose, missing, corroded)	2	1 x short bolt	
Drainage	2		
Pipeline Cutting / Embankment / Retaining Walls	3	Some overgrown vegetation in parts	
Access Roads / Tracks	3	Good access on canal side	
Armco Railing	N/A		
Fences, Gates and Padlocks	N/A		
Stairs, Ladders and Access Platforms	N/A		
Corrosion Protection Test Points	N/A

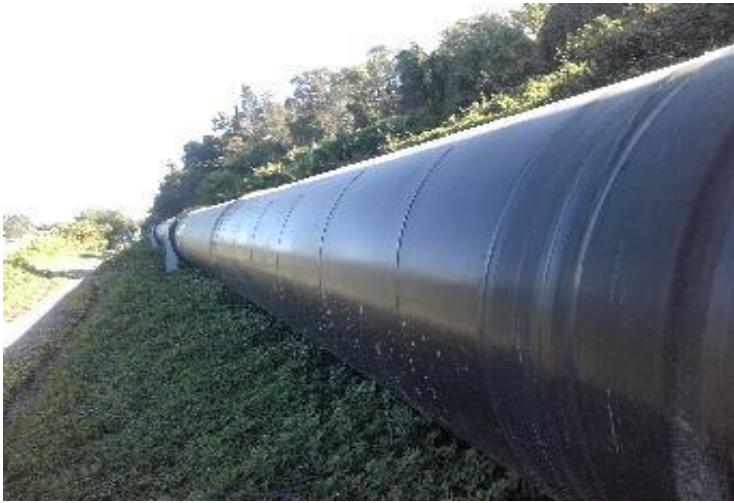
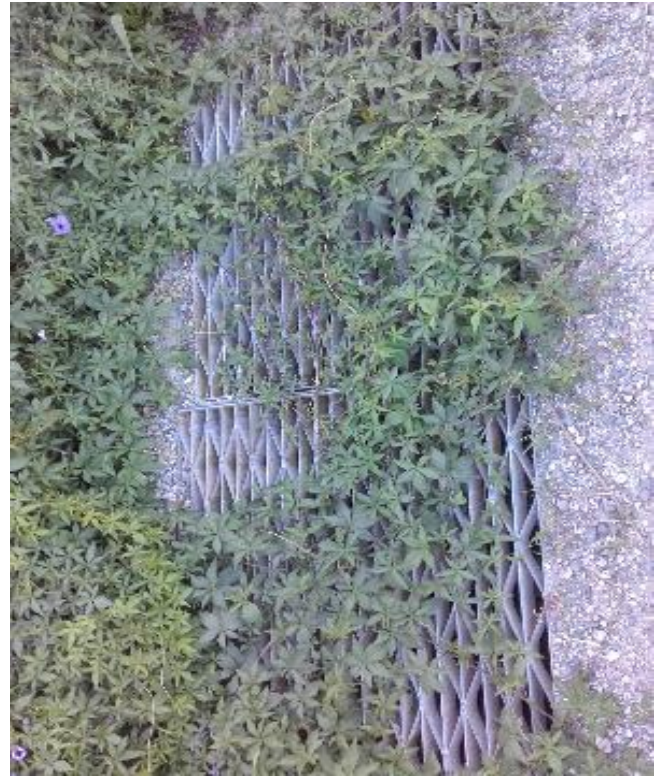
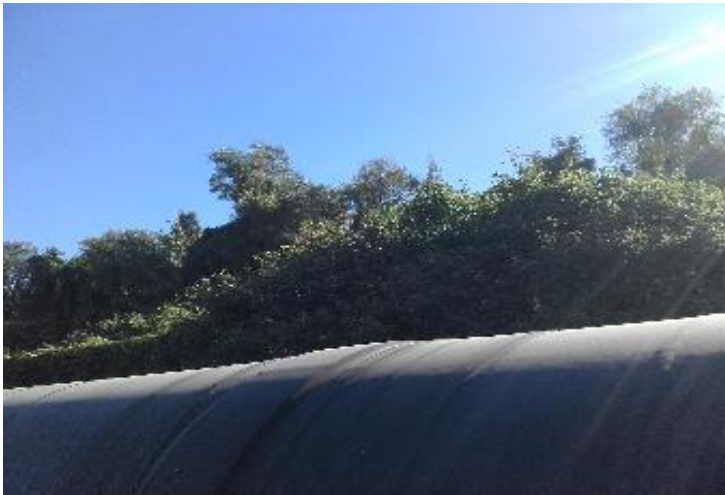
Item	Rating (1 - 5)	Comments	Photo #
External Protective Coating	2		
Pipe Joints (Welded)	N/A	No visibility under wrapping	
Expansion Joints	2	Expansion Joint # 3 - No leaks. 22mm take-up remaining. Minor surface corrosion	
Anchor Blocks	2	Minor chips and cracks	
Pipe Cradles / Footings / Rockers / Sliding Supports	2		
Fasteners (loose, missing, corroded)	2		
Drainage	2	Good - water drains into canal or stormwater drains. Drain is partially overgrown with vegetation	
Pipeline Cutting / Embankment / Retaining Walls	3	There is overgrown vegetation on embankment	
Access Roads / Tracks	3	Good access on canal side	
Armco Railing	N/A		
Fences, Gates and Padlocks	N/A		
Stairs, Ladders and Access Platforms	N/A		
Corrosion Protection Test Points	N/A		
Other (Specify)	N/A

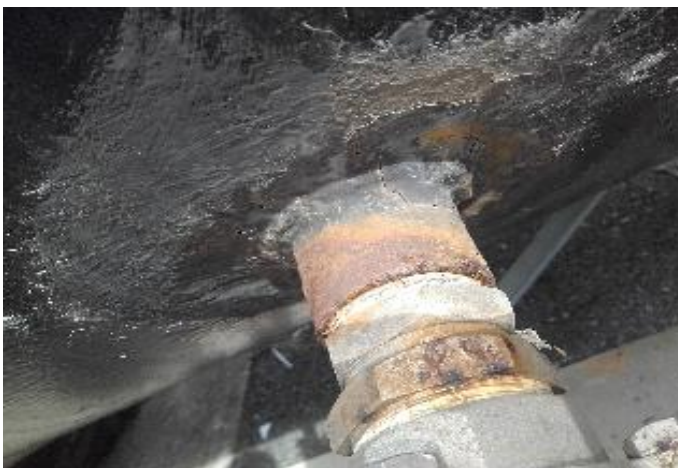
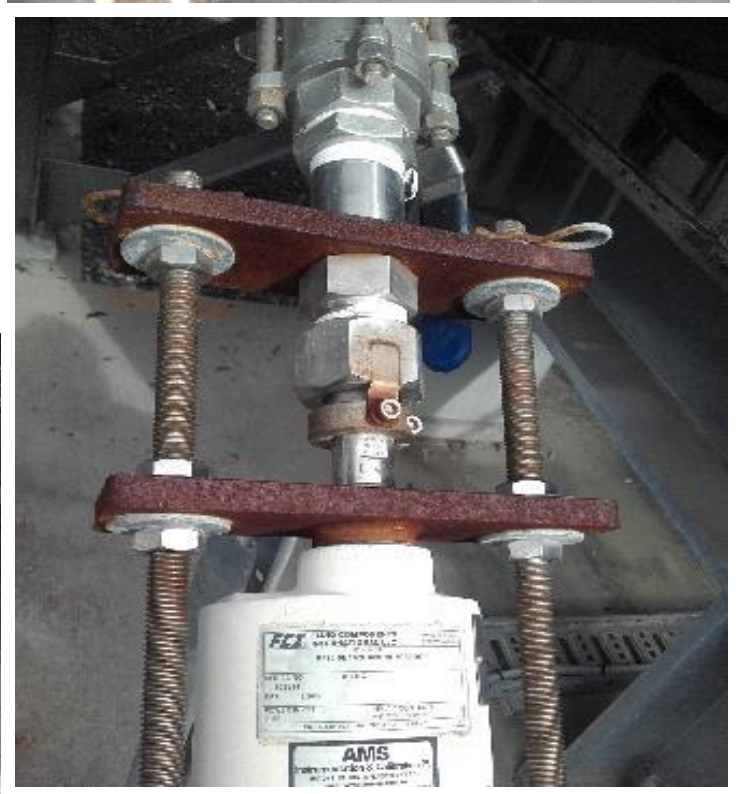
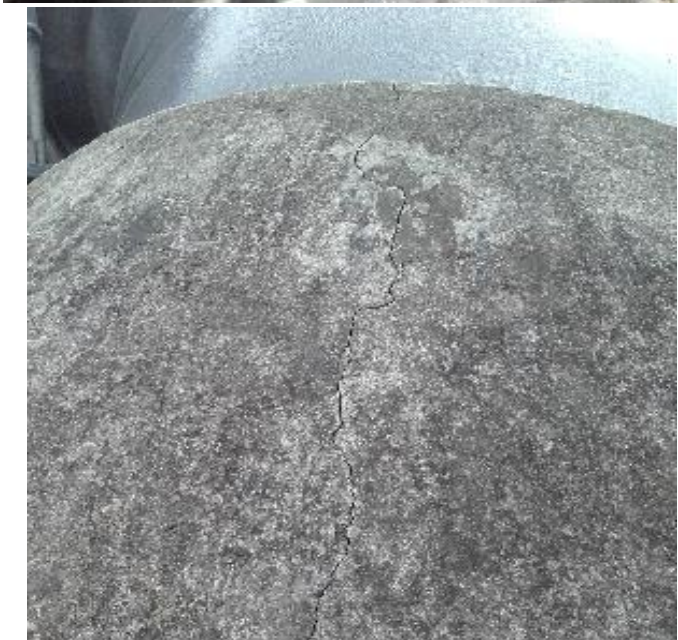
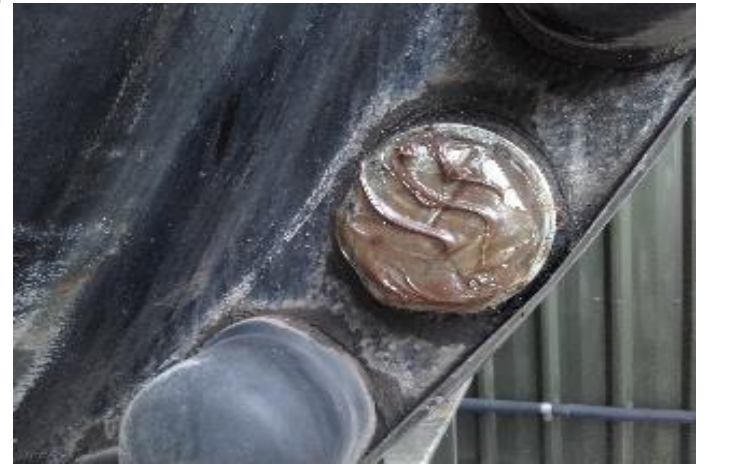
13. There is a longitudinal crack in the concrete encasement of the pipe where it rises from underground at Shaft 11C.

14. At Shaft 11C, there is corrosion and cracking where the flow switch is connected to the main pipe. There is also surface corrosion on the metal brackets used to secure the flow switch.

15. The protective tape wrapping on pipe flanges at Shaft 11C is in poor condition (several holes, coming loose from flange)

Repair cracking and patch paint where the flow switch at Shaft 11C is connected to the main pipe. Patch paint or replace metal brackets used to secure the flow switch.	Medium	Reliability of Supply
Blast and repaint of failed protective coating at Kurnell Pump Station, Shaft 11C and large flanges under air valves	Medium	Cost
Patch repair or epoxy pressure grout longitudinal crack in the concrete encasement of the pipe where it rises from underground at Shaft 11C.	Medium	Cost
For valves that are immersed for long periods of time, ensure that the pits are dewatered at least every 5 years and conduct a thorough inspection of the valve to assess and record its condition and plan for necessary maintenance works.	Medium	Cost
Replace defective protective tape wrapping on pipe flanges at Shaft 11C.	Low	Cost
