Lockhart Shire Council
Lockhart and The Rock Swimming Pools
Assessment Report

December 2014

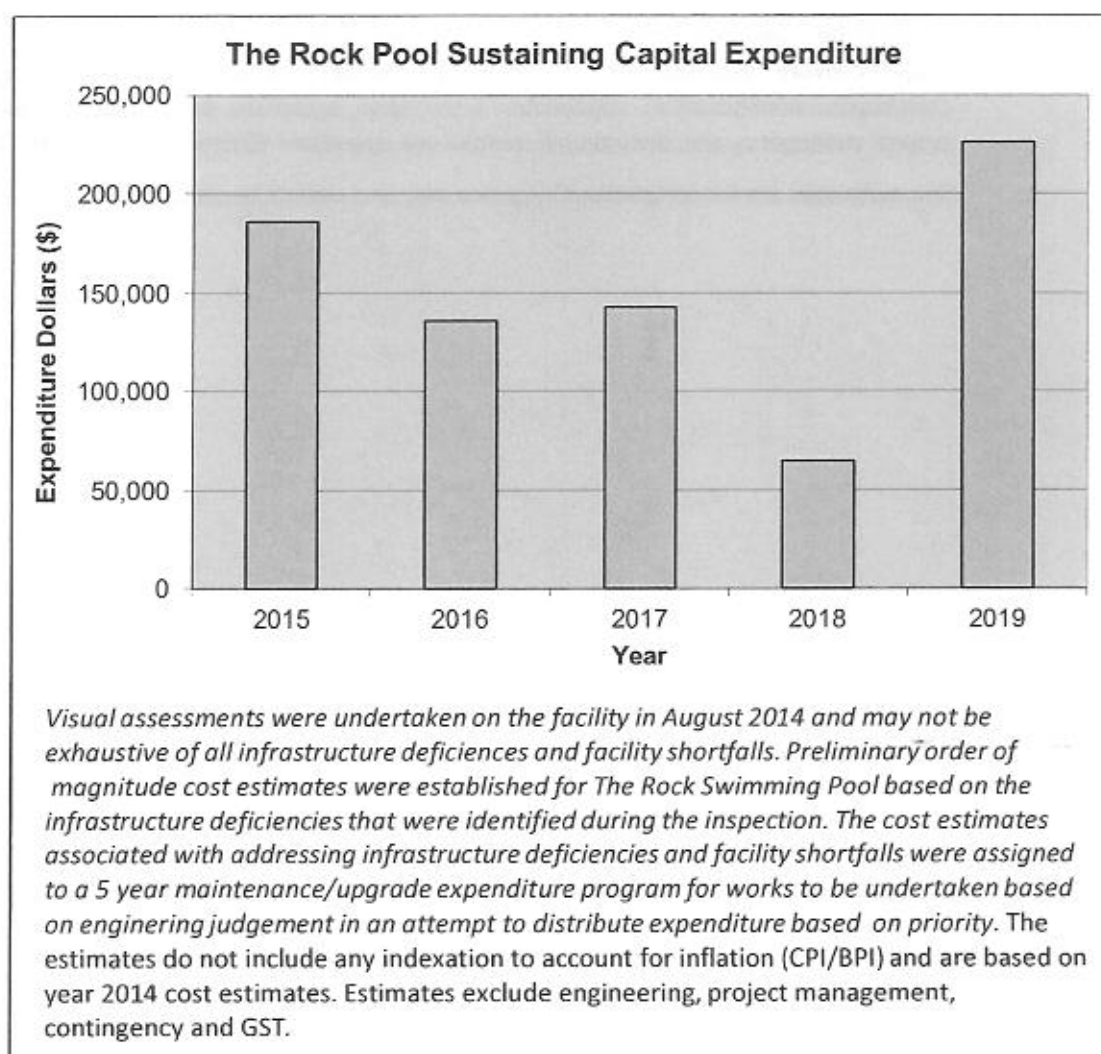
Figure 2 The Rock Swimming Pool Programmed Maintenance

Preliminary order of magnitude cost estimates were established for the Lockhart and The Rock Swimming Pools based on the infrastructure deficiencies that were identified during the inspection. The cost estimates associated with addressing infrastructure deficiencies and facility shortfalls were assigned to a 5 year maintenance/upgrade expenditure program for works to be undertaken based on ongoing judgement in an attempt to distribute expenditure based on priority. These estimates can be found in Appendix C and are summarised below in Figure 1 and Figure 2. The estimates do not include any indexation to account for inflation (CPI/BPI) and are based on year 2014 cost estimates. Estimates exclude engineering, project management, contingency and GST.
