STRATEGIC ENVIRONMENTAL
AND ENGINEERING
CONSULTING

Re: Chelsea Gardens Estate

SEEC have been invited by Aoyuan International (our client) to respond to peer reviewed comment on SEEC report 2000035-LC by 03/05/2022 to align with a scheduled meeting between the client and Wingecarribee Shire Council. The report in question has multiple revisions it is assumed the comments made relate to the latest revision 20000305-LC-03 dated 6/11/2020. Comments made by the peer reviewer and SEECs response are presented below:

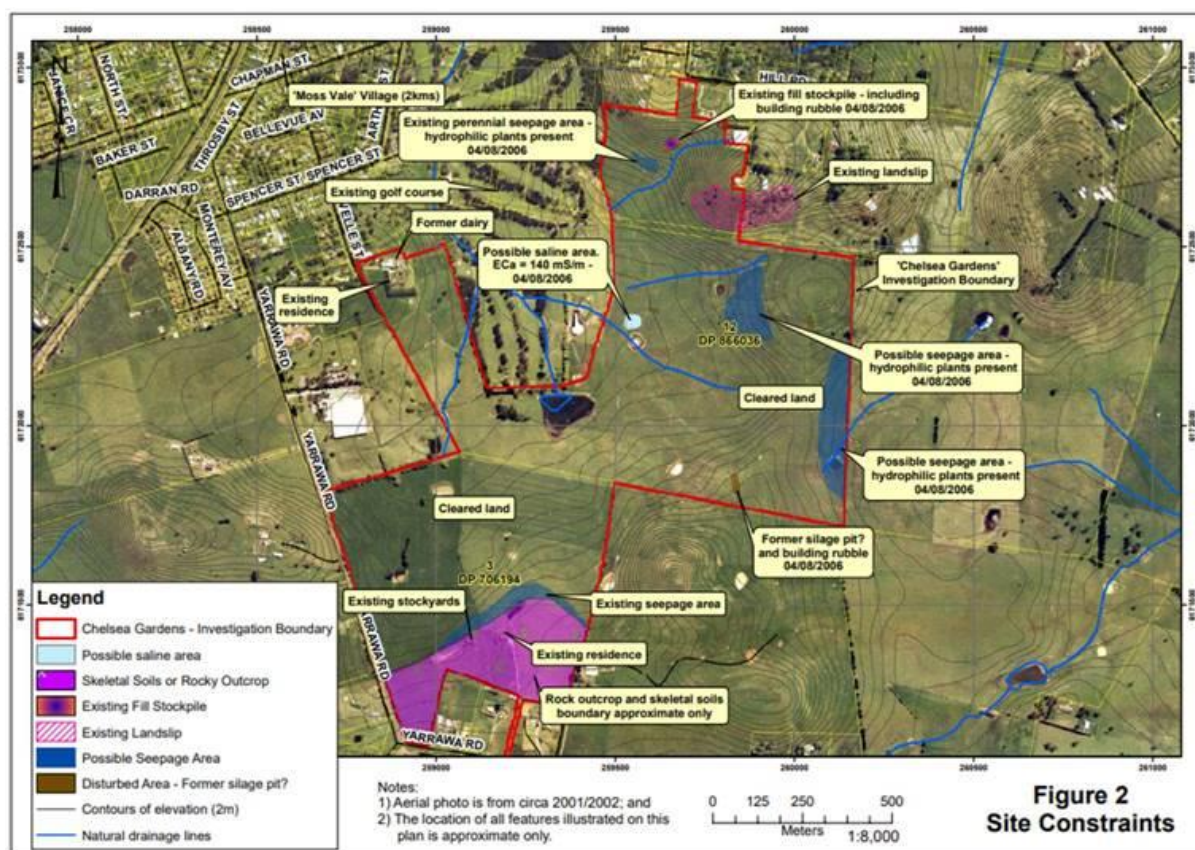
Copy of Figure 2 from Harvest Report 2006.

At Page 7, an area of seepage is reported as having been observed around the rock outcrop on the south-east portion of the site (currently planned for Stage 2). This area is identified in Figure 2 as being around the perimeter of the purple-coloured rock area and is distant from the proposed irrigation area in the east of the site.

Further, an existing perennial seepage area is noted as having been observed in the northern portion of the site. This area is located to the north of Shelly Road in Figure 2 and again distant from the proposed irrigation area.

At page 7, the report there is a comment that “rush plant species (*Juncus* sp) were observed sporadically over the major part of this site. This plant species indicates that the site is probably poorly drained (in places) and possibly intermittently saturates.” There are two areas in Figure 2 which are adjacent to the proposed irrigation area where these plants were observed. It is noted that these areas are not identified as seepage areas, just areas with rush plants.

At page 20, the Harvest Report confirms that “During field investigations on the 4th of August, 2006, two main areas of seepage were observed on this property (Figure 2). The first

of these was located in the northern portion of the CGDS in the steep area near hill road and the second occurs in the southern portion of this CGDS at the base of the syenite/microsyenite plateau.” Both of these areas are identified in Figure 2 and are both distant from the proposed irrigation zone.

It is noted that SEEC Test pits 2 and 5 are located in the eastern blue area marked in the Harvest Figure 2 as a “possible seepage area” and that SEEC Test pits 4 and 7 are in the

other blue area marked in the Harvest Figure 2 as “possible seepage area” located to the immediate west of the proposed irrigation area.

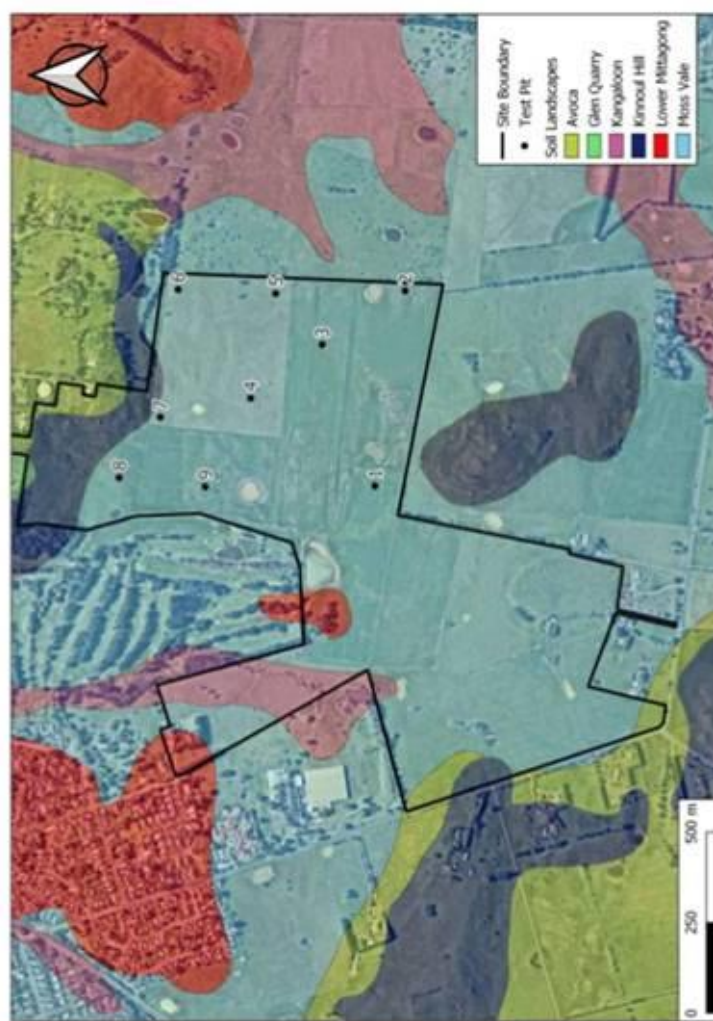
The Land Capability Assessment (LCA) completed by SEEC in October 2020 was based on 9 test pits with the test pits being spread across the proposed irrigation site as indicated in Figure 4 of the LCA (copied below).

Figure 4: Soil Landscapes and Location of Test Pits.

Copy of Figure 4 from SEEC LCA.

These SEEC test pits were excavated to a depth of at least 1m and no sign of saturation or seepage was noted. The soils were generally classified as being “moderately well drained”.
