Rosehill Network Pty Ltd – WICA Application

BACKGROUND OF Rosehill Recycled Water Scheme ('RRWS')

Rosehill Network Pty Ltd – WICA Variation Application

Rosehill Recycled Water Scheme

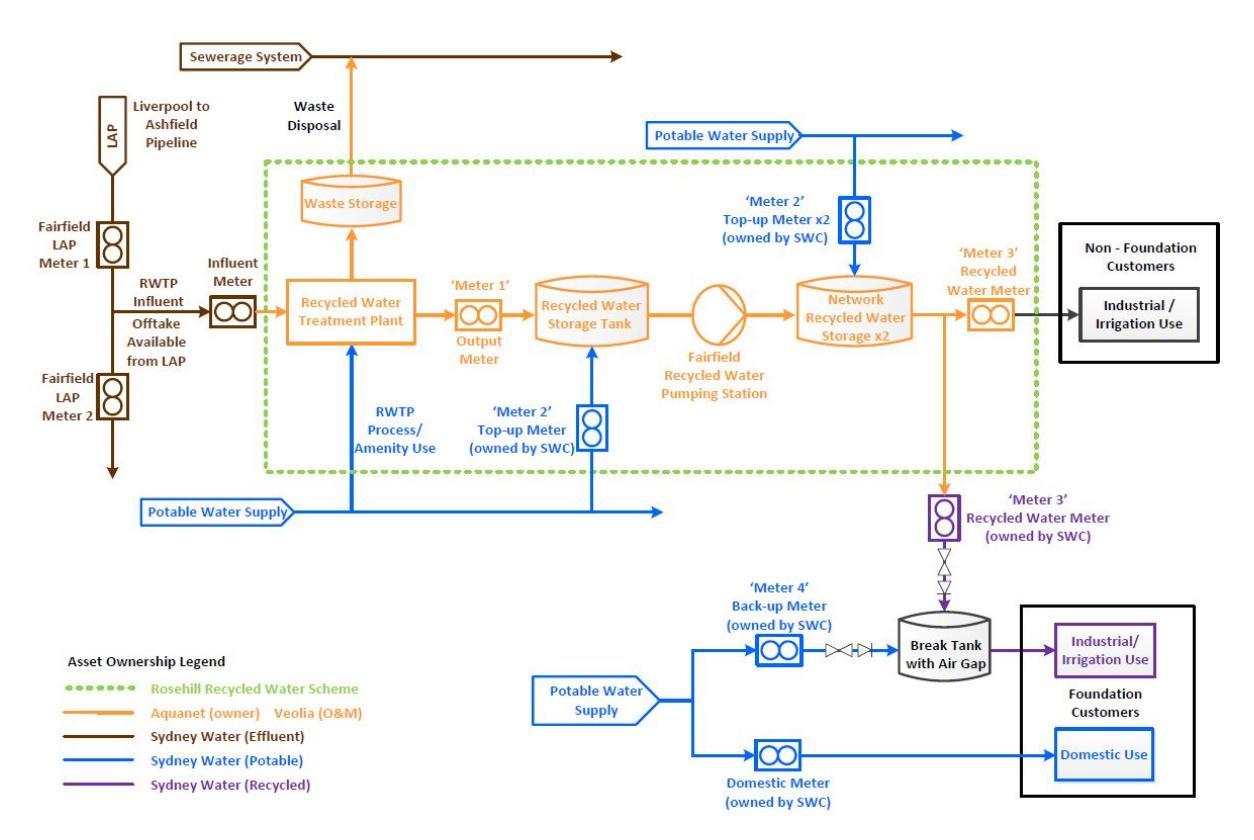
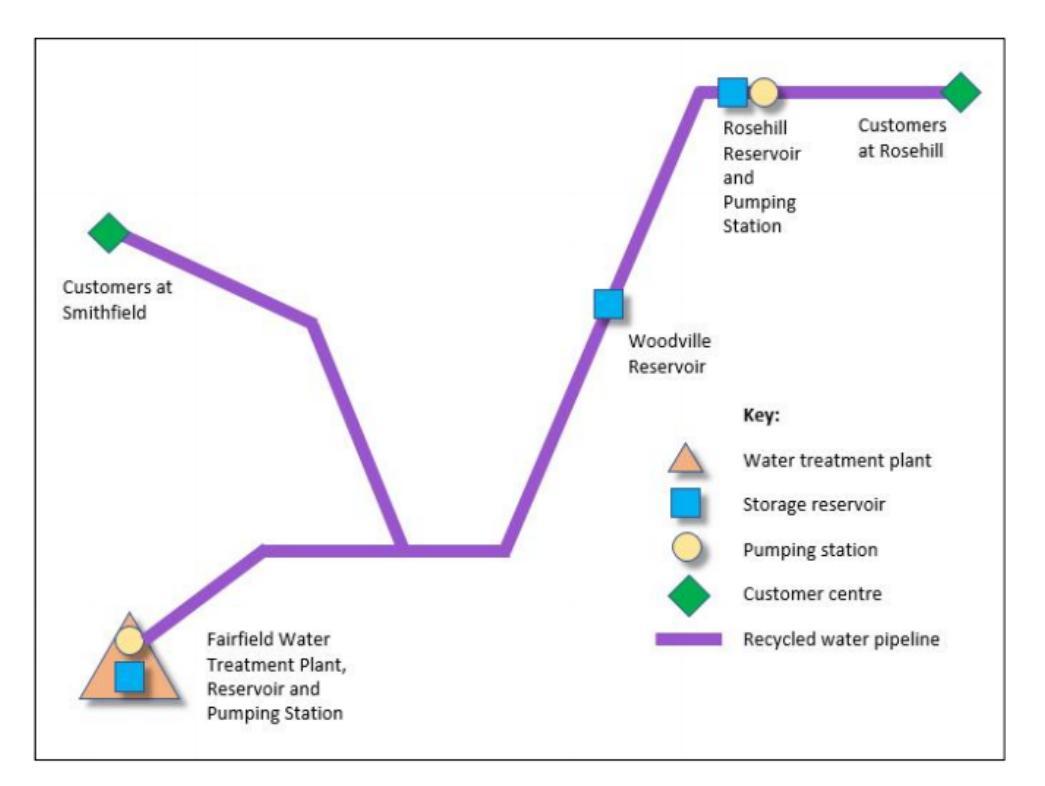
Image 2.2 - RRWN Schematic

- Effluent collection and treatment by Sydney Water and supply to the LAP
- Effluent extraction at the LAP
- Plant (including treatment by reverse osmosis, ultrafiltration, chlorination and other processes)
- Trade waste pumped to the Sydney Water sewerage system
- Network (consisting of pipes, reservoirs and pump stations)
- Potable water connection points
- Customers

A detailed description of the RRWS is provided in the Veolia Document, *PRO-3820-3 Rosehill Recycled Water Scheme Overview*, and shown in the images below.

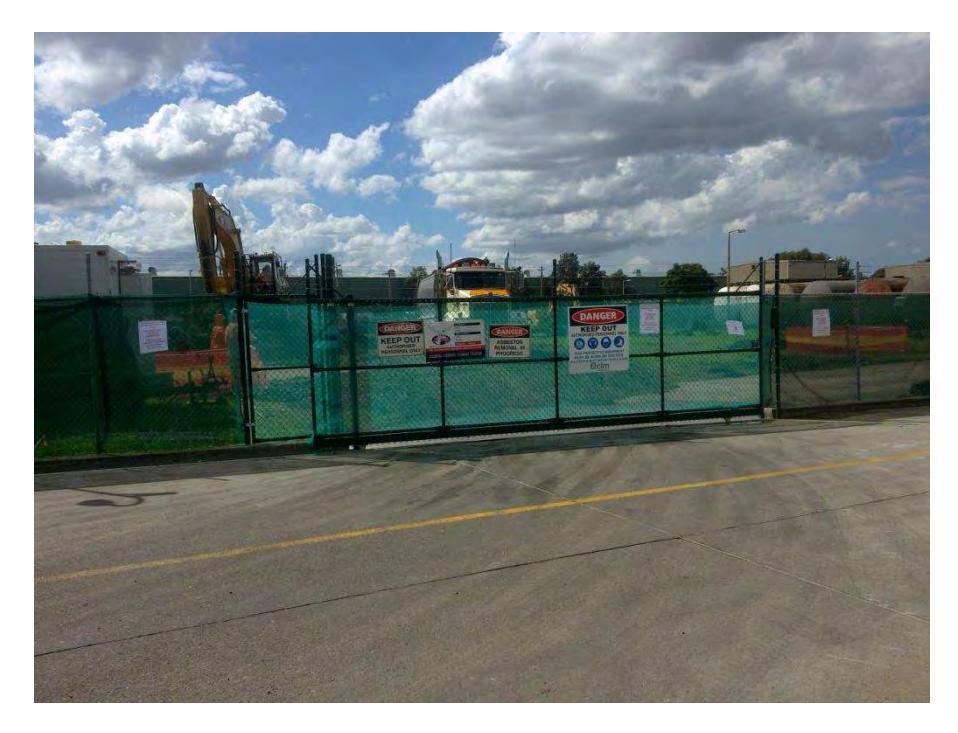
Site establishment works included setting out of site boundaries, placement of shade cloth on perimeter fencing and posting of signage on perimeter fencing (refer Image 5.2.1).

Image 5.2.1 Site establishment, south west corner

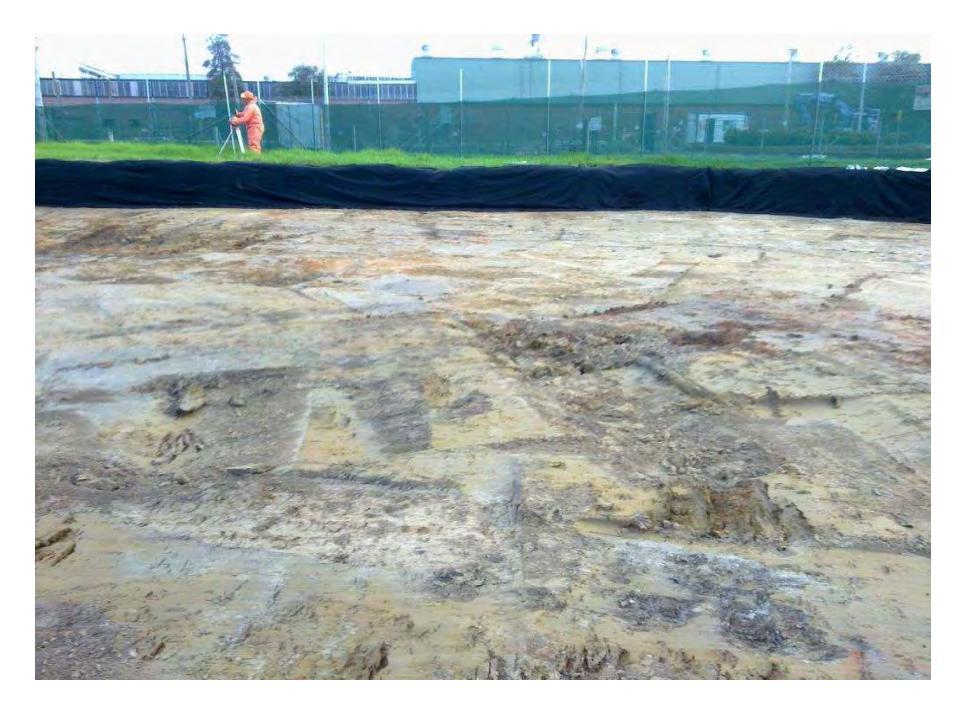
The horizontal extent of excavation across the site included removal of fill material to the northern and eastern limits of the site boundary (refer Image 5.3.1 to 5.3.2).

Image 5.3.1 Northern extent of excavation, exposing natural soils

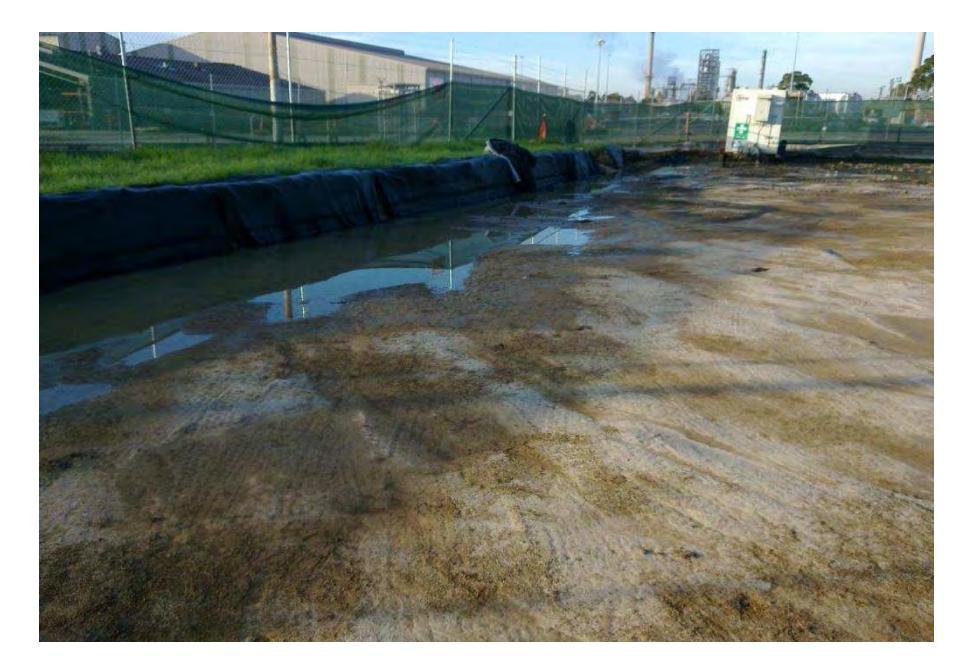
Image 5.3.2 Eastern extent of excavation, exposing natural soils

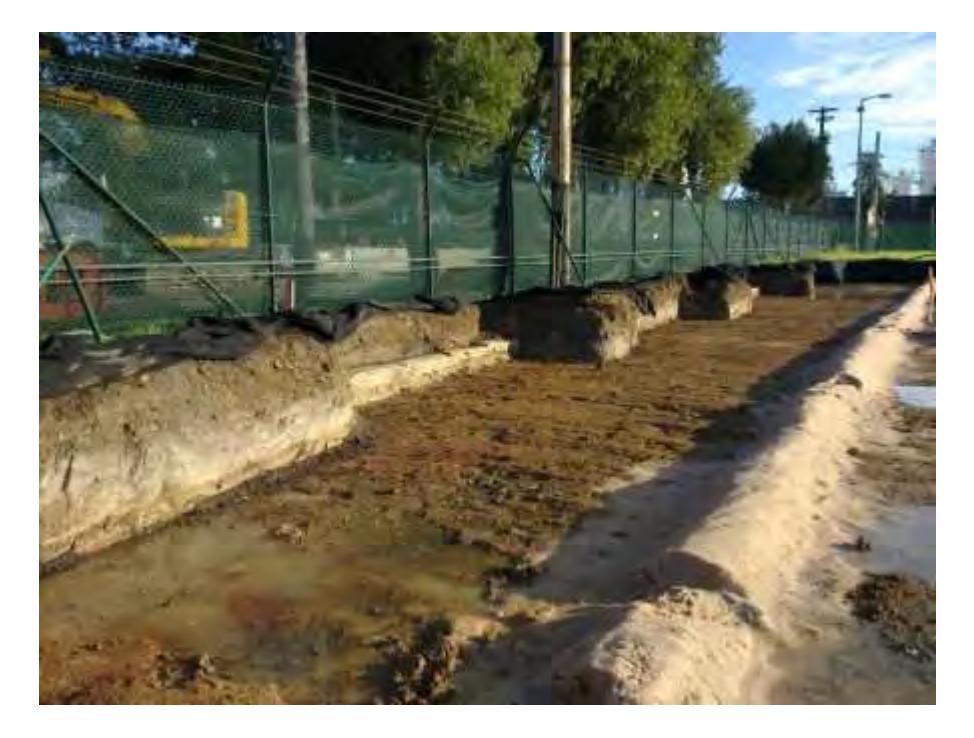
The horizontal extent of excavation towards the west was to the site boundary in some areas and to within a 1m to 2m radius in the vicinity of aboveground structures on the site, which included footings for boundary fence stay footings, a light pole and fire water main infrastructure (refer Image 5.3.3 to 5.3.4.

Image 5.3.3 Western extent of excavation (fence stays footings and light pole)

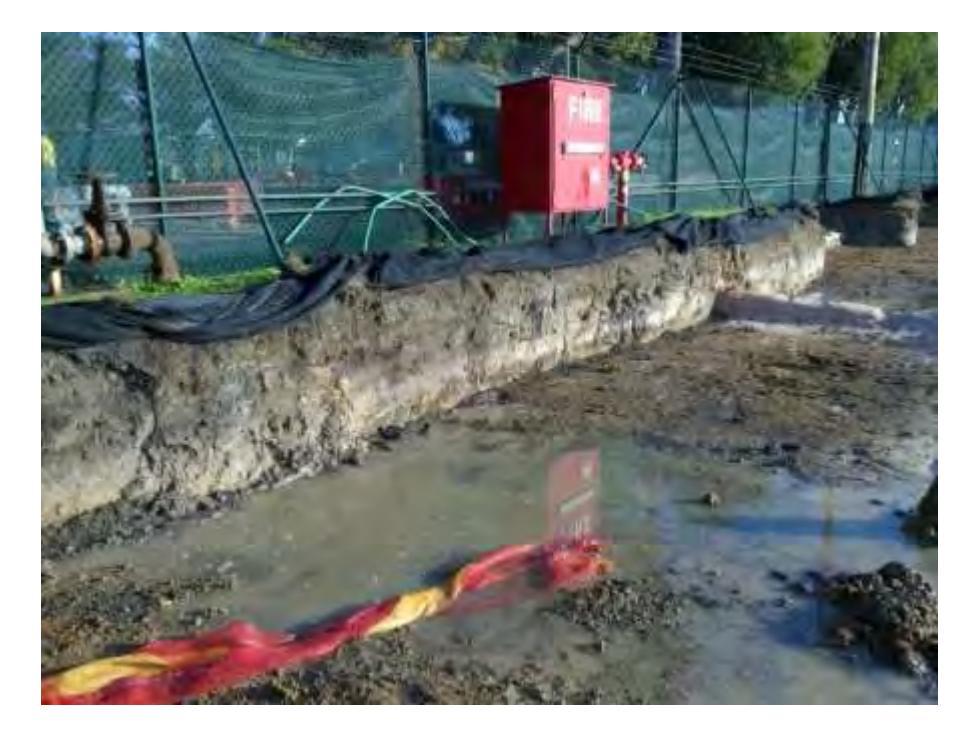
Image 5.3.4 Western extent of excavation (fire water main infrastructure)

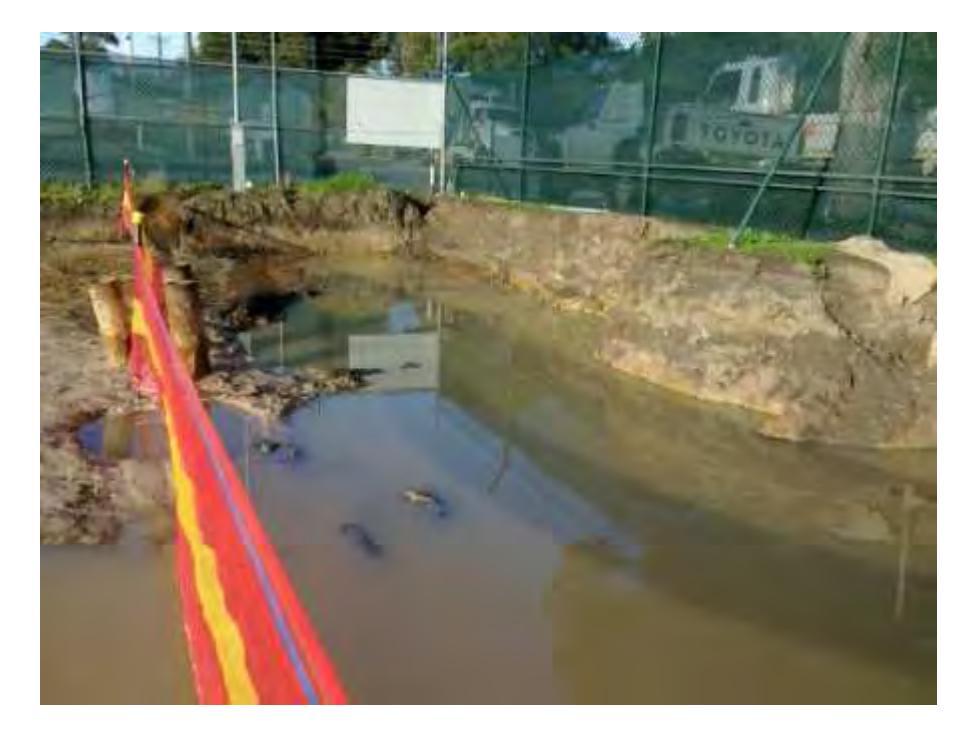
The horizontal extent of excavation towards the south was to the site boundary in some areas and to within approximately 1m to 2m of the boundary in the vicinity of aboveground structures on the site, which included a security camera pole, a concrete driveway and a concrete slab overlying storm water infrastructure (refer Image 5.3.5 to 5.3.6).

Image 5.3.5 Southern extent of excavation (security camera pole)

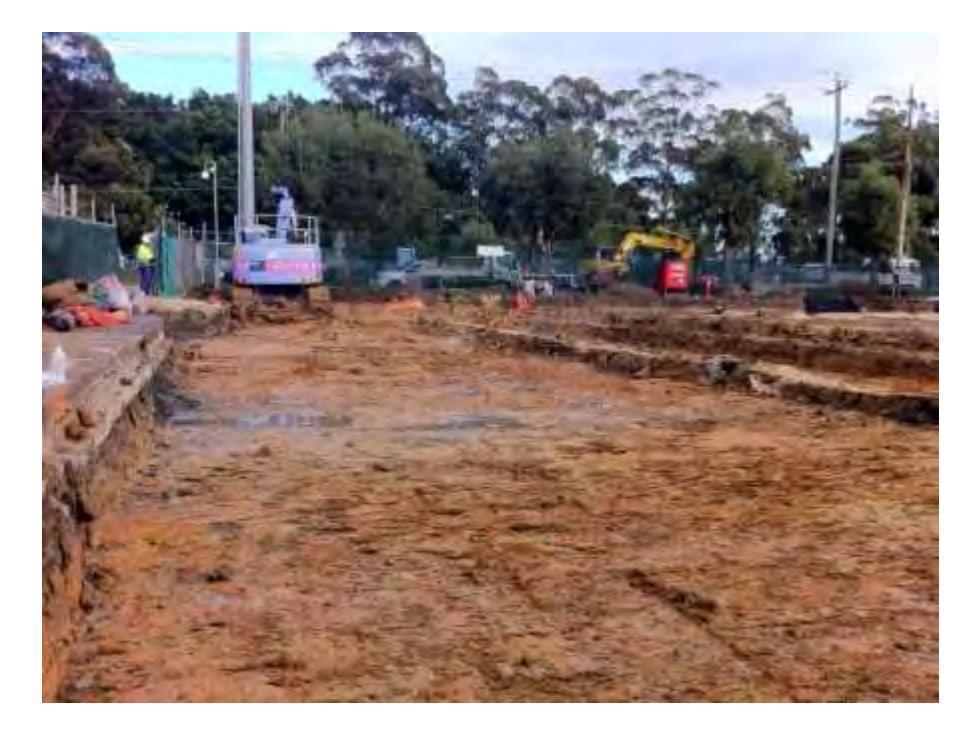
Image 5.3.6 Southern extent of excavation (retained concrete slab and driveway)

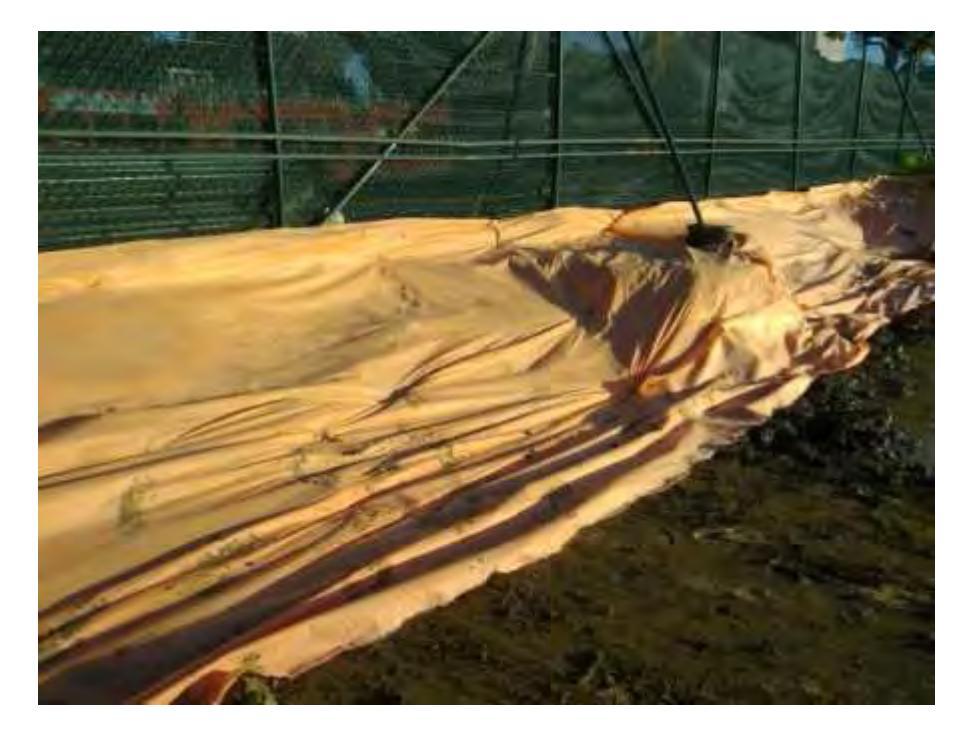
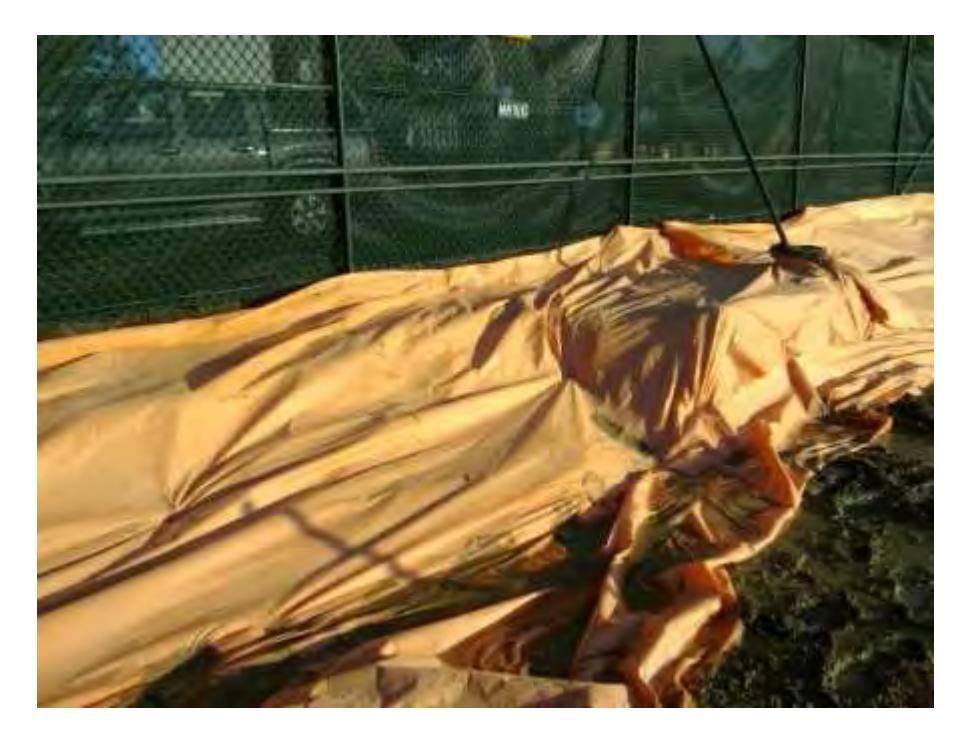
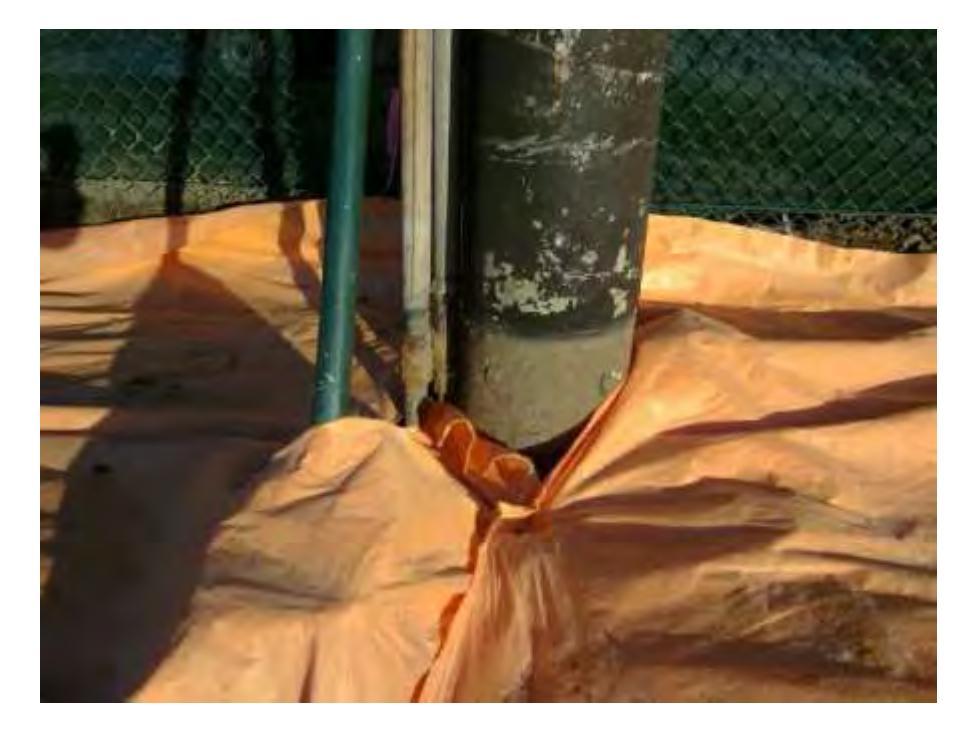
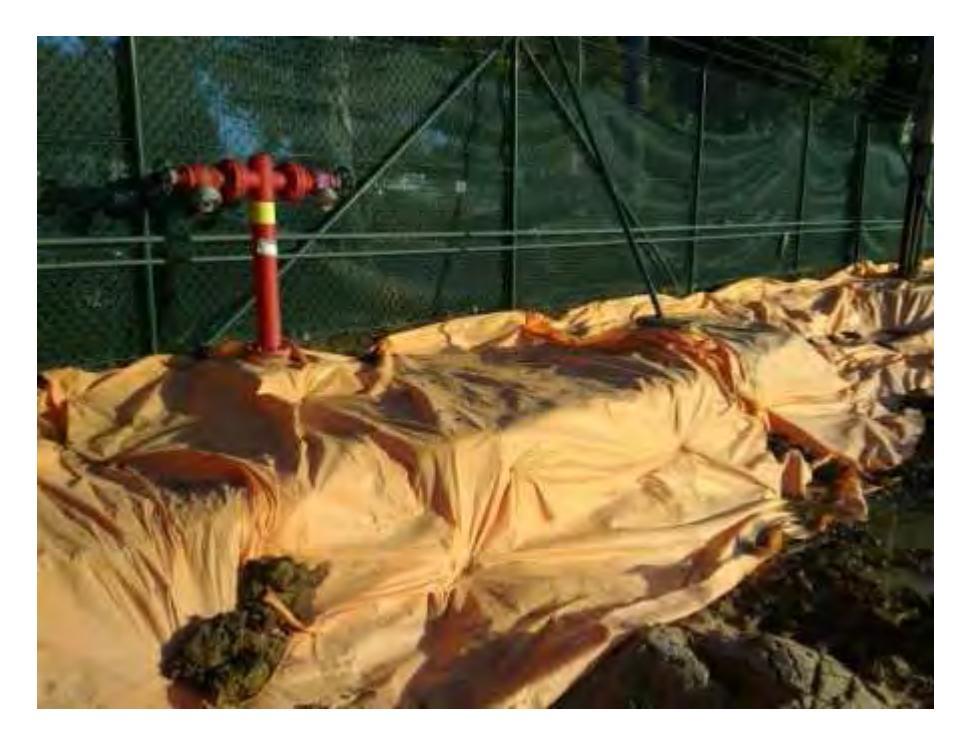
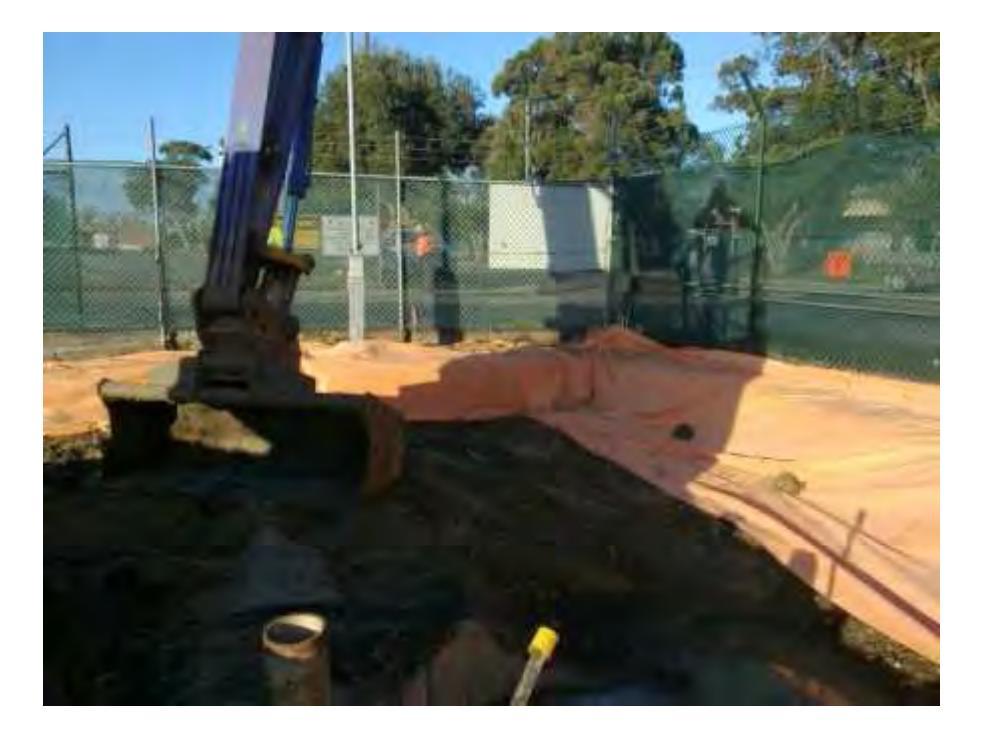
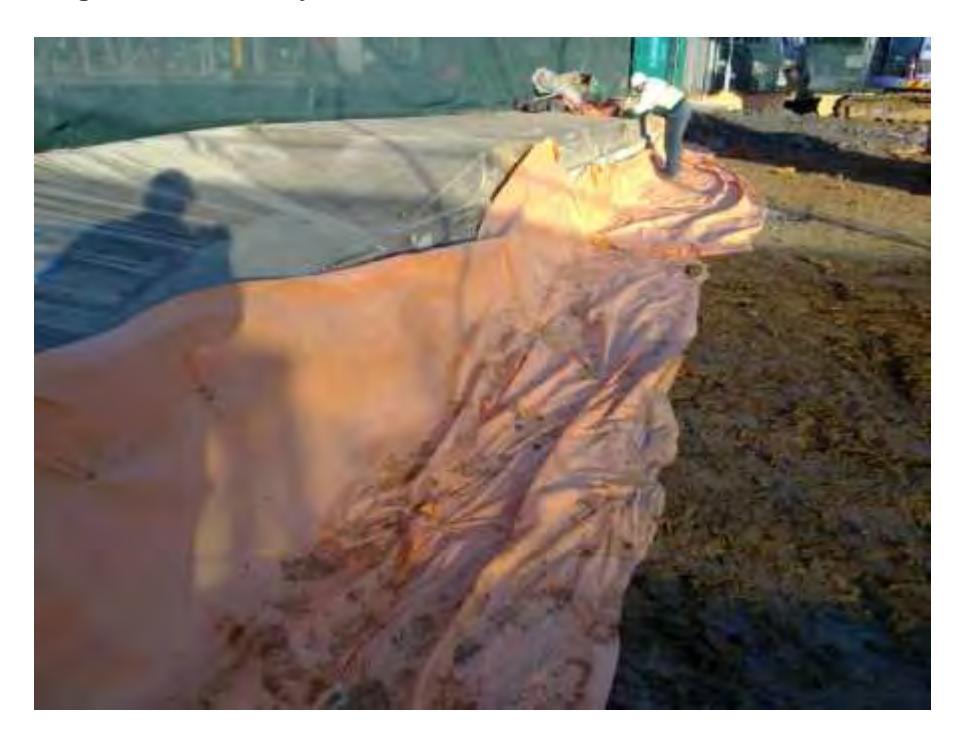
An orange geotextile marker layer was placed over the retained fill, with the exception of surfaces already covered with concrete slab (i.e. along southern boundary). At these locations, the marker layer placement was limited to the excavated walls of the retained fill. It was noted that the horizontal extent of the marker layer extended along the entire length of the western boundary (including those areas where excavation works had extended to the site boundary), to facilitate installation of the layer. The marker layer was a high visibility (orange) geotextile, selected because it allows infiltration of moisture and is not susceptible to biodegradation. A specification sheet for the geotextile selected for the marker layer, is presented in Appendix C. Images 5.4.1 to 5.4.6 show the installation of the marker layer.

Image 5.4.1 Marker layer - north western corner

Image 5.4.2 Marker layer – western boundary

Image 5.4.3 Marker layer – western boundary (light pole)

Image 5.4.4 Marker layer – western boundary (fire water main)

Image 5.4.5 Marker layer – south western corner

Image 5.4.6 Marker layer – southern boundary

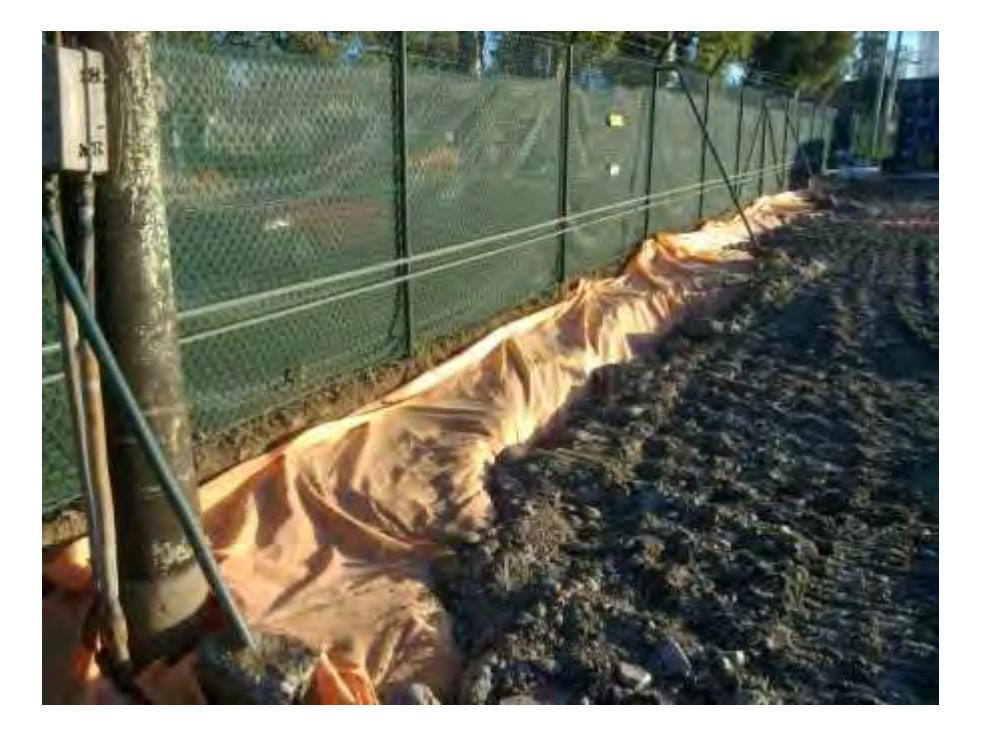
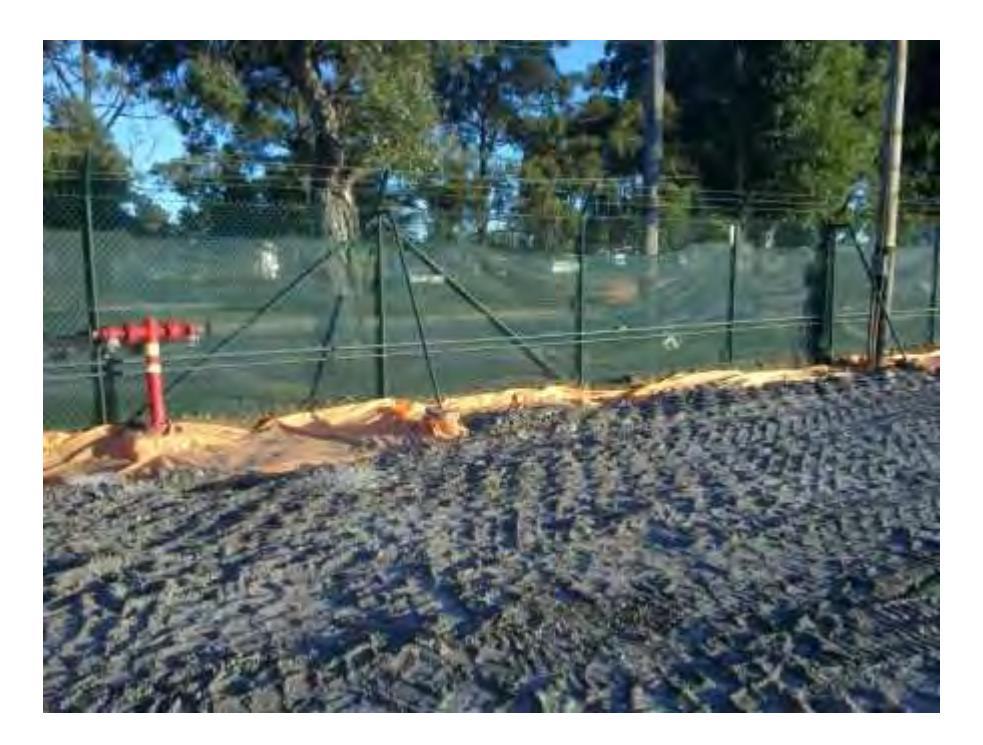
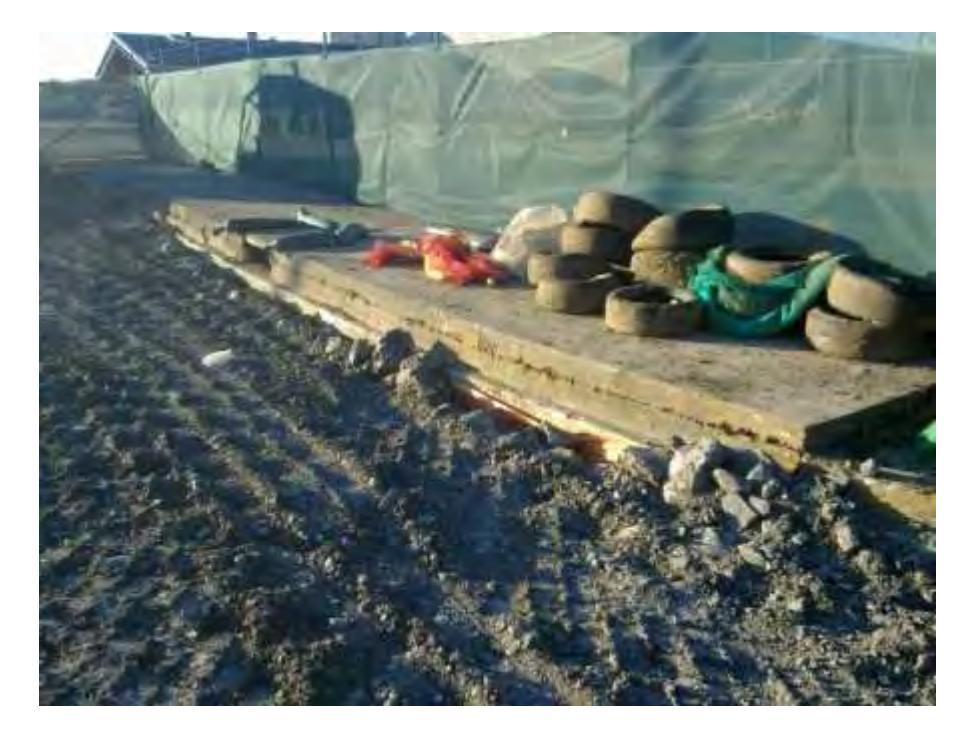
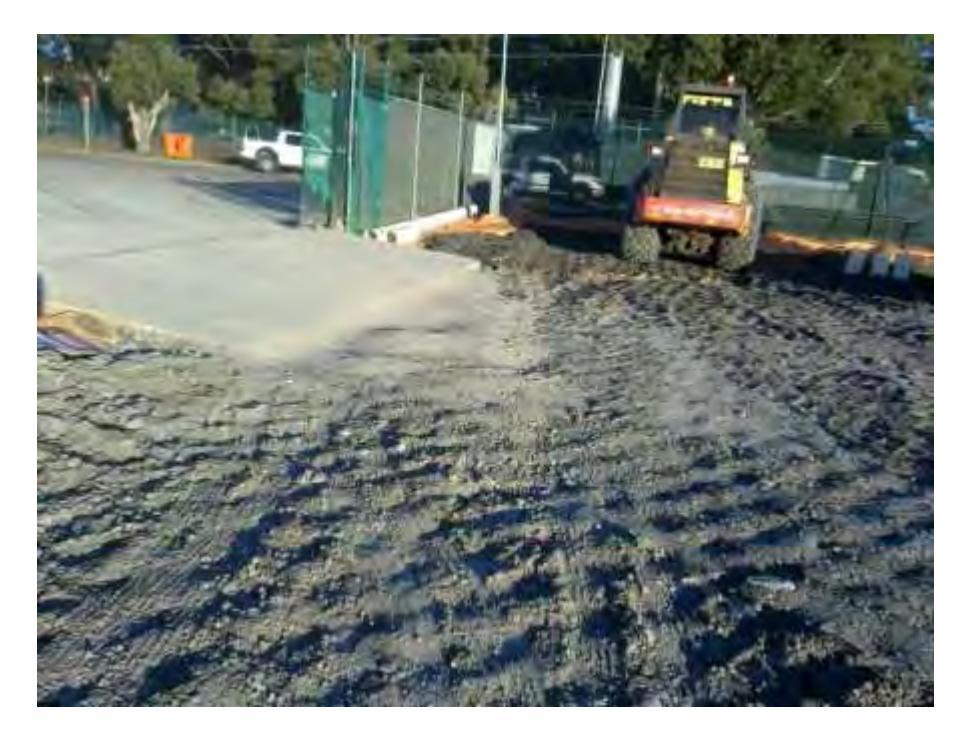
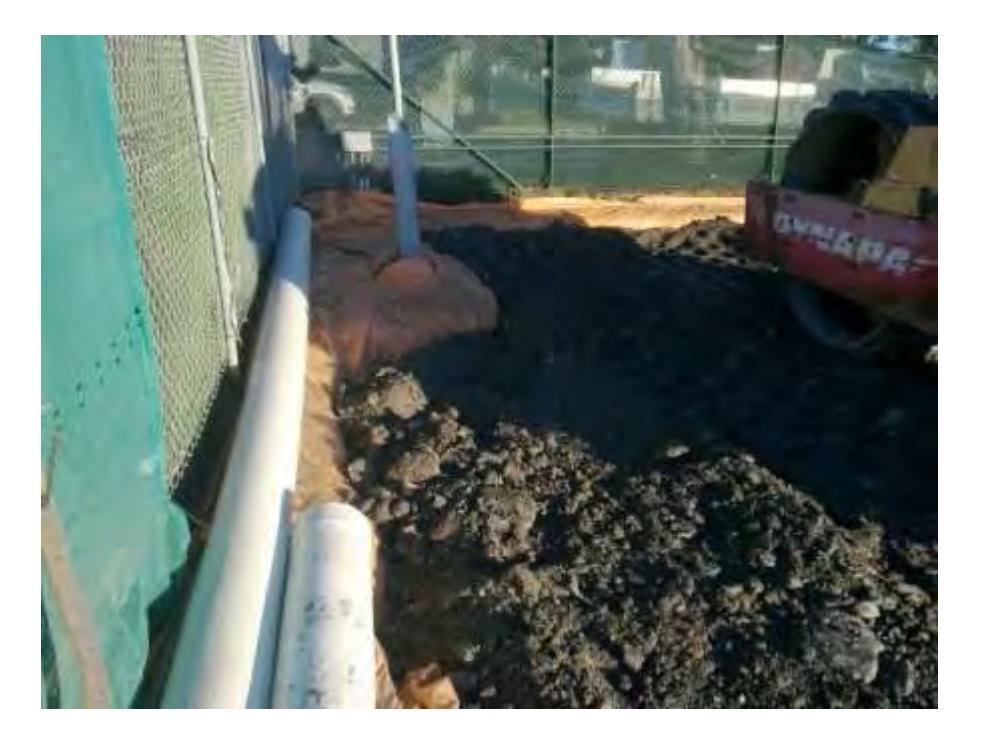
Imported material (VENM) was placed against the walls of the retained fill material to retain the marker layer in place and facilitate backfilling of the remedial excavation (refer Images 5.4.7 to 5.4.11).

Image 5.4.7 Western boundary – backfill against marker layer

Image 5.4.8 Western boundary – backfill against marker layer

Image 5.4.9 Southern boundary – backfill against marker layer

Image 5.4.10 Southern boundary – backfill against marker layer

Image 5.4.11 South west corner – backfill against marker layer

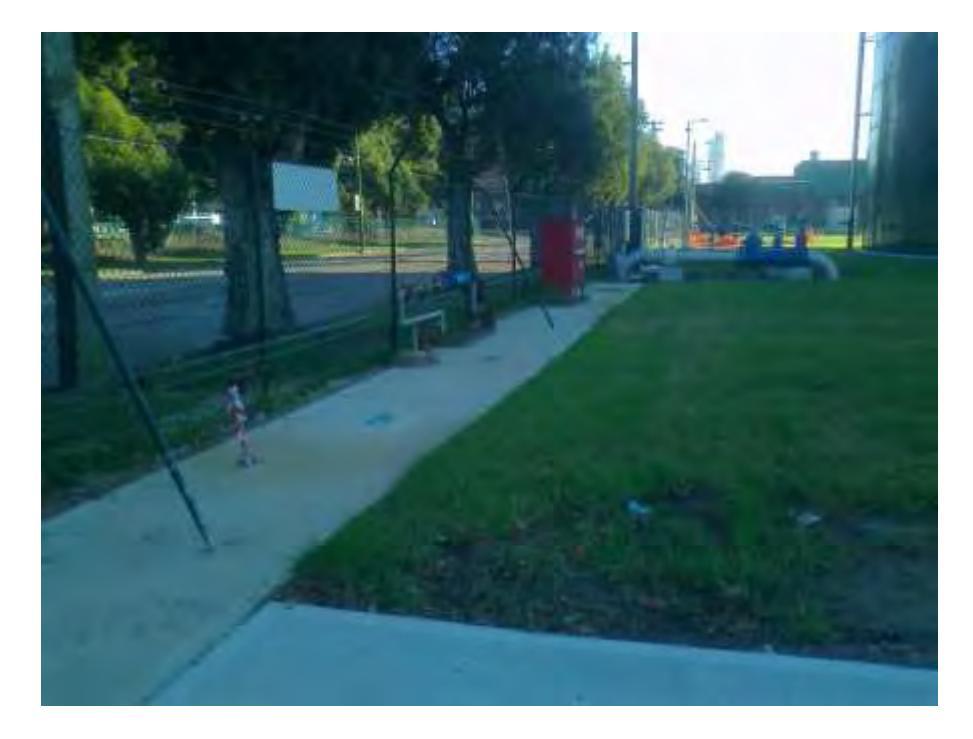
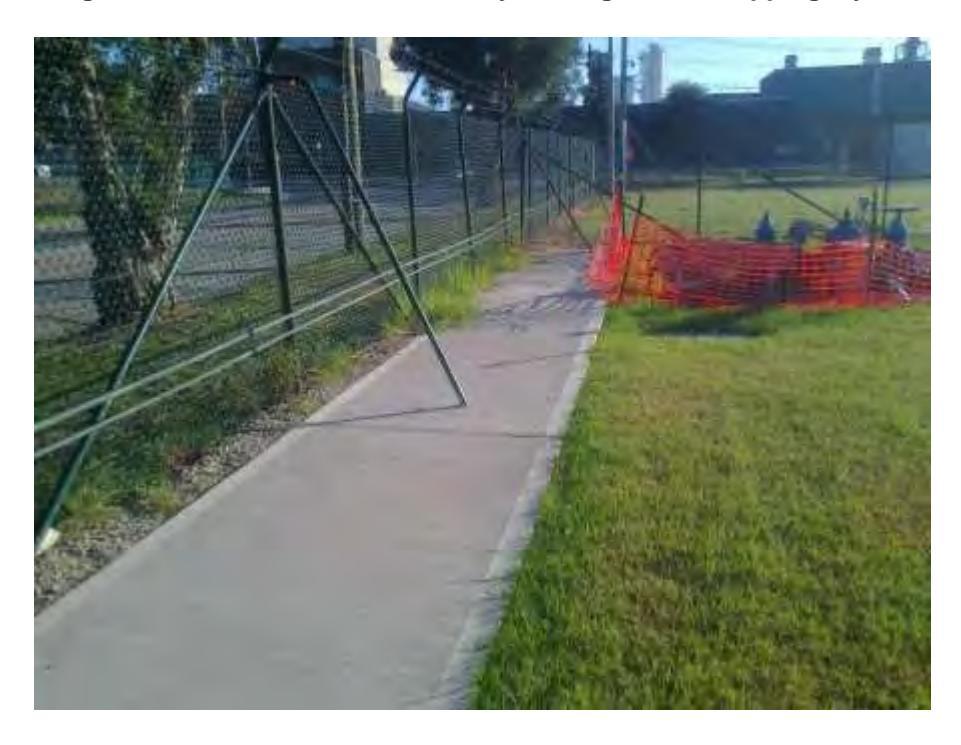
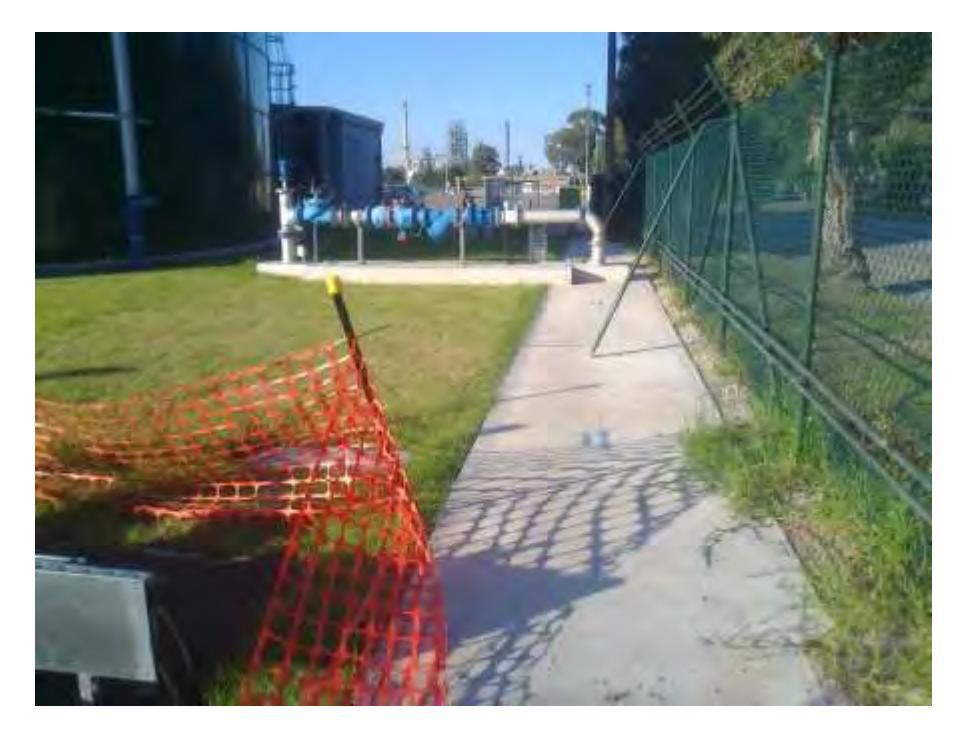
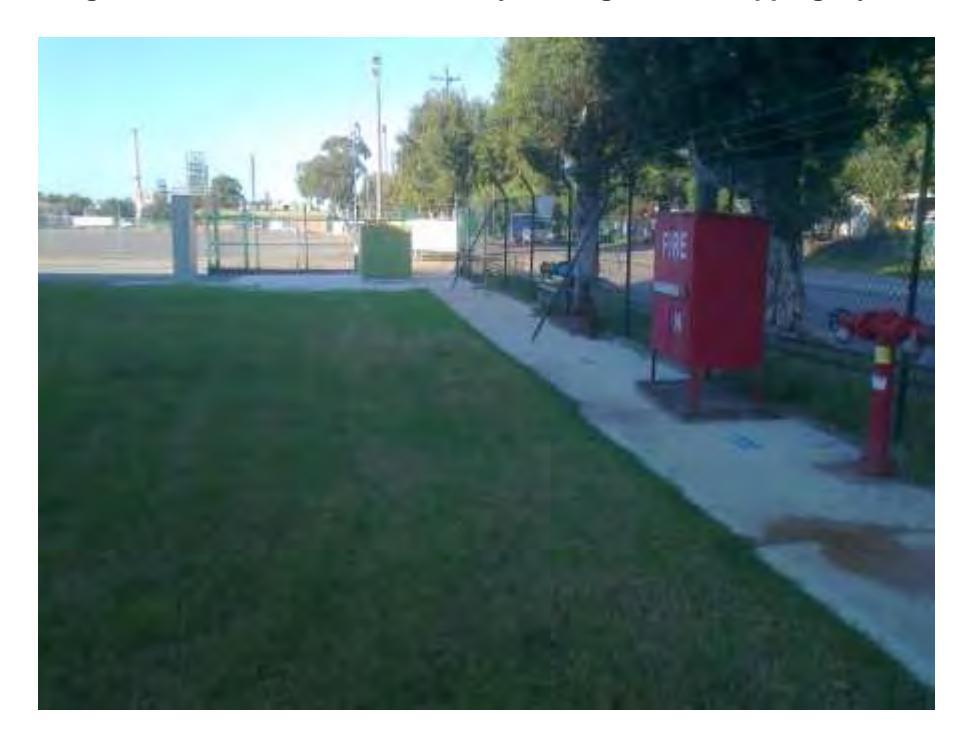
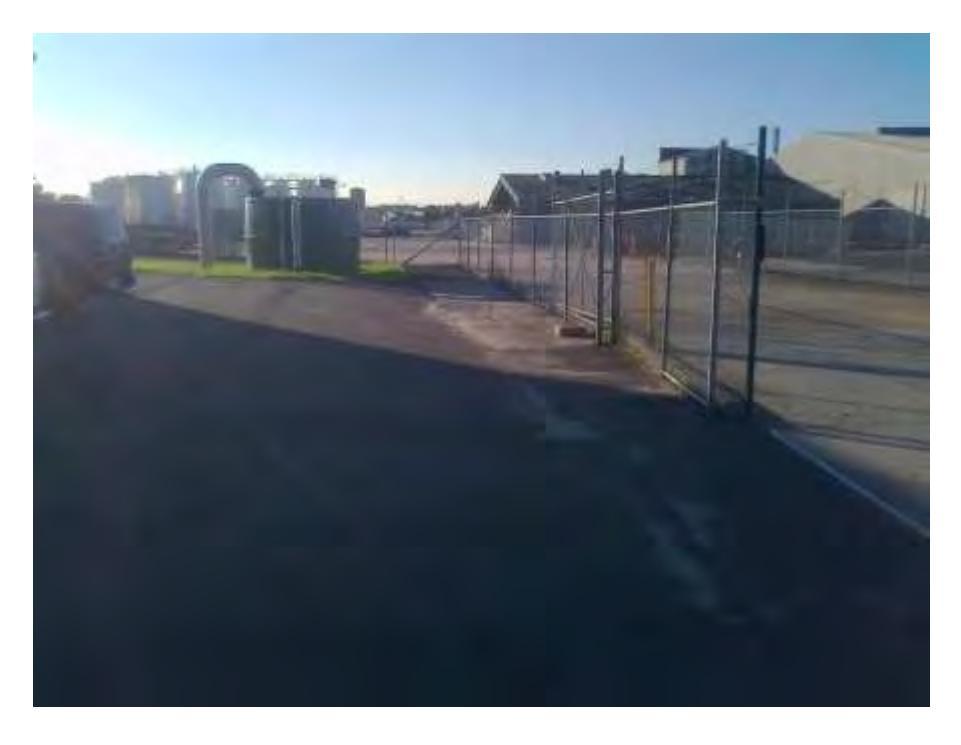
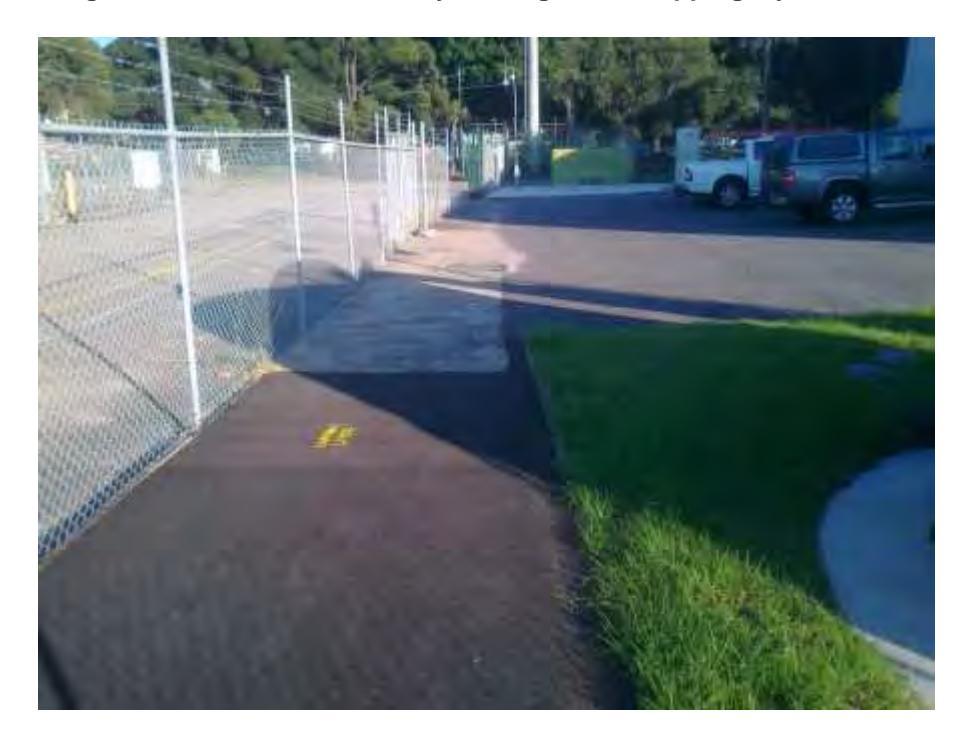
A concrete capping layer of 100mm minimum thickness (advice from Haley Short of Jemena Major Projects) was placed over the horizontal exposed surfaces of the retained fill material along the western boundary and south west corner of the site. A concrete slab (already in-situ) was located across the top of the retained fill material along the southern boundary (including along the existing gate entry, refer Image 5.4.10). Portions of the in-situ slab along the southern boundary were topped with asphalt, (eastern end and along the existing gate entry).

Image 5.4.12 South western boundary looking north – capping layer over retained fill material

Image 5.4.13 North western boundary looking north - capping layer over retained fill material

Image 5.4.14 North western boundary looking south - capping layer over retained fill material

Image 5.4.15 South west boundary looking south - capping layer over retained fill material

Image 5.4.16 Southern boundary looking east – capping layer over retained fill material

Image 5.4.17 Southern boundary looking west – capping layer over retained fill material

Evidence of the capping layer is presented in Images 5.4.12 to 5.4.11).

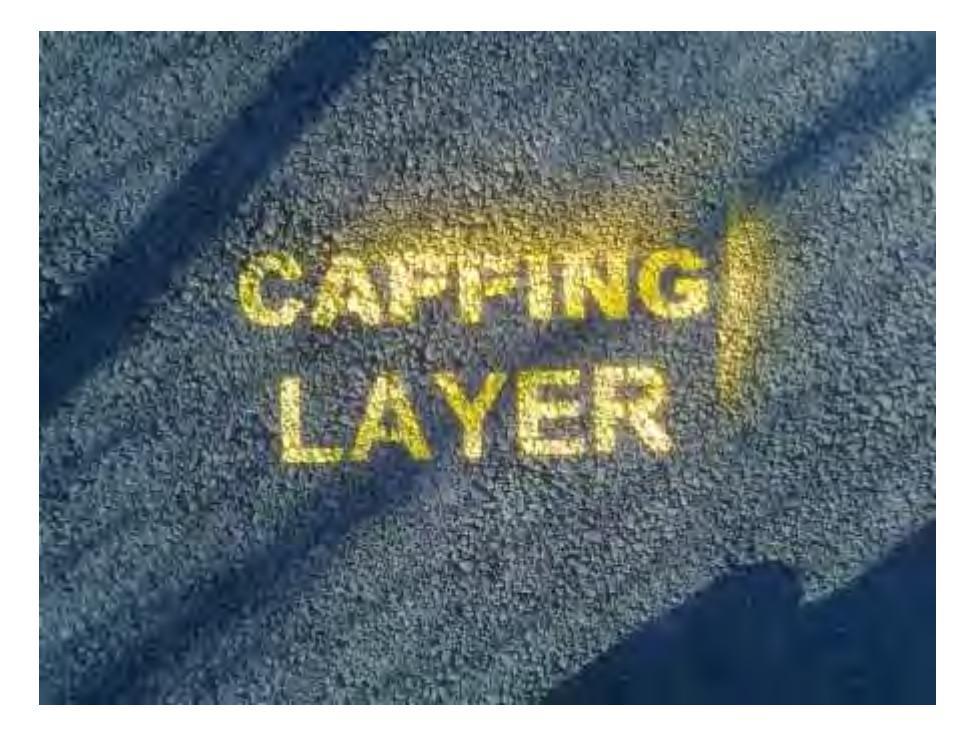
Image 5.4.18 Example of capping layer labelling
