Rosehill Network Pty Ltd – WICA Application

BACKGROUND OF Rosehill Recycled Water Scheme ('RRWS')

Rosehill Network Pty Ltd – WICA Variation Application

Rosehill Recycled Water Scheme

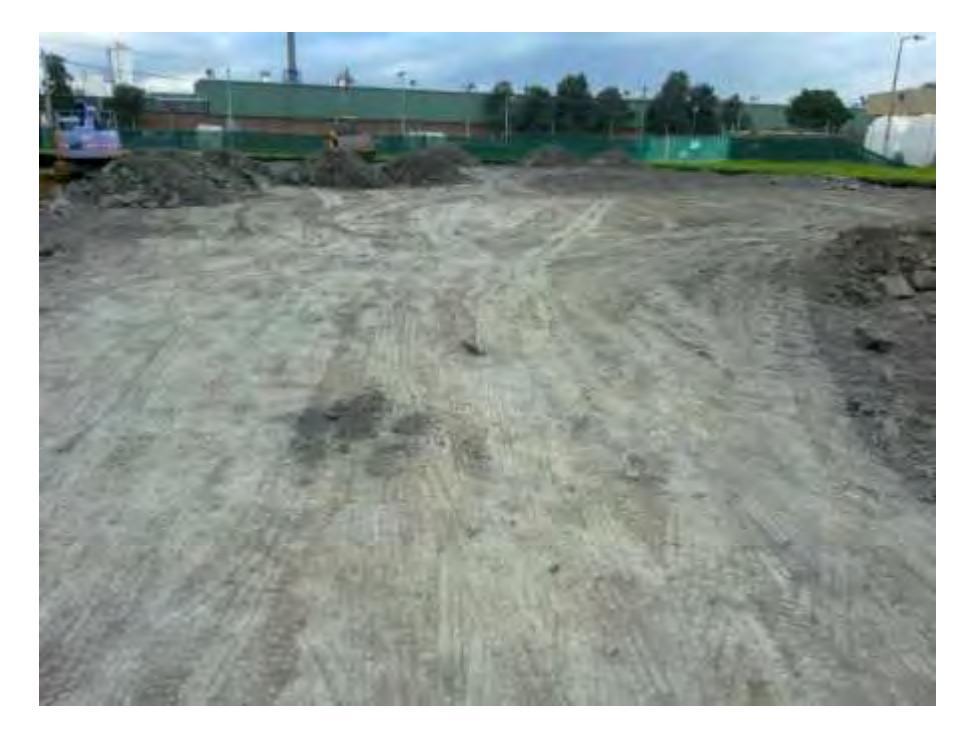
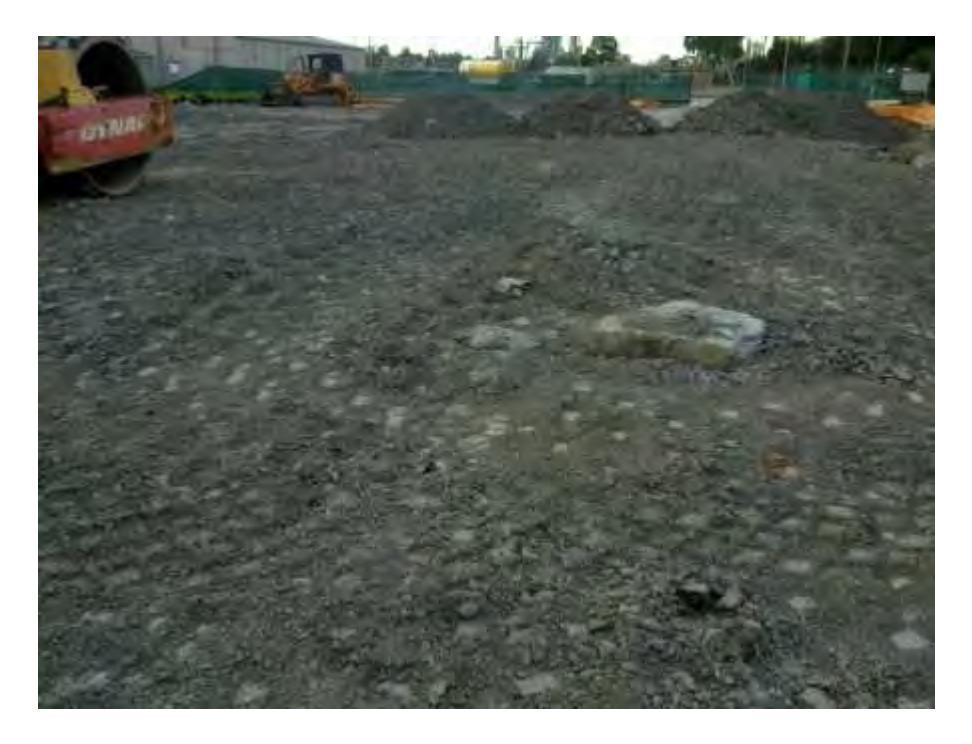
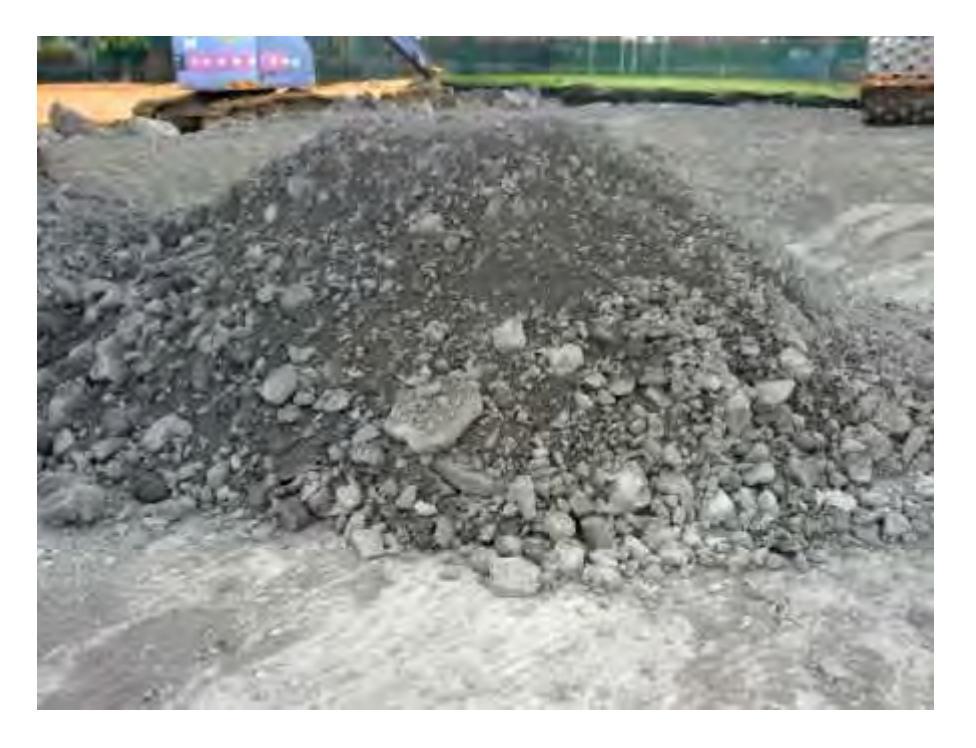
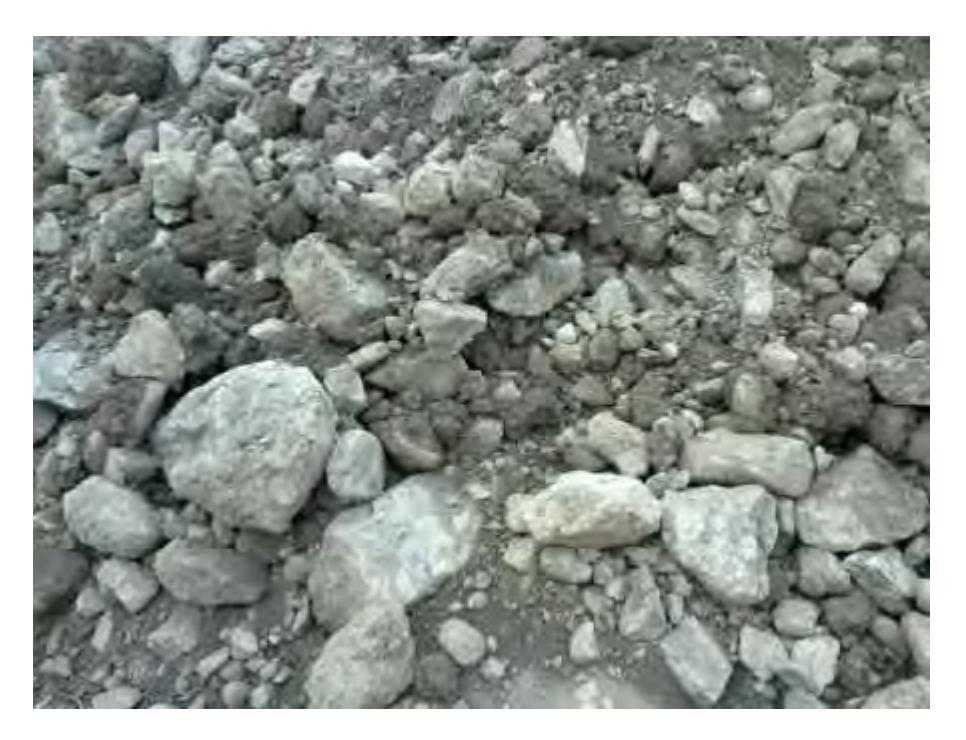
A Coffey environmental scientist observed the material being imported to the site on 9 May 2011 and the material was consistent with the material reported in Coffey Environments (2011b) (refer Image 5.6.1 to 5.6.4).

Image 5.6.1 Imported VENM on site - looking north

Image 5.6.2 Imported VENM on site - looking south

Image 5.6.3 Imported VENM on site - stockpile

Image 5.6.4 Imported VENM on site - stockpile

Based on the remediation contractor's VENM tracking records, 3,291.72 tonnes of VENM was imported and spread across the Site. Coffey understands the placed material was compacted to a depth of approximately 0.2m below surrounding ground level.

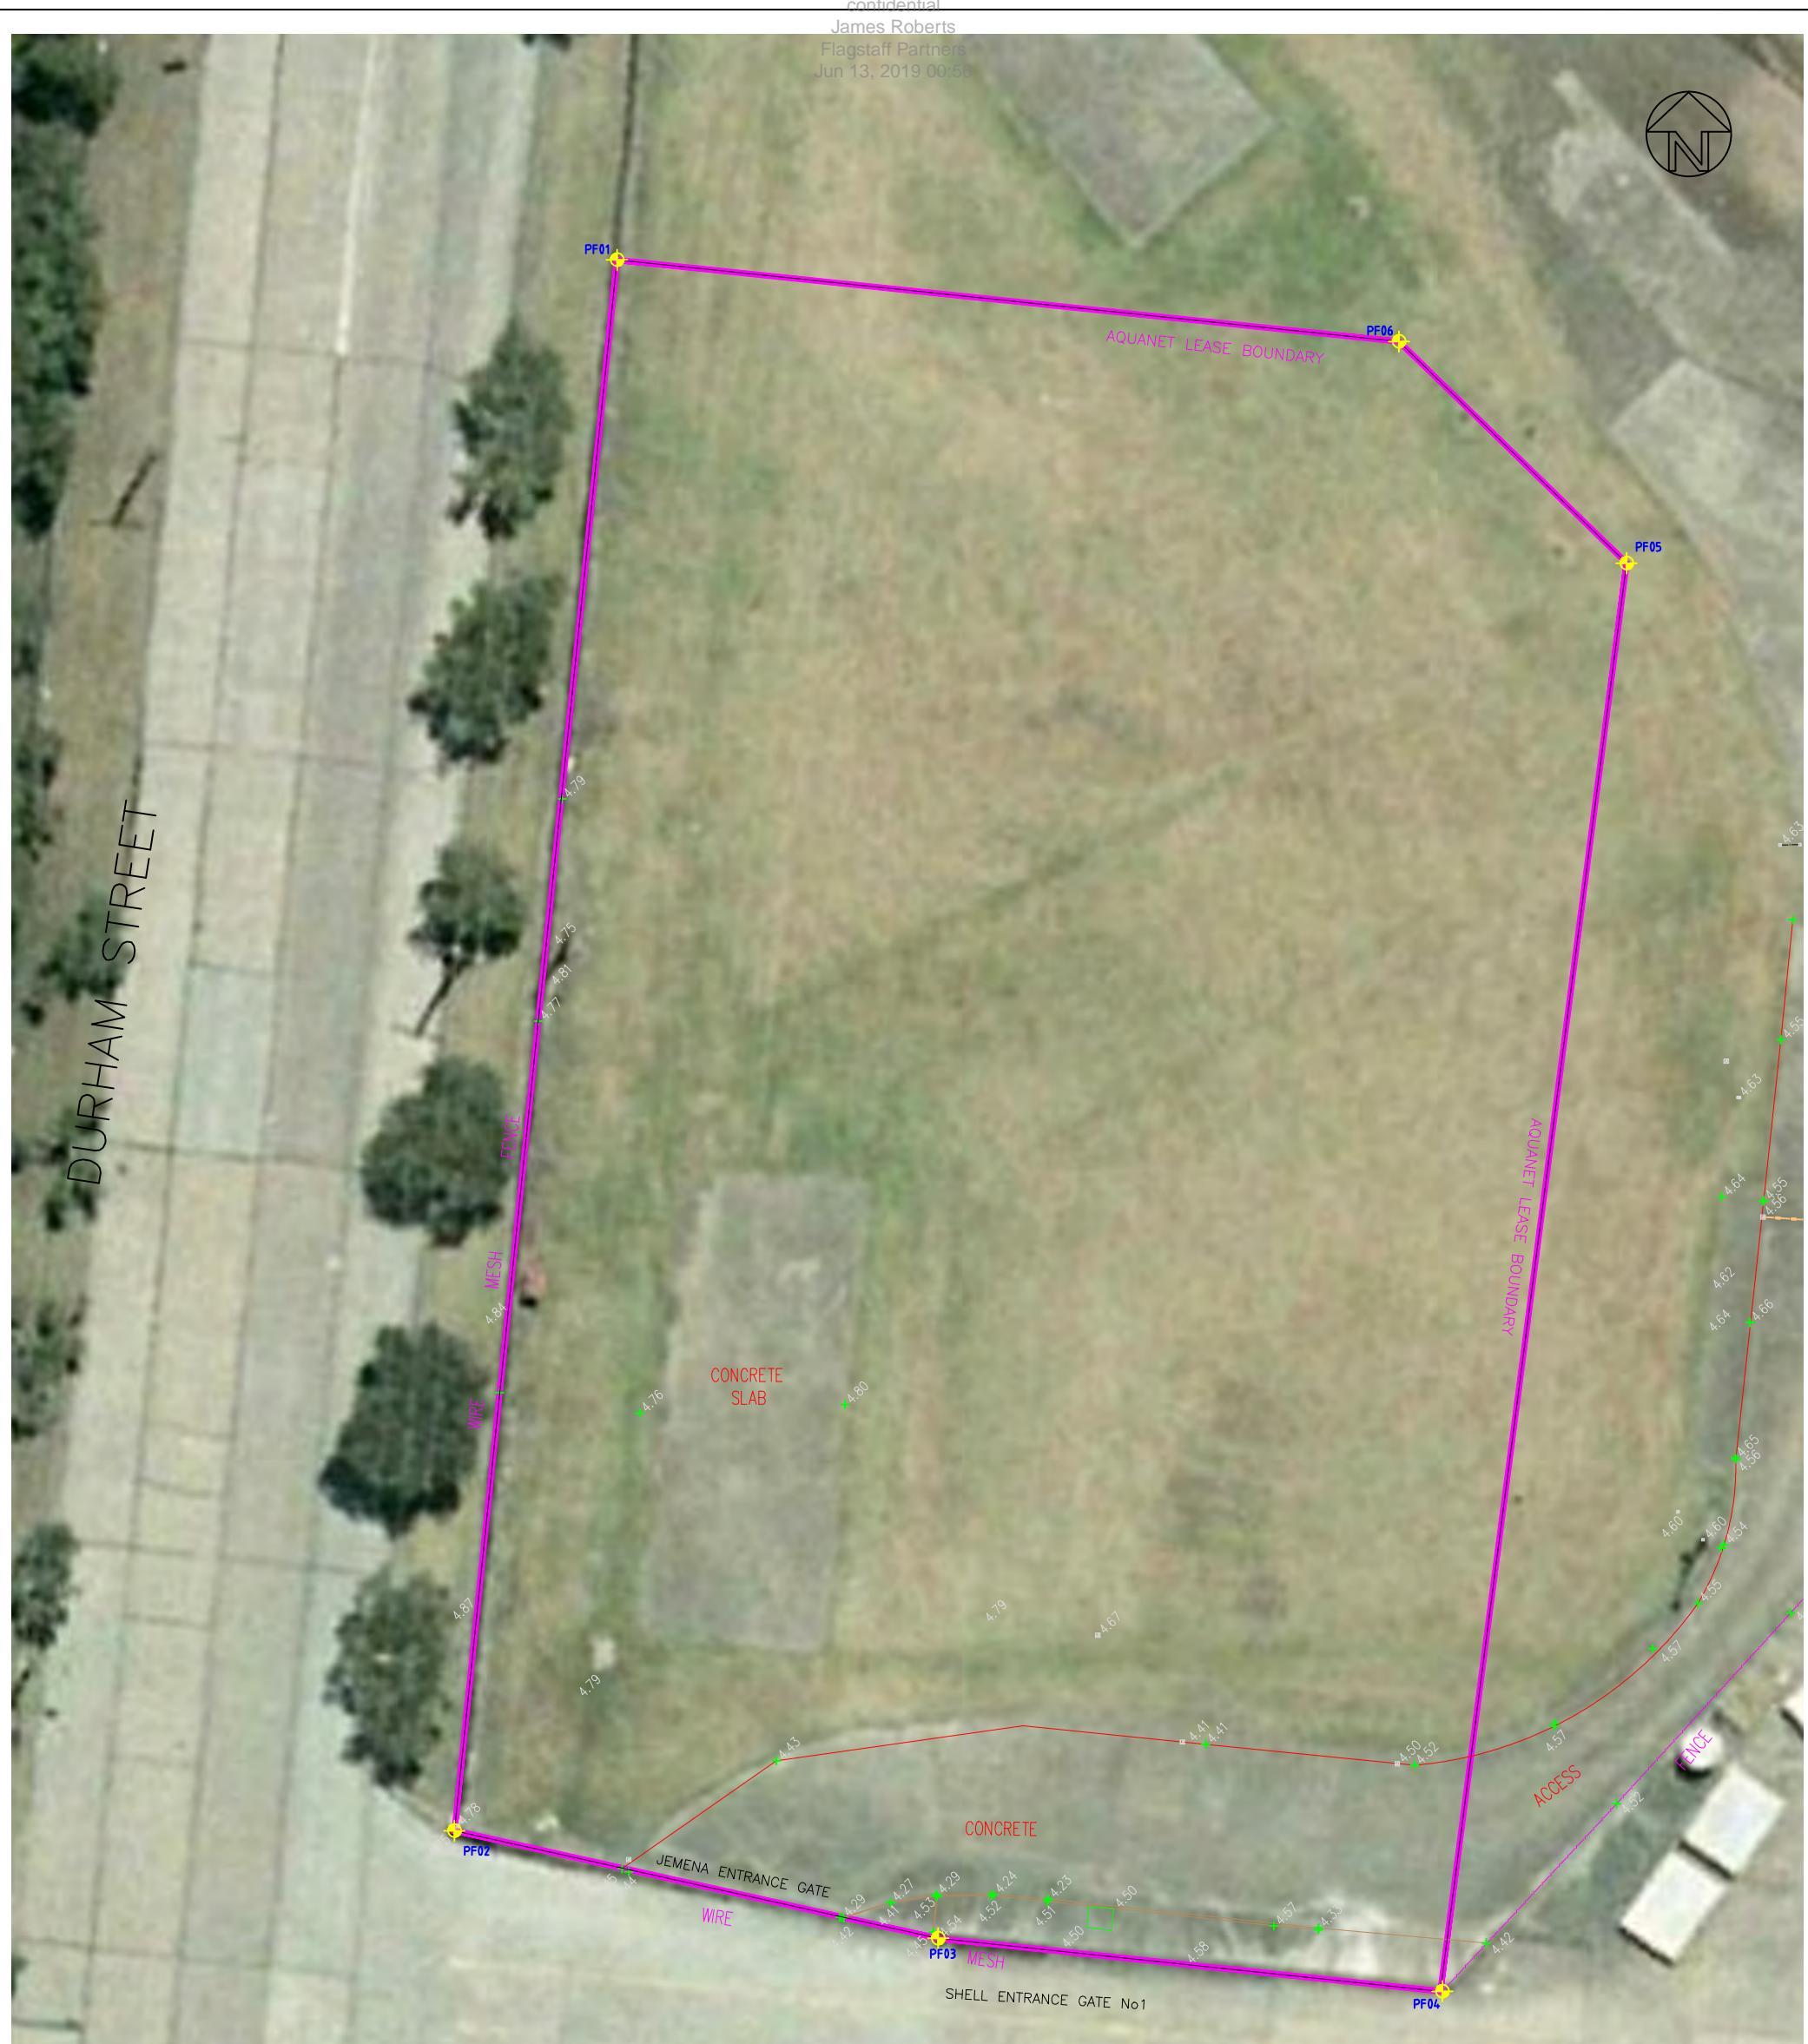
- NVIKI	PF04	318440.381	625	5866	.362					
HOU	PF05	318447.391	625	5920	.752				Ch. Sectore Ch. Sectore Co.	and the second
ENVIR	PF06	318438.730	625	5929	.193				Scale (metres) 1:250	and an a
		14	F						IMAGE SOURCE: GOOGLE EARTH PRO 2011 IMAGE @: SINCLAIR KNIGHT MERZ 2011	5-14
Coffey	Environments Australia Pty	© Ltd						DRAWING SOURC	E: JEMENA ENGINEERING SERVICES, RRW-01-DWG-K-00321	
rev.	description		app.	drn	date	drawn	MV		client: JEMENA ASSET MANAGEMENT	
WV 00:/						approved	СС	coffev	project: ROSEHILL RECYCLED WATER SCHEME, SITE VALIDATION	ON REPORT
212						date	04/05/12	environments	CORNER DURHAM STREET AND GRAND AVENUE, ROS	SEHILL, NSW
. 0/0/						scale	AS SHOWN	SPECIALISTS IN ENVIRONMENTAL, SOCIAL AND SAFETY PERFORMANCE	title: SITE LAYOUT PLAN	
	_		-	-	-	original size	A3	confidential James Roberts	project no: ENVIRHOD01225AA-R03 figure no: FIGU	RE 2 rev.
