Fatal incident from work on energised overhead low voltage conductors

16 June 2025

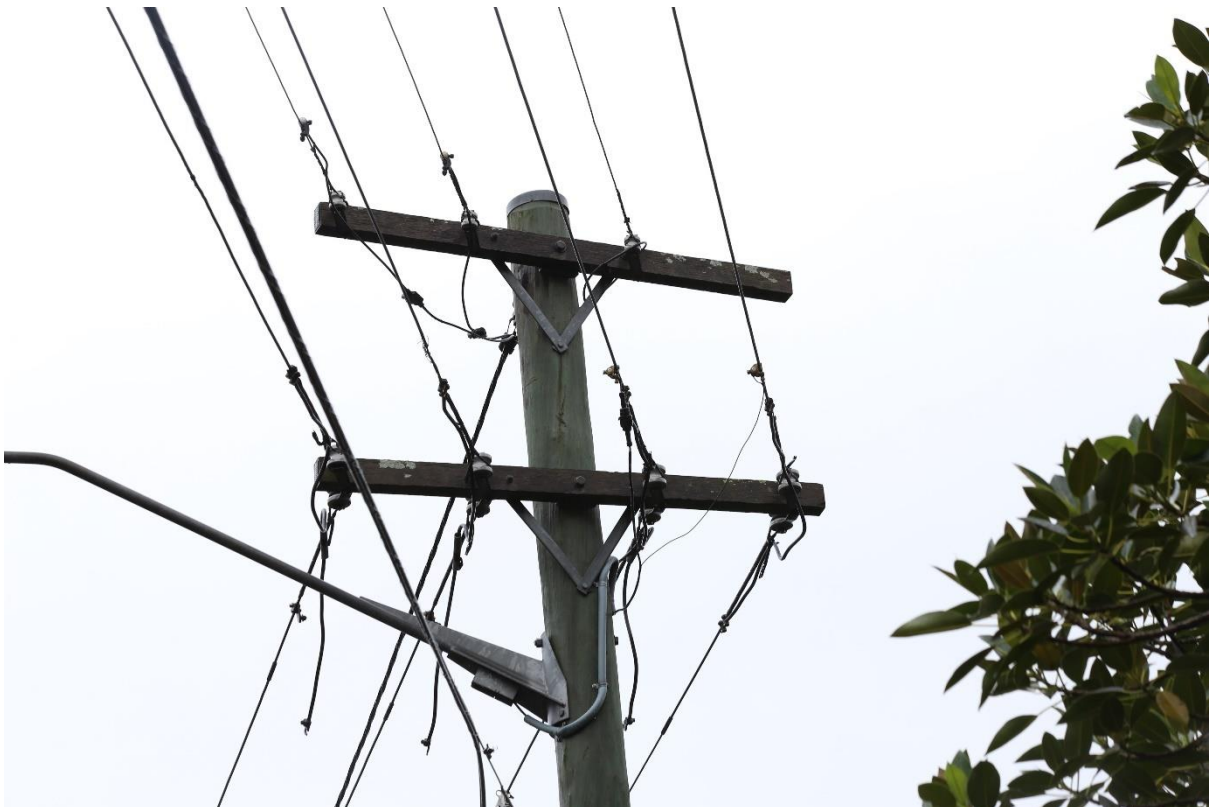
Image of the incident site taken by an IPART inspector after the incident.

It is understood that the line worker was in the process of reconnecting (bonding) three de-energised street lighting conductors across either side of the upper cross arm (see above photo). Two bonds had been completed, and the worker was in the process of completing the third bond when the incident occurred. The LV conductors on one side of the pole (foreground of the photo) were energised at the time of the incident.

Risk controls for live work may include, but are not limited to:

- the use of temporary insulation to all live exposed conductors that are within reach, other than the conductor being worked on.^a Note that temporary insulating covers must be adequately secured. Workers must also be insulated from earth potential.
- wearing LV insulating gloves with protective outer gloves.
- keeping uninsulated parts of the body separated from all conductors – both the exposed conductor being worked on and the adjacent conductors covered with temporary insulation.
