# Process Flow Diagram of Kurrajong Hamlet Water Treatment Plant

# 'On-site Wastewater Management Report'

Lot 19 Vincent Rd., KURRAJONG, NSW

REP-21408-A

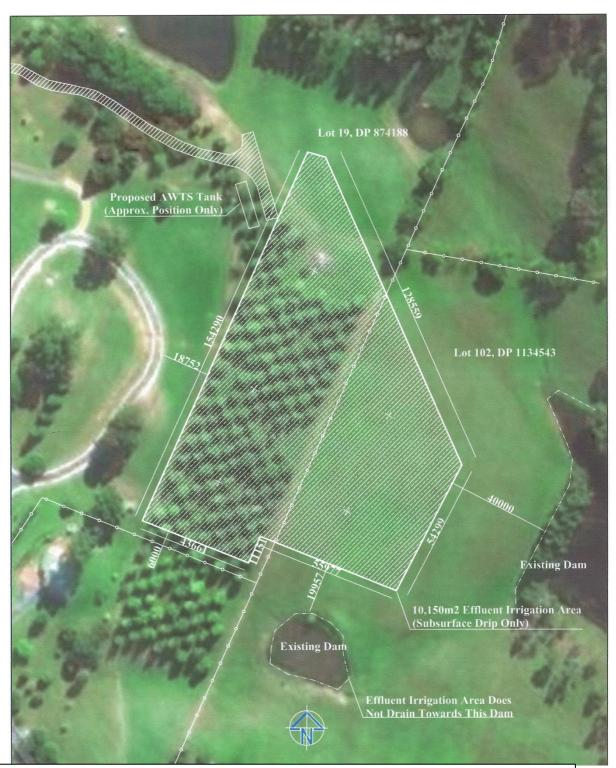
Figure 1.2. Detail of irrigation area (Source :Envirotech, 2012).

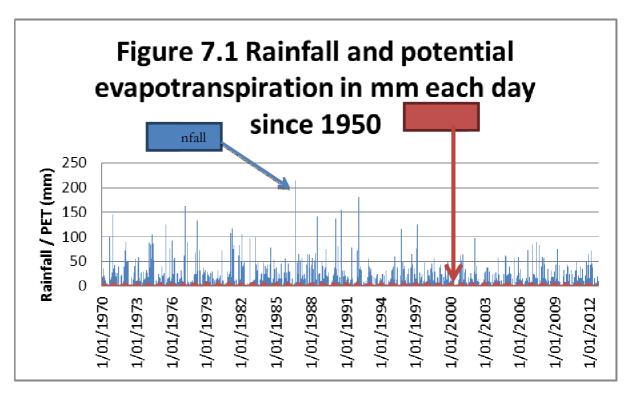
Figure 7.2 shows the effect of applying 1.2mm/day irrigation on the soil water balance.

The main effect of the irrigation is to increase the mid-range soil water content. During prolonged dry periods the irrigation impact is relatively minor. During periods of heavy rainfall, the 1.2 mm/day is small compared with the more than 20mm of rainfall during the same day.

The non-irrigated soil has moisture content in excess of field capacity (92mm in the top 500 mm) in 3% of days whilst the soil receiving 1.2 mm/day irrigation has moisture content exceeding field capacity in 8% of days. The result is increased percolation on the irrigated soil, but this only occurs during heavy rainfall.

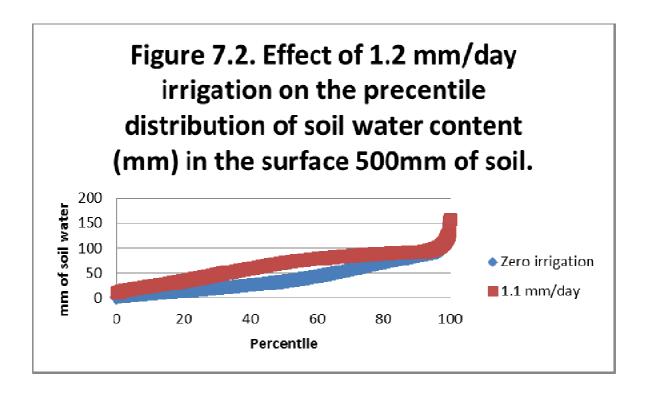
It is concluded at the proposed irrigation rate will not increase runoff from the subsurface irrigation area. There will be increased deep percolation, but this will only occur during heavy rainfall events.

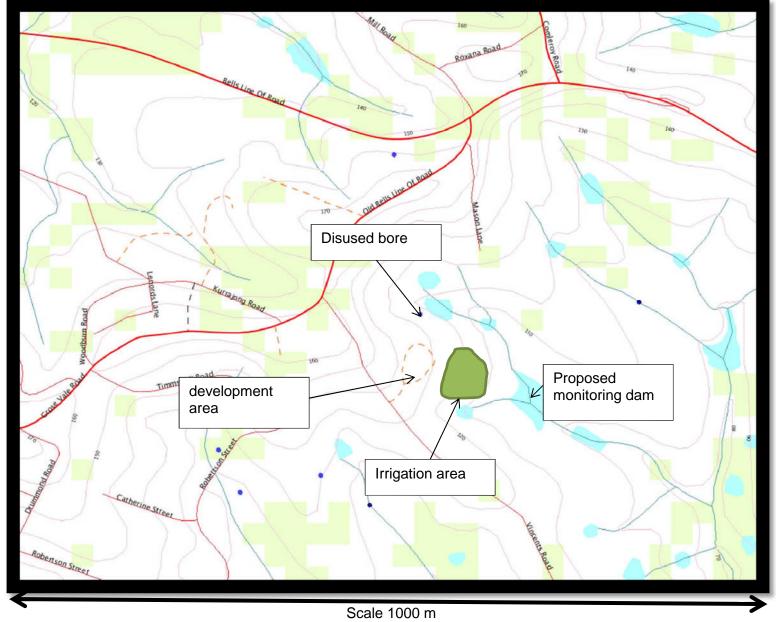
Figure 2. Location of bore and proposed monitoring dam in relation to subsurface irrigation area.

The only bore within the 250m recommended separation distance for domestic use water supplies (DEC, 2004) is a disused one some 120m uphill to the NW of the irrigation area. Apparently the bore was used before the Sydney Water Corporation installed reticulated water in the area. The bore number is GW104396. The main water zone is between 156 and 160 m.

It is RECOMMENDED that the dam be tested before the irrigation commences and then annually to detect and 'leakage'.

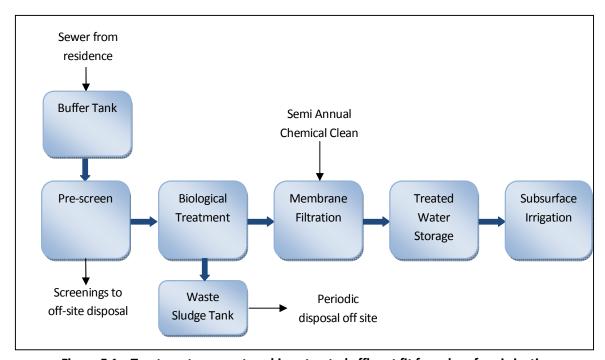
Figure 5.1 – Treatment process to achieve treated effluent fit for subsurface irrigation.

The treatment process will be MBR technology which is capable of achieving significant pathogen reduction and very high treated water quality. This, combined with an extremely low risk of human contact during normal operations, ensure that the risk to human health is eliminated.

The process selected to achieve the required water quality as discussed above, and described in further detail in the following sections, is shown below.

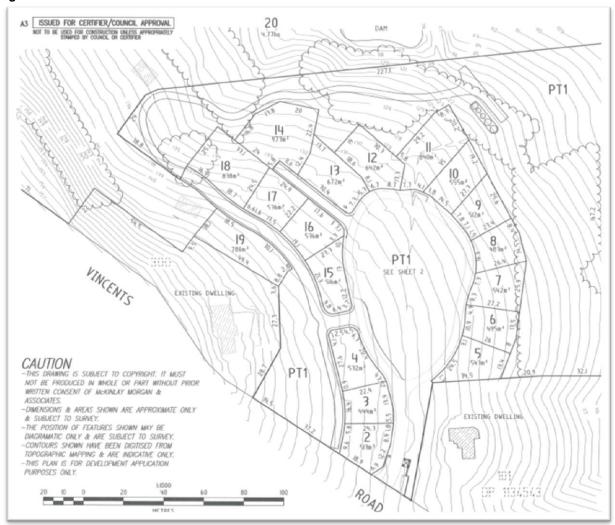
Figure 3: Extract from Subdivision Plan

Lot No.	Area	Proposed Use			
1	2.3 Ha	Community Building & Effluent Disposal			
2	513m2	Dwelling Lot			
3	444m2	Dwelling Lot			
4	532m2	Dwelling Lot			
5	543m2	Dwelling Lot			
6	495m2	Dwelling Lot			
7	542m2	Dwelling Lot			
8	483m2	Dwelling Lot			
9	512m2	Dwelling Lot			
10	555m2	Dwelling Lot			
11	840m2	Dwelling Lot			
12	642m2	Dwelling Lot			
13	672m2	Dwelling Lot			
14	973m2	Dwelling Lot			
15	516m2	Dwelling Lot			
16	536m2	Dwelling Lot			
17	536m2	Dwelling Lot			
18	838m2	Dwelling Lot			
19	786m2	Dwelling Lot			
20	4.77ha	Vacant except for existing shed
