# Preliminary Site Investigation

## **Rosehill Recycled Water Scheme Extension**

Smithfield, Wetherill Park and Horsley Park, NSW

**Project No. 25284**

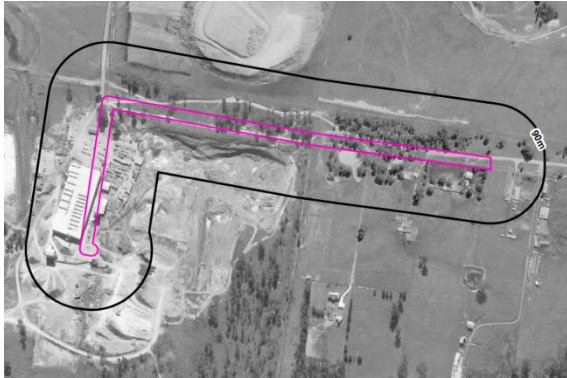
| YEAR | IMAGE | OBSERVATIONS |
|---|---|---|
| 1978 | | <p><b>Land Uses</b><br/>Quarry / brickworks – western portion</p> <p><b>Potential Sources of Contamination</b><br/>Uncontrolled fill</p> |

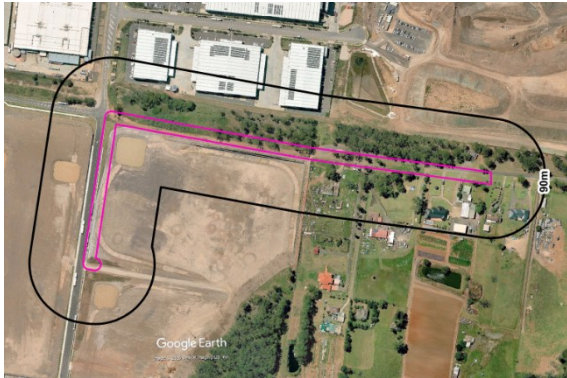
| YEAR | IMAGE | OBSERVATIONS |
|---|---|---|
| 2014 | | <p><b>Land Uses</b><br/>Development site.</p> <p><b>Potential Sources of Contamination</b><br/>No additional sources of contamination identified since previous image.</p> |

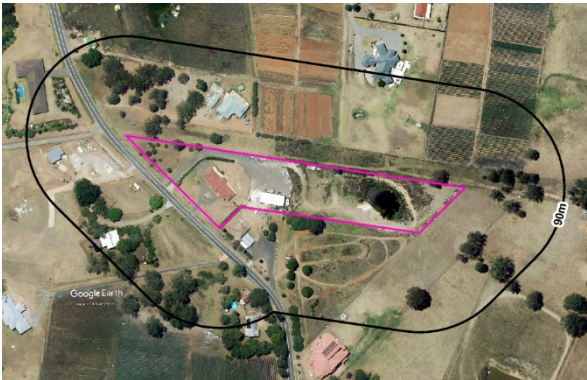
| YEAR | IMAGE | OBSERVATIONS |
|---|---|---|
| 2014 | | <p><b>Land Uses</b><br/>Low density residential and agricultural.</p> <p><b>Potential Sources of Contamination</b><br/>Uncontrolled fill.</p> |

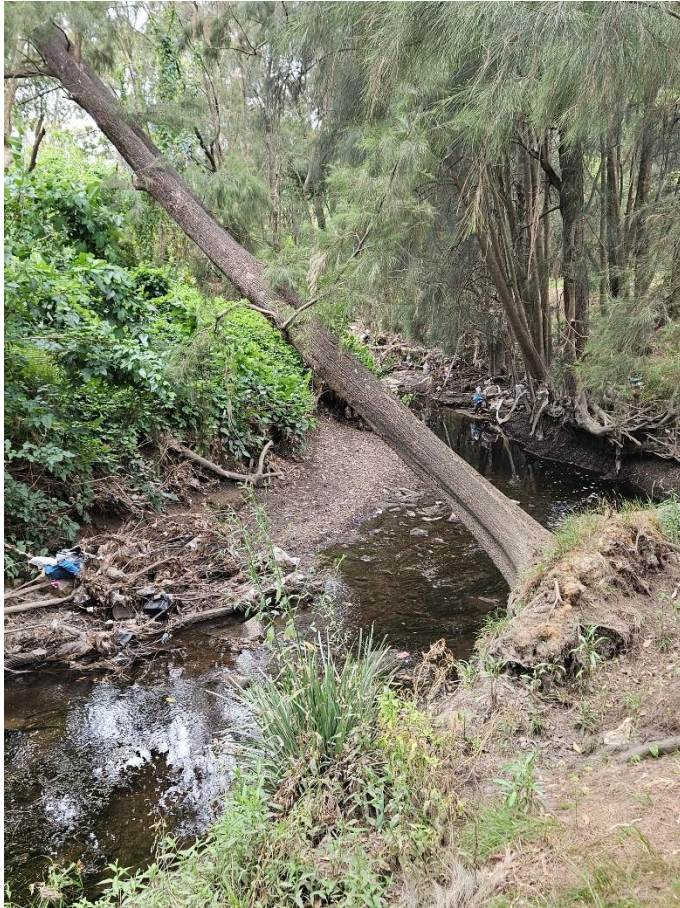
Latitudem Longitude: -33.8537514, 150.9458373

**Photo Description: Prospect Ck, flowing east with evidence of high velocity flow (large woody debris and anthropogenic litter max. 4m height on banks).**

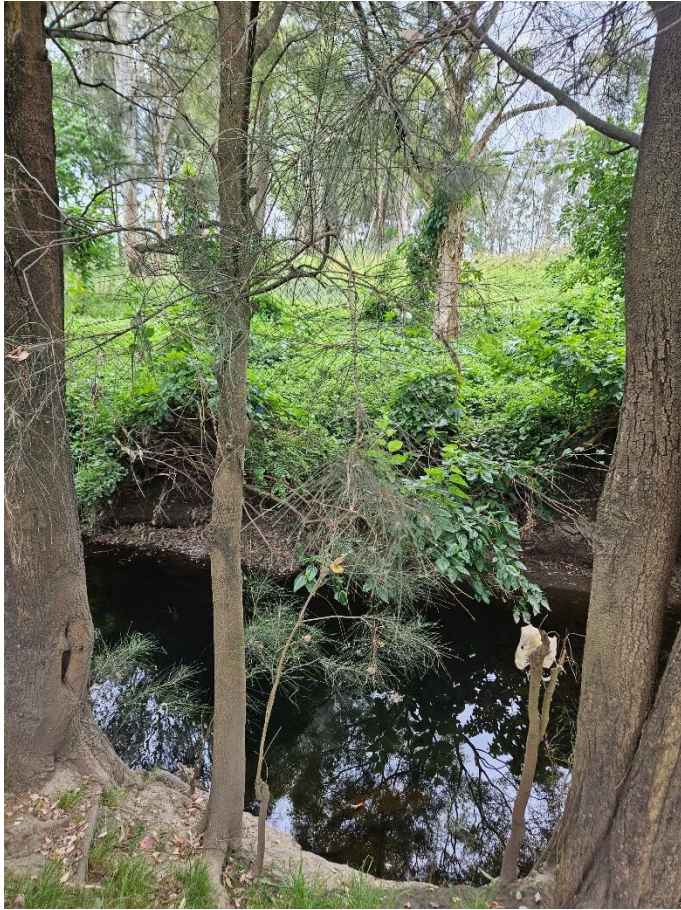
Latitudem Longitude: -33.8527683, 150.9454298

**Photo Description: The eastern bank of Prospect Creek has significant invasive species coverage**

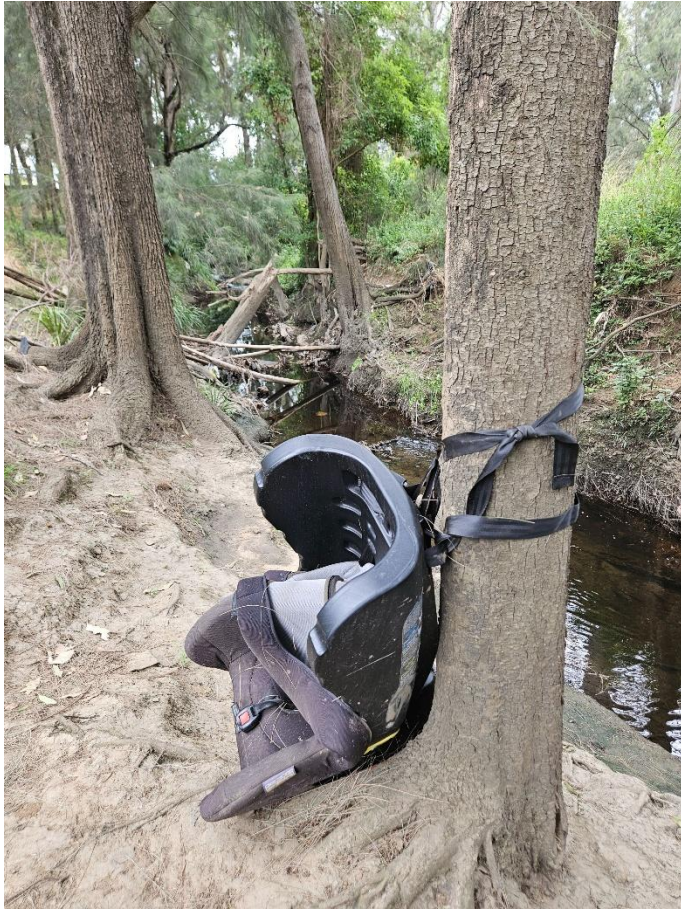
Latitudem Longitude: -33.8518746, 150.9451179

**Photo Description: Evidence of illegal dumping**

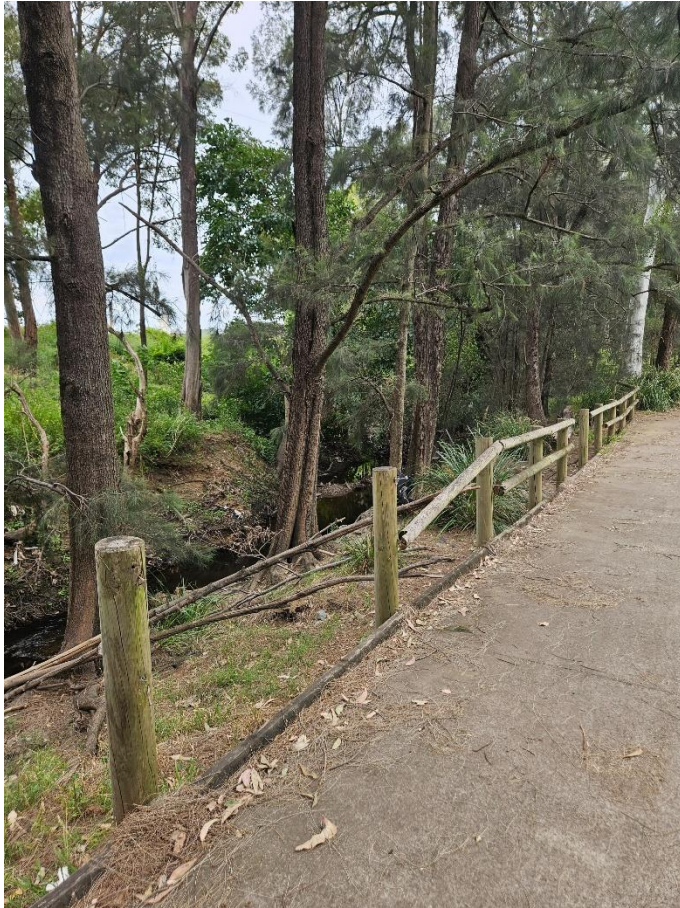
Latitudem Longitude: -33.8518382, 150.9450111

**Photo Description: Limited physical boundaries to repel illegal dumping**

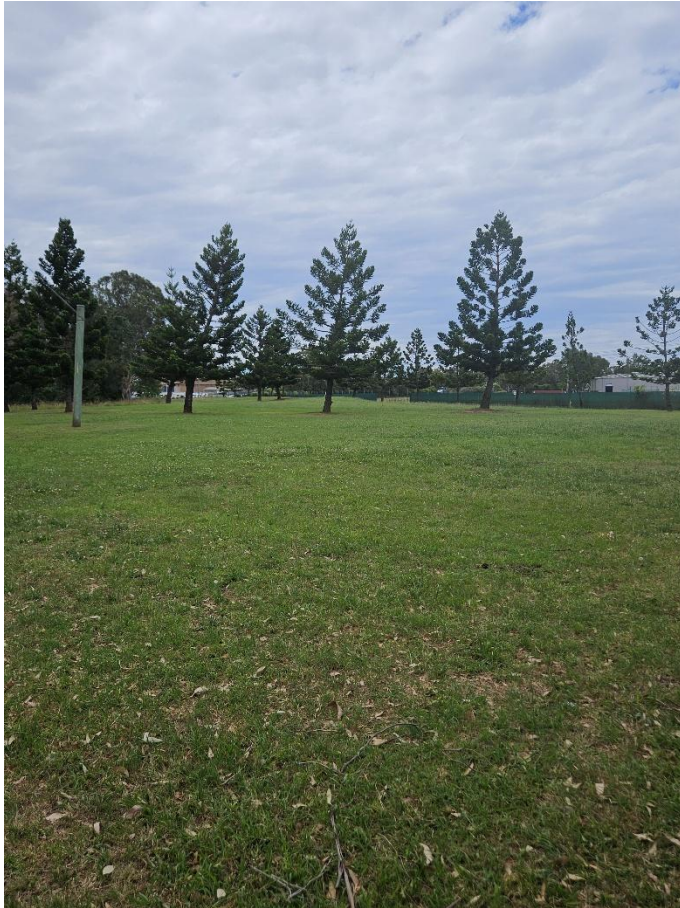
Latitudem Longitude: -33.8519623, 150.9457492

**Photo Description: Open grassed space between creek and VISY Smithfield with gentle sloping. Suspected historical landfill.**

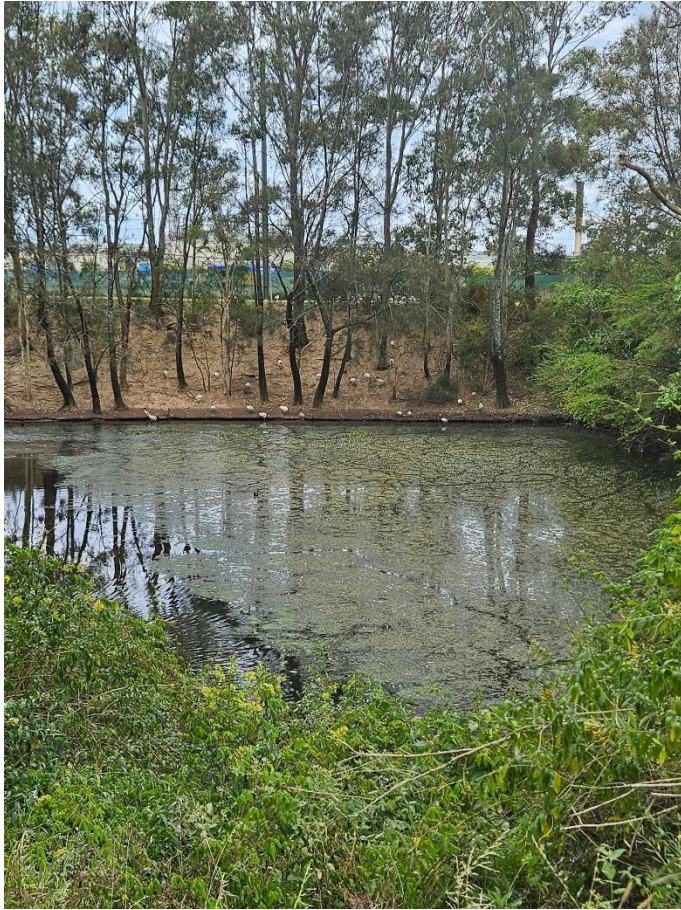
Latitudem Longitude: -33.8524276, 150.9458755

**Photo Description: A lake, appears to be engineered. Algal growth, no visible sheen or bubbling**

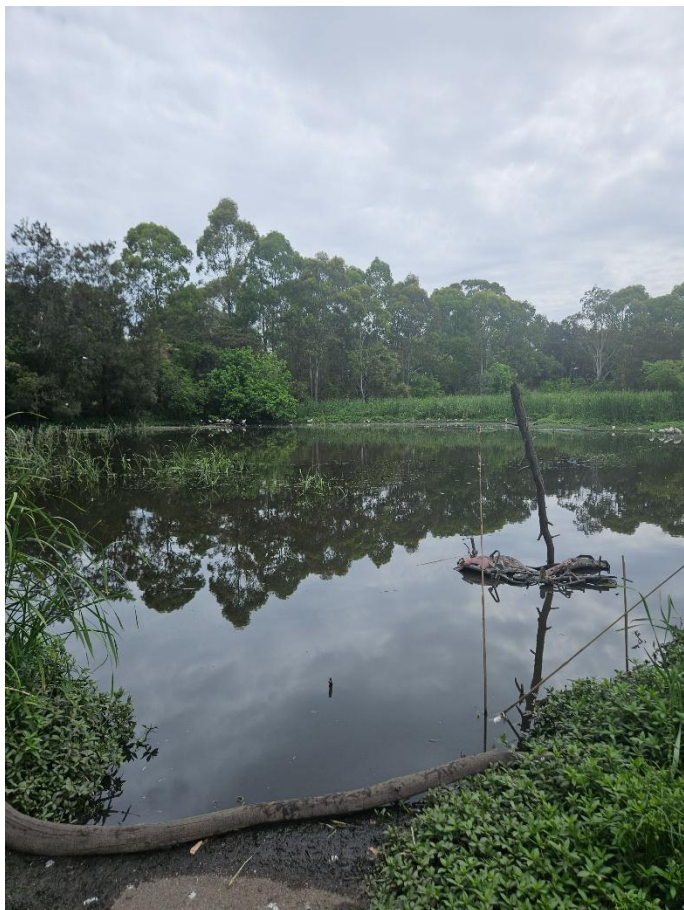
Latitudem Longitude: -33.8531334, 150.9482352

**Photo Description: Surface water body, dumped motorcycle, significant water bird diversity. No indicators of contamination.**

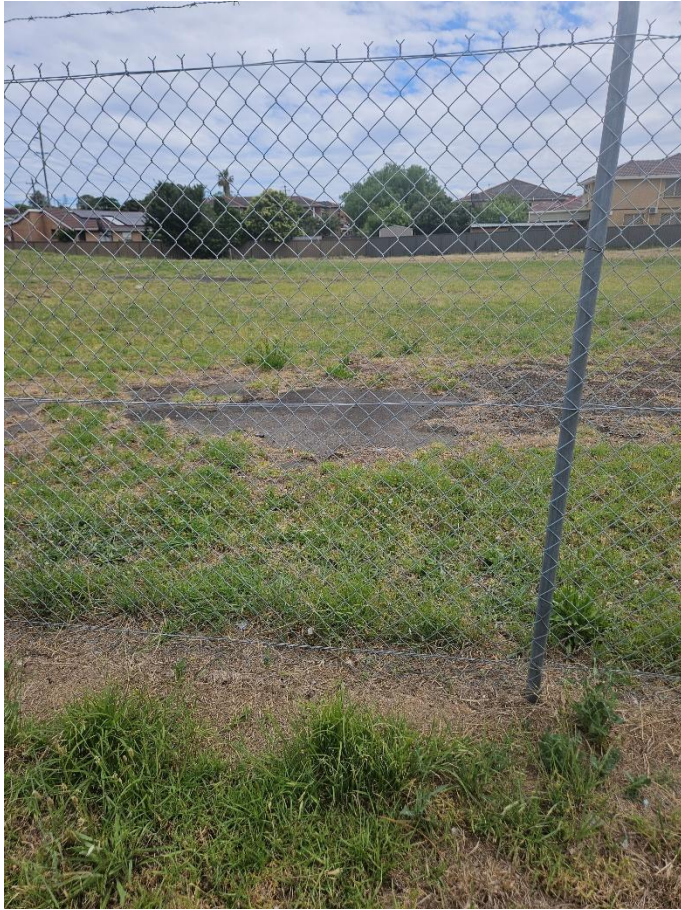
**Photo Description: Potential pump station site**

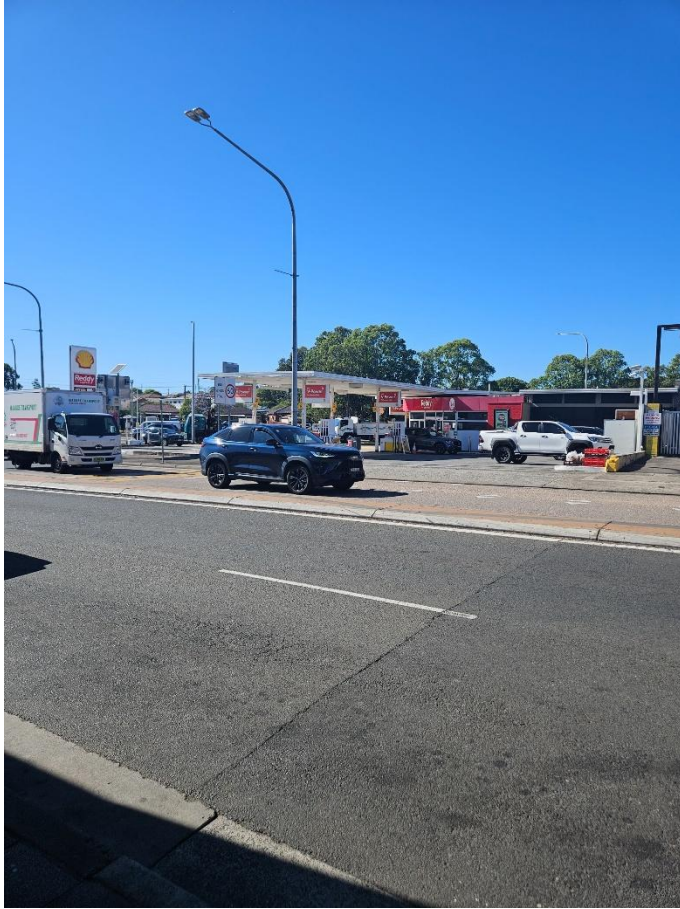
**Photo Description: Reddy Express Service Station**

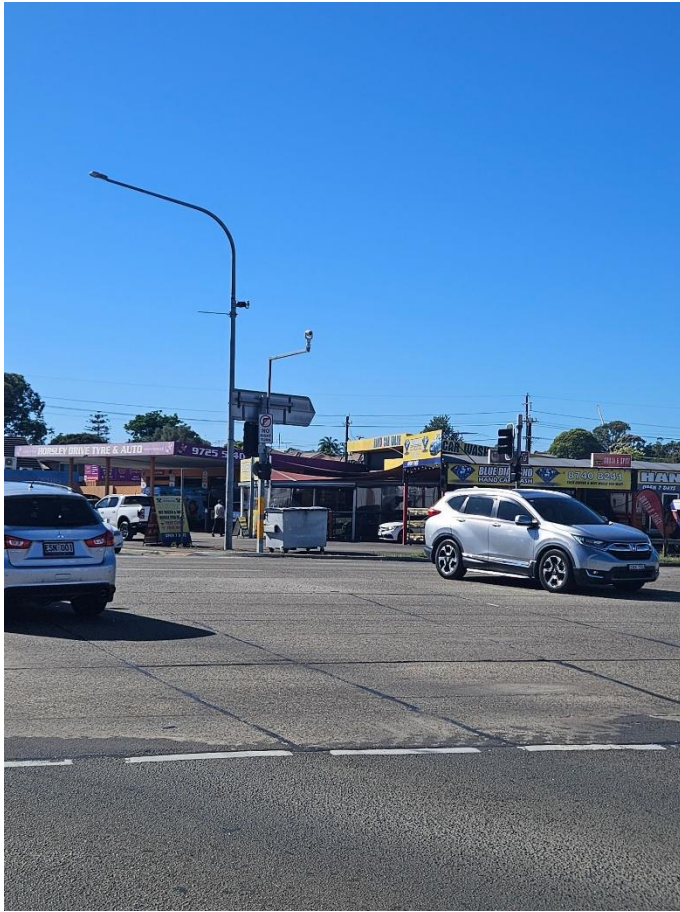
**Photo Description: Blue Diamond Hand Car Wash and Horsley Drive Tyre and Auto**

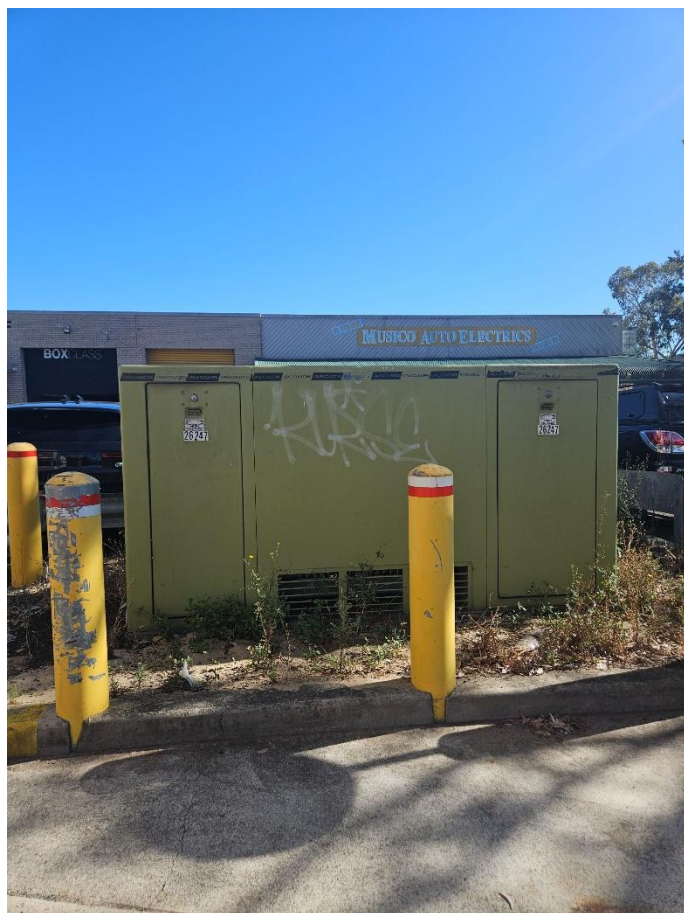
**Photo Description: Transformer located in carpark of Smithfield Square**

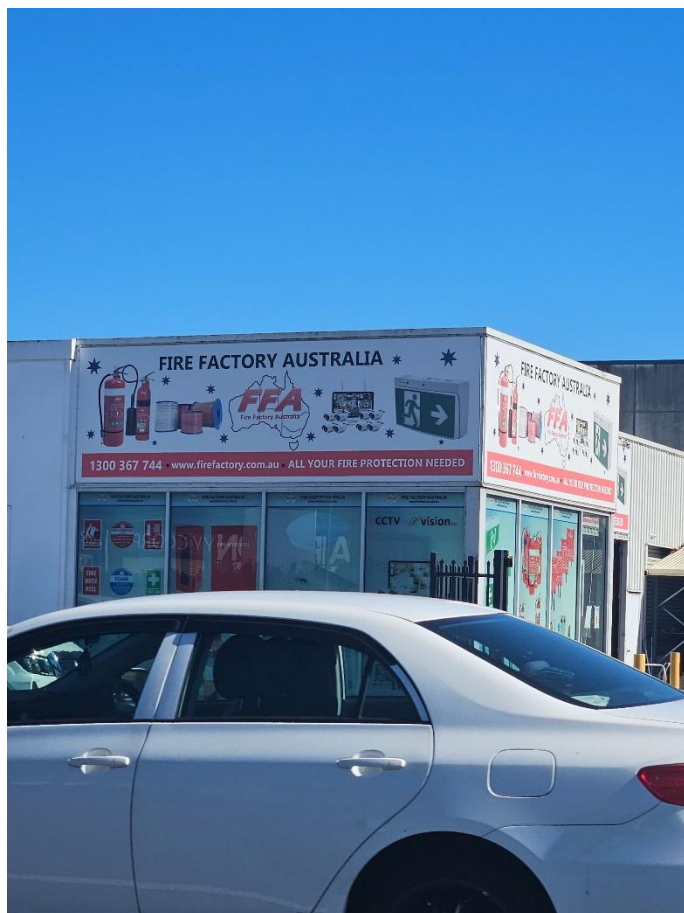
Photo Description: Fire Factory Australia

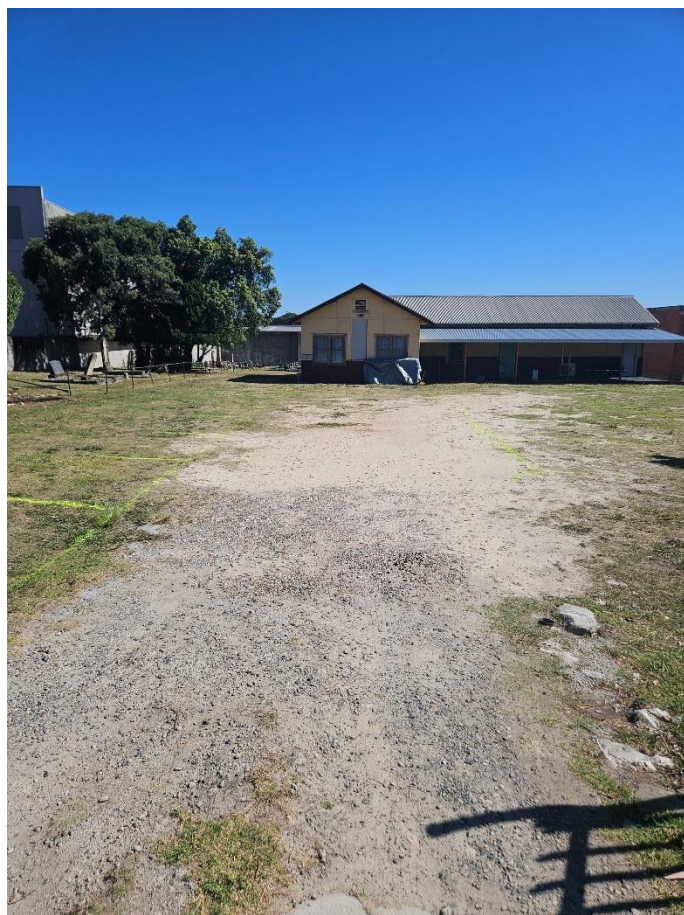
Photo Description: Church and graveyard (onsite), unnamed

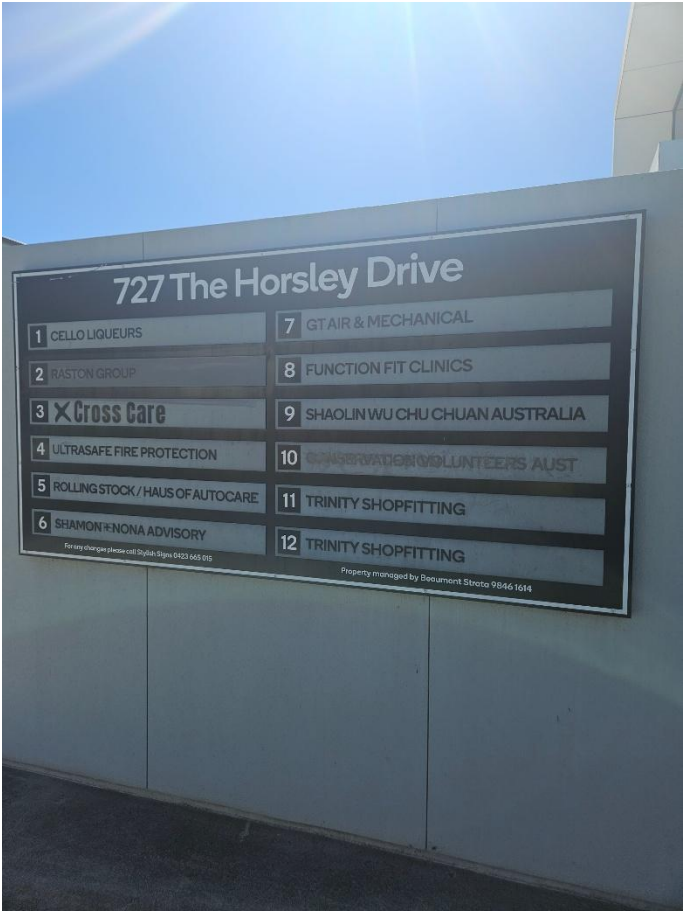
**Photo Description: Comm businesses including mechanics and fire protection**

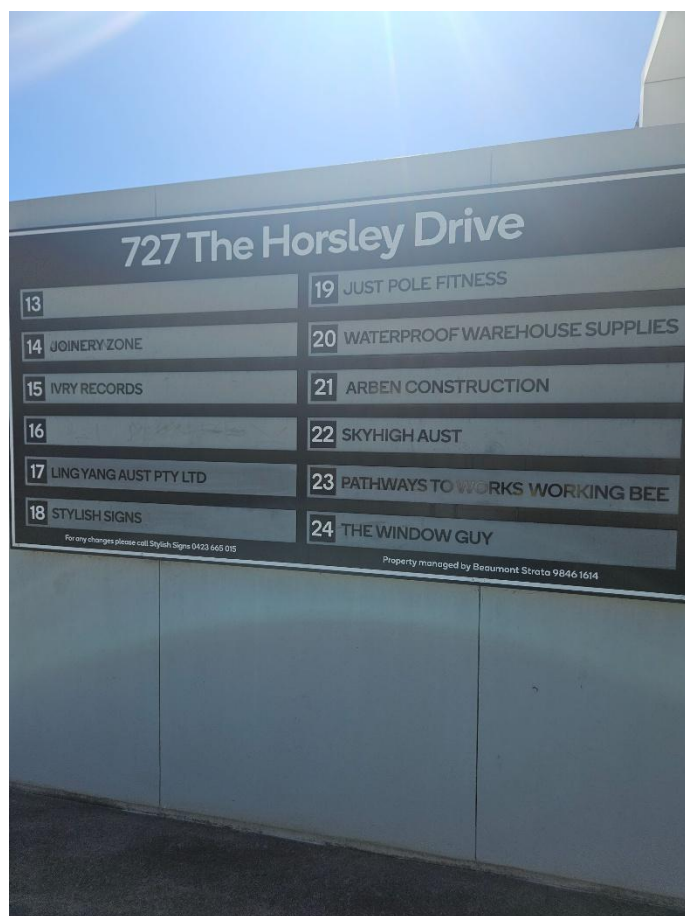
**Photo Description: Comm businesses including joinery and construction businesses**

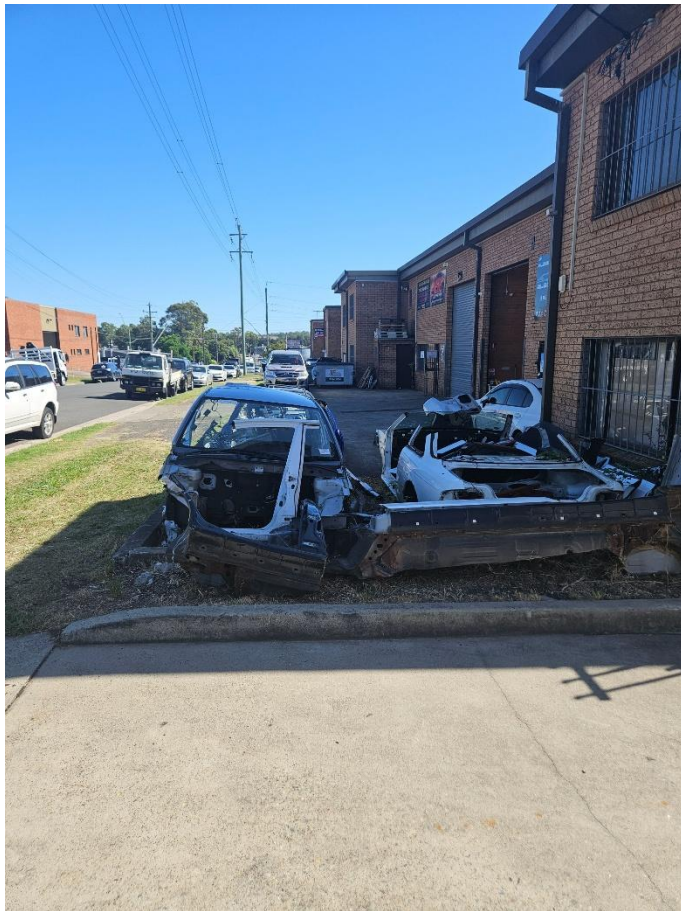
Photo Description: Car wreckers adjacent street

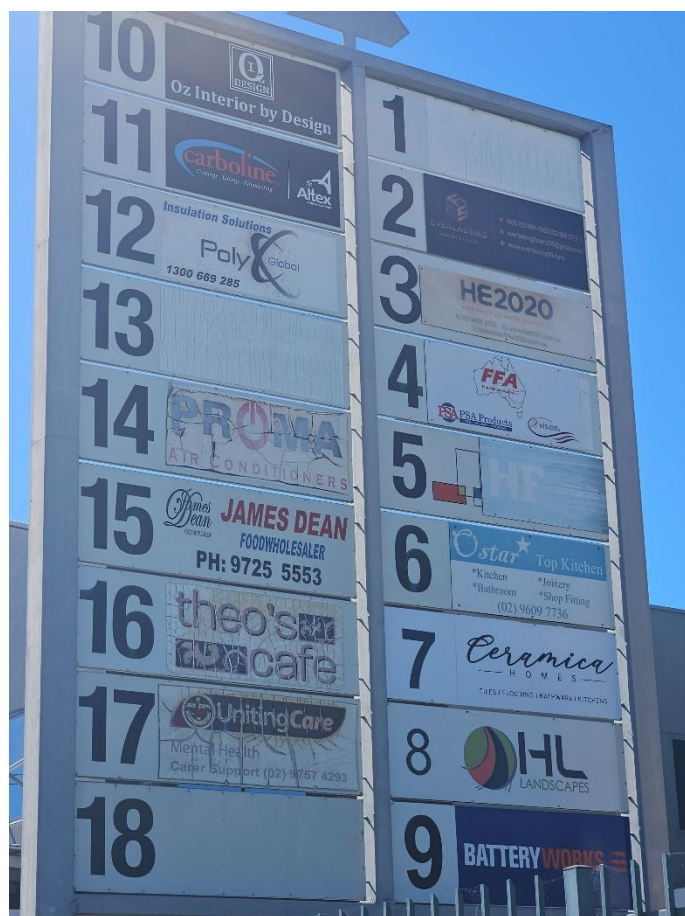
**Photo Description: Multiple comm businesses including battery works, air conditioning businesses, coatings and direproofing business,**

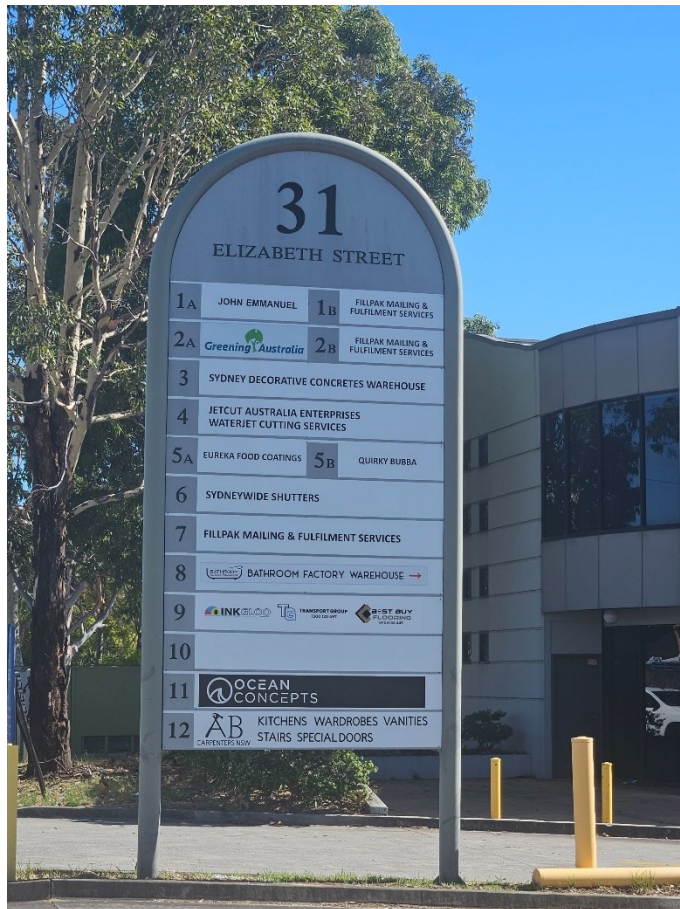
Photo Description: Commercial hub

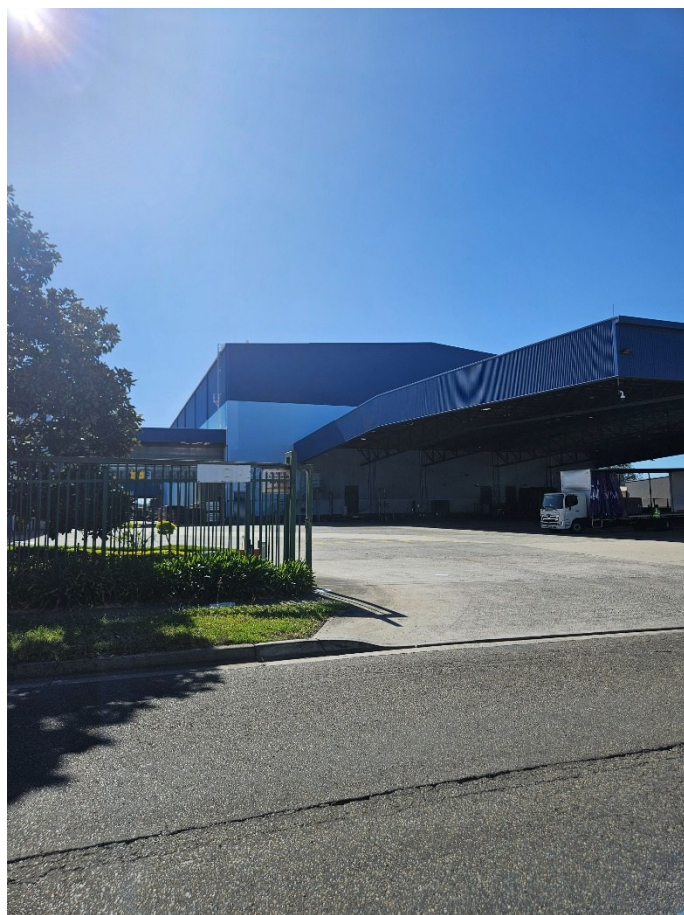
**Photo Description: ABC Tissue Products**

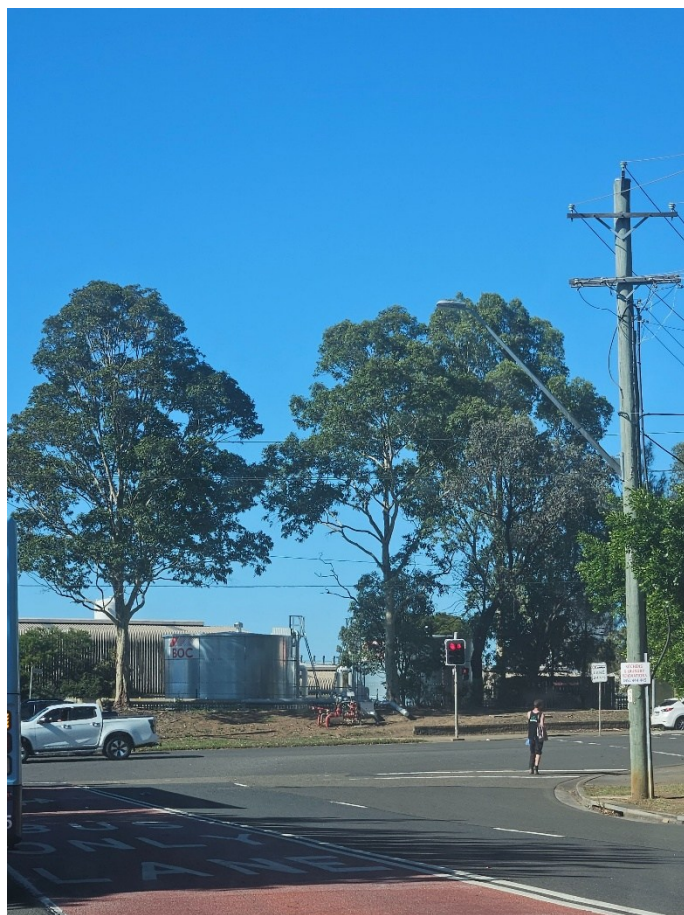
Photo Description: AST at BOC facility

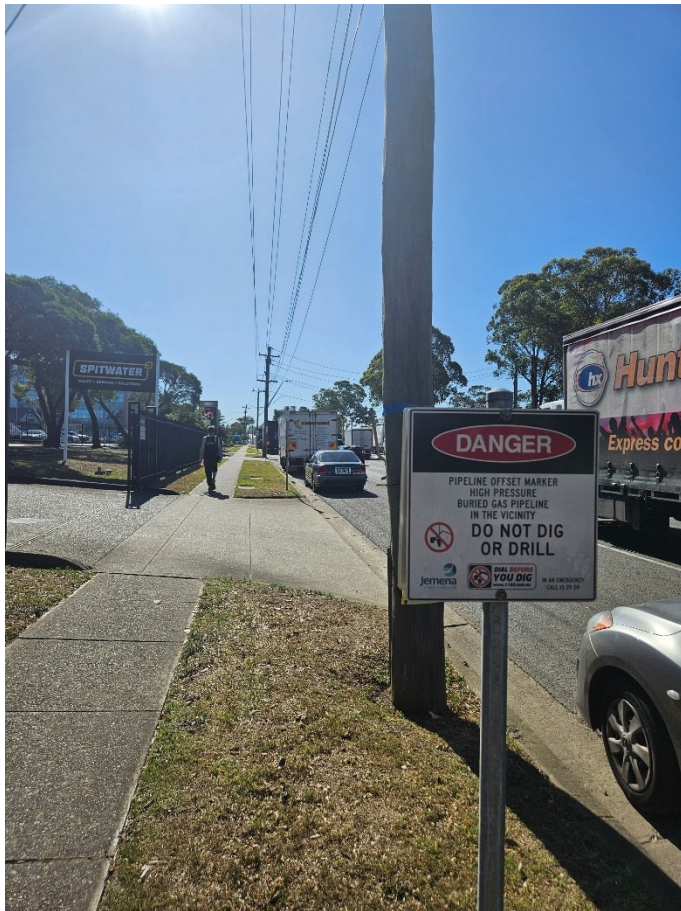
**Photo Description: Jemena buried high pressure gas pipeline now on the south side of the street**

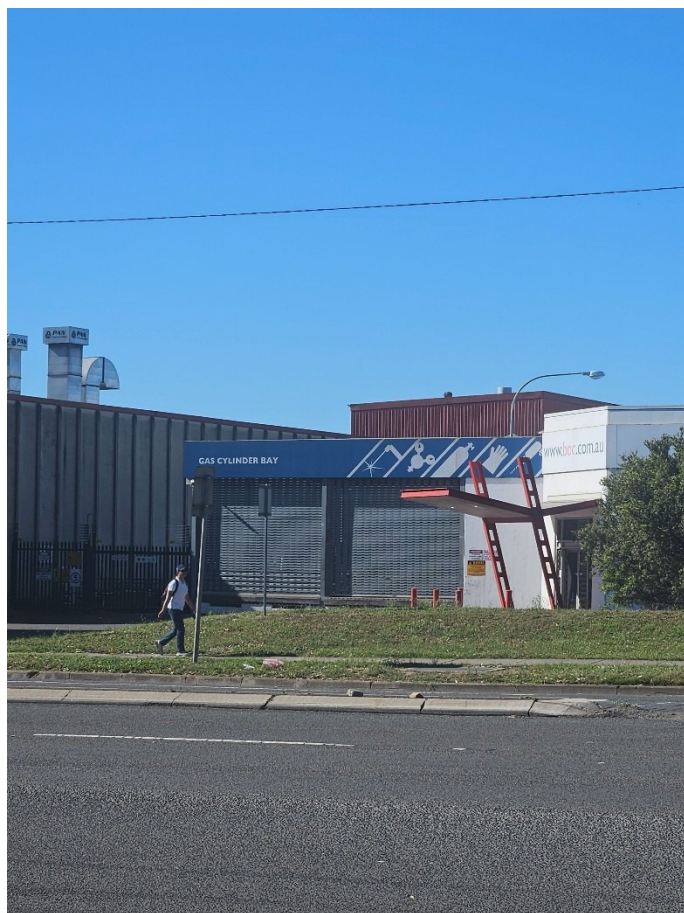
**Photo Description: BOC Storage of gas cylinders**

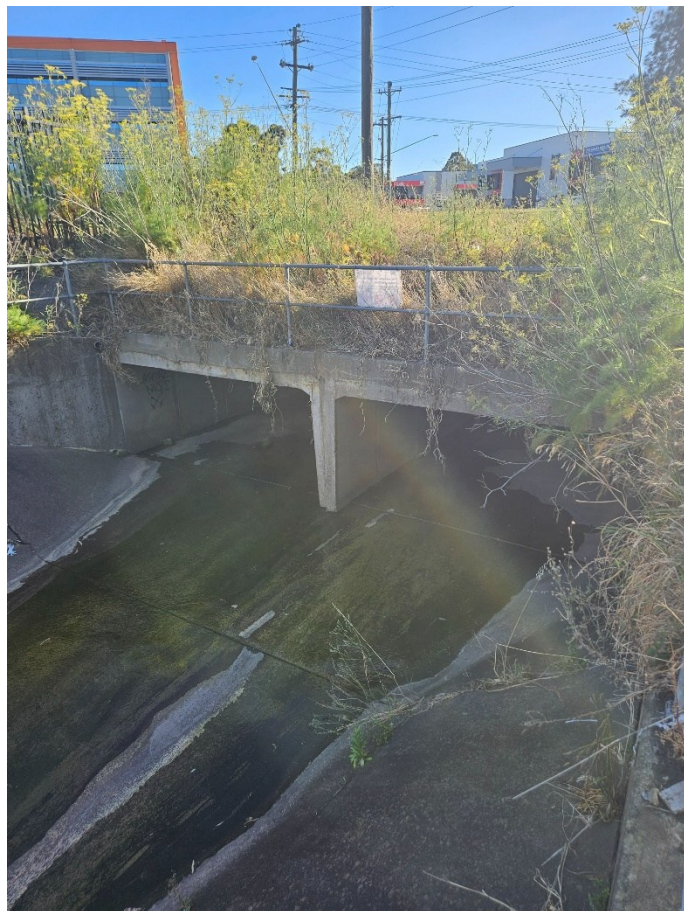
**Photo Description: Drainage channel flowing north-east, low flow, direction facing Southwest with roundabout in background.**

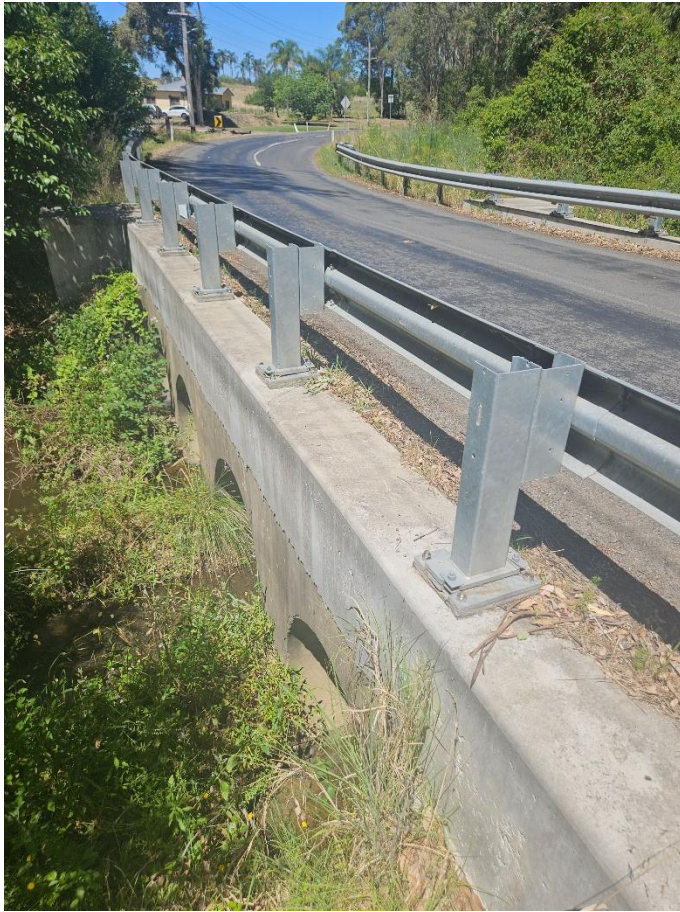
**Photo Description: Four circular culverts underlying Redmayne Rd, Stagnant water has algal growth**

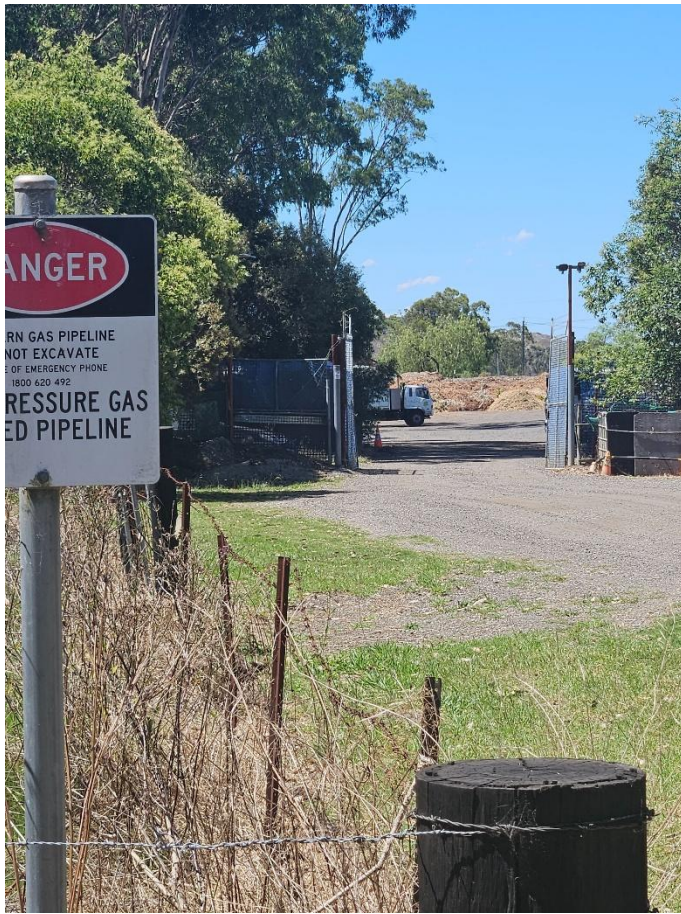
**Photo Description: Stockpiling on private property adjacent Eastern Ck and pipeline easement**

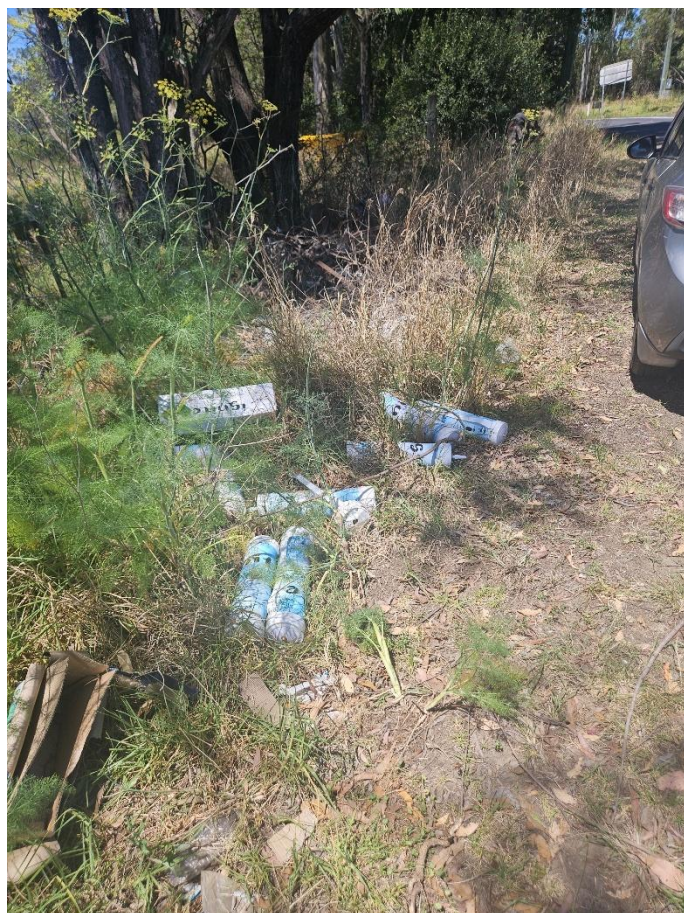
**Photo Description: Illegal dumping on side of road**

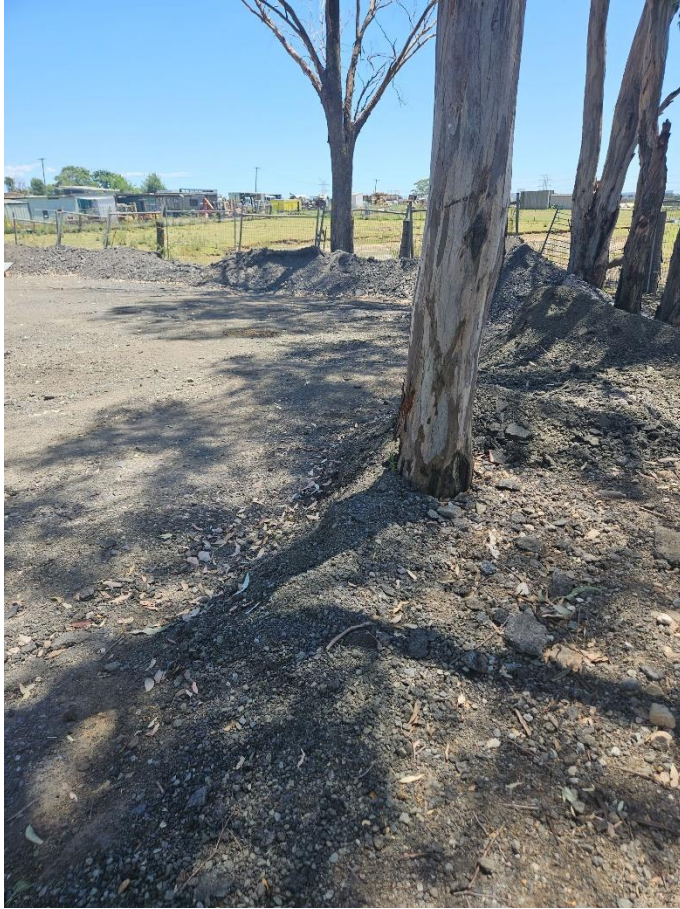
**Photo Description: Stockpiled soil and asphalt abutting road**

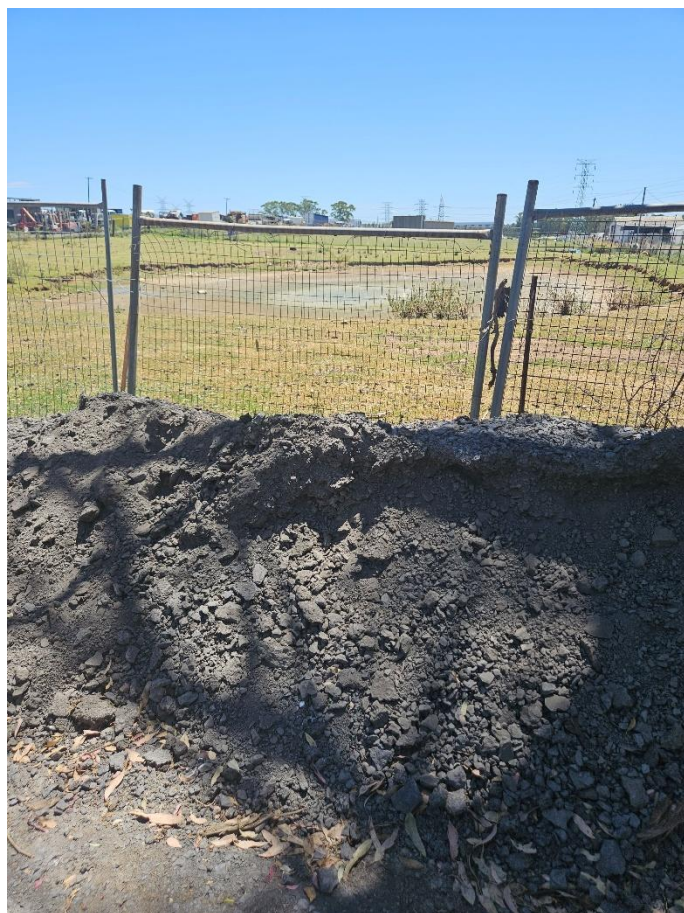
**Photo Description: Stockpiled soil and dry dam**

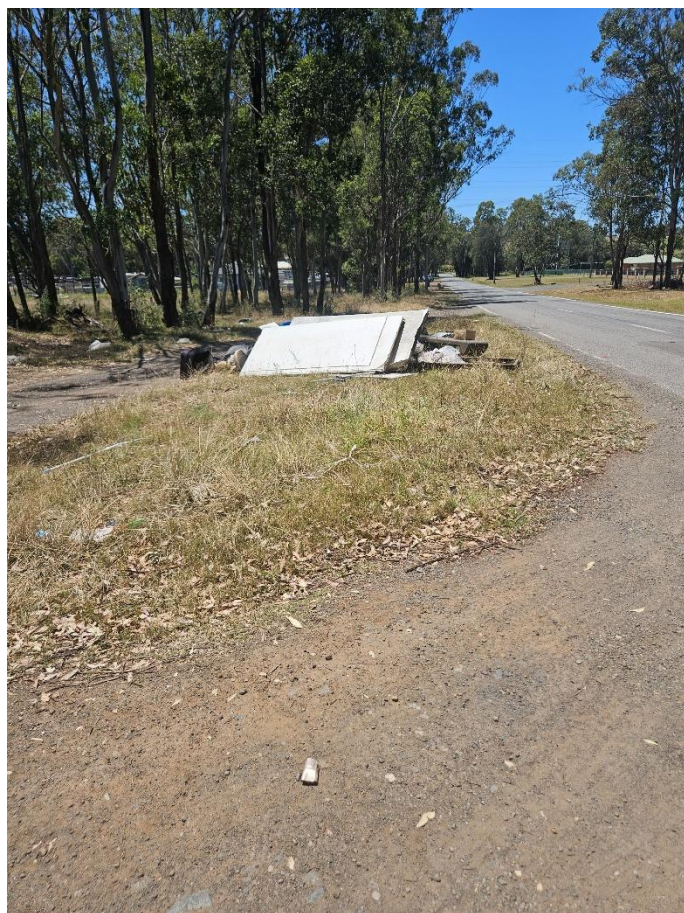
**Photo Description: Illegal dumping and general site layout**

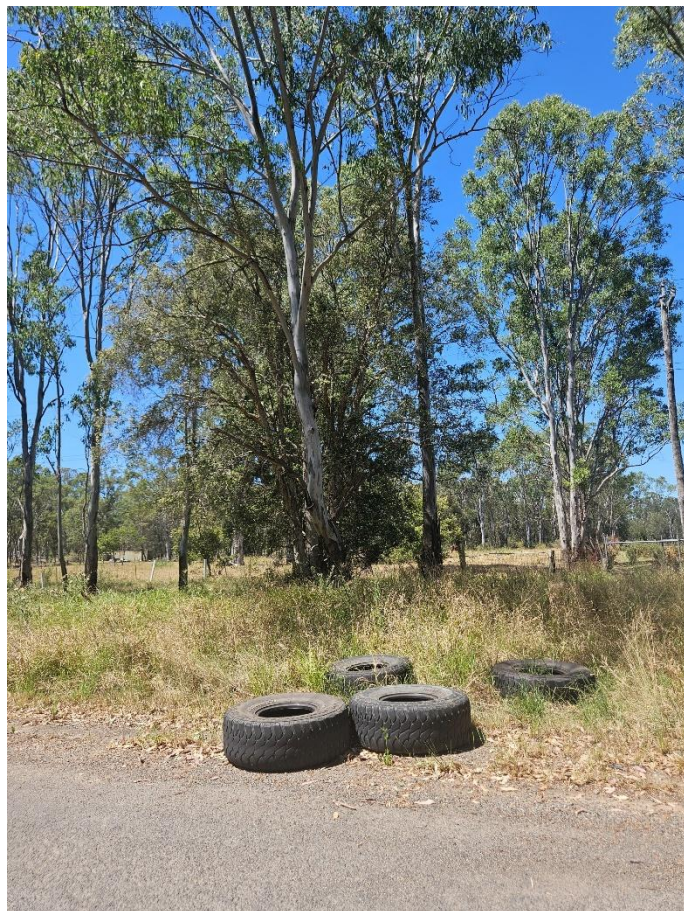
**Photo Description: Tire dumping and horse / sheep paddocks beyond**

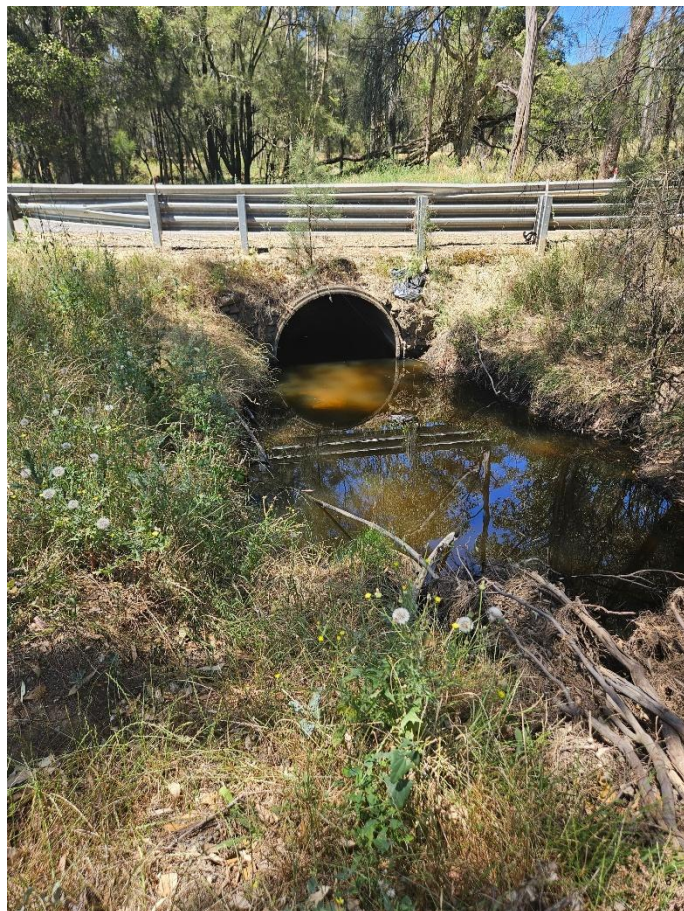
**Photo Description: Reedy Ck, facing south with Burley Rd**

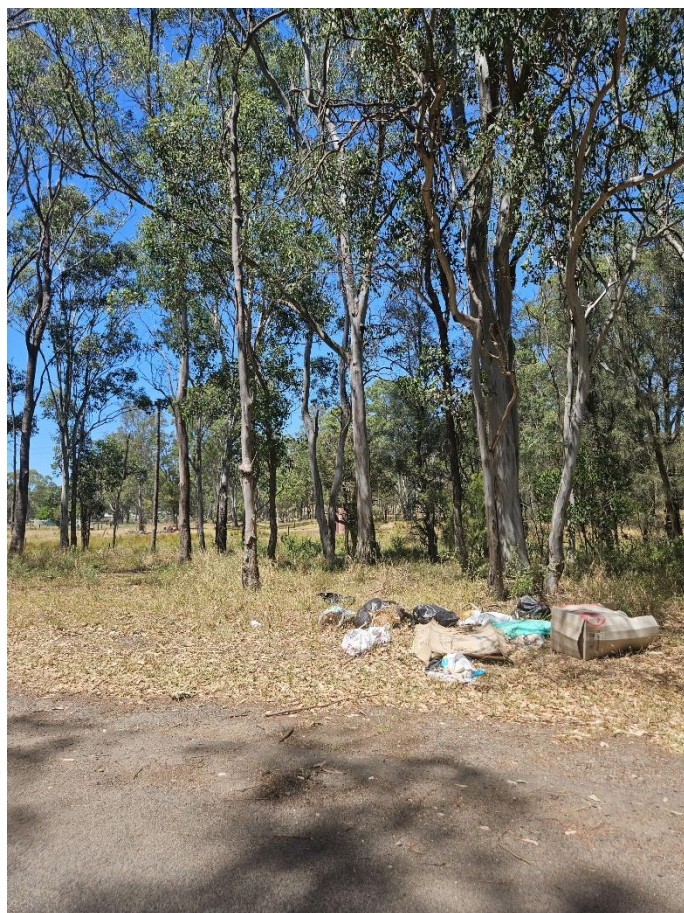
**Photo Description: Illegal dumping**

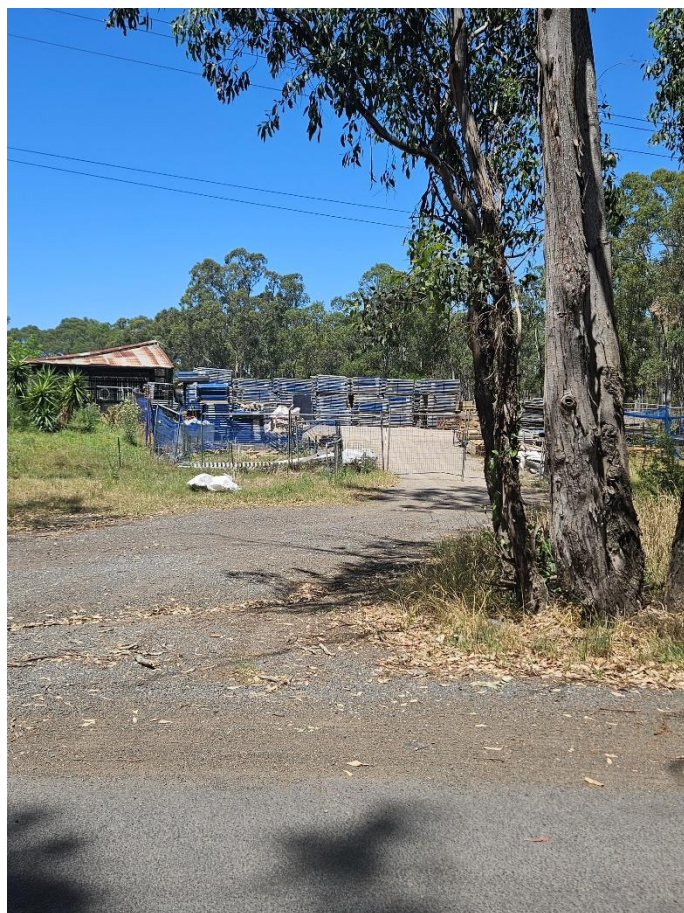
**Photo Description: Storage of steel products**

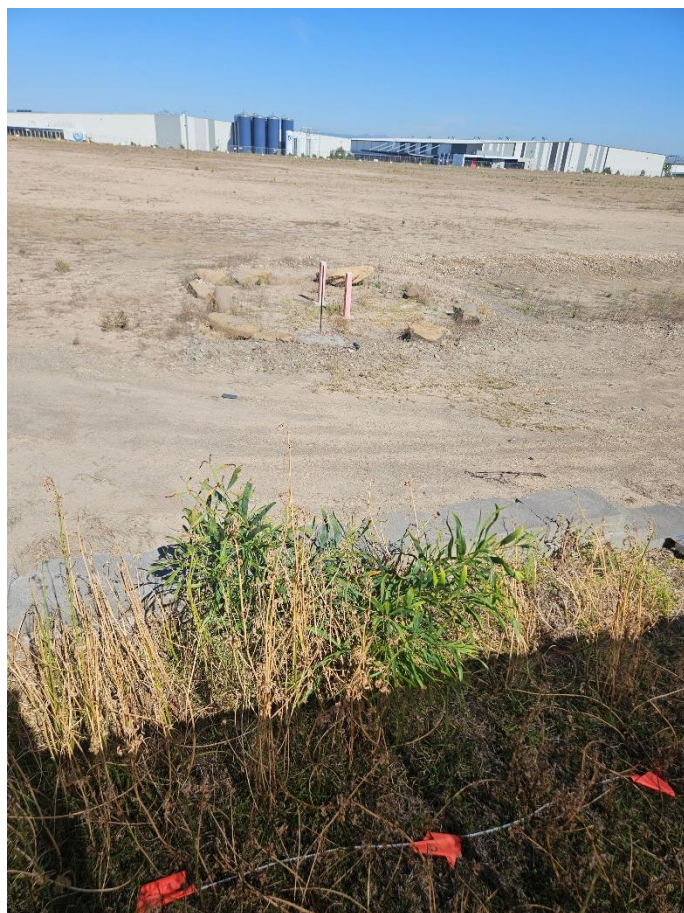
**Photo Description: Two monitoring wells located at the pipework end lot.**
