# Preliminary Site Investigation

## **Rosehill Recycled Water Scheme Extension**

Smithfield, Wetherill Park and Horsley Park, NSW

**Project No. 25284**

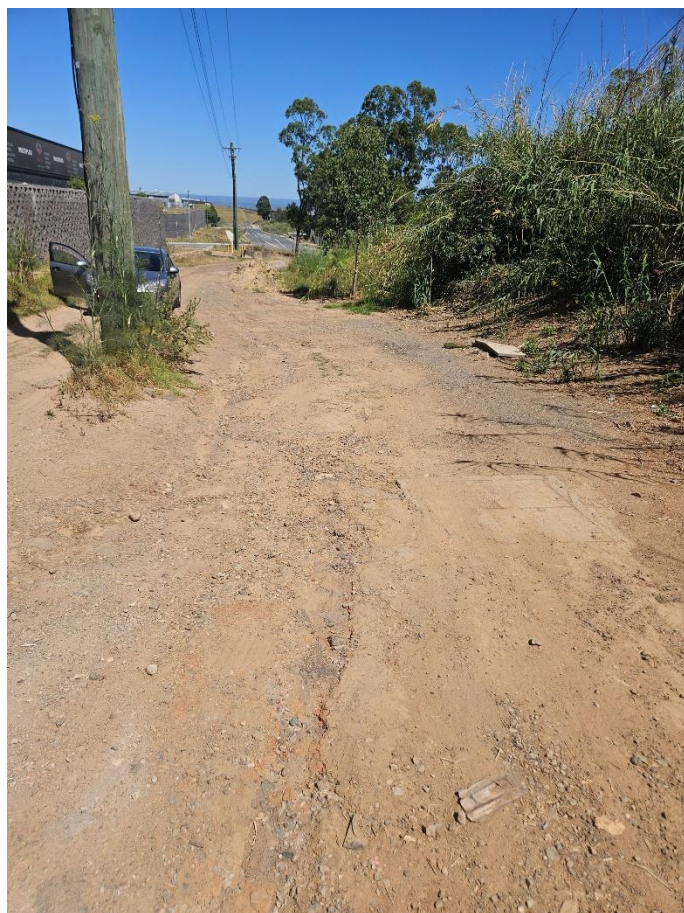
**Photo Description: Vacant land lot to the south of pipeline length along unnamed road, facing east with 10m high retaining wall and cutting evident.**

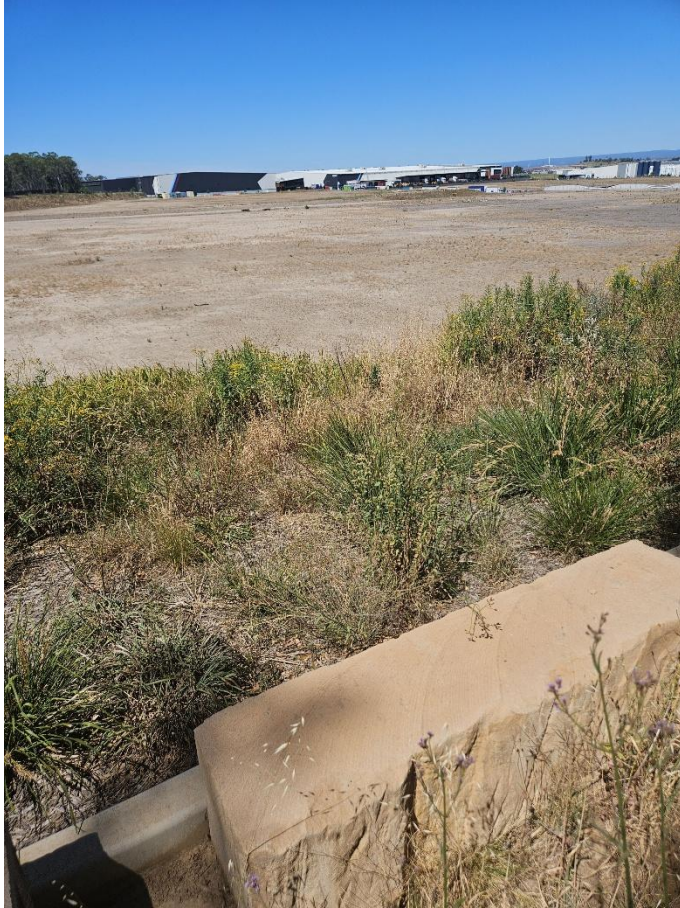
**Photo Description: Illegal dumping and underground services, facing west.**

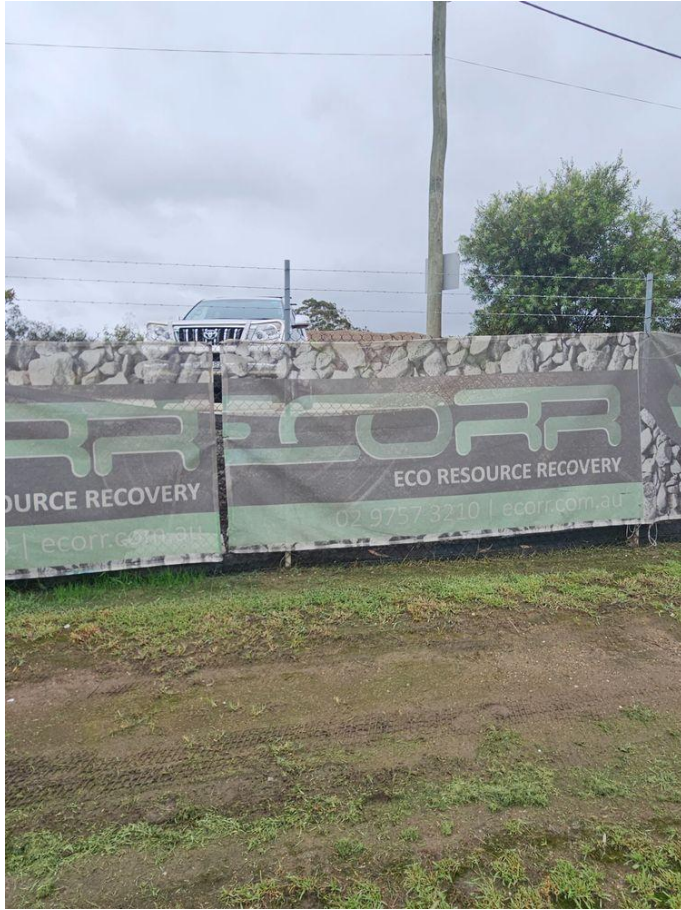
**Photo Description: Filling at ECCOR. Mild odour.**

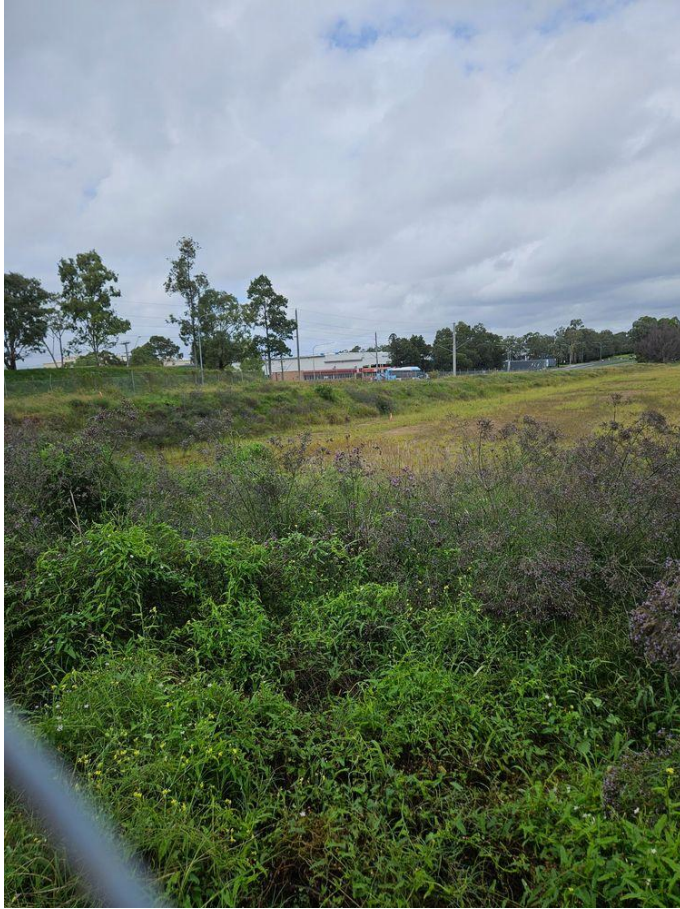
**Photo Description: Cutting works adjacent. This section of the site is generally undulating, up high clayey soils - there is not huge risk of migration onsite.**

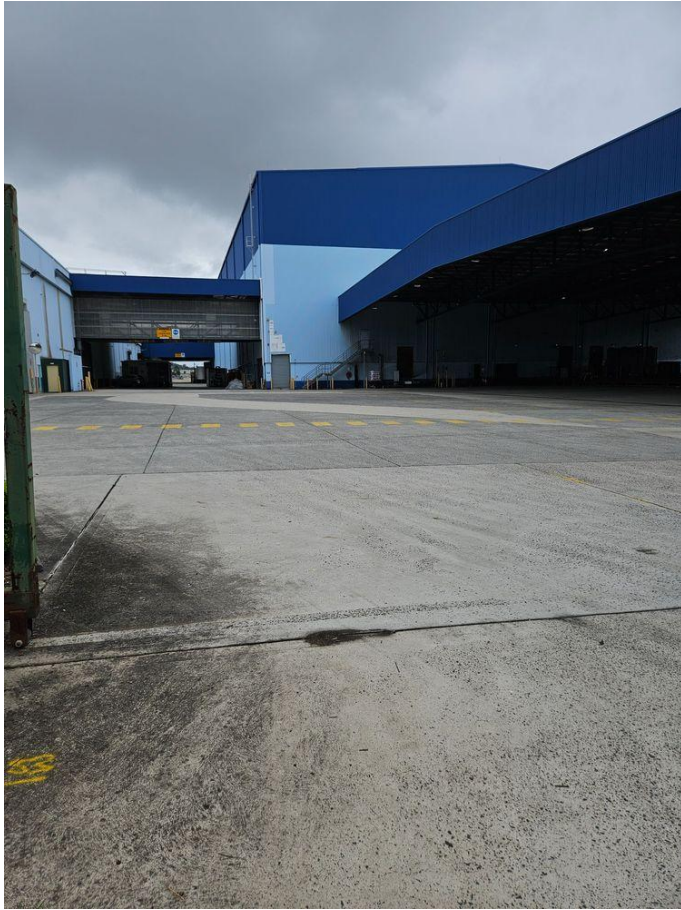
**Photo Description: BOC property.**

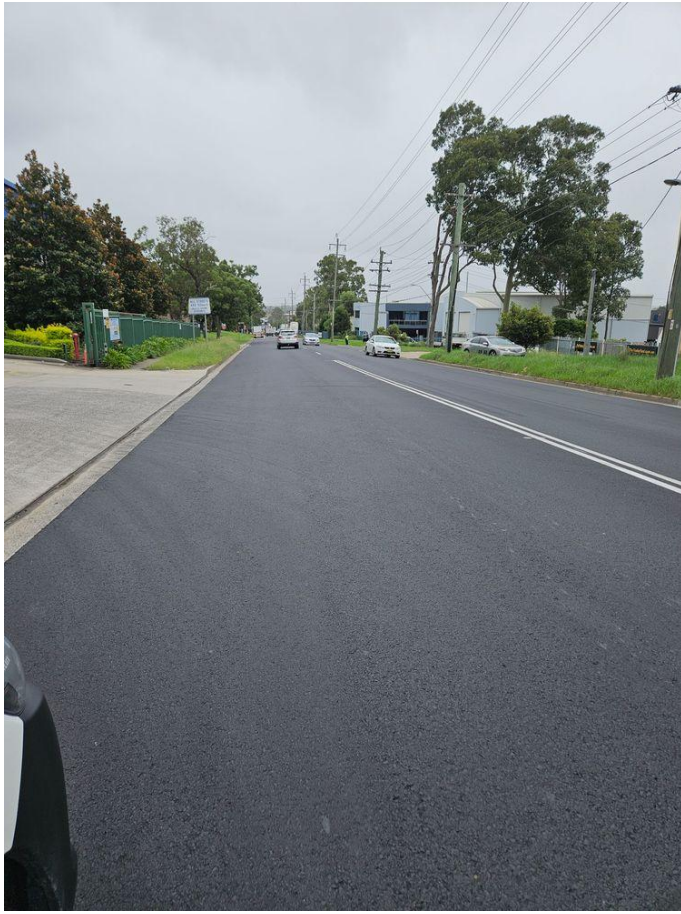
**Photo Description: Newton Rd, facing north.**

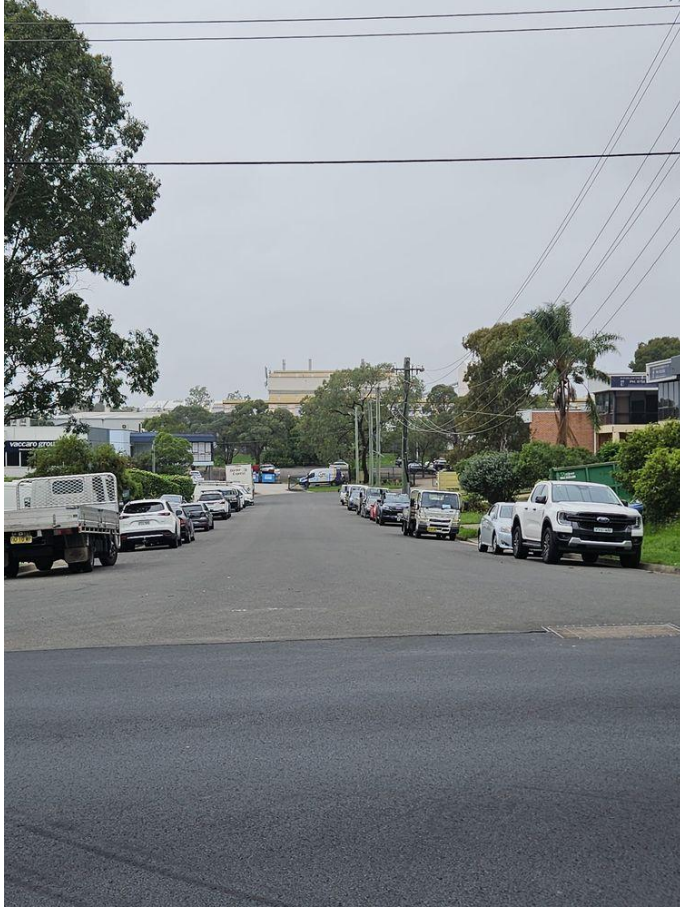
**Photo Description: Centre Pl**

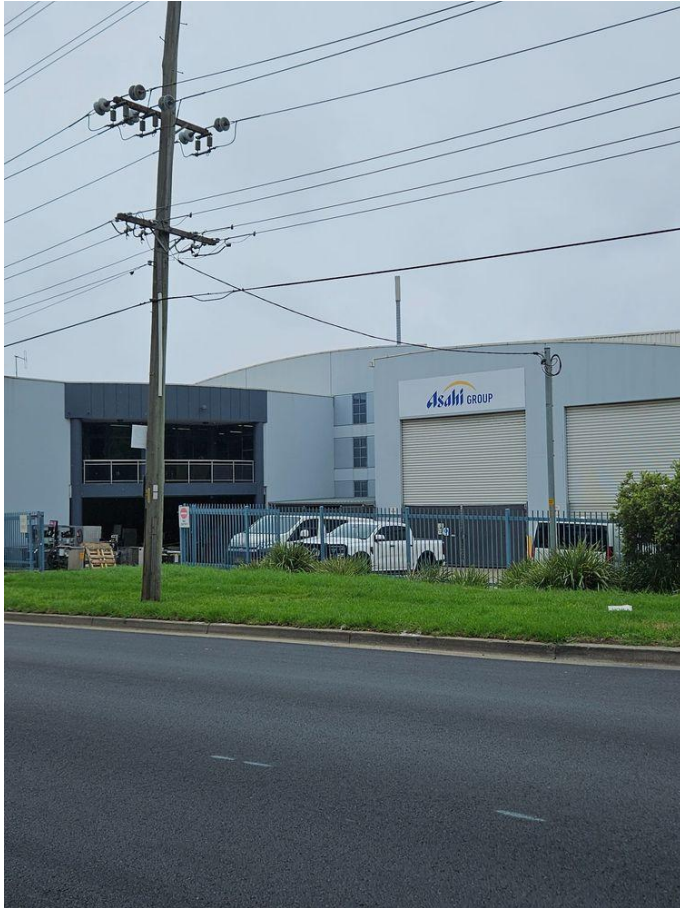
**Photo Description: Commercial property.**

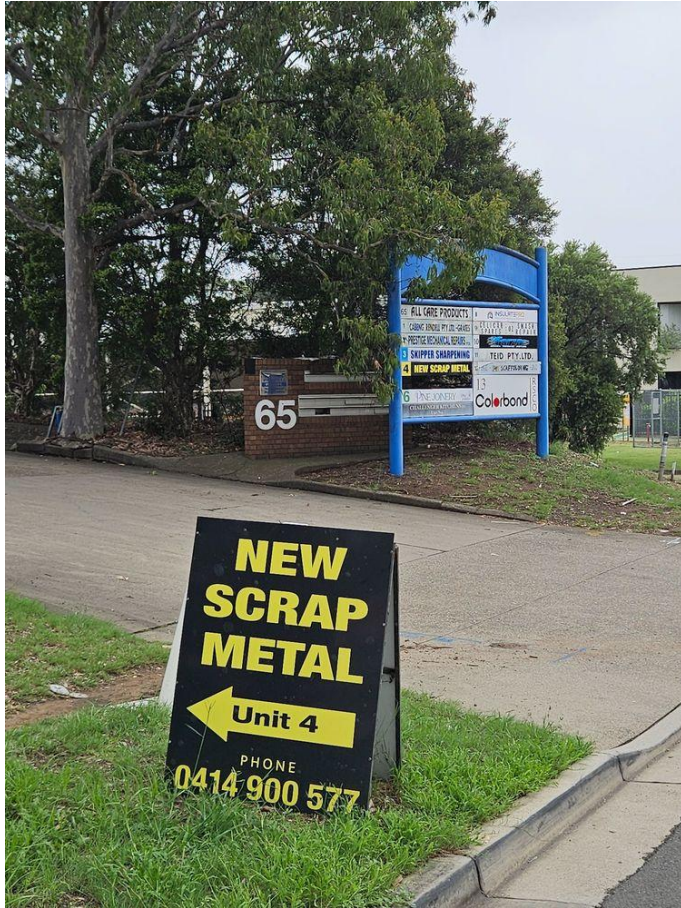
Photo Description: Commercial properties including Colourbond and scrap metal yards.

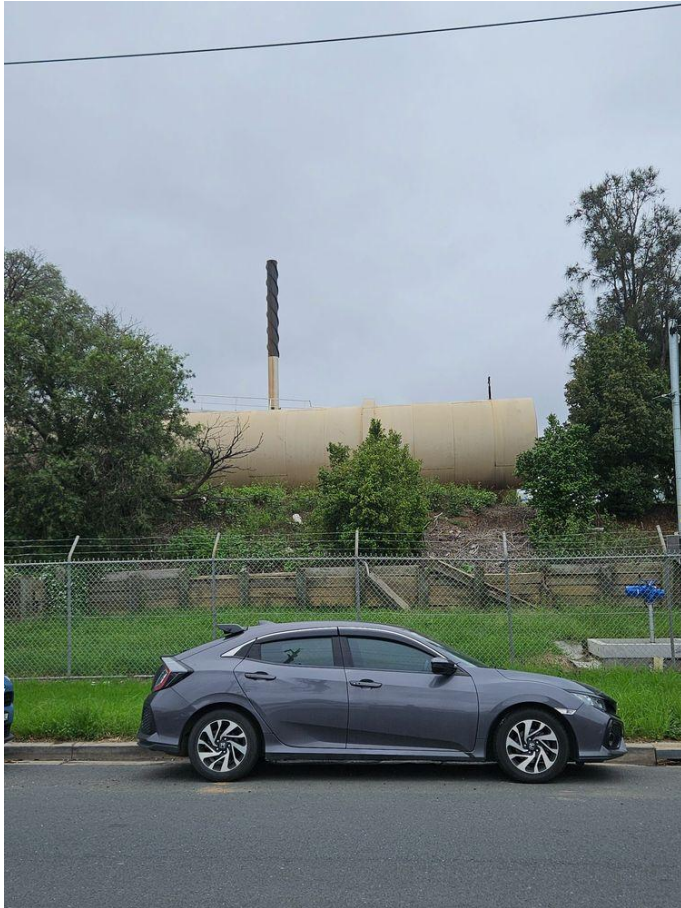
**Photo Description: The back end of the CSR factory.**

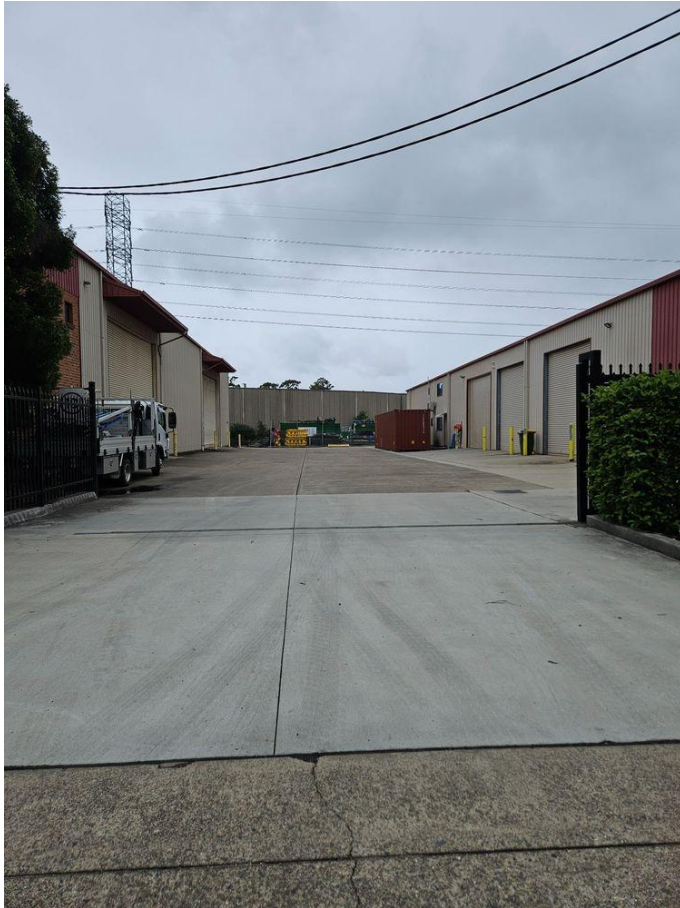
**Photo Description: Timber and moulding business (left) and concrete business (right), with the drainage channel beyond.**

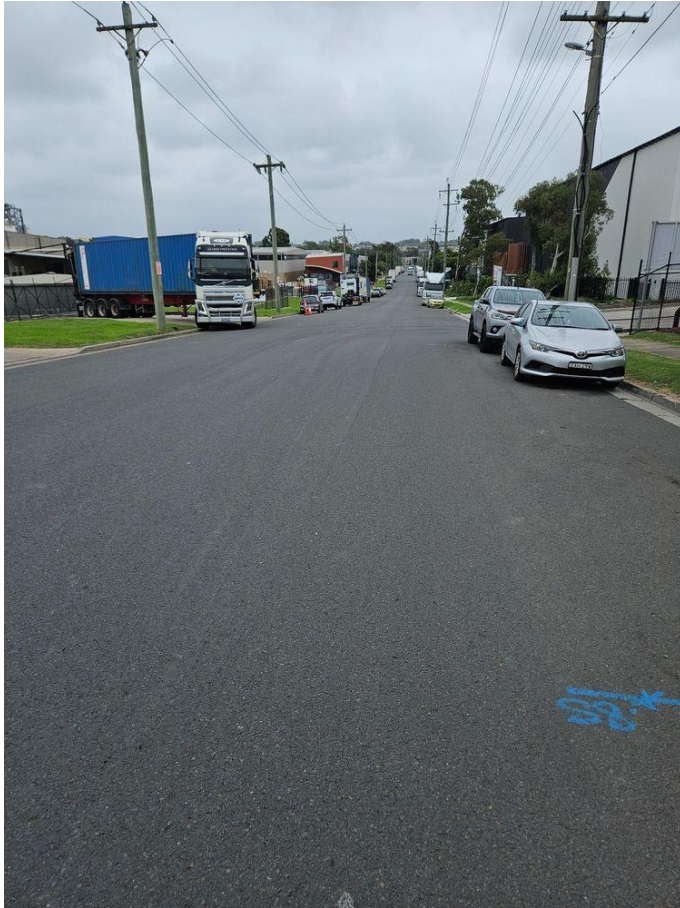
**Photo Description: Topography sloping down from Walter St.**

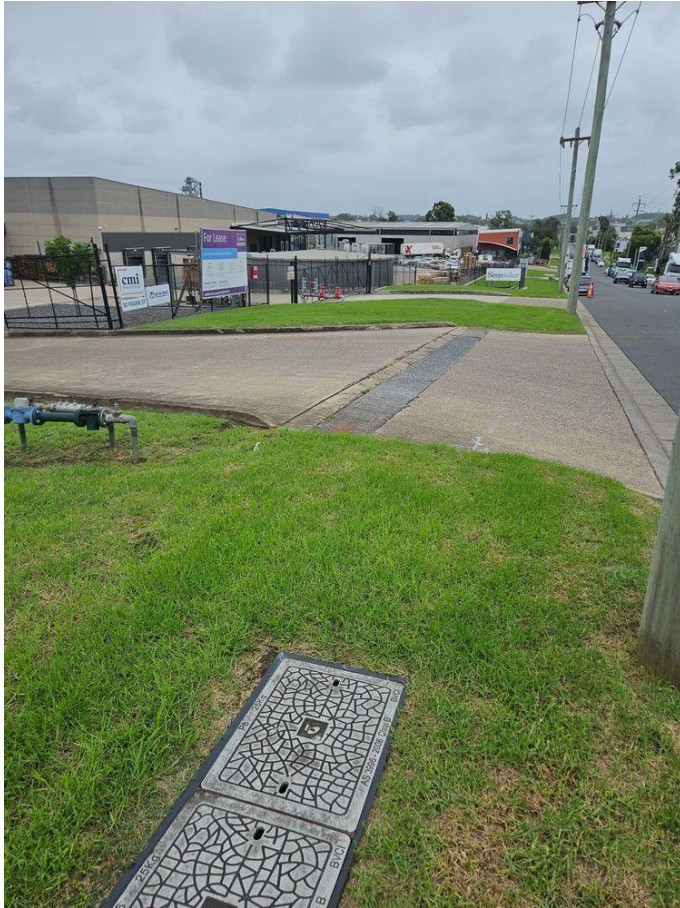
**Photo Description: Commercial/ industrial properties**

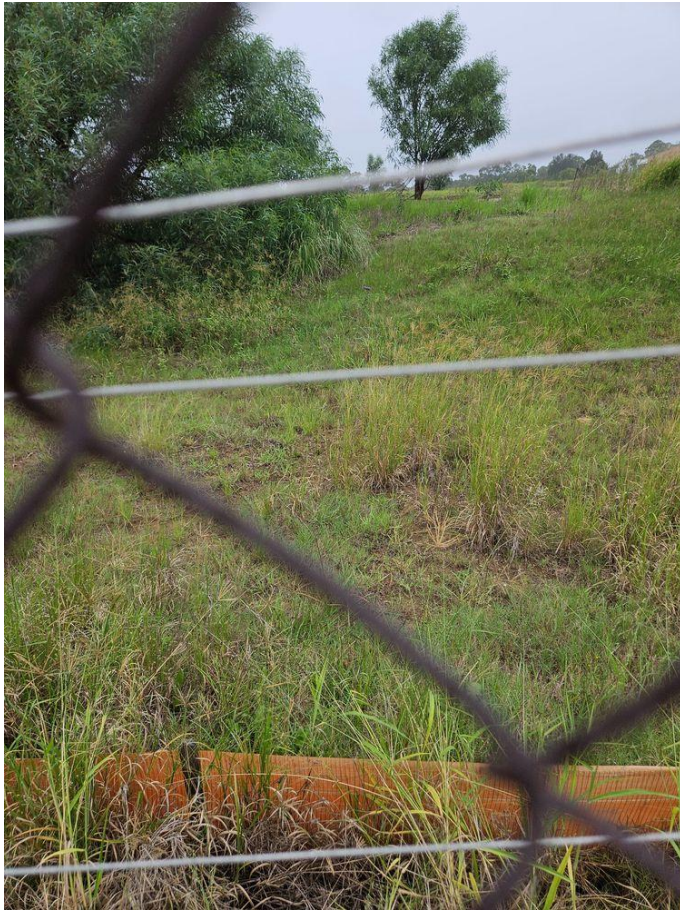
**Photo Description: Potential stockpiling at heavy vehicle station**

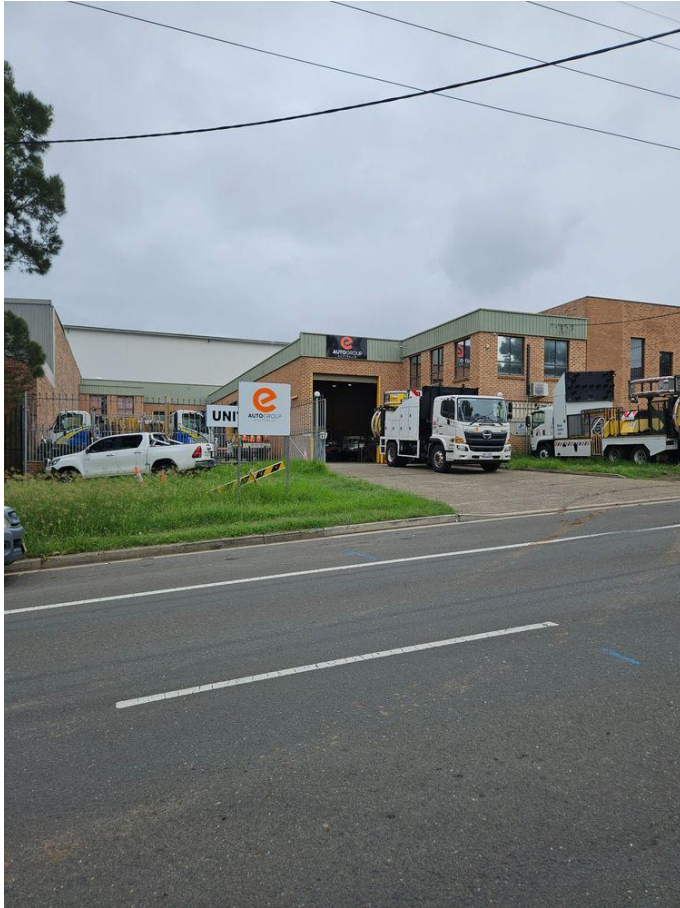
**Photo Description: Mechanical businesses.**

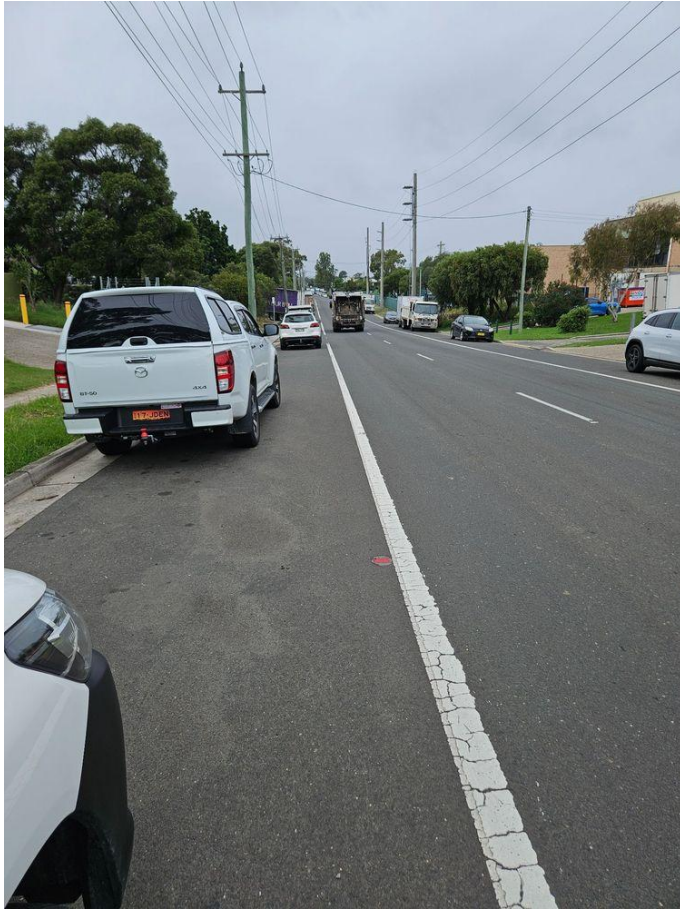
**Photo Description: Gentle downward slope from the corner of Walter St**

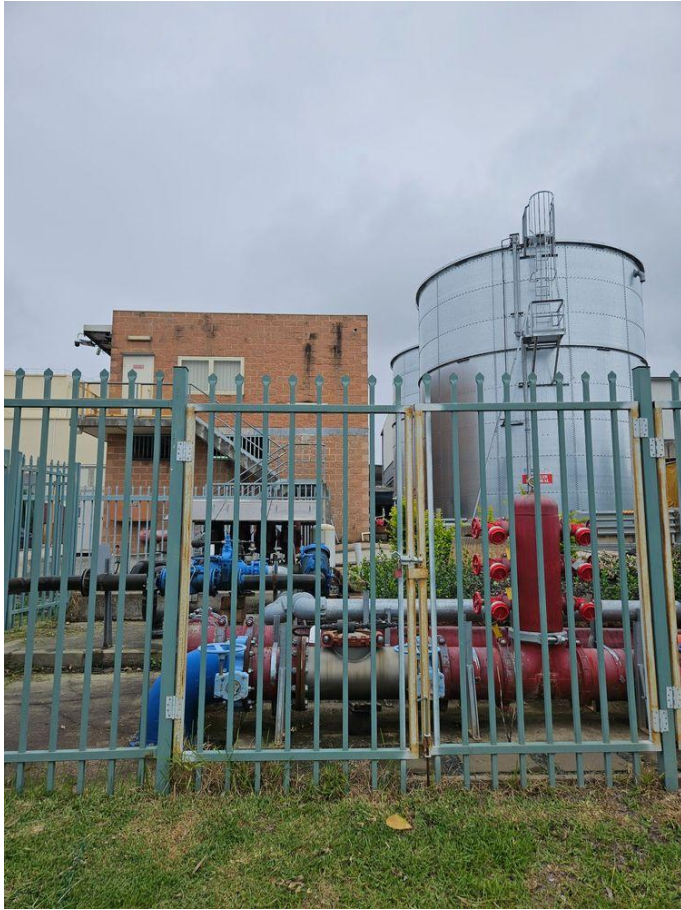
**Photo Description: Potential PFAS infrastructure**

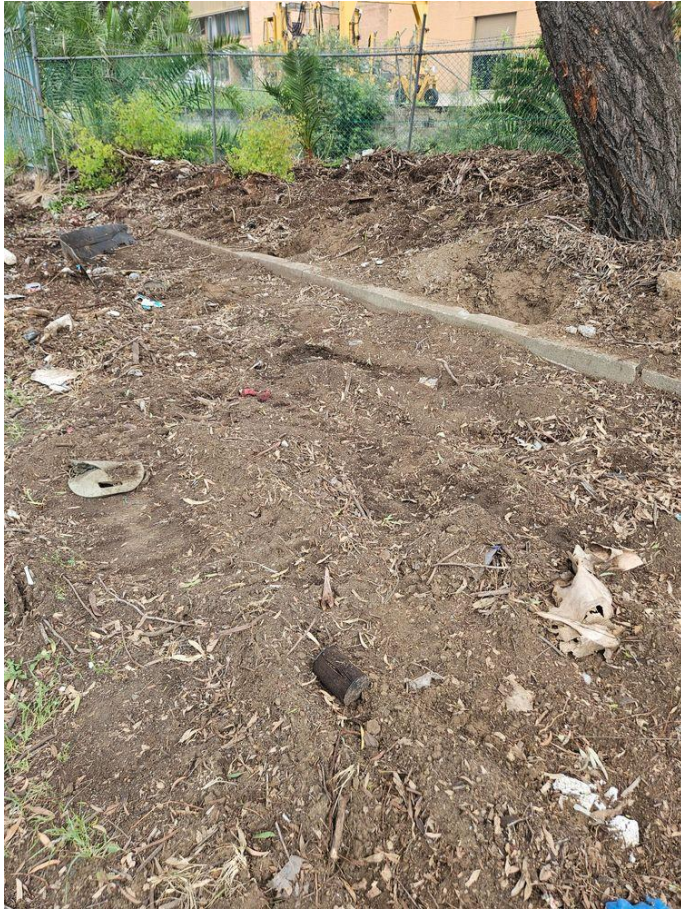
**Photo Description: Underlying silts and clays**

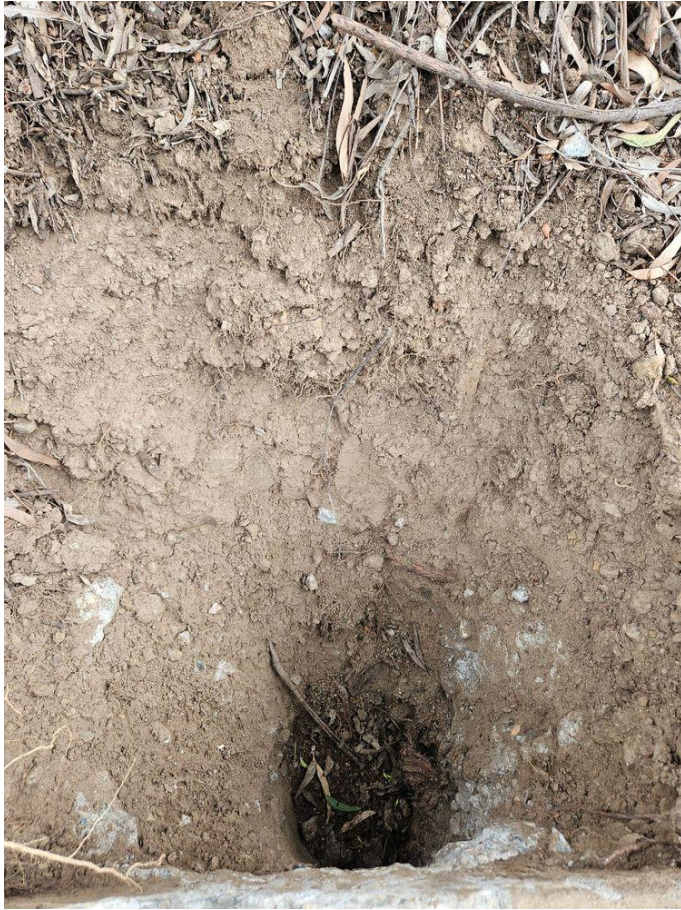
**Photo Description: Subsurface soils**

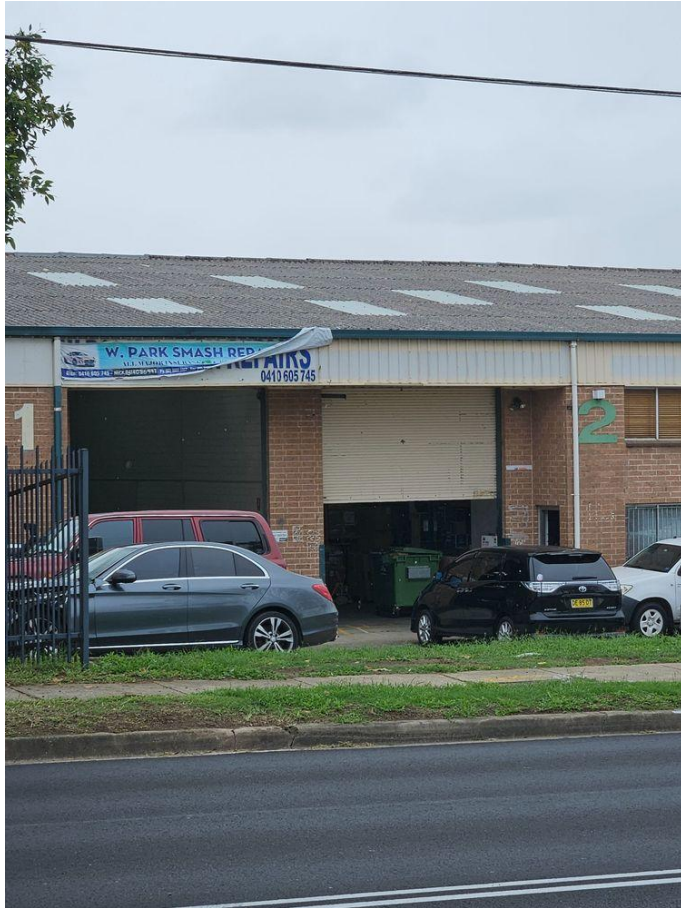
**Photo Description: Smash repairs**

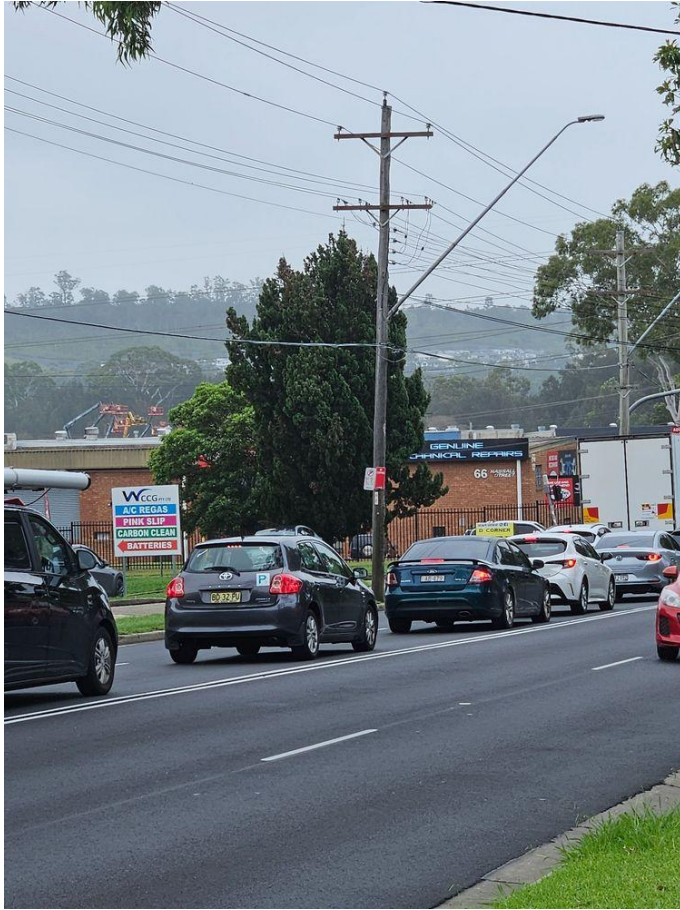
**Photo Description: Motor mechanics**

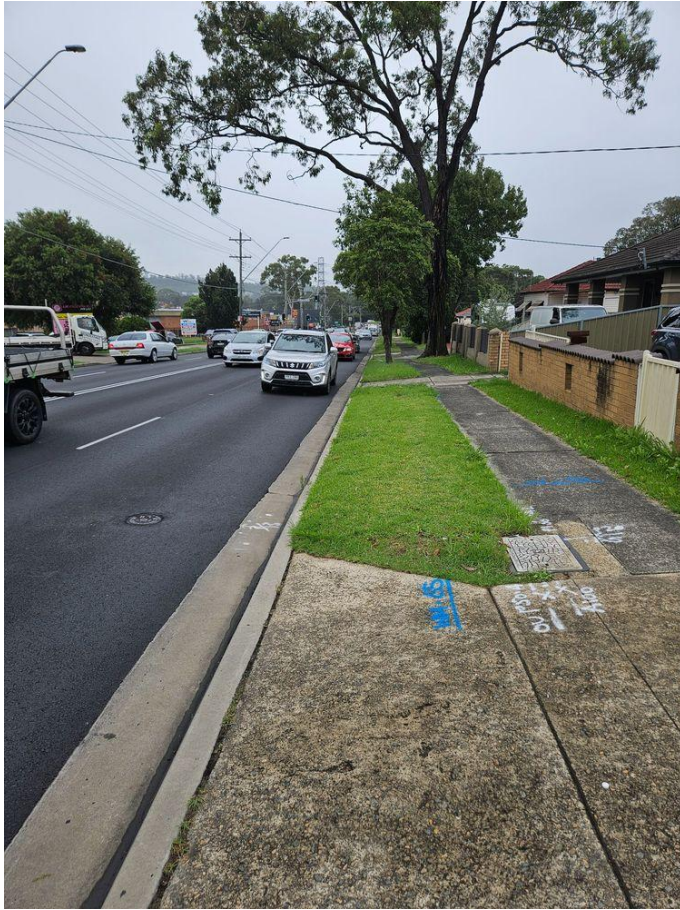
**Photo Description: Hassall St**

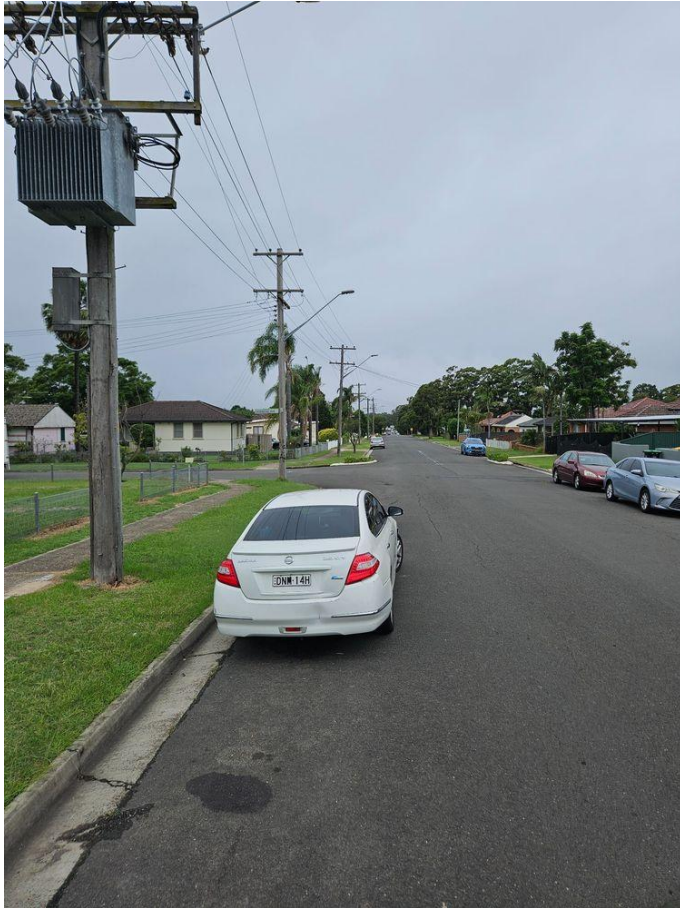
**Photo Description: Residential land use**

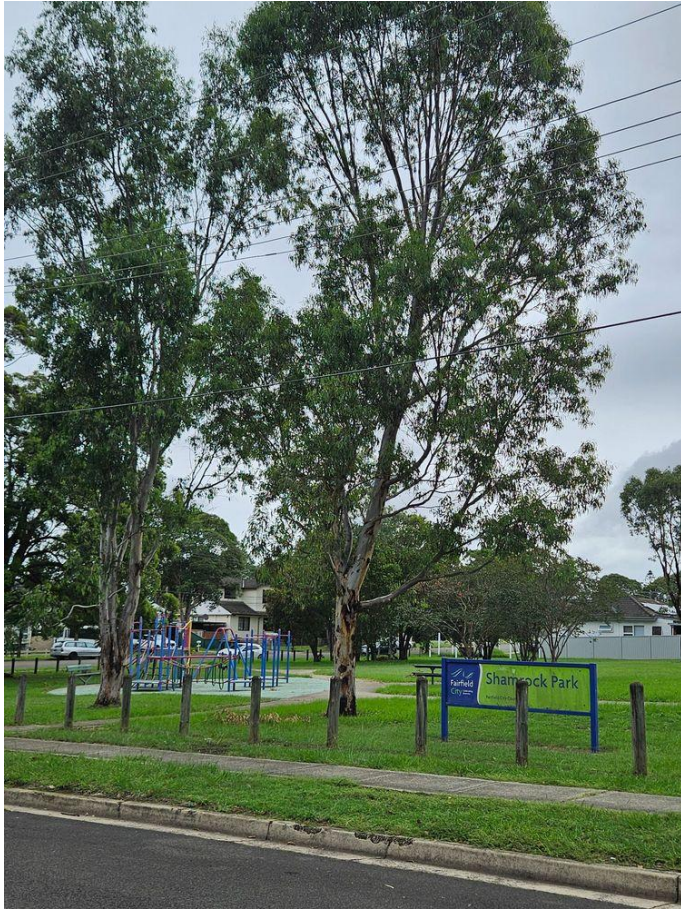
**Photo Description: Shamrock Park**

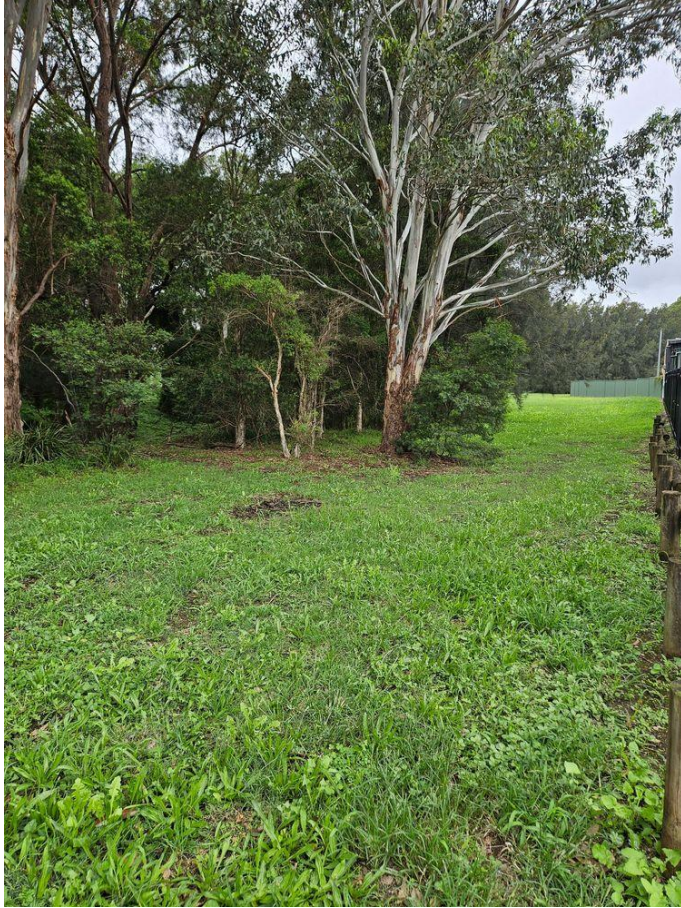
**Photo Description: Fire trail with bushland and creek beyond**

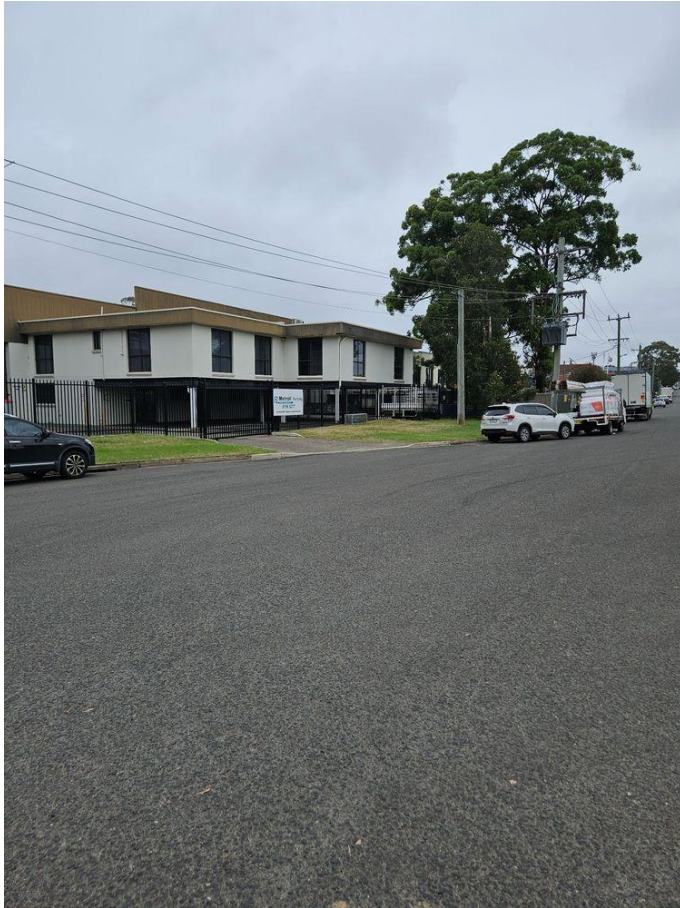
**Photo Description: Commercial / industrial such as joinery businesses**
